**SUBJECT: OYSTER CREEK NUCLEAR GENERATING STATION – NRC INSPECTION
REPORT NO. 05000219/2014009 AND PRELIMINARY YELLOW FINDING/OLD
DESIGN ISSUE**

U.S. NUCLEAR REGULATORY COMMISSION

Report Nos.: 05000219/2014009

Facility: Oyster Creek Nuclear Generating Station

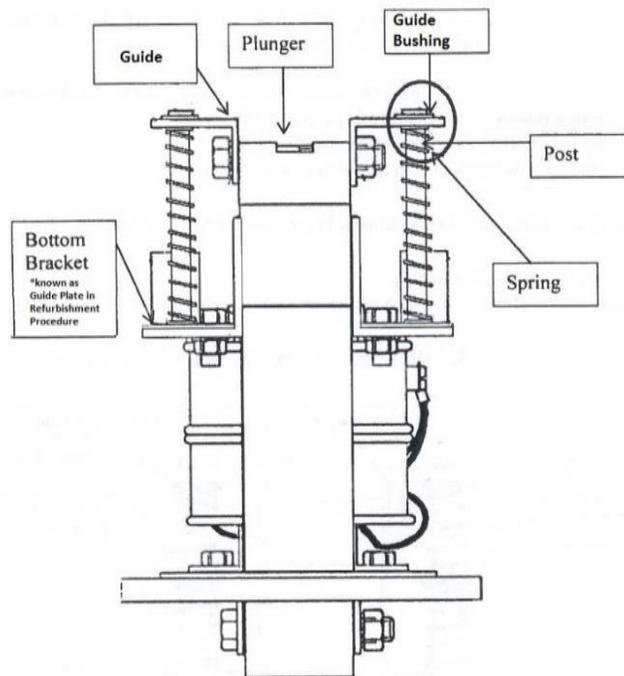
Figure 1. Original Actuator

The EMRV solenoid actuator, as seen in Figure 1 below, includes a "floating design" plunger that rests on two guides on two springs that ride along two posts when the valve is operated. When the valve is energized, the solenoid pushes the plunger downward compressing the spring to open the valve. When the solenoid is de-energized the spring decompresses to move the plunger upward to close the valve.

The inspectors conducted an independent review of this issue and determined that the original design of these valves required that the internal component clearances for the solenoid should be maintained within tight tolerances to limit excessive fretting and wear of the plunger, spring, and guides which can prevent the operation of these components, ultimately affecting the operation of the valves. During valve refurbishment activities completed in accordance with maintenance procedure, 2400-SME-3918.03, step 6.2.25, Oyster Creek maintenance technicians maintain tolerance for these components by bending the bottom bracket as necessary to ensure that the post remains aligned with the guide. The acceptance criterion for this activity, as defined by the procedure step was, "adjust both left and right guide plates (i.e., bottom brackets) and/or posts as required by bending equally until plunger slides smoothly on guides." No specific clearances were specified in the procedure. The inspectors determined that this critical activity was controlled as "skill of the craft." In addition, the inspectors noted that vendor guidance for refurbishment of the EMRV actuator does not provide the necessary acceptance criteria for alignment of the posts to guides to ensure that the springs, posts, and guides do not interact in a way that causes preferential wear of the post allowing the jamming mechanism to exist.

Exelon’s corrective actions for this issue included redesigning the EMRV actuators to ensure the spring is on the outside of the guide bushing, therefore removing the possibility of the spring to enter the guide bushing area and subsequently jamming the actuator, causing valve failure. The EMRVs currently installed in the plant all have this revised design. Exelon also revised procedures for EMRV solenoid operator removal, refurbishment, installation to strengthen preventative maintenance quality (component wear and acceptance criteria, component adjustment tolerances, and transportation guidance).

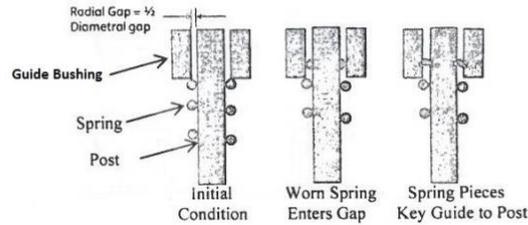
Figure 2. Progression of Wear to Binding

Exelon determined that the failure of the 'B' and 'D' EMRV actuators was due to plunger binding caused by excessive component wear, likely resulting from misalignment between the posts and the guides. This misalignment resulted in an increased gap between the posts and the guides, allowing the spring to enter the gap and wear at a fast rate (see Figure 2 above).

Exelon also concluded the design of the EMRV actuators was inadequate because when they were placed in an environment where the actuator was subject to vibration associated with plant operation, the mechanical tolerance between posts and guides created a condition where the springs could wedge between the guides and the posts jamming the actuator plunger assembly. In addition, Exelon determined that the maintenance procedure for refurbishment of the EMRV actuator did not provide the necessary acceptance criteria for alignment of the posts to guides to ensure that the spring, posts, and guides did not interact in a way that caused excessive wear that allowed the plunger assembly jamming mechanism to exist. Exelon's review of plant operating history concluded that as a result of the design deficiency and inadequate maintenance procedure, the two EMRVs were likely to have been inoperable from July 27, 2012, to October 22, 2012. This conclusion was based on successful actuation of the 'D' EMRV on July 27, 2012. Since the 'D' EMRV exhibited more wear than the 'B' EMRV, it is reasonable to conclude that the 'B' and 'D' EMRVs were operable during the cycle until July 27, 2012.
