2CAN021502

SUBJECT: Anti-Vibration Bar Positioning and Sludge Evaluation Information
Concerning the Spring 2014 Steam Generator Inspections
Arkansas Nuclear One – Unit 2
Docket No. 50-368
License No. NPF-6

**ANTI-VIBRATION BAR POSITIONING AND DEPOSIT LOADING INFORMATION
BASED ON THE SPRING 2014 STEAM GENERATOR INSPECTIONS**

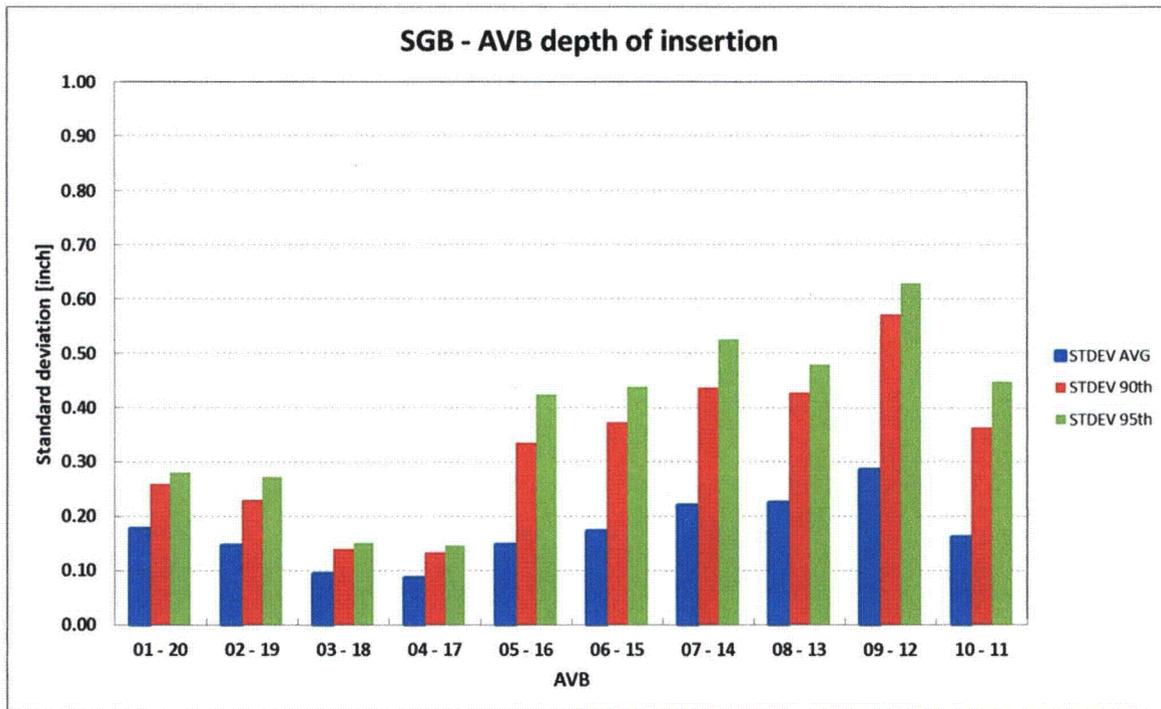
There are AVB assemblies that do not reach typical depth of insertion. The penetration depths are associated with the low row tubes which experience minimal flow velocities. Therefore there is little risk of a vibrational issue. In Figure 2 below, the depth of insertion for the various AVBs

is listed for Steam Generator B (SGB). SGB was bounding for Steam Generator A (SGA). As identified in the figure, the largest 95th percentile value was slightly higher than 0.6 inches of actual versus design depth.

Regular eddy current examination provides bobbin data that is always evaluated for the presence of AVB wear such that if any wear will result due to less than optimal support, it will be detected and reported.

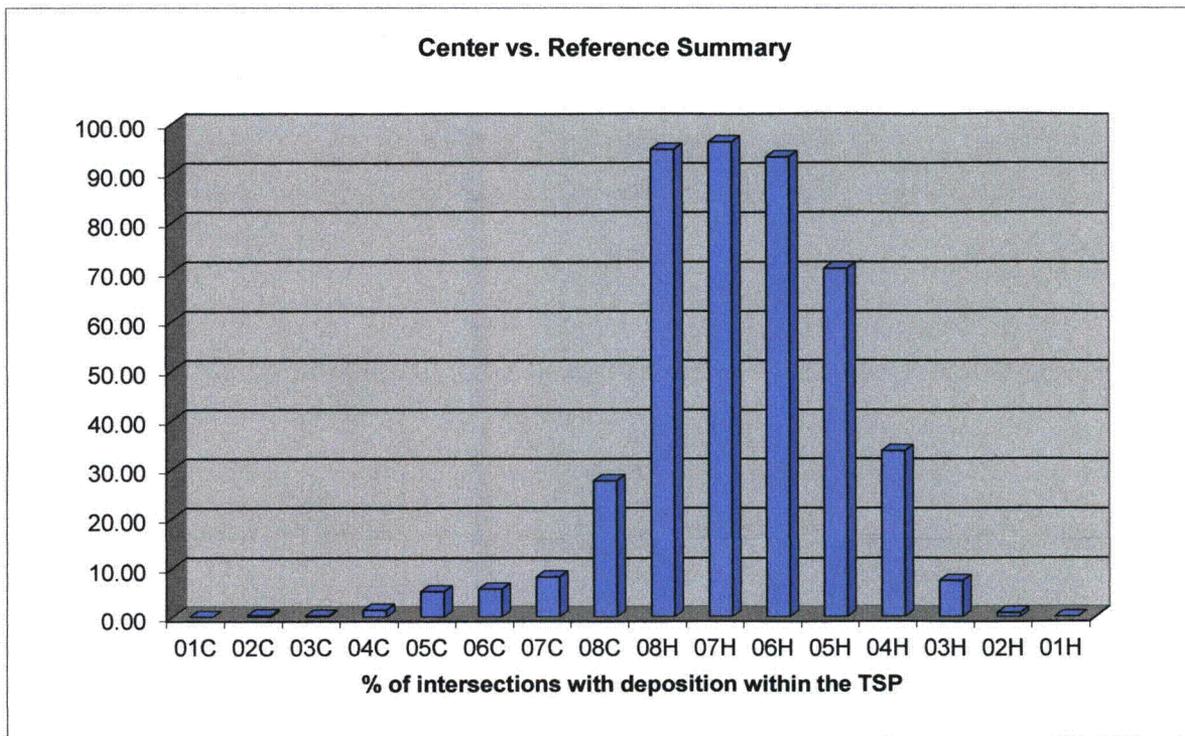
- Deposit is accumulating within the TSP, primarily on the hot leg side.
- Deposit is continuing to increase within the TSP, in both quantities of deposit and percentage of the support affected.
- Based on industry Operating Experience from AREVA deposit mapping analyses at other utilities, deposit will continue to increase adjacent to and within the TSPs at ANO-2.

Figure 3 plots the percentage of broached holes per support plate for SGA which have deposition identified by the "CentRef" measurement (i.e. contained within the support). As seen in the figure, greater than 90% of the hot leg side and 25% of the cold leg side of the TSP have deposit identified within the support. The one inch deposit measurements immediately above and immediately below the support resulted in similar distributions.

SGA 2R23 Tube Depositions at TSPs – “CentRef”

Management of the deposit buildup is being addressed in accordance with EPRI Integrity Assessment guidelines for maintenance of SG secondary side integrity.

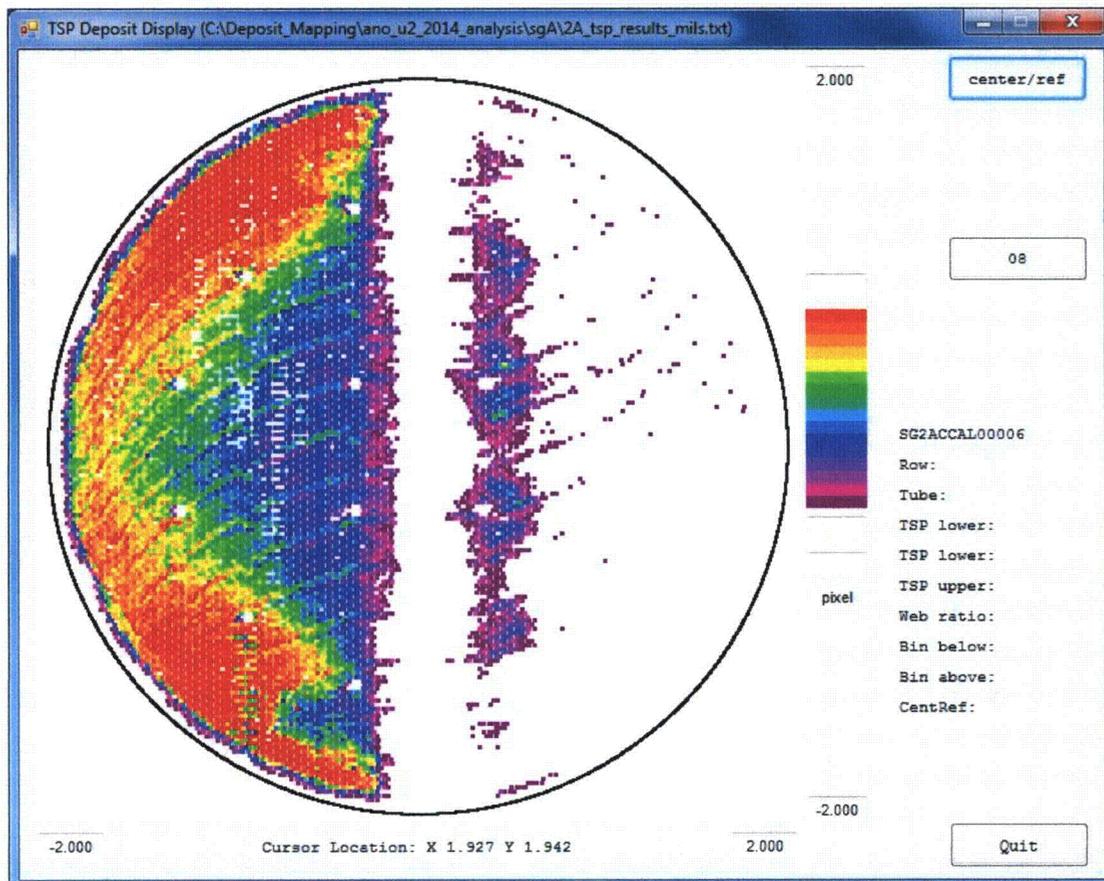
Figure 4 provides a qualitative look at the deposits in SGA. Quantitative values would require development of a specific sludge standard so voltage can be related to sludge depth.

SGA 2R23 Top Support Plate Deposition Profile – “CentRef”
