LOST CREEK ISR, LLC

February 11, 2015

**Re: Report of Unplanned Release 11402
Lost Creek ISR Project SUA-1598**

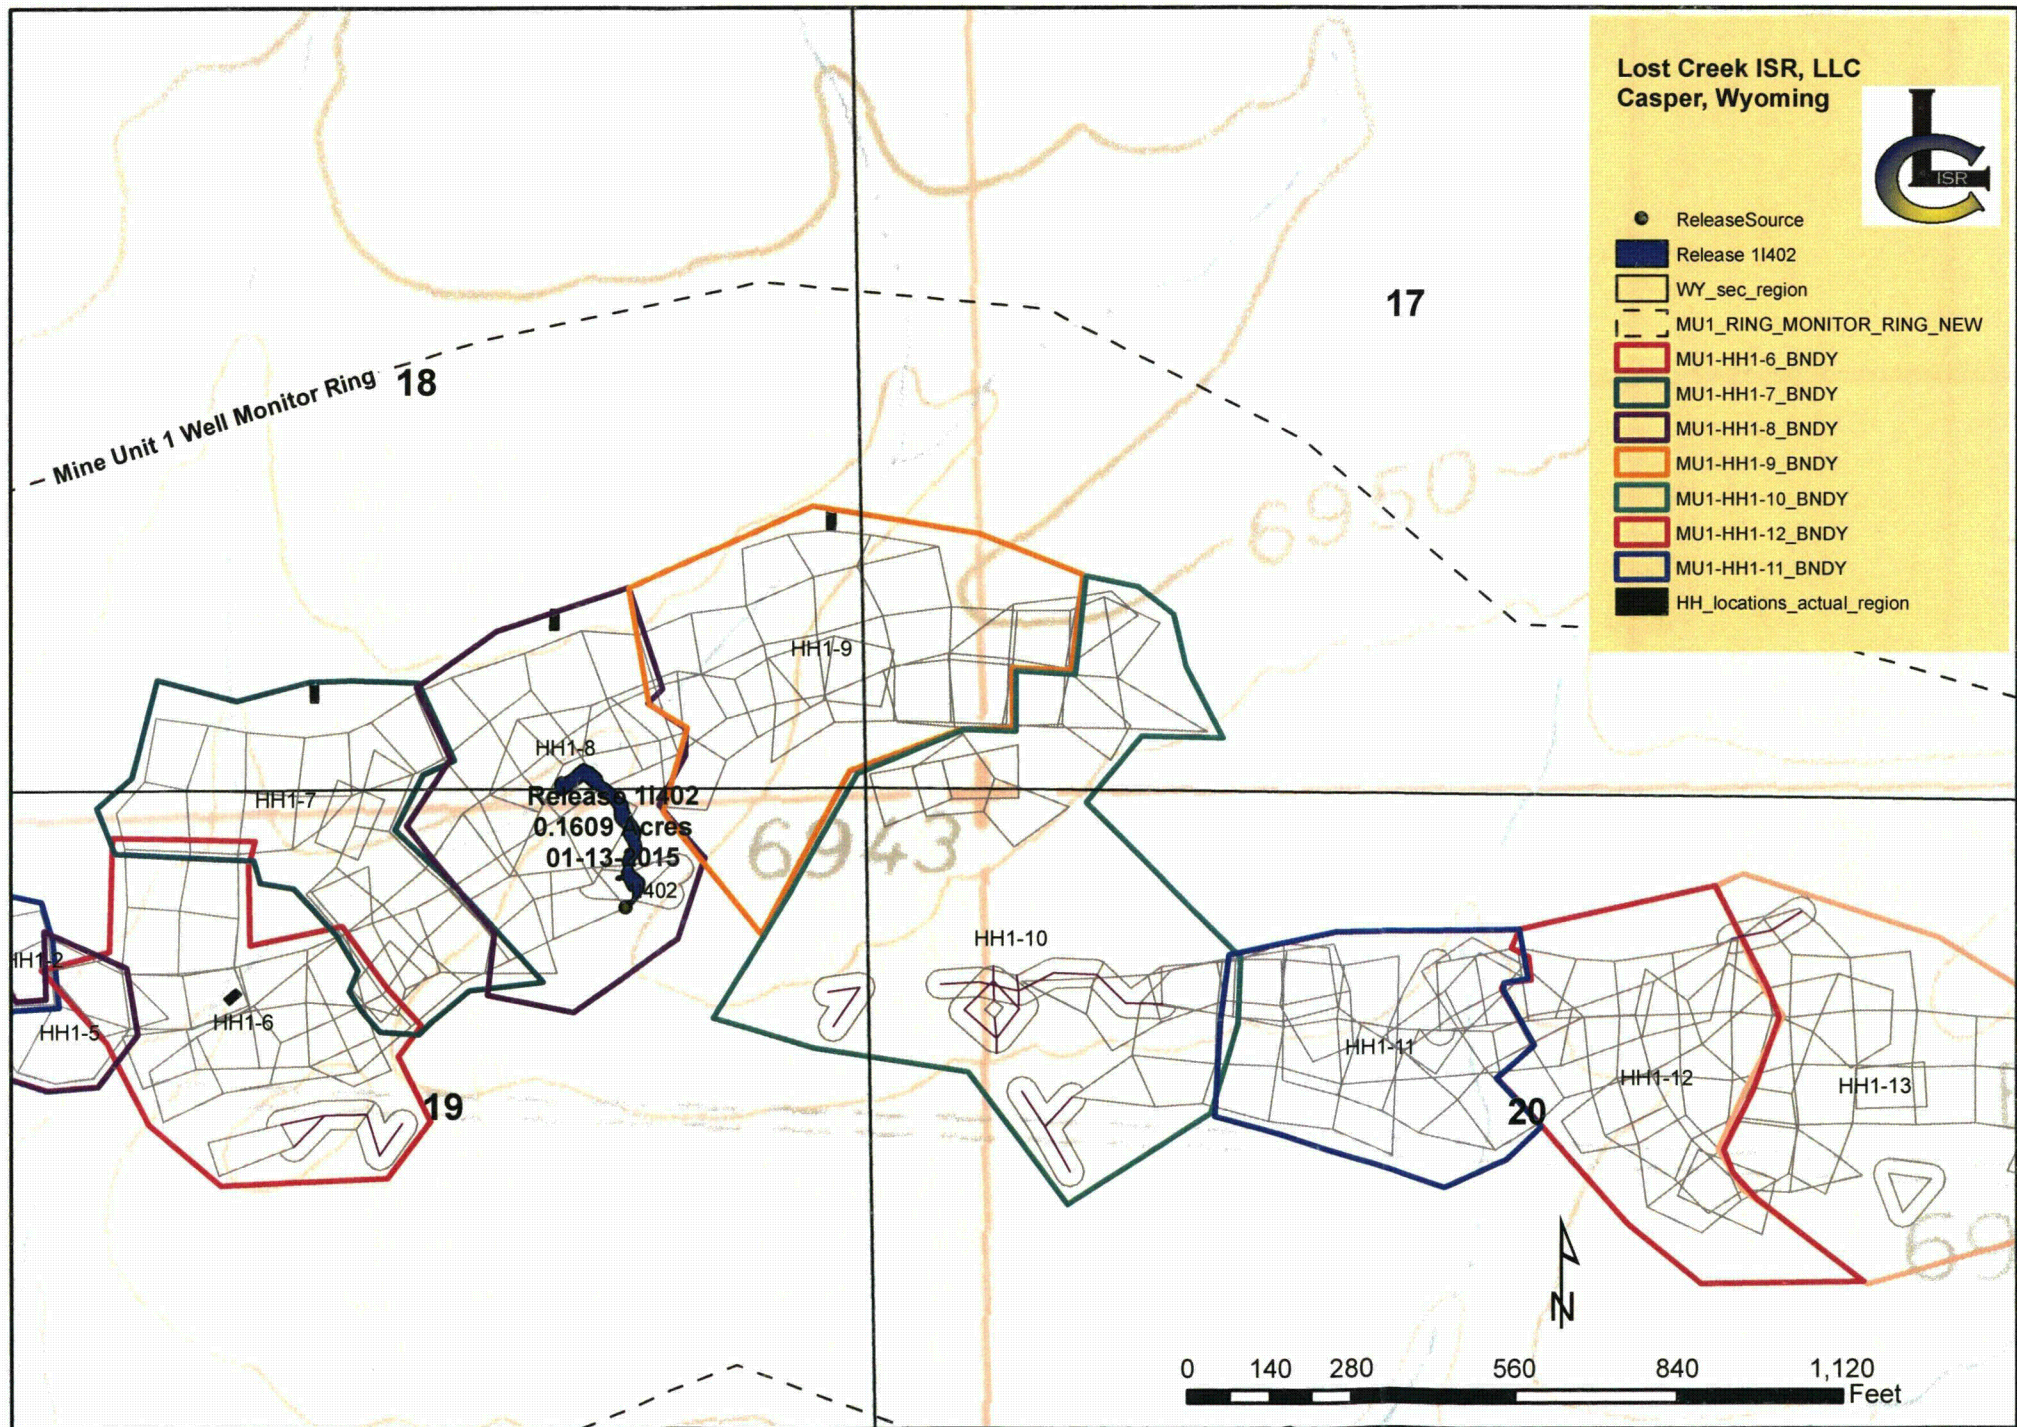
Figure 1: Release 11402 (NE Sec 19, T52N, R92W)

Pursuant to License Condition 11.6, Lost Creek ISR, LLC ("LCI") hereby provides a written report detailing the inadvertent release of injection fluid that was reportable to the Wyoming Department of Environmental Quality (WDEQ). Notification of the release was submitted to WDEQ via webpage (Incident ID 150113-1214) and e-mail (Brian Wood) and to the NRC via email (John Saxton and Linda Gersey) on January 13, 2015. Volume released was originally stated as approximately 817 gallons but the number was actually in cubic feet and had not been converted to gallons. The volume converted to gallons is approximately 6,128 gallons. The release originated from injection well 11402 which is south of Header House 1-8 (HH1-8) in the NE-NE quarter-quarter of Section 19, T25N, R92W shown on **Figure 1** attached.

A wellfield operator discovered the leak on January 13, 2015 during wellfield operations. The cause of the release was an open vent valve on the wellhead that was left open due to human error. The HH1-8 zone had just initially been brought online for production and the valve was likely overlooked and not closed prior to startup. It was not known when the spill started thus the spill volume, determined by size of affected area, was estimated at approximately 6,128 gallons. The injection fluid was sampled at the header house, representative of the released fluid, and analyzed by the onsite lab yielding a concentration of natural uranium of 2.3 ppm. Soil sampling for U-nat and Ra-226 analysis will be conducted when soil has thawed and is amenable to collection.

- The valve was closed to stop the flow
- A Wellfield Operator inspected all of the wells in the HH1-8 for open valves or any other apparent issues. Other vent valves were discovered to be open in the area but had not resulted in a release and were subsequently closed.

- Wellfield inspection and operation procedures were reviewed by the Wellfield Superintendent and were determined to be adequate. Refresher training on the procedures was provided by the Superintendent for the wellfield operations personnel.
- No changes to the procedures were required but the pre-startup wellfield authorization checklist (OPS-051A) was edited to include an inspection item for the vent valves.
