5.0 Falls City, Texas, Disposal Site

5.1 Compliance Summary

6.0 Grand Junction, Colorado, Disposal Site

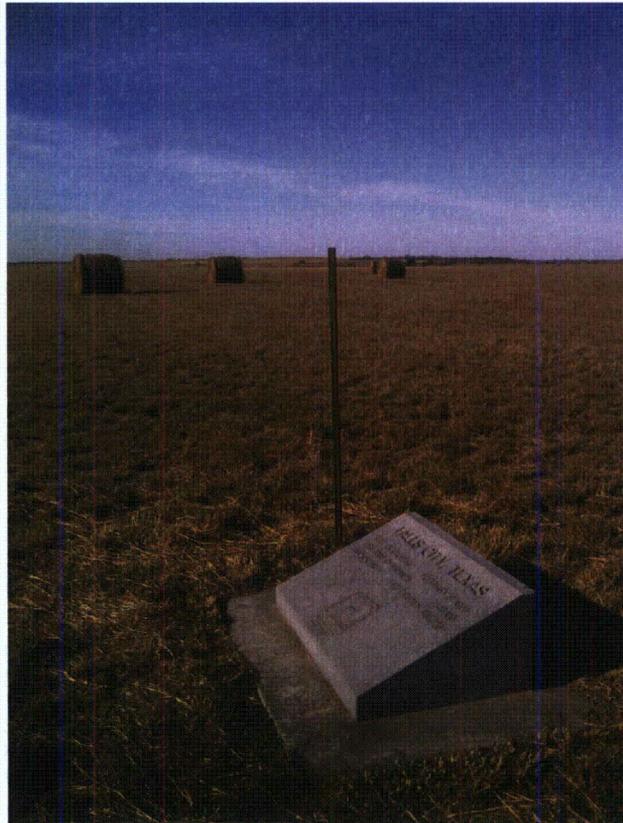
There are two site markers. The marker on top of the disposal cell (SMK-2) was in excellent condition (PL-1). The marker at the main entrance gate (SMK-1) was also in excellent condition (PL-2), but the corners of the concrete base that the marker sits on are cracked. The cracks appear to be unchanged from last year, and repairs are not needed at this time.

FCT 1/2014. PL-1. Site marker SMK-2.

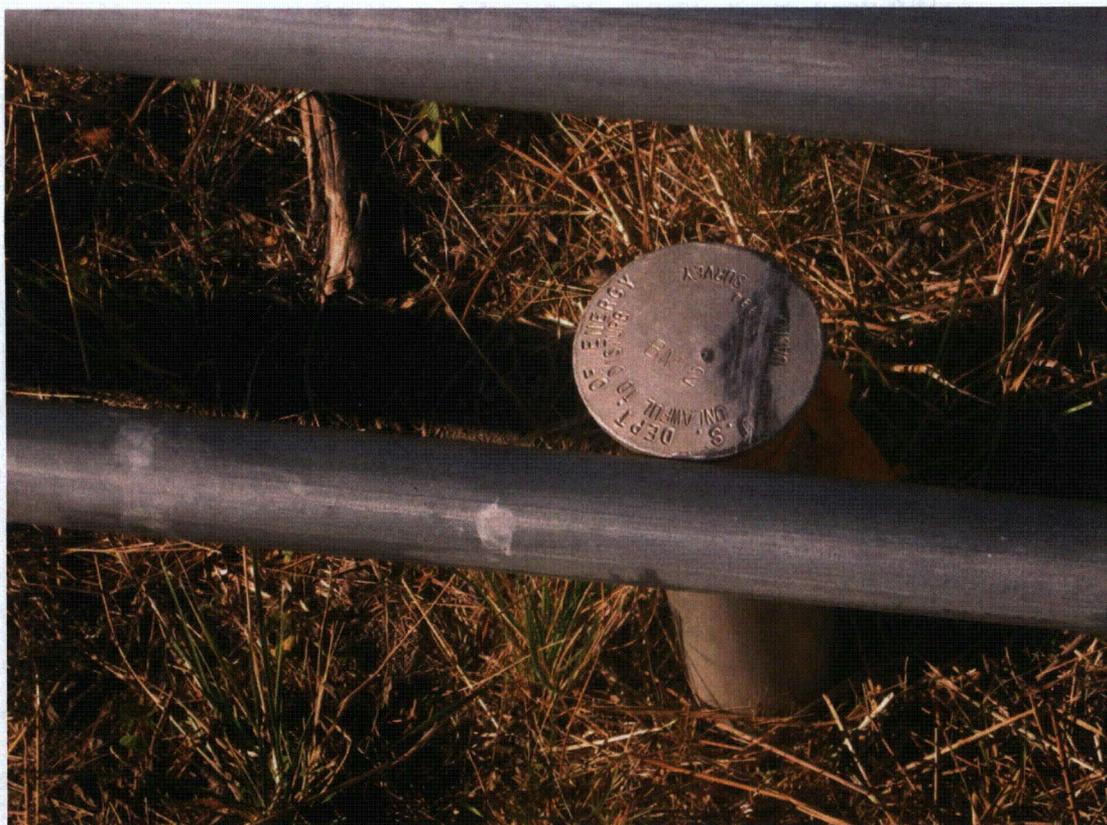
Three survey monuments and two boundary monuments situated at the corners of the site were undisturbed and in excellent condition (PL-3).

FCT 1/2014. PL-3. Boundary monument BM-2.

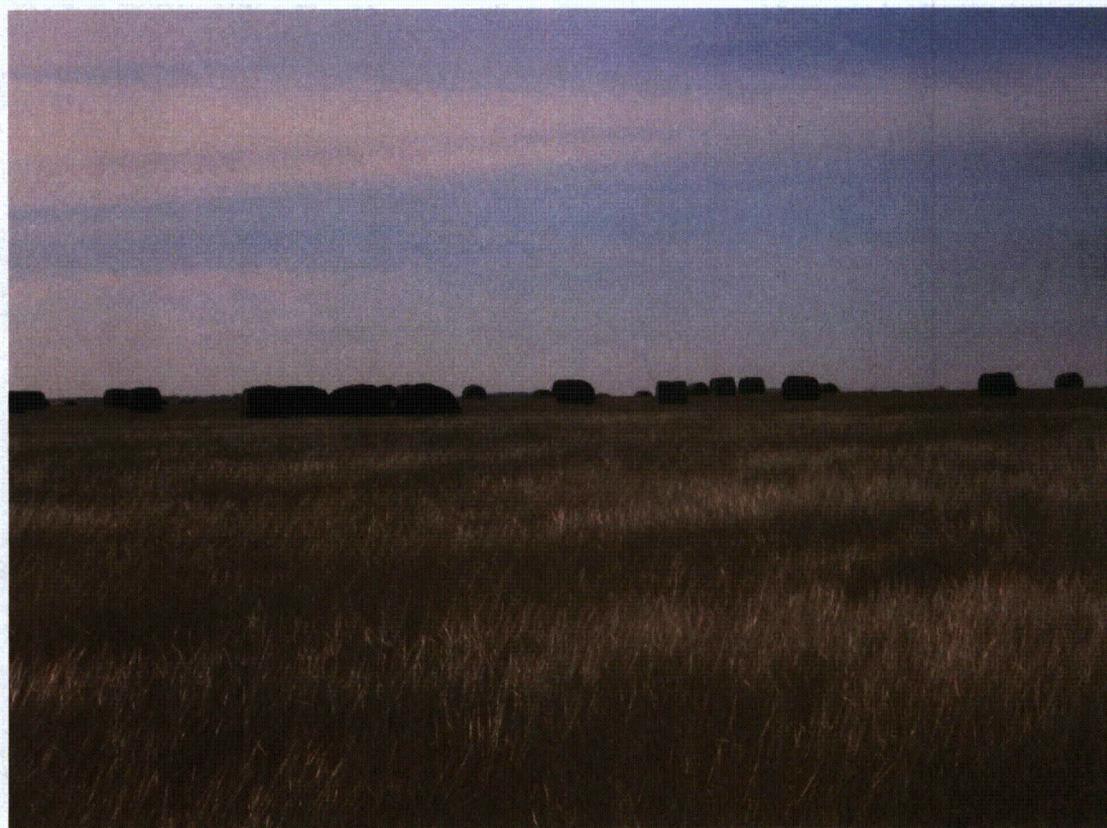
The top of the disposal cell was in excellent condition (PL-4). The cell is covered with well-established coastal Bermuda grass. Kleingrass and other species are interspersed. The site maintenance subcontractor typically takes three cuttings of hay each year from the property, which includes the top of the disposal cell.

FCT 1/2014. PL-4. Hay bales on top of cell.

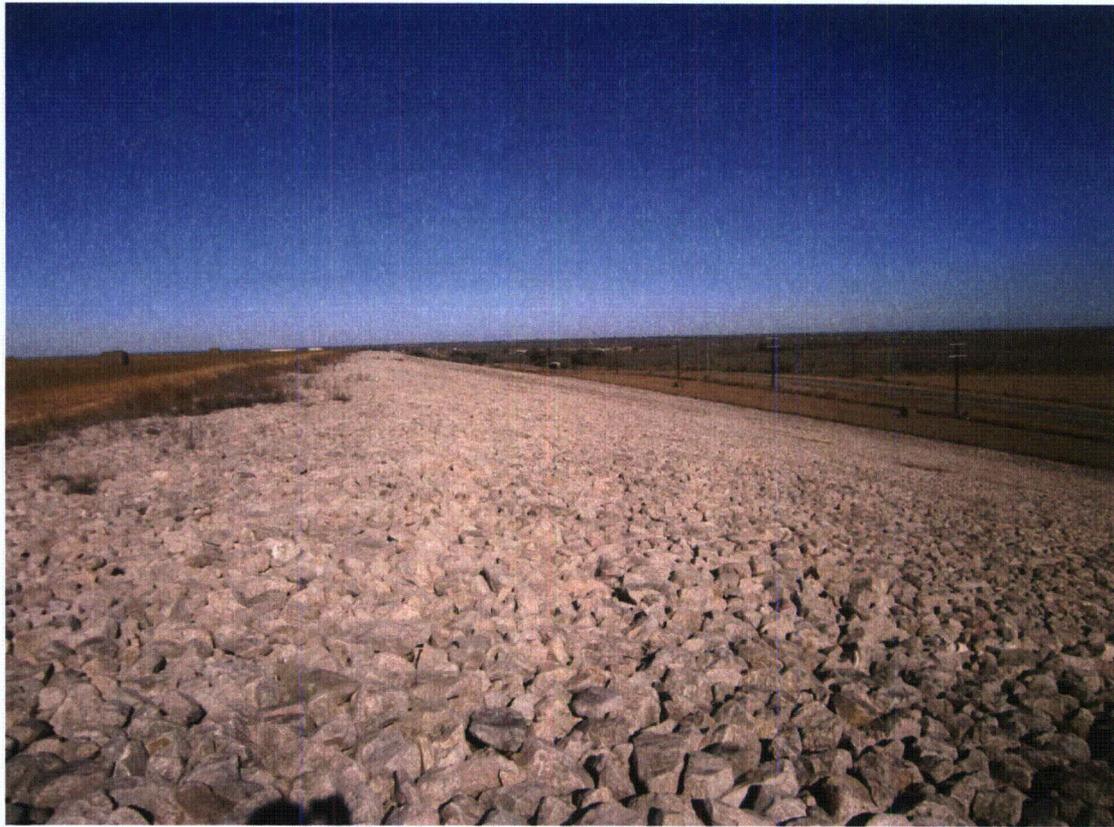
The side slopes are covered with riprap and were in excellent condition (PL-5). A couple of small riprap disturbances (depressions) were observed on the northwest side slope of the disposal cell during the 2010 inspection. These depressions do not compromise the protectiveness of the riprap side slope and no changes have been observed since 2010.

FCT 1/2014. PL-5. Northwest side slope.

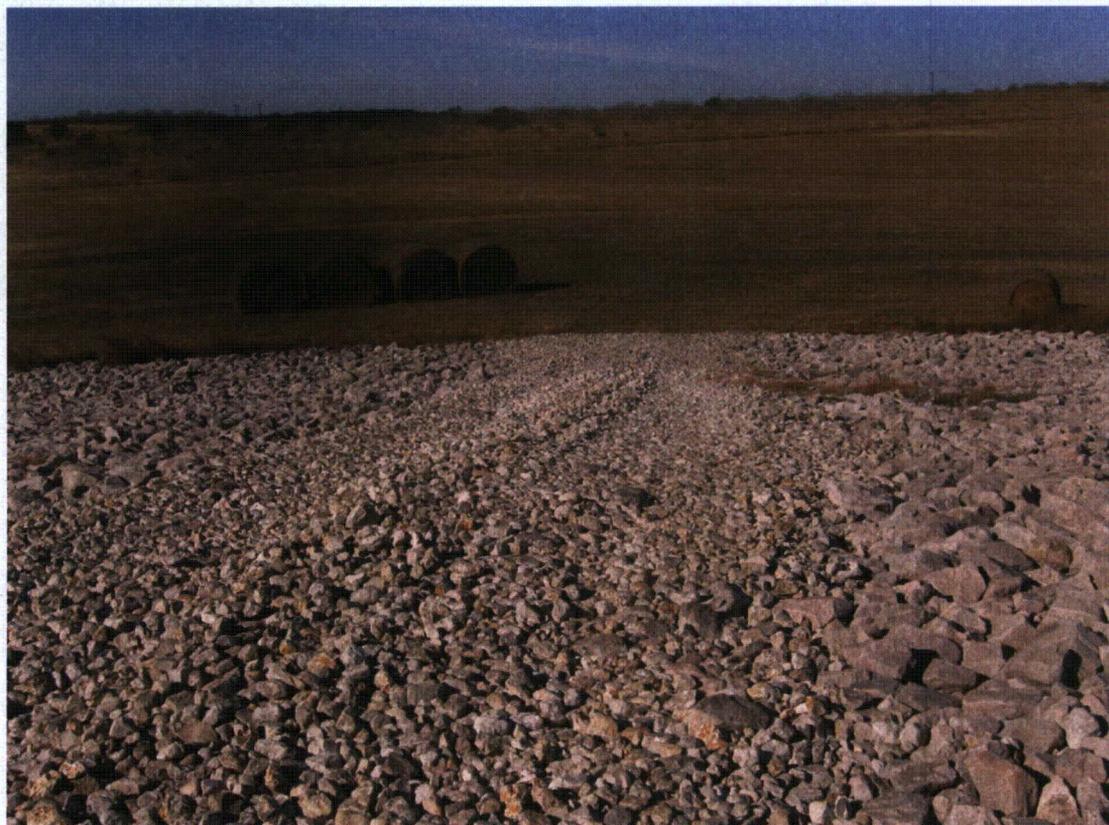
An equipment access ramp to the top of the cell is located at the west corner of the side slope (PL-8). The ramp was installed in 2008 and constructed with clean angular riprap of progressively smaller sizes of rock to provide a free-draining and stable driving surface that does not encourage vegetation encroachment. Vehicle wear to the ramp has occurred, but the ramp remains serviceable.

FCT 1/2014. PL-8. Equipment access ramp at west corner of cell.

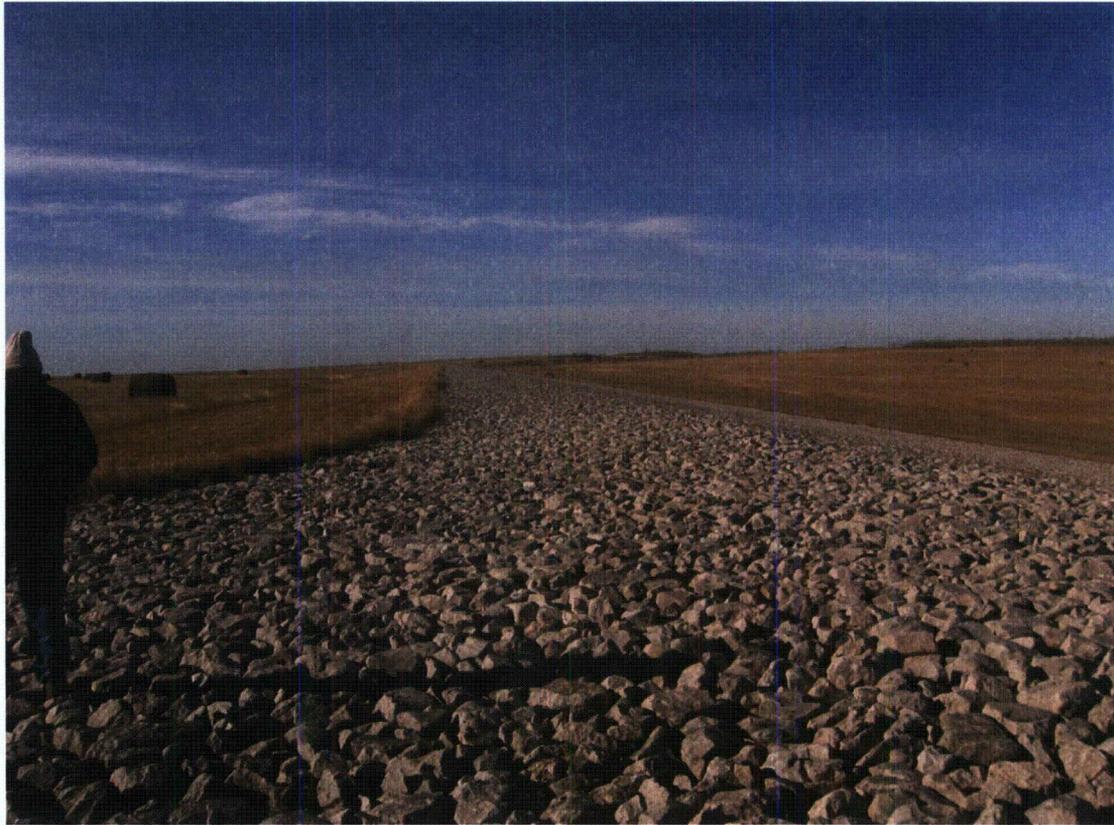
Vegetation management on the cell and side slopes was excellent (PL-9). Much of the vegetation observed during the inspection on the side slopes was either dead or dormant grass. Deep roots of woody vegetation could penetrate the radon barrier, so the vegetation is controlled through cutting and applying herbicide.

FCT 1/2014. PL-9. Northwest side slope.

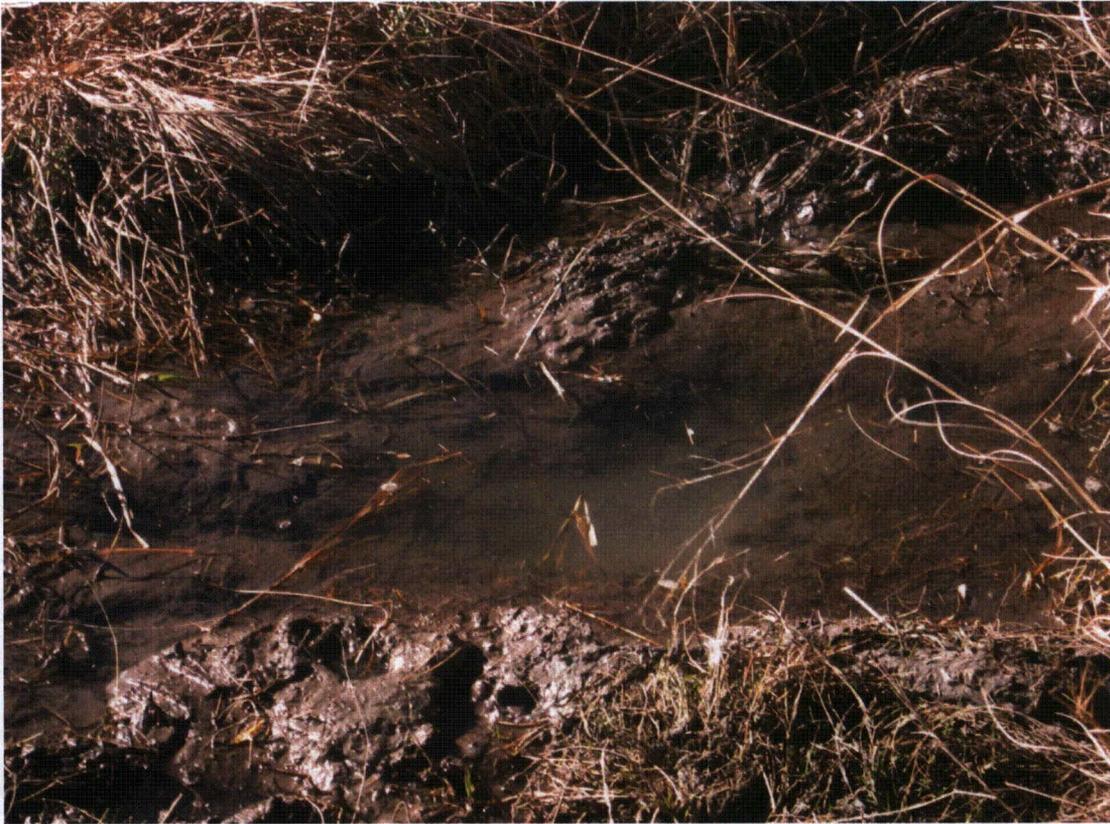
No water was flowing in the south rock drain during this year's inspection, but water was ponded at the end of the drain (PL-11). No water was observed in the north rock drain. Vegetation is left uncut at the outlets of the rock drains to assist in dissipating the energy of site runoff during storm events. Baffling the flow of water at the outlets helps to alleviate soil erosion near the outlet areas during large precipitation events. Tall thick grass at the drain outlets is therefore considered to be a desirable feature. Vegetation in the apron outfall, located midway along the northeast side slope, is being properly managed.

FCT 1/2014. PL-11. Water ponded at outlet of south rock drain.

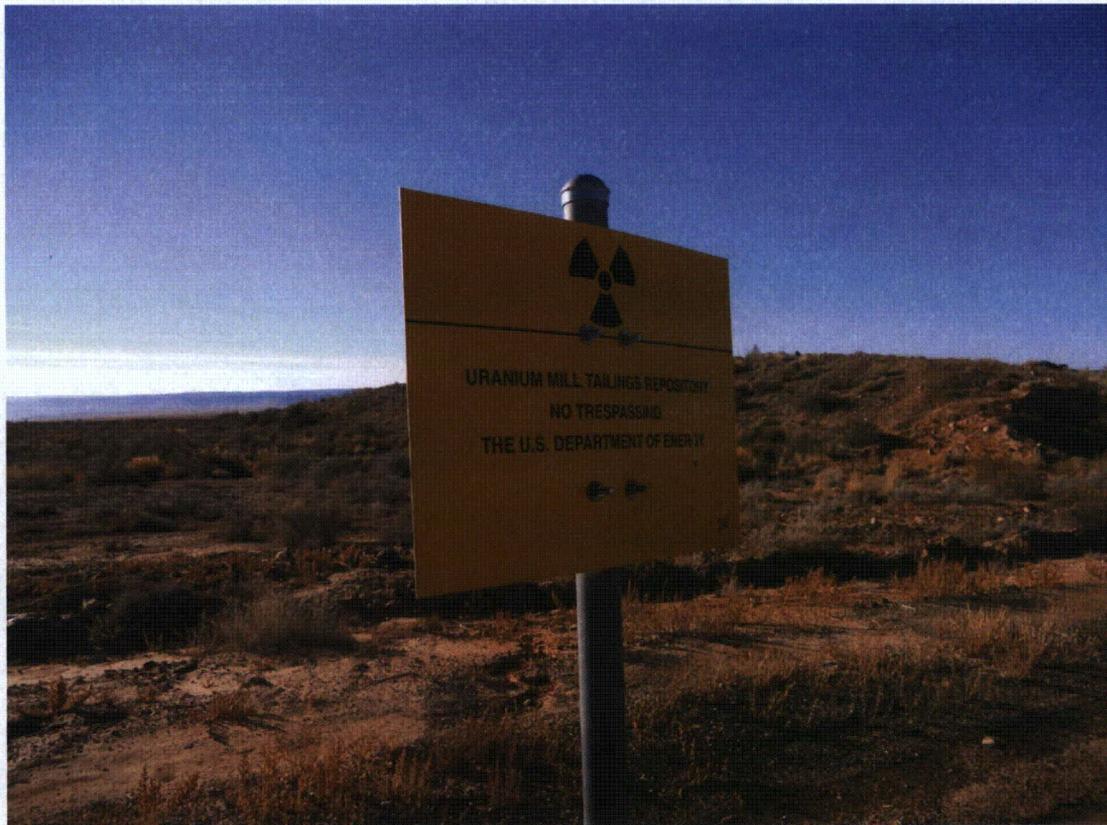
6A A total of 29 perimeter signs are at regular intervals along the DOE property boundary. The signs are installed on galvanized steel posts set in concrete. Damaged perimeter sign P17 was replaced prior to the inspection. Signs P4 and P16 were slightly bent but legible. All of the other signs were in good condition (PL-1).

GRJ 12/2014. PL-1. Perimeter sign P24.

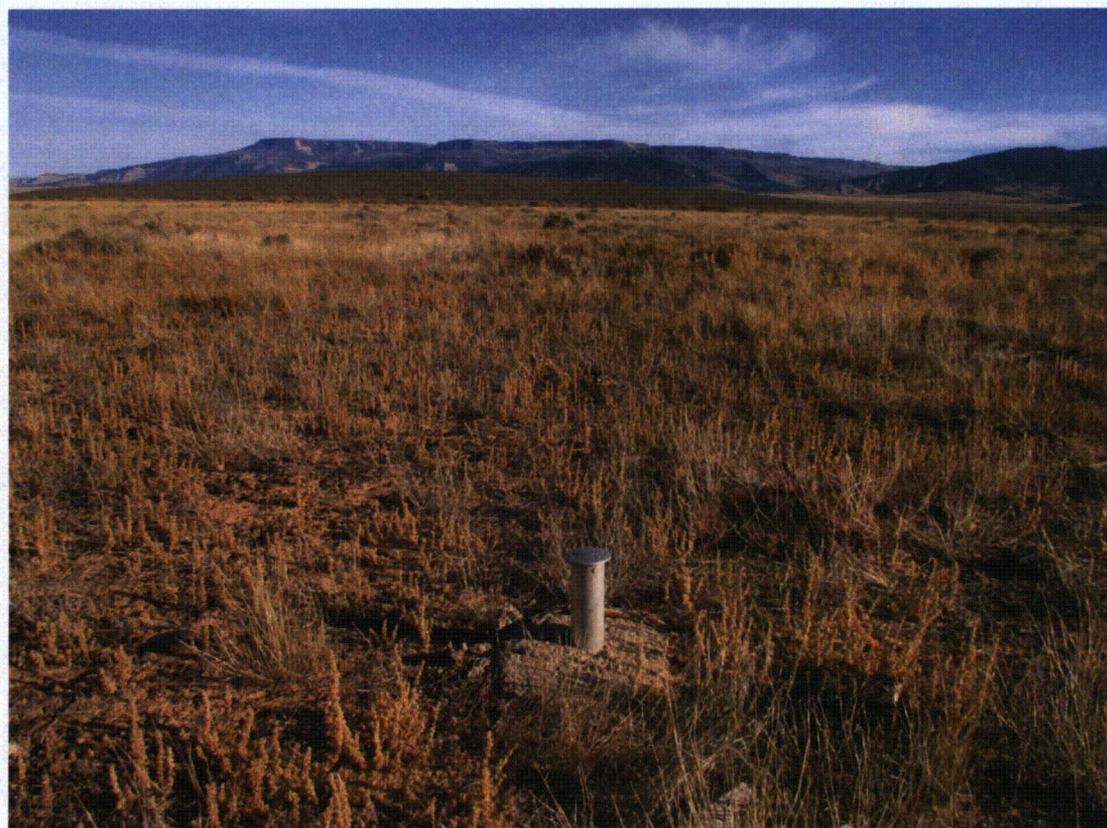
The site has four permanent boundary monuments, one at each of the four corners. All of the boundary monuments were present and in good condition (PL-2).

GRJ 12/2014. PL-2. Boundary monument BM-4.

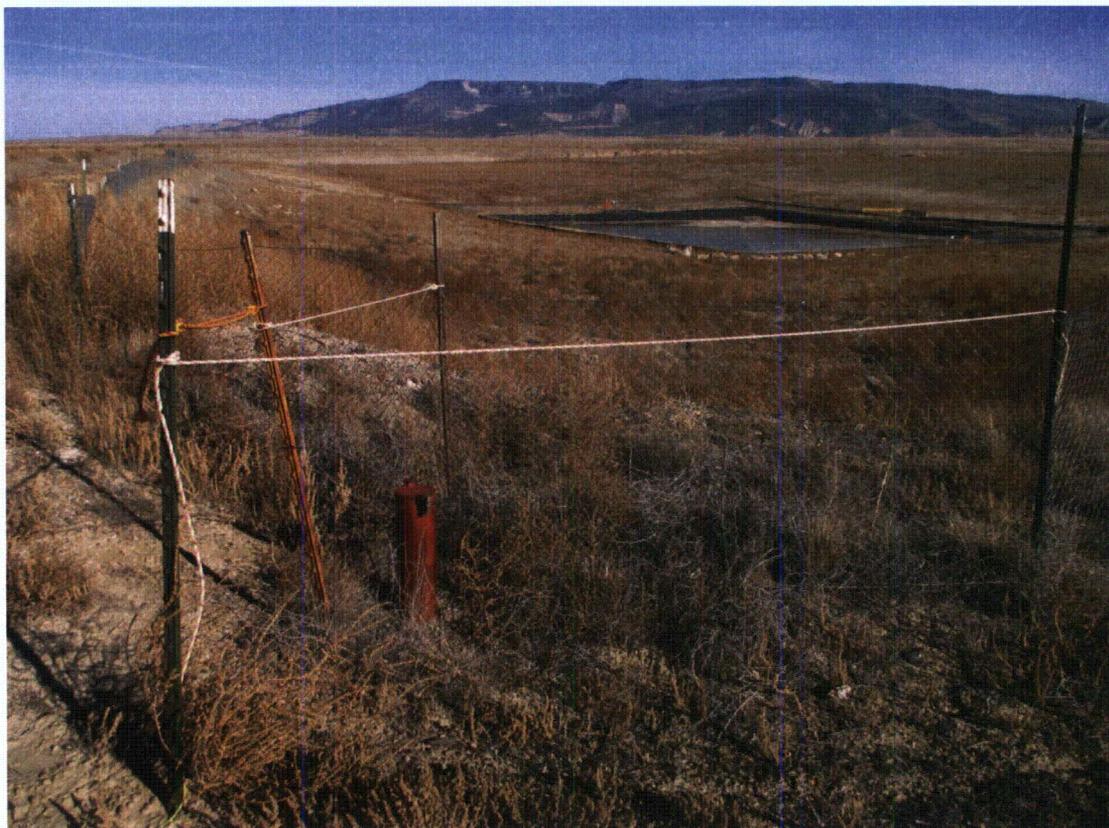
The groundwater monitoring network consists of three monitoring wells. All three are inside the site boundary. The well protective casings were locked and in good condition (PL-3).

GRJ 12/2014. PL-3. Monitoring well 0733 and open portion of cell.

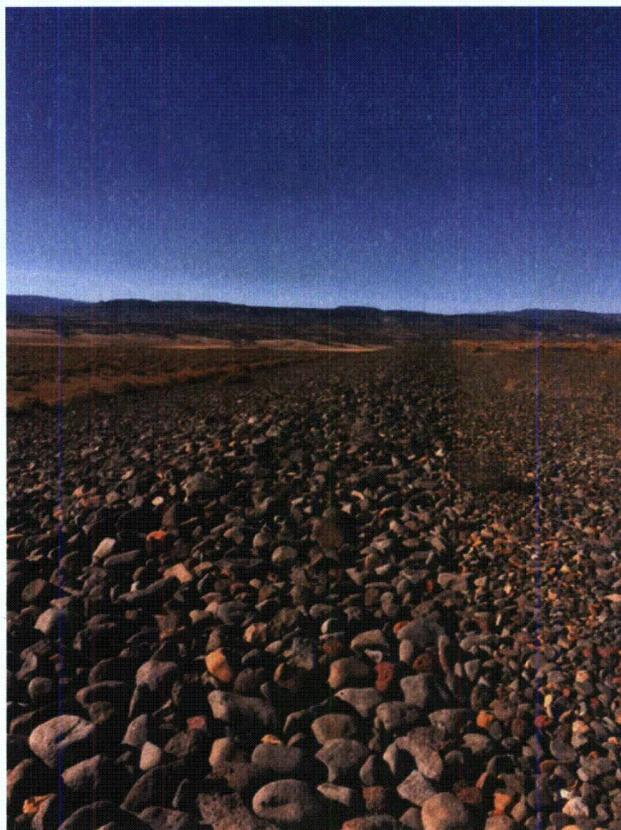
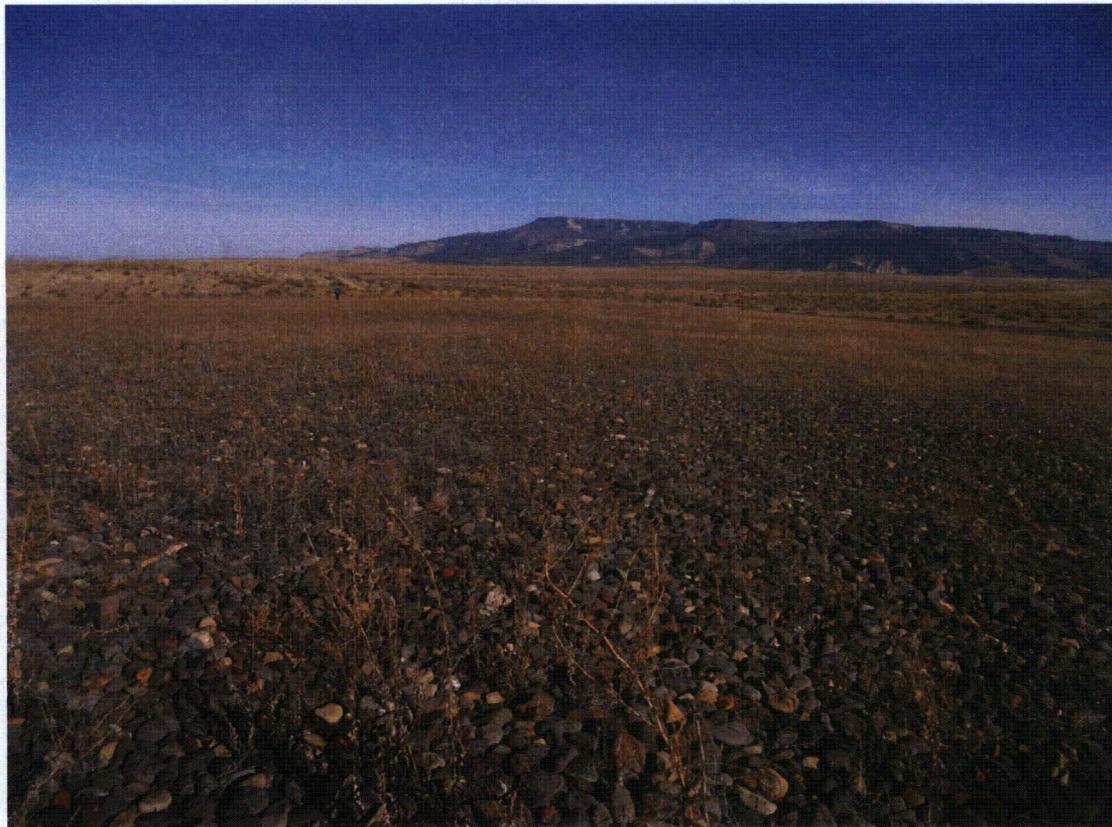
Basalt riprap covers the top and side slopes of the disposal cell. The rock was in good condition with no significant weathering. The disposal cell top and side slopes showed no evidence of settling, slumping, cracking, erosion, or slope instability (PL-4 and PL-5).

GRJ 12/2014. PL-4. View southwest of top and side slope from south edge of disposal cell.

GRJ 12/2014. PL-5. Northeast portion of disposal cell top slope.

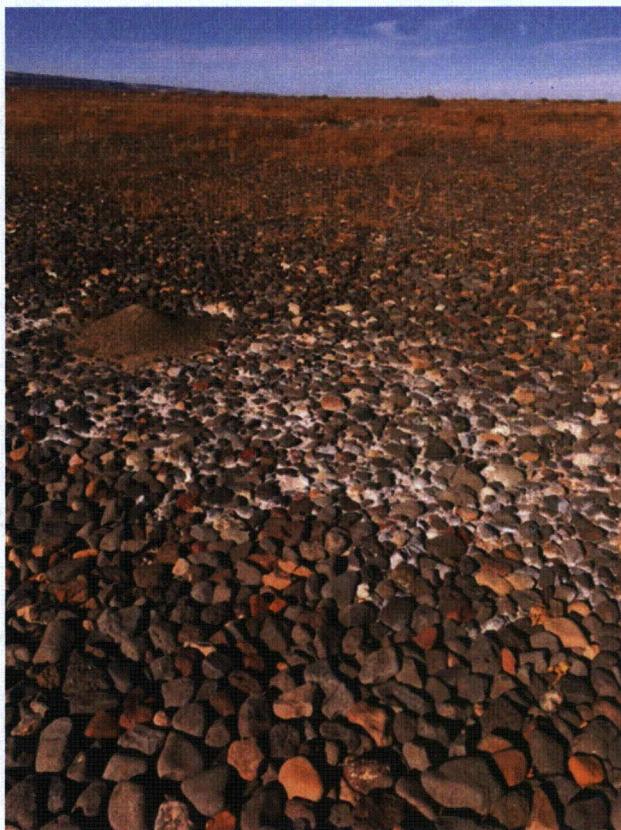
On the disposal cell cover, numerous areas with alkali deposits have been reported during previous inspections. The deposits are thought to be evaporite minerals, and there is no indication that the alkali areas degrade the performance of the disposal cell. No significant change to the alkali areas was noted in 2014 (PL-6).

GRJ 12/2014. PL-6. Alkali area on top of disposal cell.

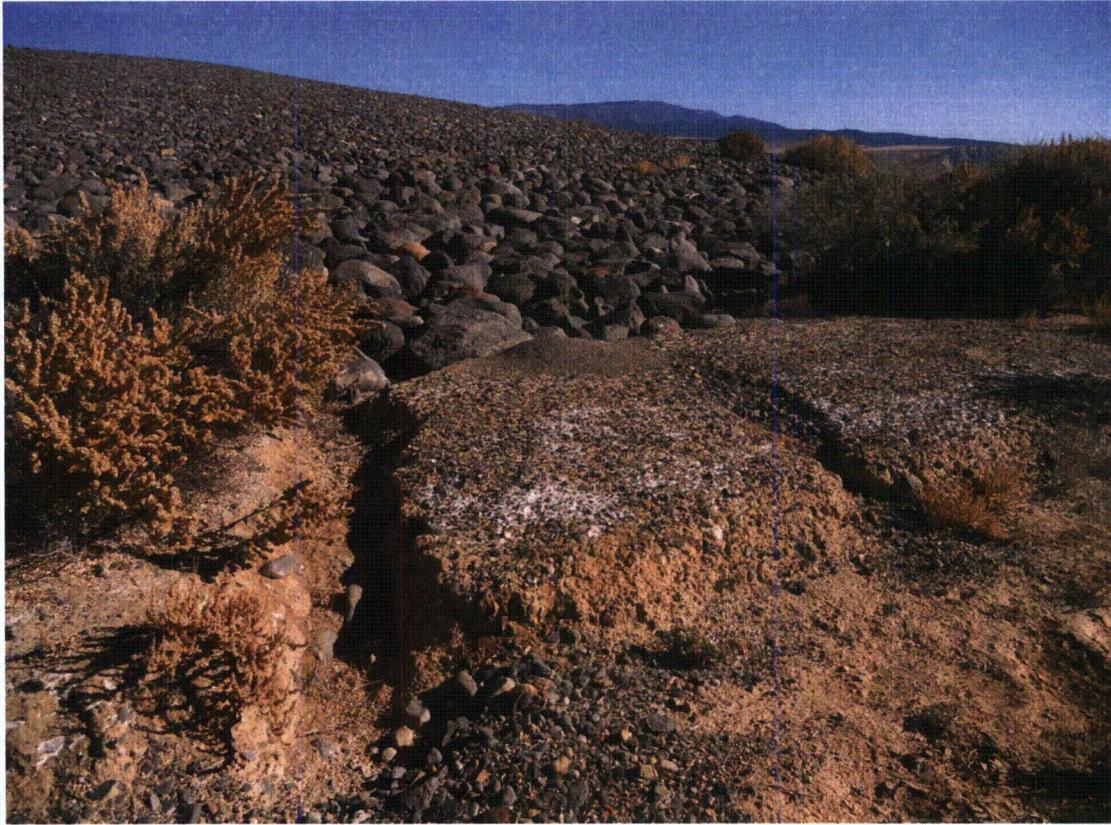
Several small erosion rills were observed in soils at the base of the cell's southwestern corner (PL-7). Recent road grading activities slightly lowered the elevation of the access road in that area, causing the development of rills when runoff water discharged from the apron at the corner of the cell. The rills do not threaten the integrity of the cell or the rock apron.

GRJ 12/2014. PL-7. Erosion rills at toe of disposal cell.

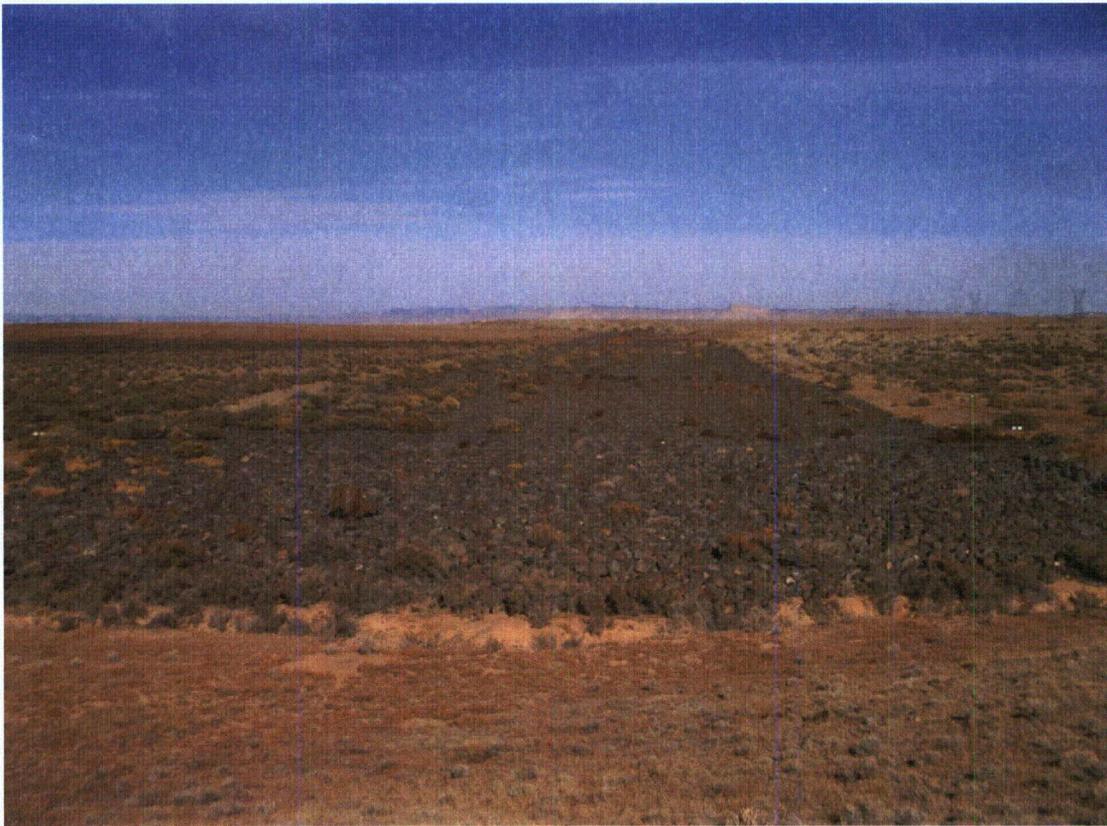
The south diversion channel is a large, riprap-armored structure that conveys runoff from the disposal cell into a natural drainage that flows away from the site to the southwest. The diversion channel was in good condition (PL-8). Some plants, including grasses, weeds, and shrubs, grow within the channel. However, the presence of vegetation is not expected to degrade the channel's

performance. The discharge area of the channel is armored with large-diameter basalt riprap and was also in good condition.

GRJ 12/2014. PL-8. Outlet of south diversion channel.

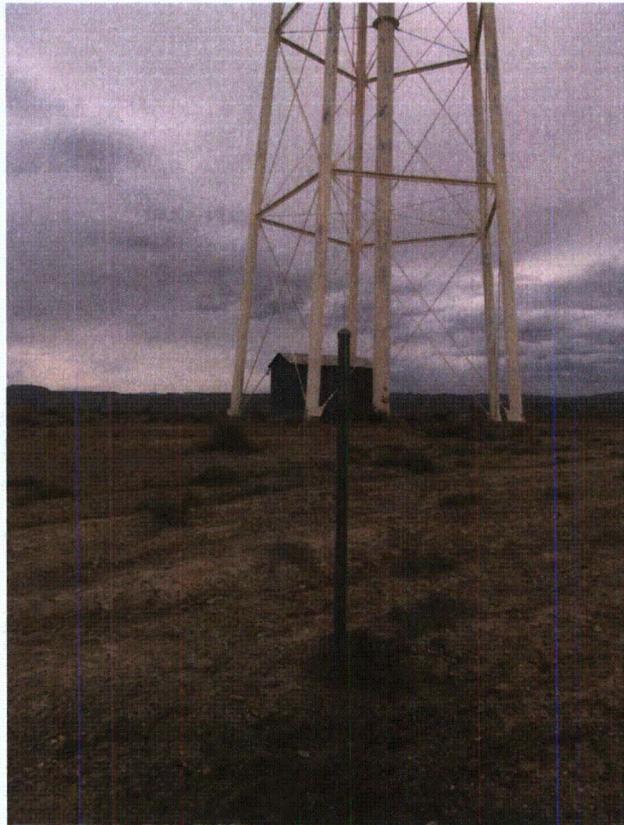
GRN 3/2014. PL-3. Missing perimeter sign P7.

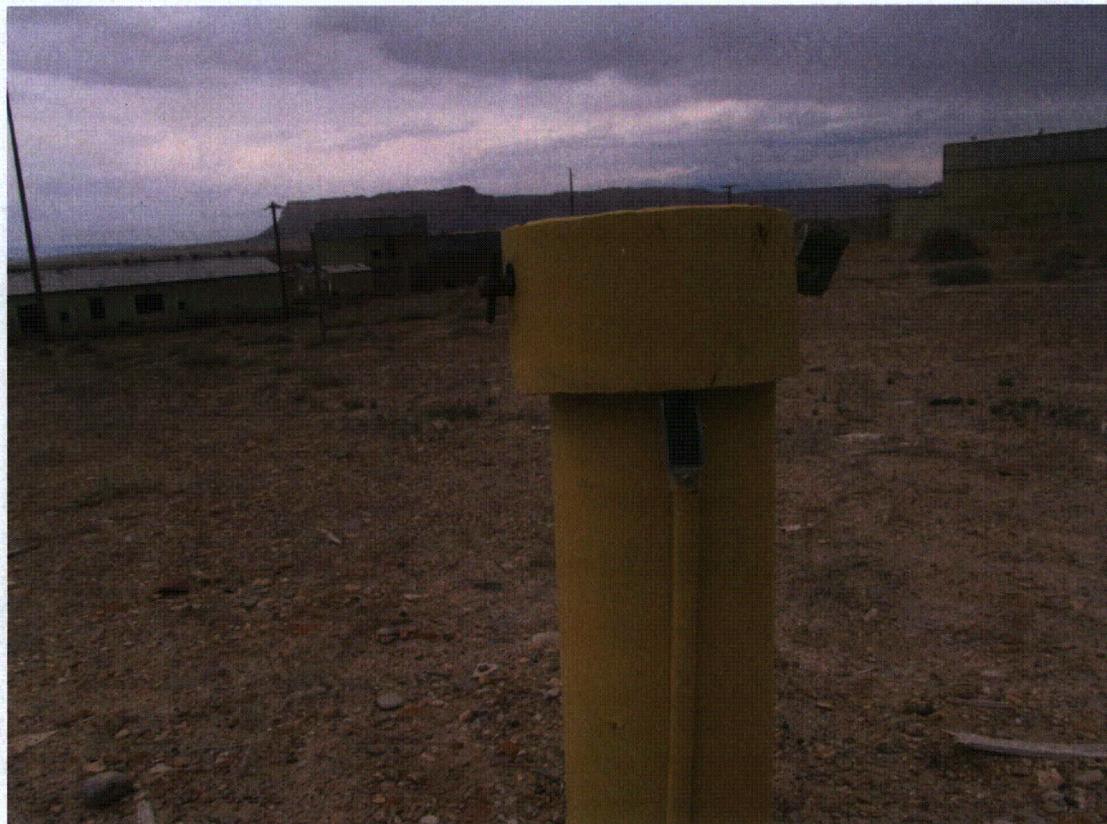
GRN 3/2014. PL-6. Monitoring well 0813 missing an electrical access box cover.
