8.0 Gunnison, Colorado, Disposal Site

8.1 Compliance Summary

The Gunnison, Colorado, Uranium Mill Tailings Radiation Control Act (UMTRCA) Title I Disposal Site was inspected on June 11, 2014. The disposal cell and all associated surface water diversion and drainage structures were in excellent condition and functioning as designed. Six riprap test areas on the cell apron and diversion ditches were visually inspected; no rock degradation was noted when compared to 2012 photos. Inspectors identified no maintenance needs or cause for a follow-up inspection.

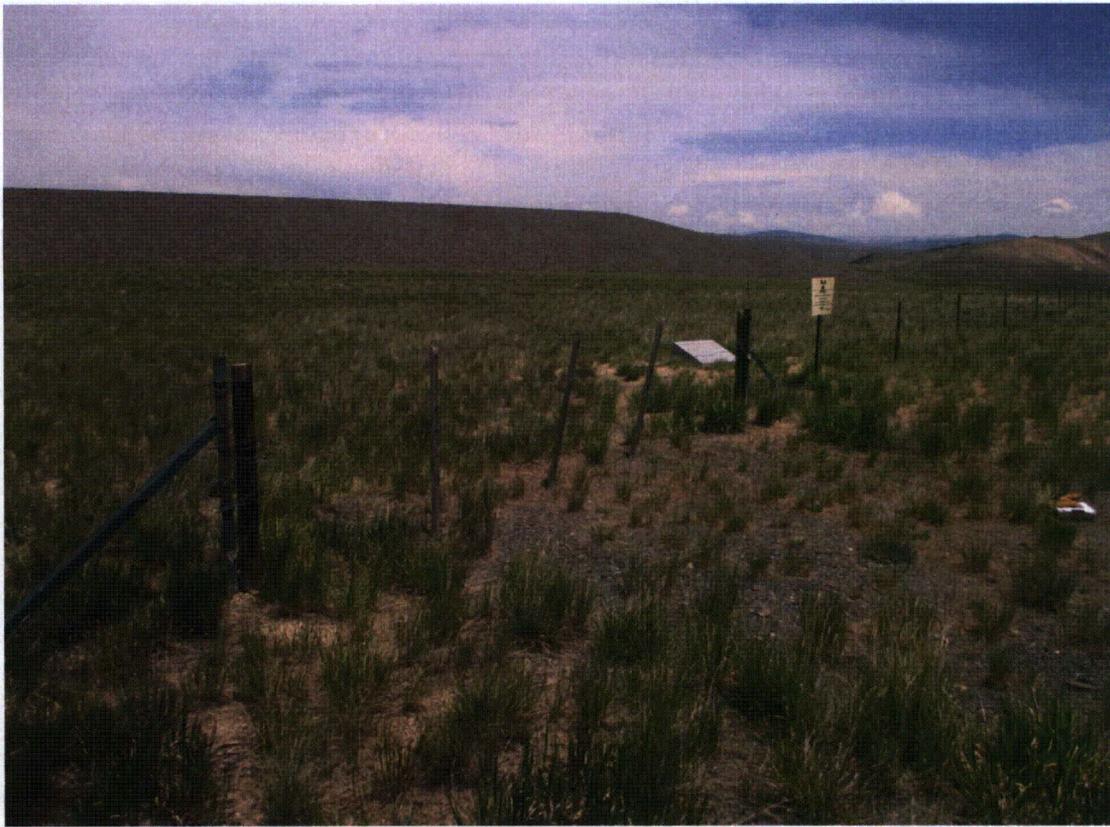
The entrance gate is a barbed-wire gate in the stock fence that surrounds the site. The entrance gate, located along the south portion of the perimeter fence, was secured by a padlock and chain to the adjoining post and was in good condition (PL-1).

GUD 6/2014. PL-1. Site entrance gate.

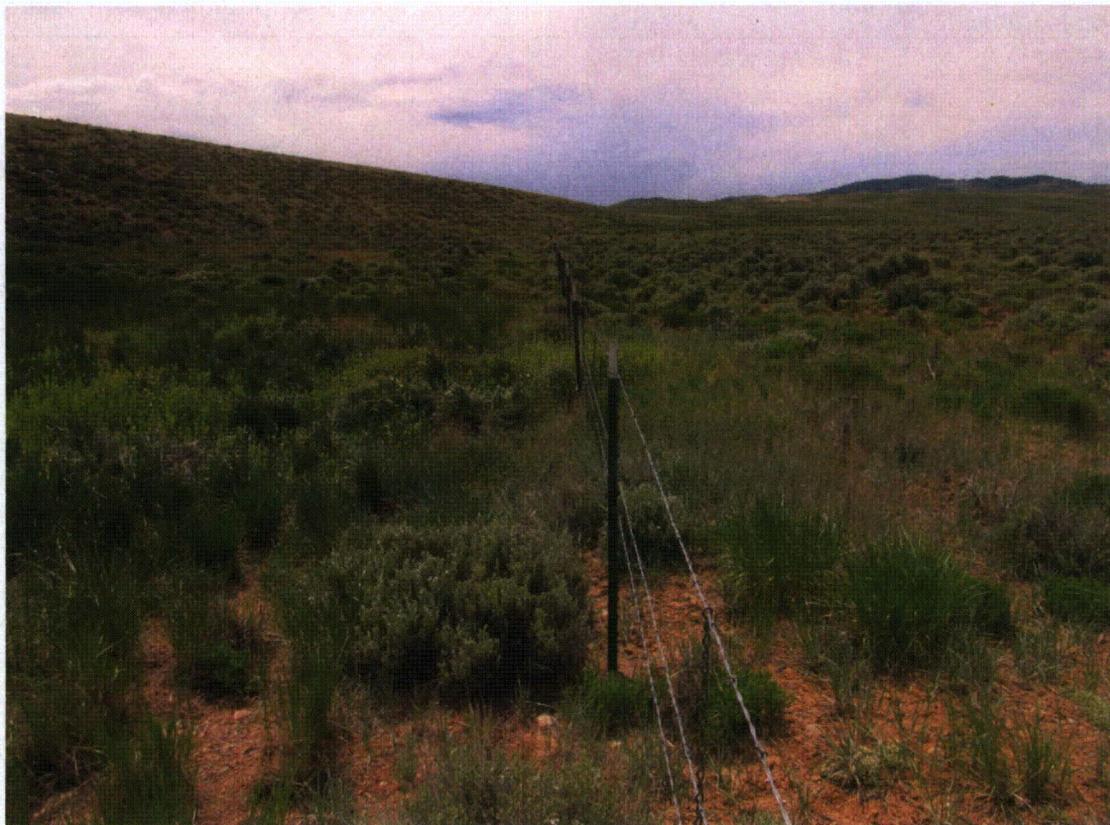
A barbed-wire fence delineates the site; most of it is set along the property boundary. The fence was in good condition (PL-2). Two locked barbed-wire gates—one on the north fence line and the other on the east fence line—provide access to offsite monitoring wells. The gates were locked and in good condition.

GUD 6/2014. PL-2. Perimeter fence along west property boundary.

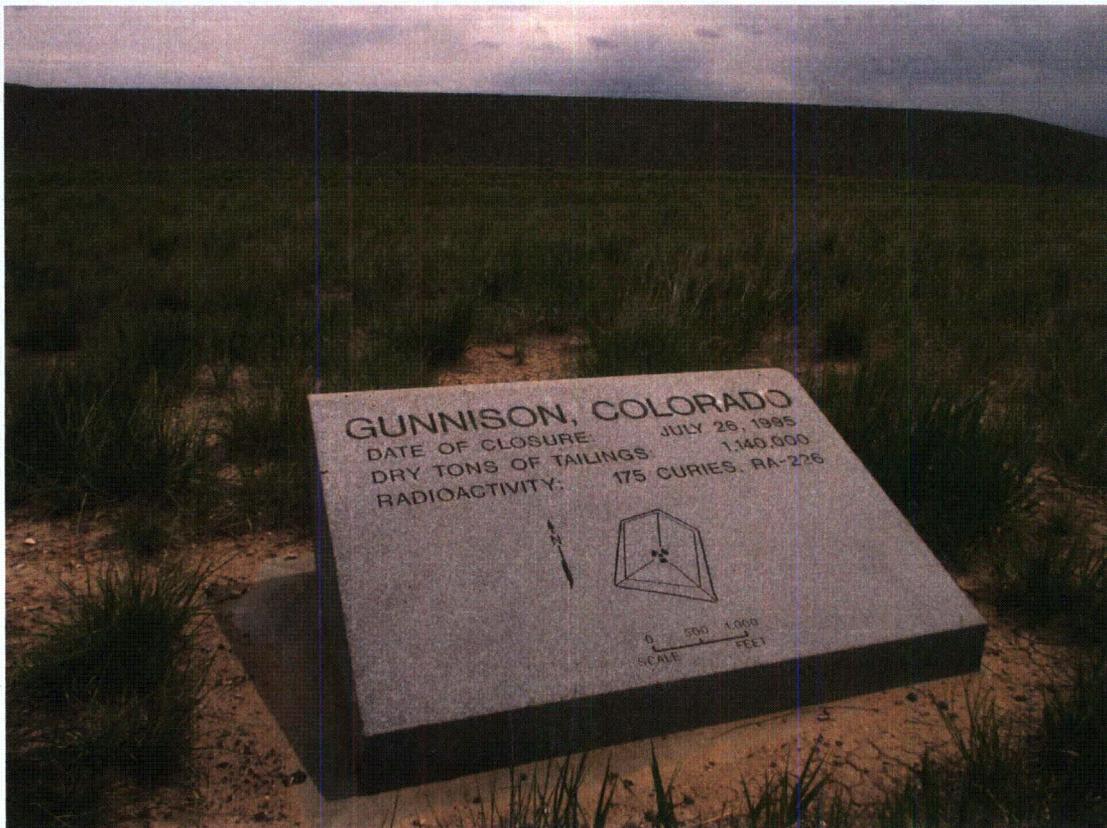
The site has two granite site markers. Site markers SMK-1 (just inside the entrance gate; PL-3) and SMK-2 (on top of the disposal cell) were in excellent condition.

GUD 6/2014. PL-3. Site marker SMK-1.

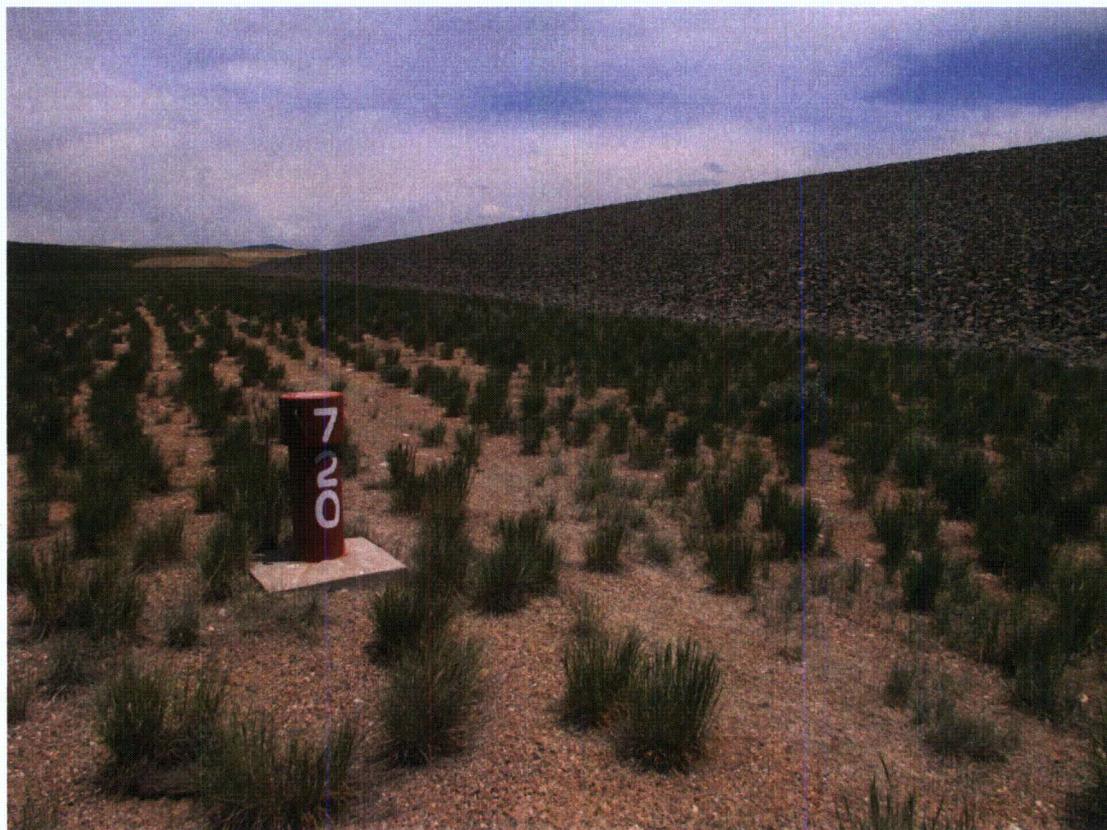
Sixteen wells constitute the groundwater monitoring network for the site. The wells were secure and in excellent condition (PL-4). The Gunnison County landfill operators have placed concrete barriers to protect monitoring well 0716, which is located on landfill property, from landfill activities (PL-5). The edge of a spoil pile is approximately 30 feet from the barriers, and it appeared to be same size as observed during the previous inspection.

GUD 6/2014. PL-4. Monitoring well 0720 near west side of disposal cell.

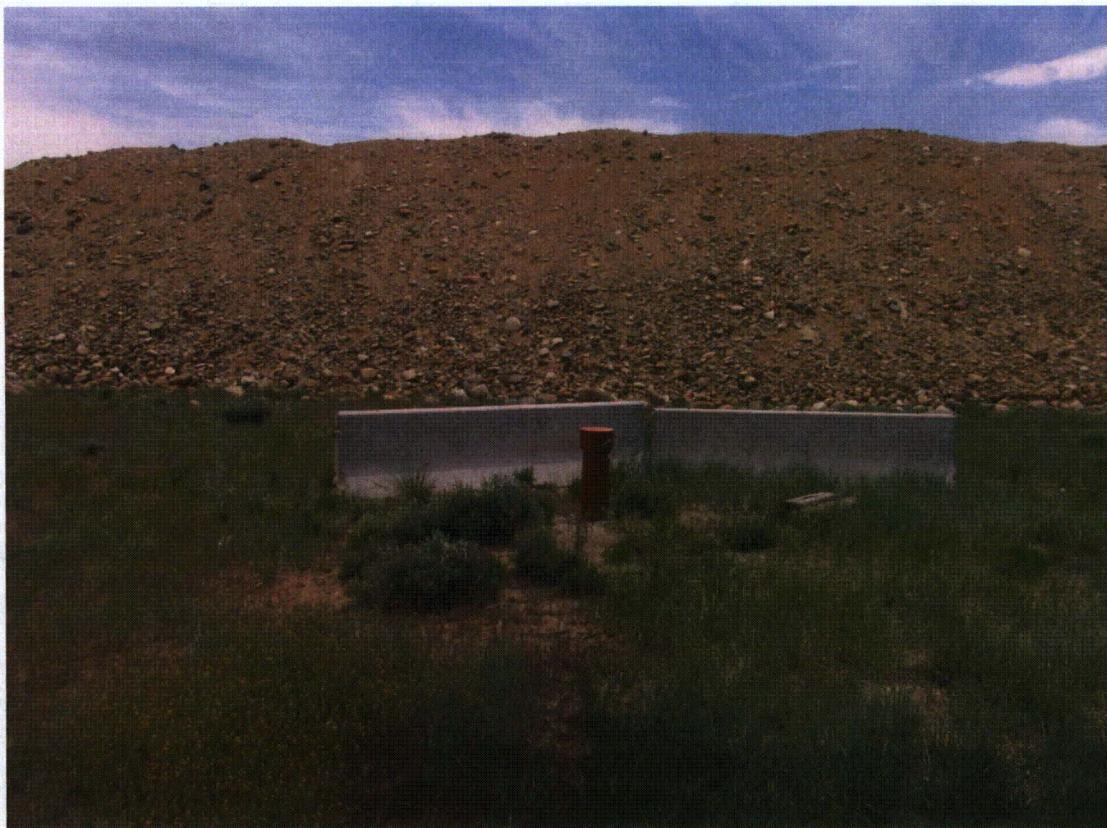
GUD 6/2014. PL-5. Monitoring well 0716 near county landfill spoil pile.

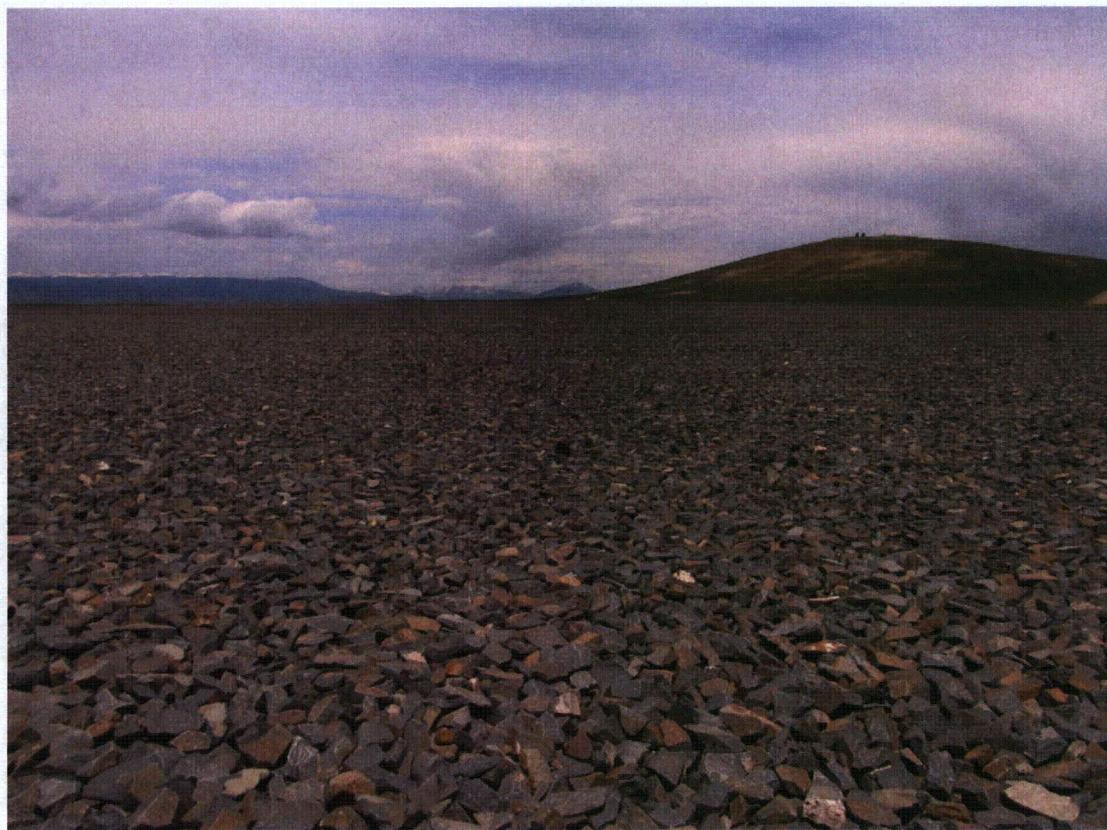
The rock-covered top of the disposal cell was in excellent condition (PL-6). There was no evidence of erosion, settling, slumping, or rock degradation. Several isolated patches of grass are randomly distributed over the disposal cell cover; however, these shallow-rooted plants are not a cause for concern. Two small tree saplings were removed from the cover; no other deep-rooted plants were observed on the disposal cell.

GUD 6/2014. PL-6. Top slope of disposal cell.

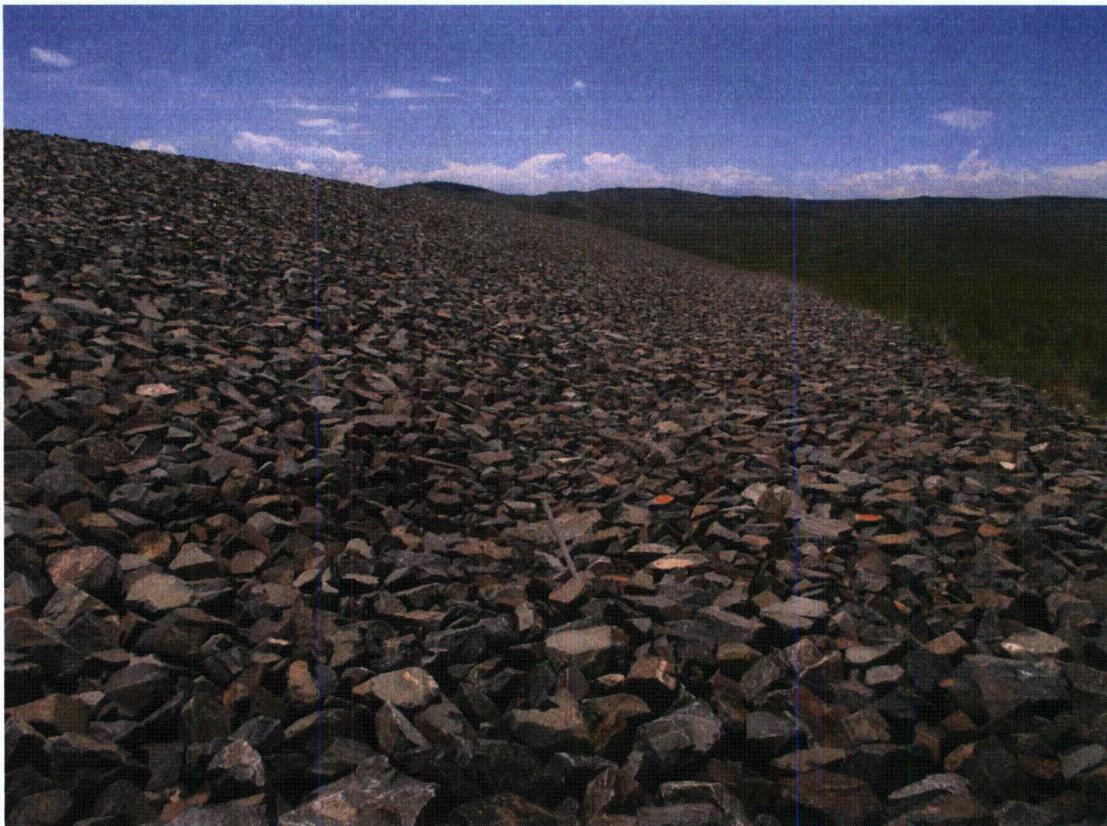
The riprap-covered side slopes, apron, and diversion channels were in good condition (PL-7 and PL-8). No evidence of slumping, settling, rock degradation, or encroachment of vegetation was observed.

GUD 6/2014. PL-7. West side slope and apron of disposal cell; Riprap Test Area No. 3 in foreground.

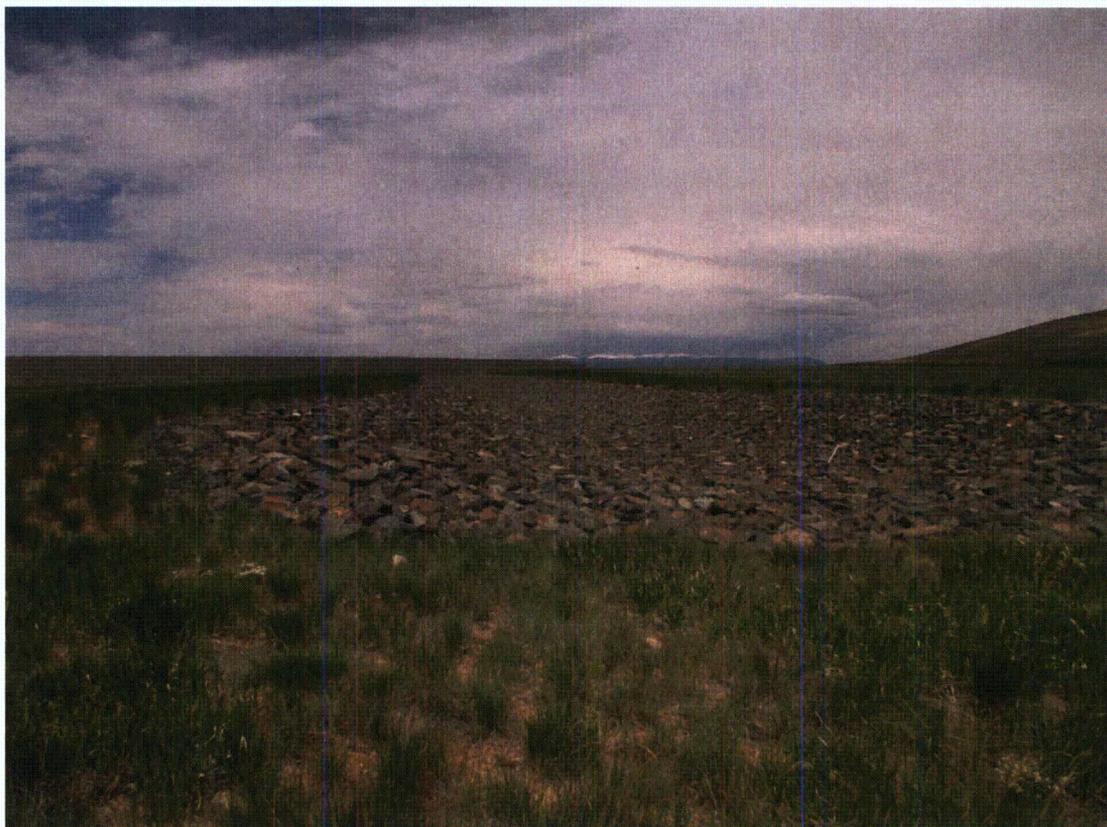
GUD 6/2014. PL-8. East diversion channel.

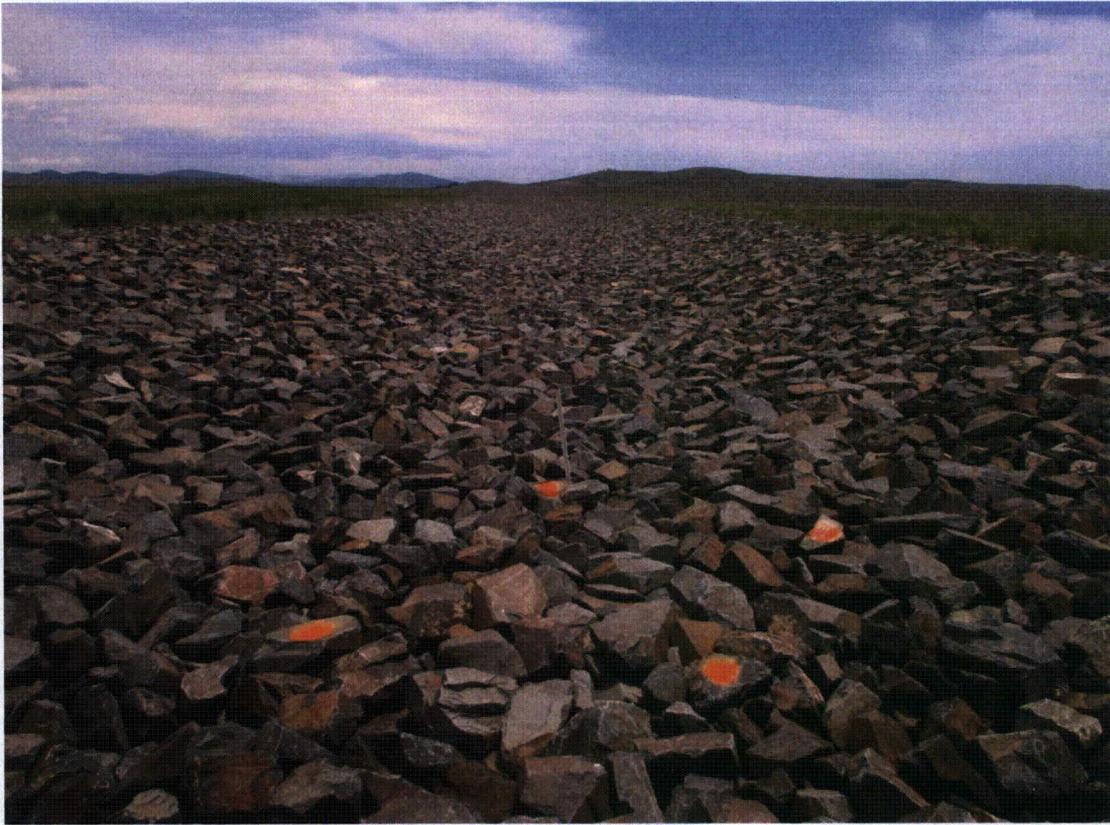
The condition of the riprap in six monitoring test areas was visually inspected. The test areas, each approximately 1 square meter in area, are in critical flow path locations in the apron and diversion channels (PL-9). The corners of each monitoring plot are marked with orange paint; the corners were repainted during the inspection. The riprap in all of the test areas was in excellent condition. When the rocks were compared to the photos taken of them in 2012, there was no evidence that individual rocks had split or otherwise been degraded. Annual photographing and comparing of these test areas was performed through 2002 in accordance with the LTSP; after that, the LTSP requires the test areas to be photographed every 5 years through 2017. The next and final set of photos will be taken in 2017.

GUD 6/2014. PL-9. West diversion channel; Riprap Test Area No. 6 in foreground.

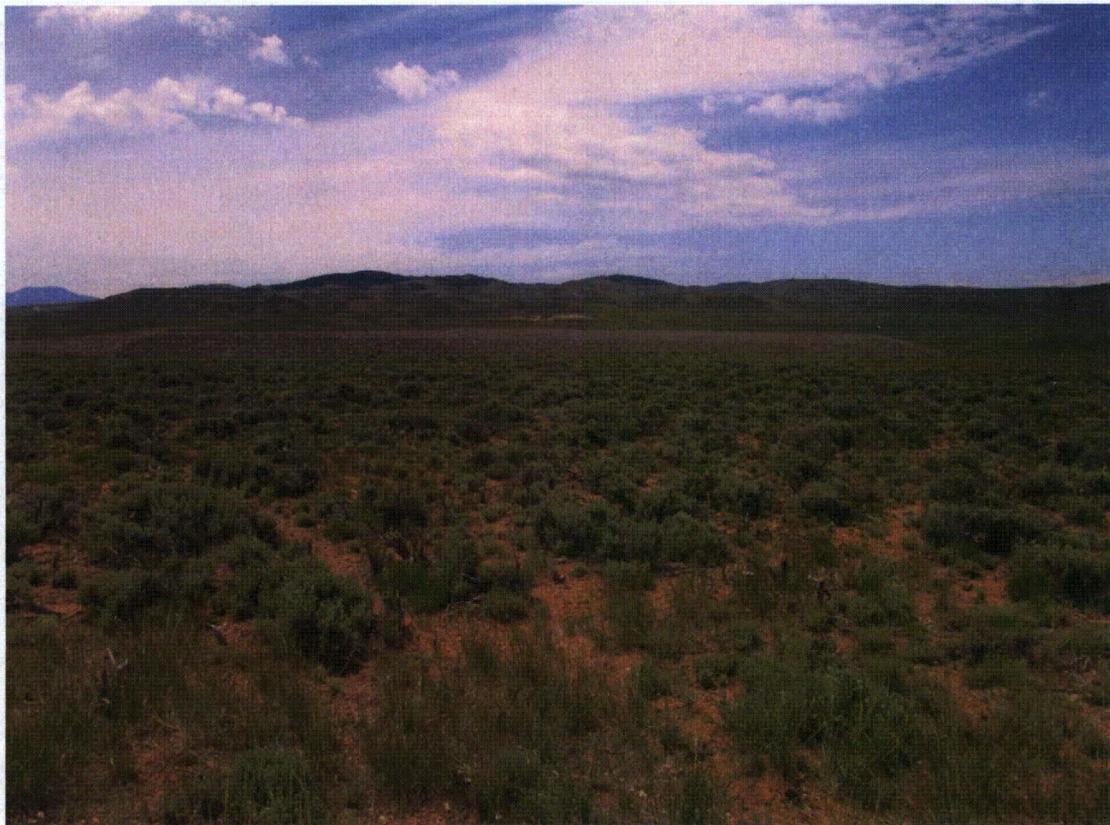
There are reclaimed and undisturbed areas between the disposal cell and the site perimeter. Both types of areas were in good condition (PL-10). No erosion concerns were observed. In general, reclaimed areas have good vegetation coverage, consisting mostly of grass. Shrubs and forbs are much less abundant and less diverse in reclaimed areas than they are in undisturbed areas.

GUD 6/2014. PL-10. Disposal cell and natural vegetation in an undisturbed area.

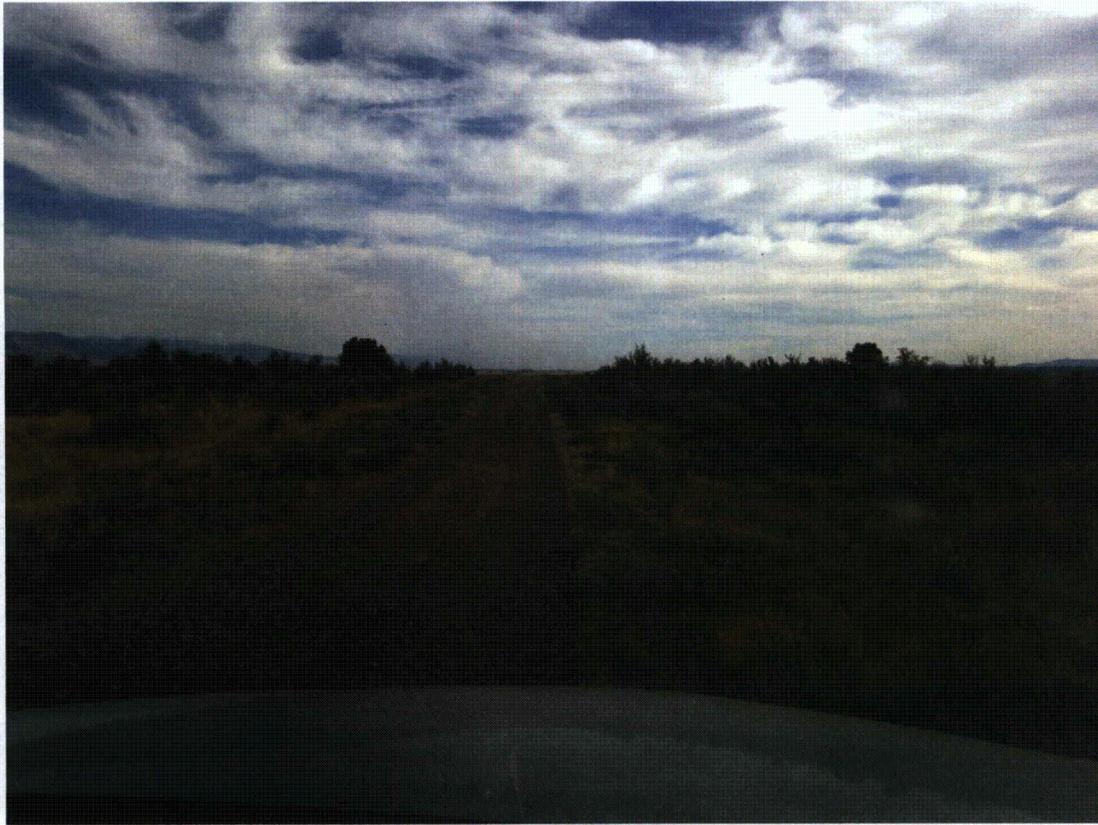
Access to the site is gained by traveling a gravel road that heads west off County Road 2-16B. DOE was granted a perpetual easement on the approximately 1.2 mile access road between the county road and the DOE property boundary. A lockable gate across the access road on the adjacent privately owned land limits access to the site. The site access road was in good condition (PL-1).

LKD 9/2014. PL-1. Access road south of entrance gate.

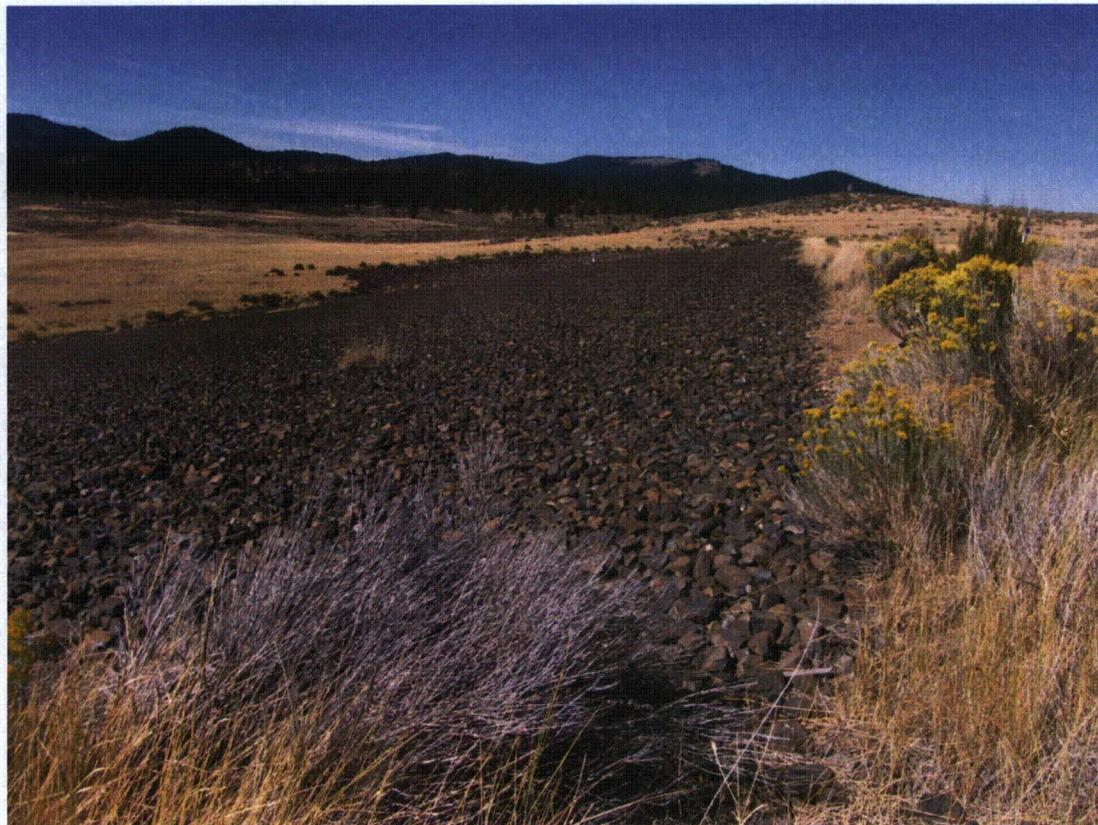
LKD 9/2014. PL-2. West side slope.

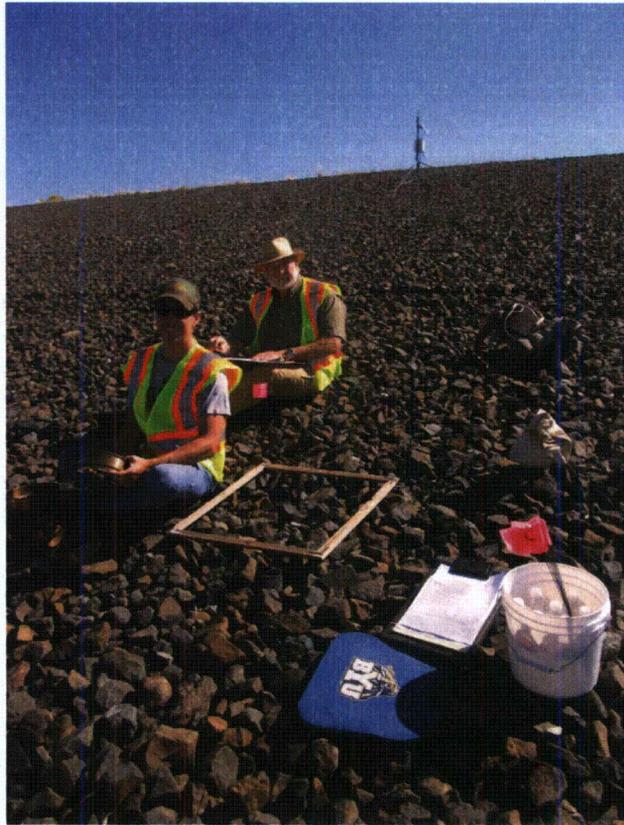
LKD 9/2014. PL-3. Rock monitoring on west side slope.

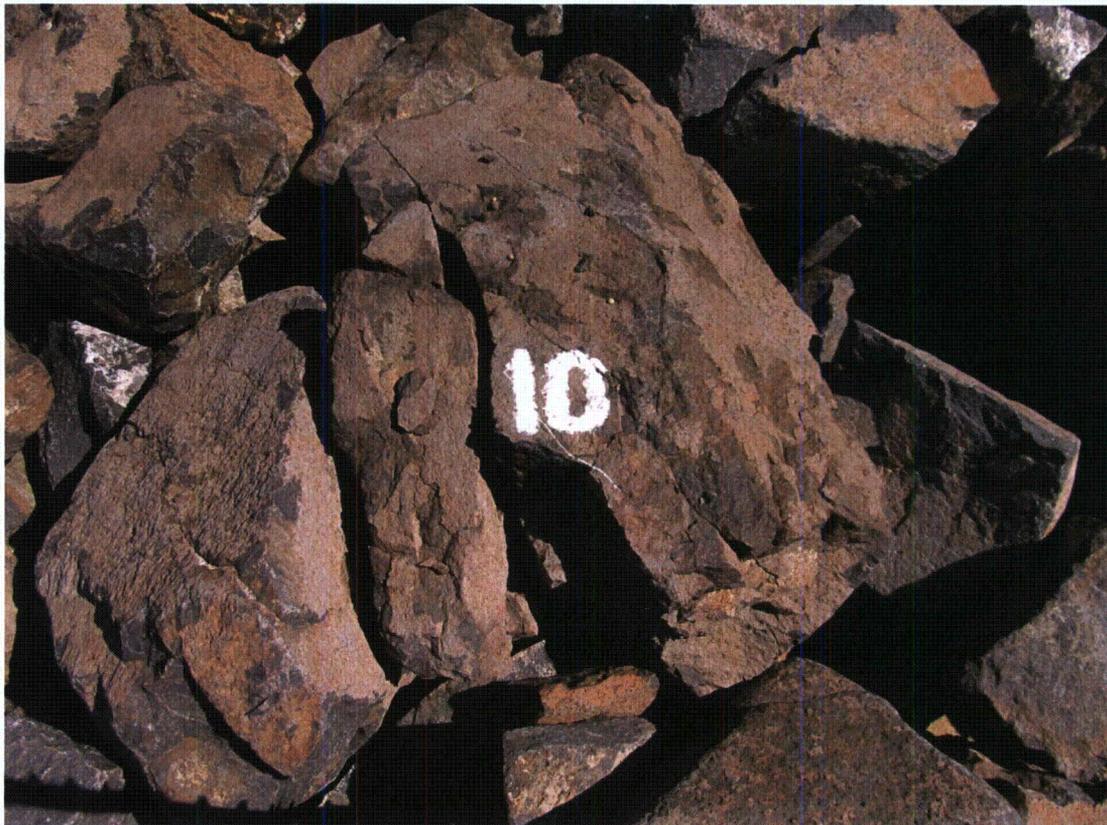
The annual photographic monitoring of the 18 photograph locations for long-term rock monitoring was conducted in the energy dissipation area (EDA). Rocks at photo-monitoring locations 10 and 12 are shown in photo PL-4 and photo PL-5. Minor rock degradation has been observed since monitoring began at the original 10 photograph locations established in 1997 and at the eight additional locations established in 2000. The rock used in the EDA and drainage channel areas is much more homogeneous than the varied rock used on the side slopes, and appeared in good condition.

LKD 9/2014. PL-4. Riprap photo-monitoring location 10 in EDA.

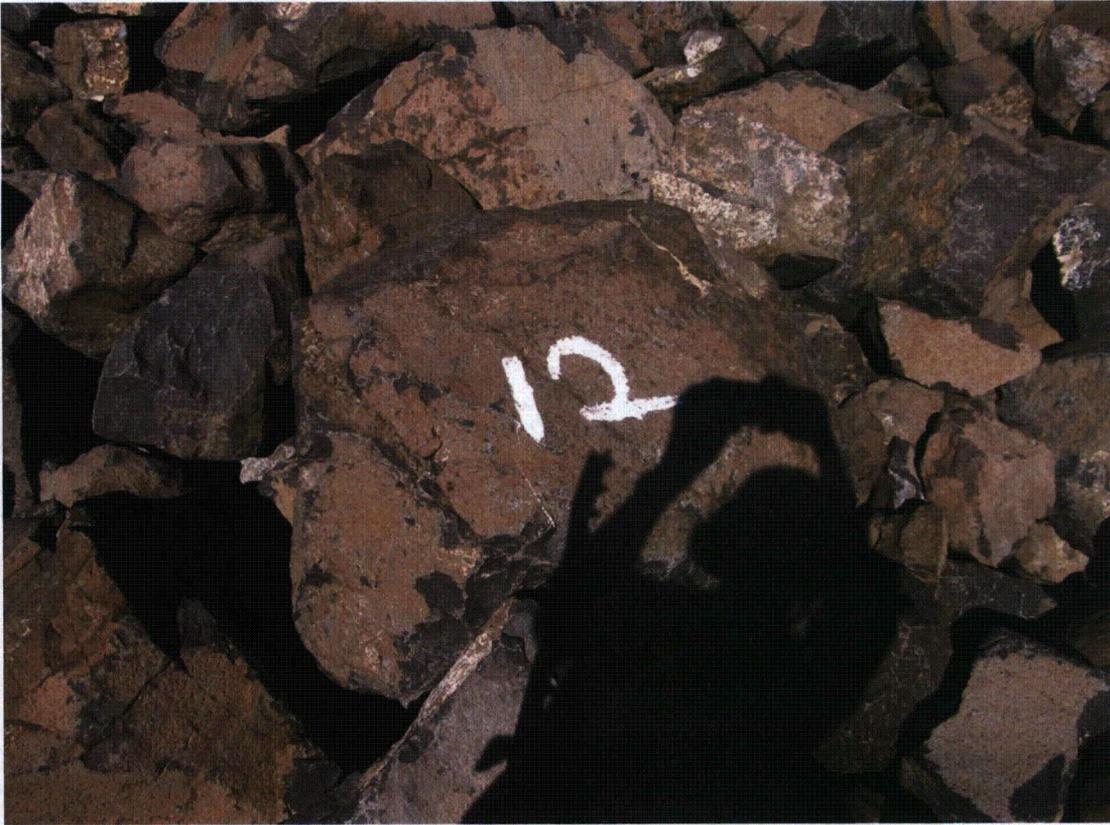
LKD 9/2014. PL-5. Riprap photo-monitoring location 12 in EDA.

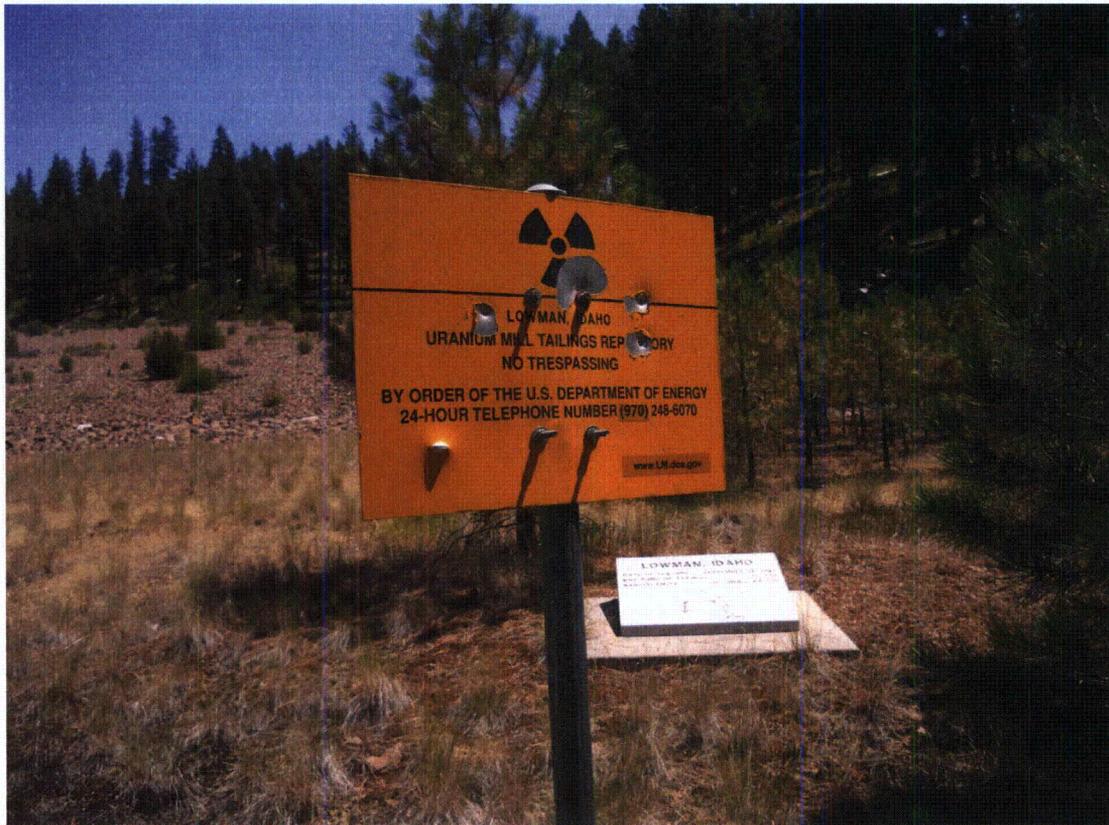
Eighteen perimeter signs are located along the site boundary. The perimeter signs and an entrance sign (PL-1) near site marker SMK-1 are on steel posts set in concrete. Several signs have bullet damage but remain legible and do not need to be replaced at this time. Perimeter signs along the east site boundary were not observed during the inspection due to nearby forest fires. P. Rekow of Boise County weed control had walked the area the week prior to the inspection and noted that the signs were all in place.

Two site markers are present at the site. Site marker SMK-1 (PL-1) is just inside the site's southwest boundary, and site marker SMK-2 is on top of the disposal cell. Both markers were in excellent condition.

LOW 7/2014. PL-1. Entrance sign and site marker SMK-1.

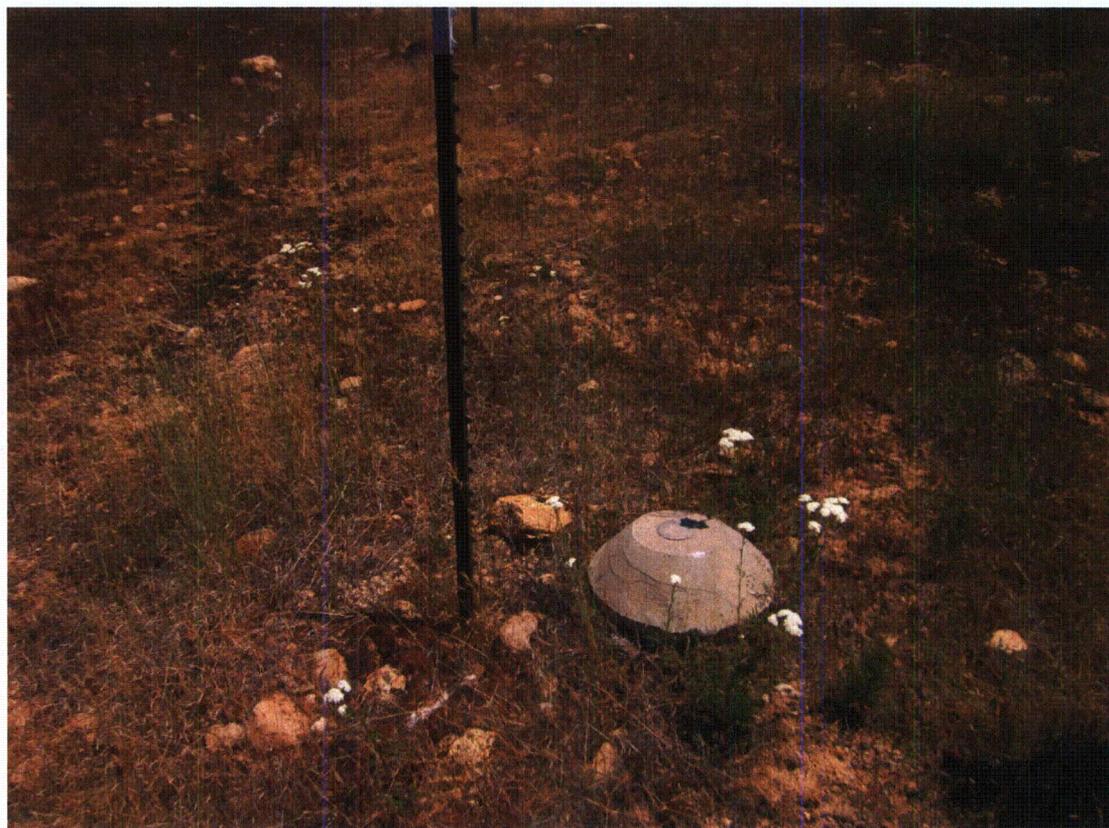
LOW 7/2014. PL-2. Boundary monument BM-2.

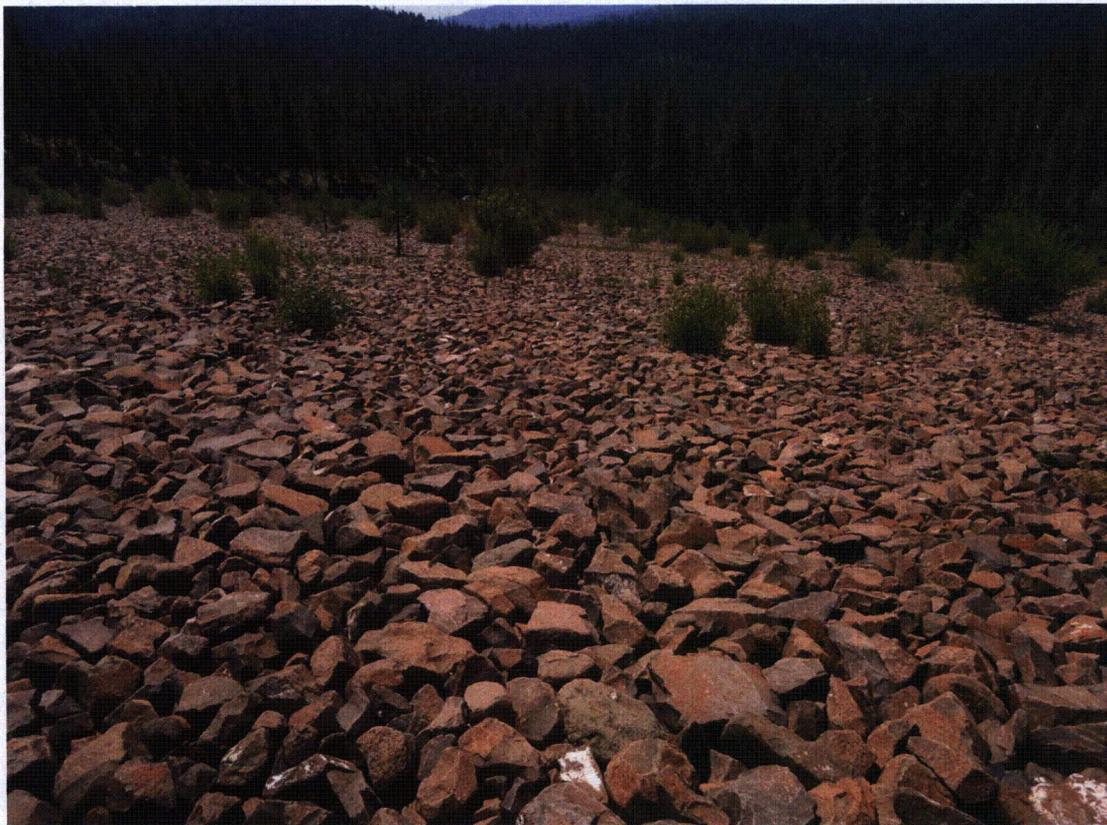
The disposal cell was completed in 1991. Basalt riprap armors the top and west-facing side slopes of the disposal cell. An apron of larger riprap surrounds the disposal cell on all sides. The riprap was in excellent condition (PL-3, PL-4, and PL-5). No evidence of instability, such as subsidence, slumping, or cracking, was observed on the cell surfaces.

LOW 7/2014. PL-3. Side slope of disposal cell.

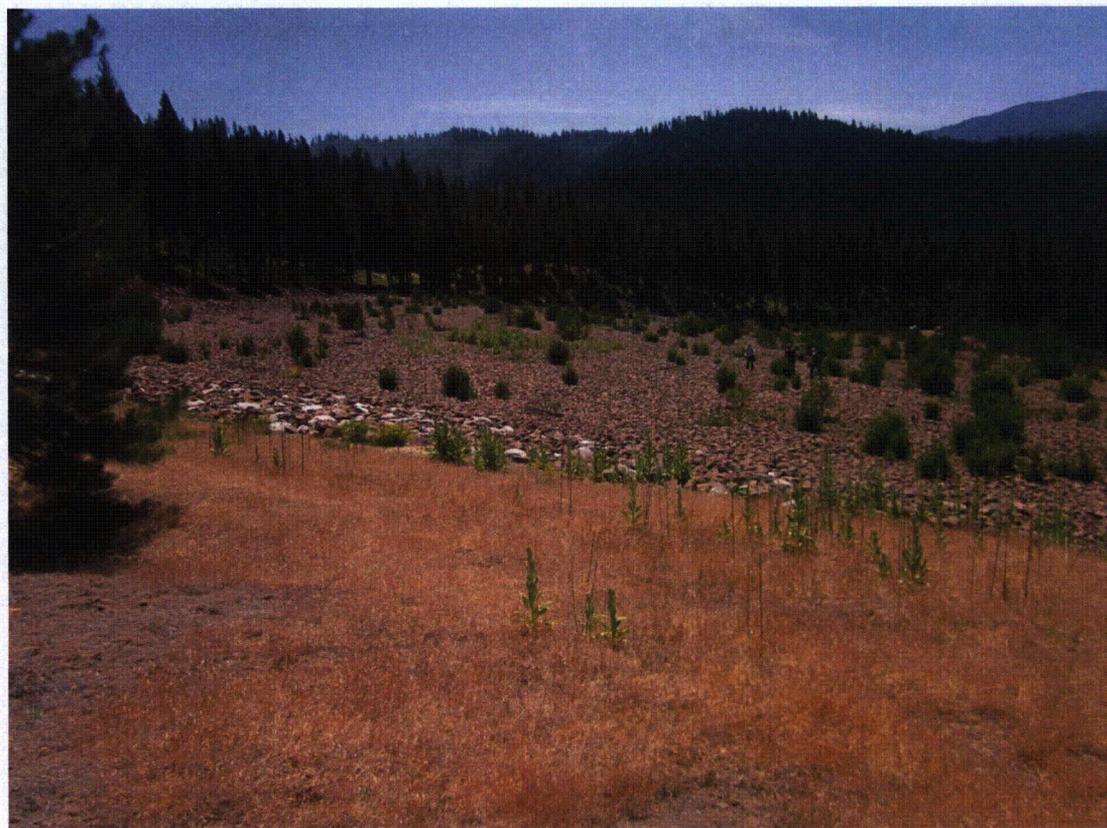
LOW 7/2014. PL-4. View south of disposal cell cover and apron.

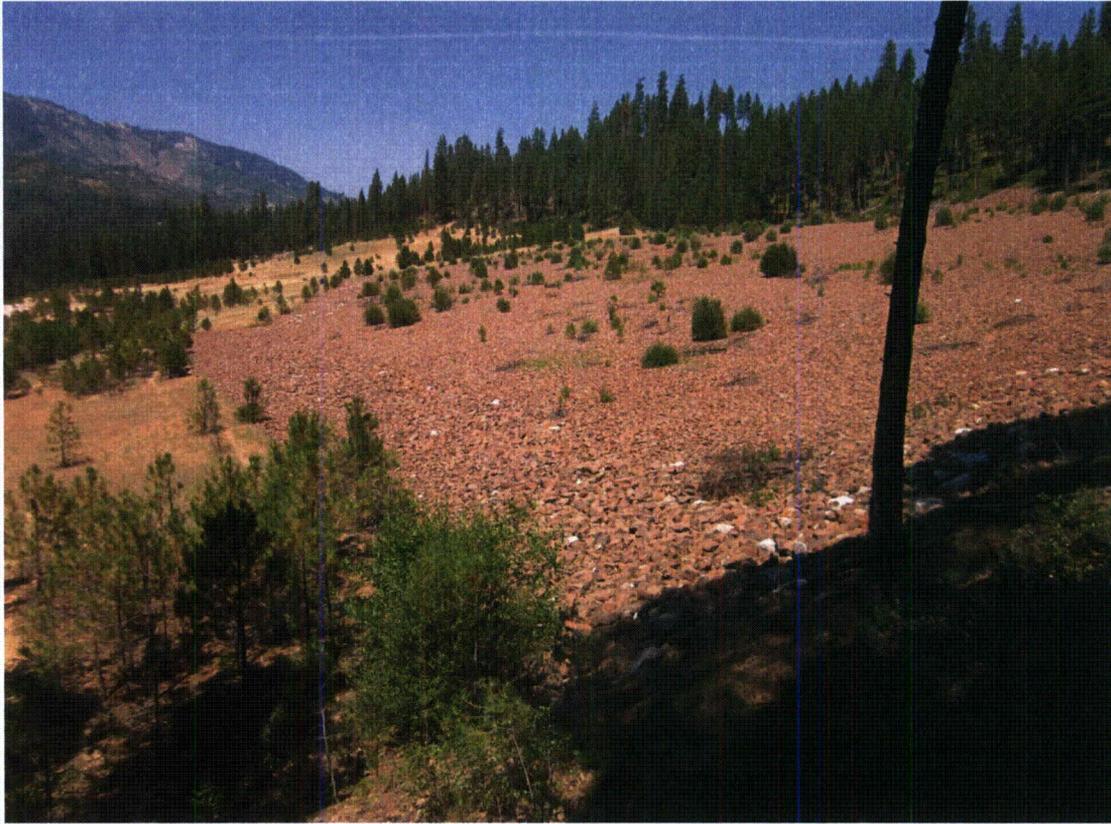
LOW 7/2014. PL-5. View north-northeast of disposal cell.

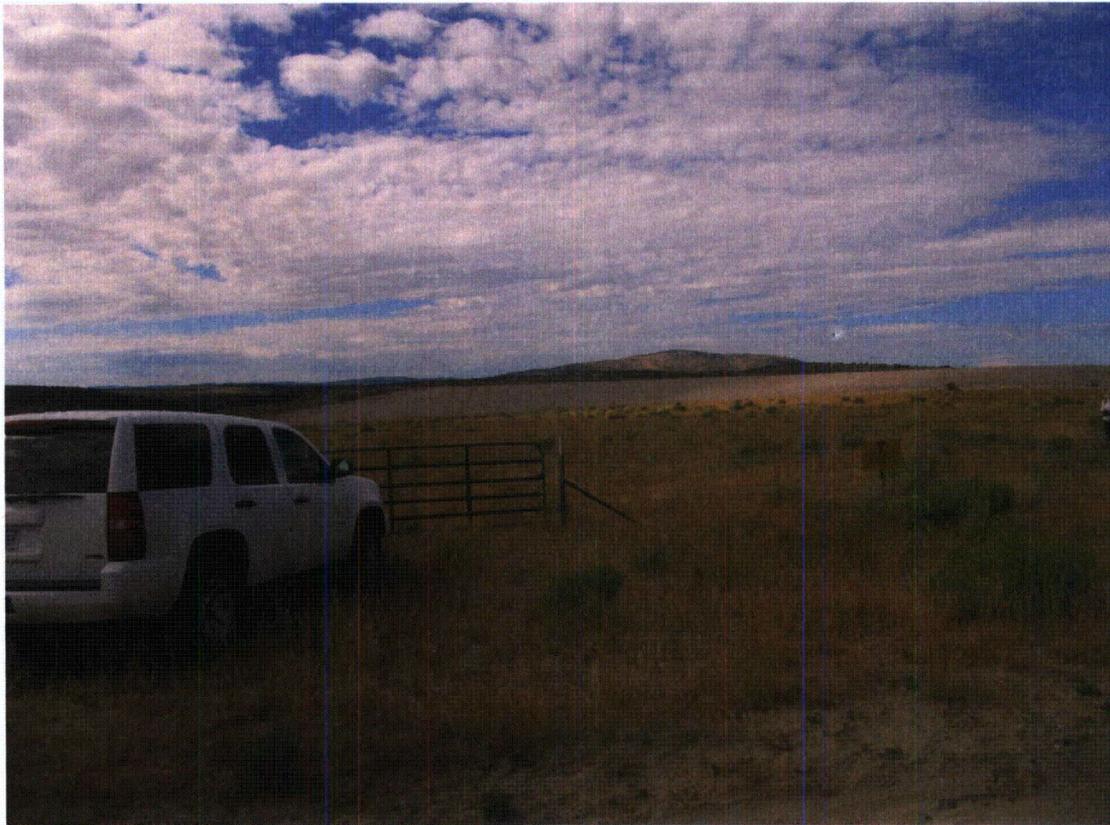
MAY 8/2014. PL-1. Site entrance gate and sign; disposal cell in background.

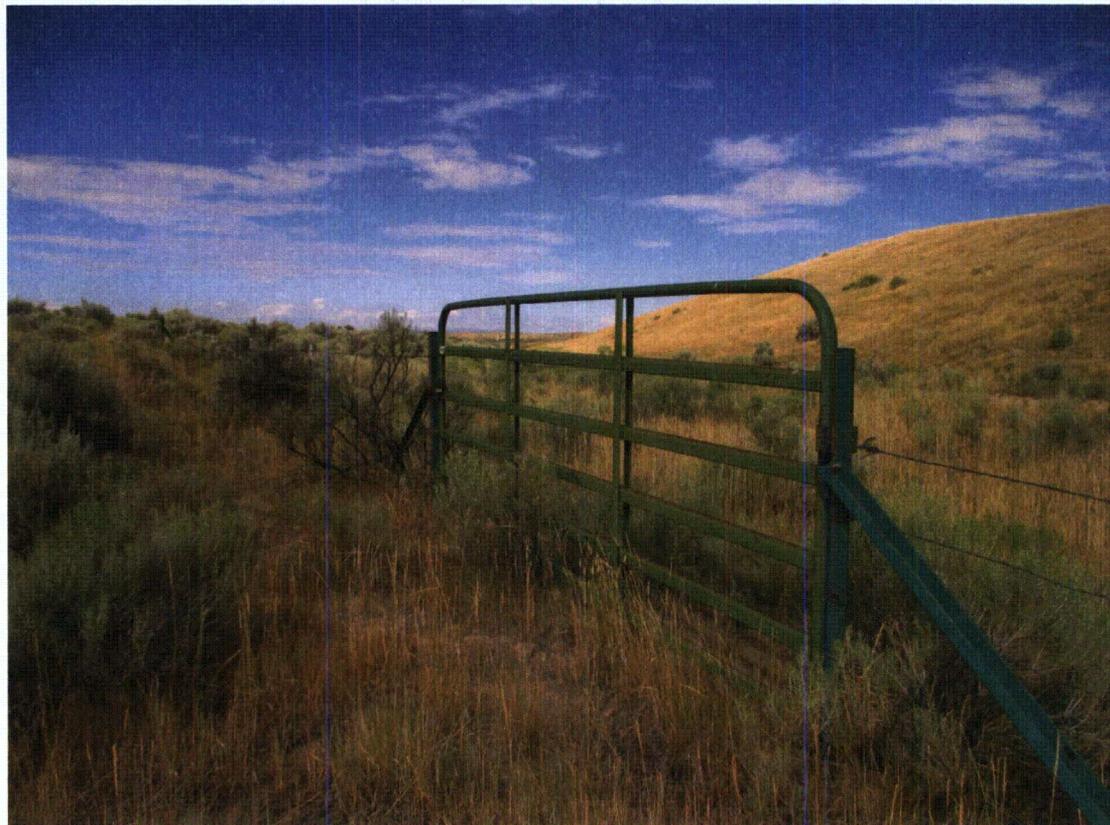
MAY 8/2014. PL-2. Site auxiliary gate.

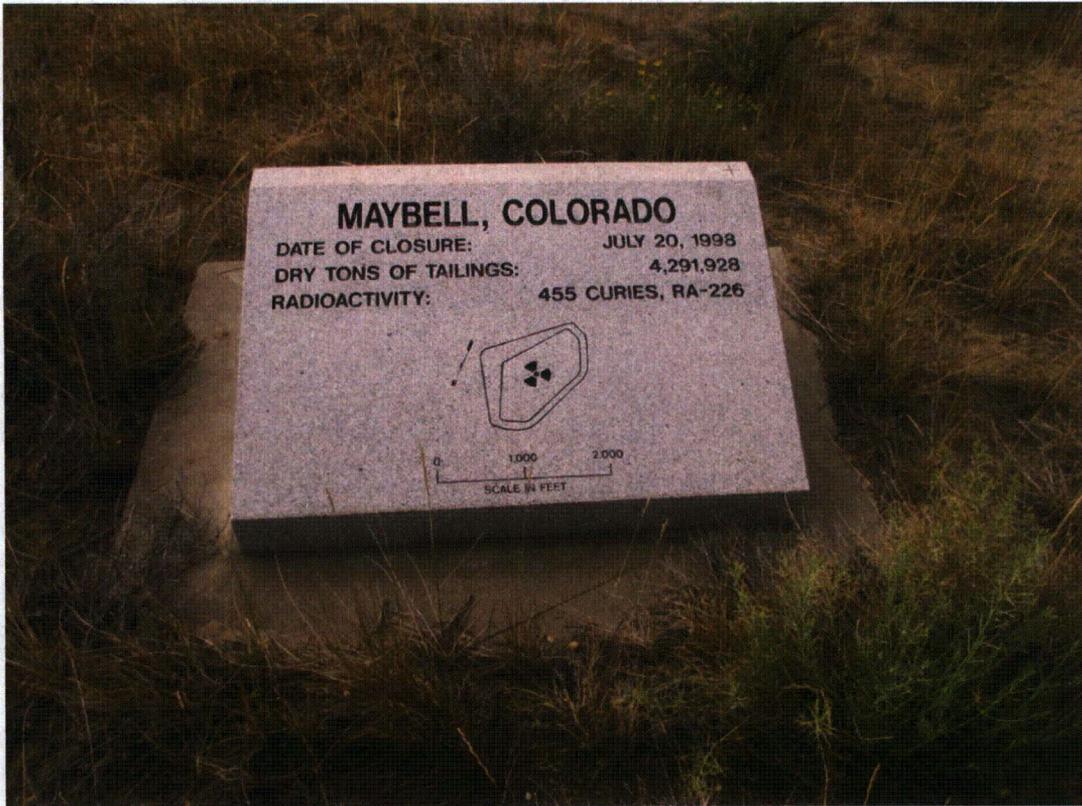
MAY 8/2014. PL-3. Site marker SMK-1.
