8.0 Gunnison, Colorado, Disposal Site

8.1 Compliance Summary

The Gunnison, Colorado, Uranium Mill Tailings Radiation Control Act (UMTRCA) Title I Disposal Site was inspected on June 11, 2014. The disposal cell and all associated surface water diversion and drainage structures were in excellent condition and functioning as designed. Six riprap test areas on the cell apron and diversion ditches were visually inspected; no rock degradation was noted when compared to 2012 photos. Inspectors identified no maintenance needs or cause for a follow-up inspection.

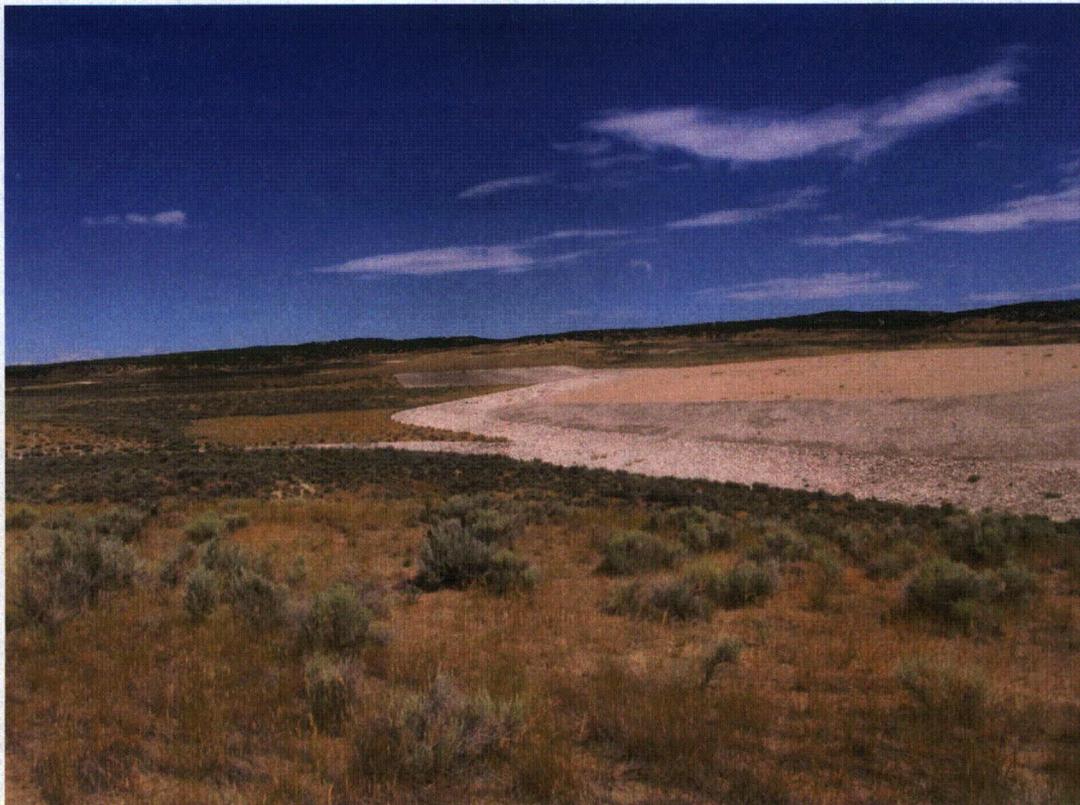
MAY 8/2014. PL-4. Southwest portion of disposal cell; confluence of Diversion Channels No. 1 and No. 2 in foreground.

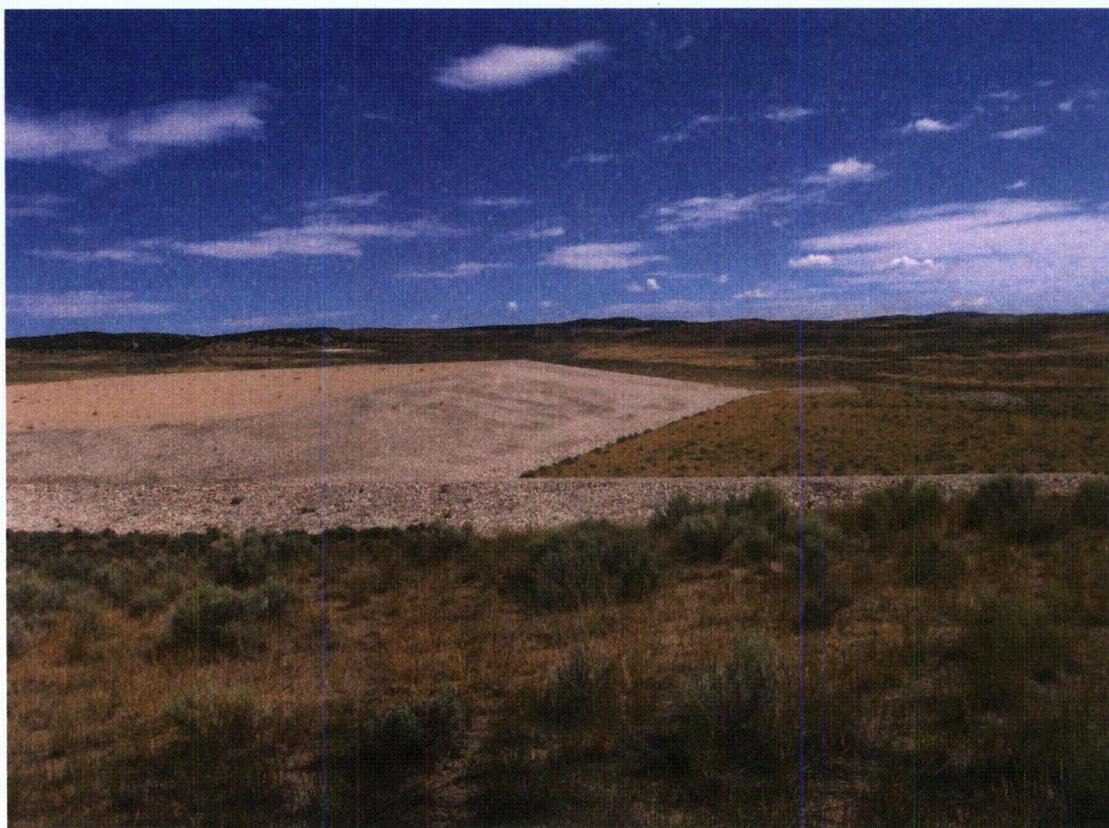
MAY 8/2014. PL-5. Southeast portion of disposal cell; Diversion Channel No. 1 in foreground.

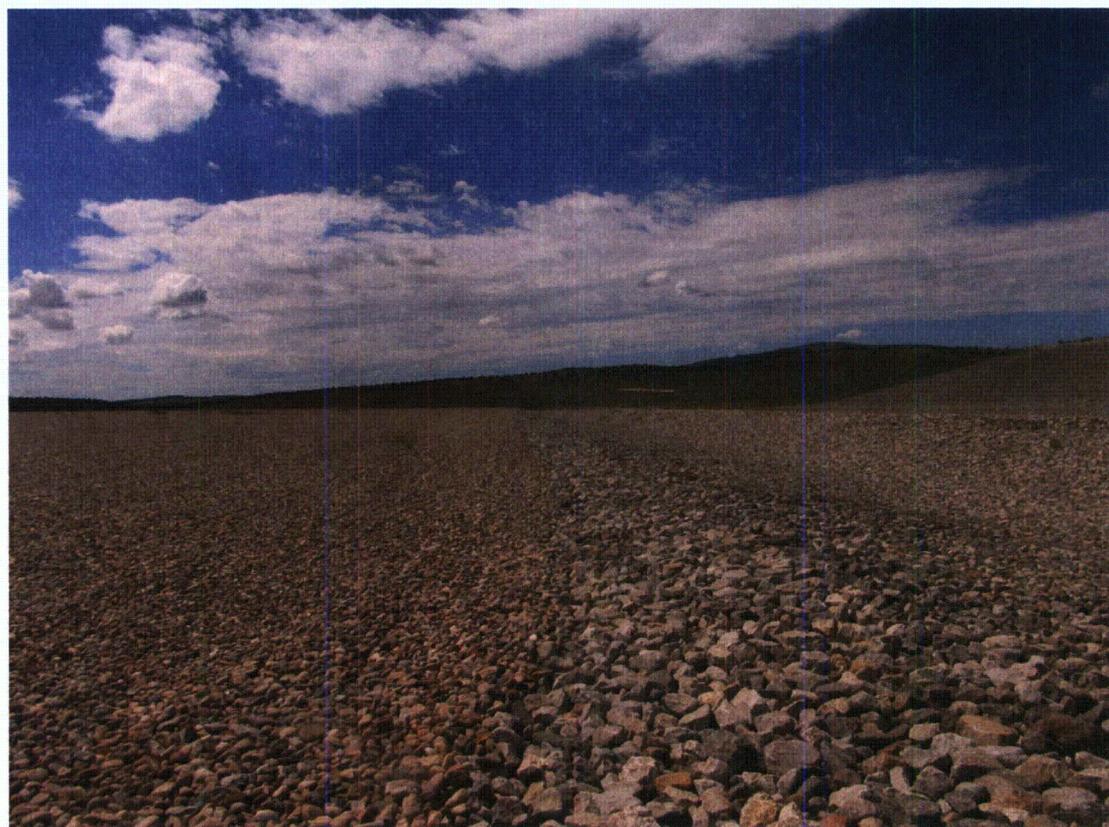
MAY 8/2014. PL-6. Intersection of top and west side slopes of disposal cell.

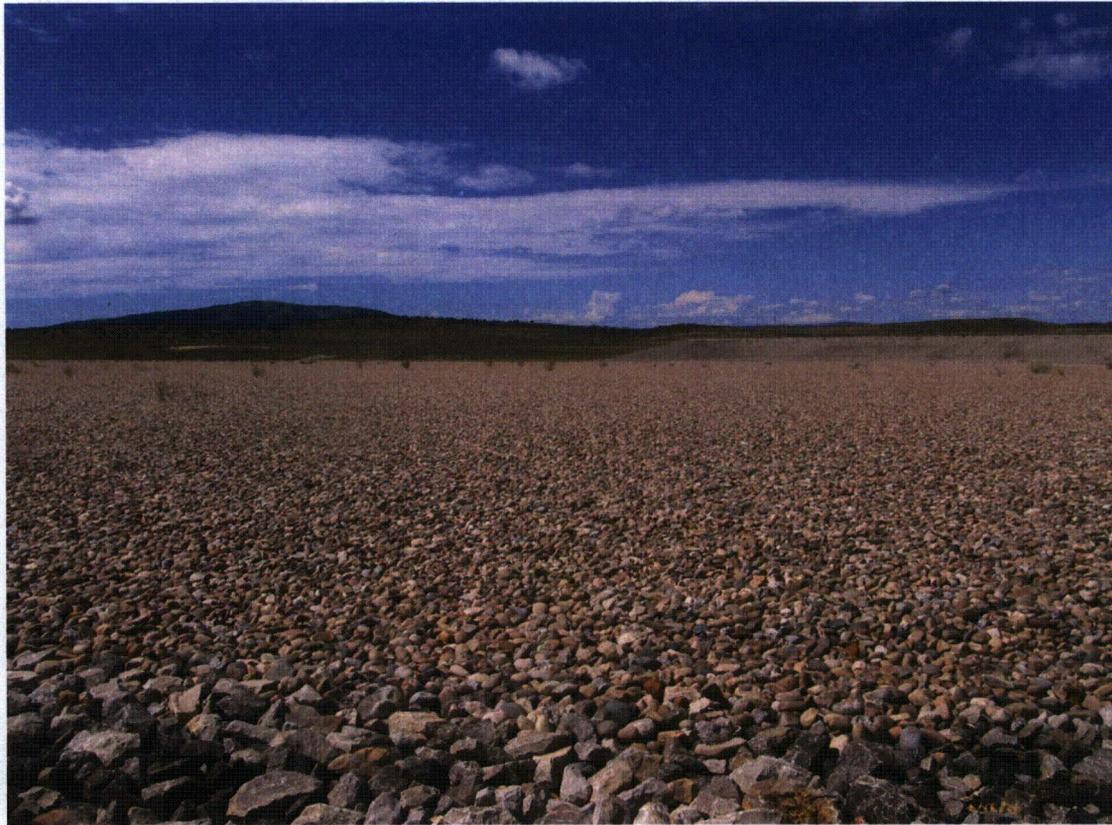
MAY 8/2014. PL-7. Top of disposal cell.

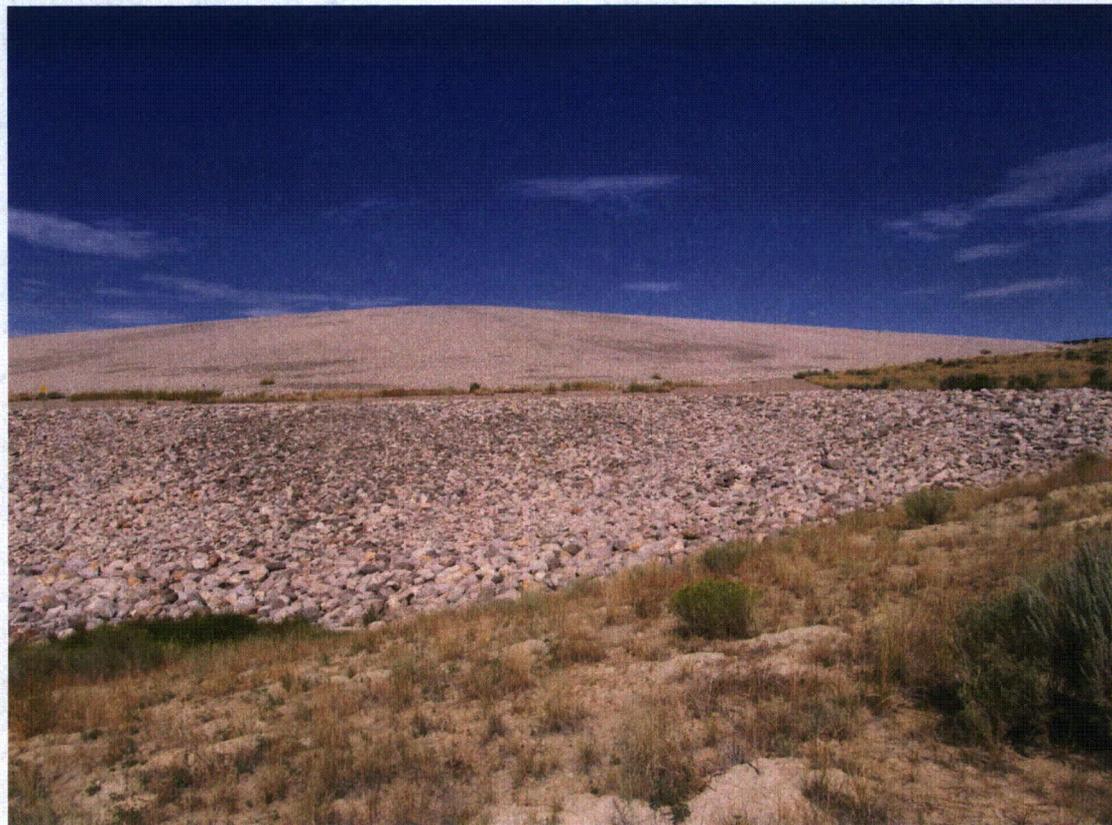
MAY 8/2014. PL-8. Gully No. 1; disposal cell in background.

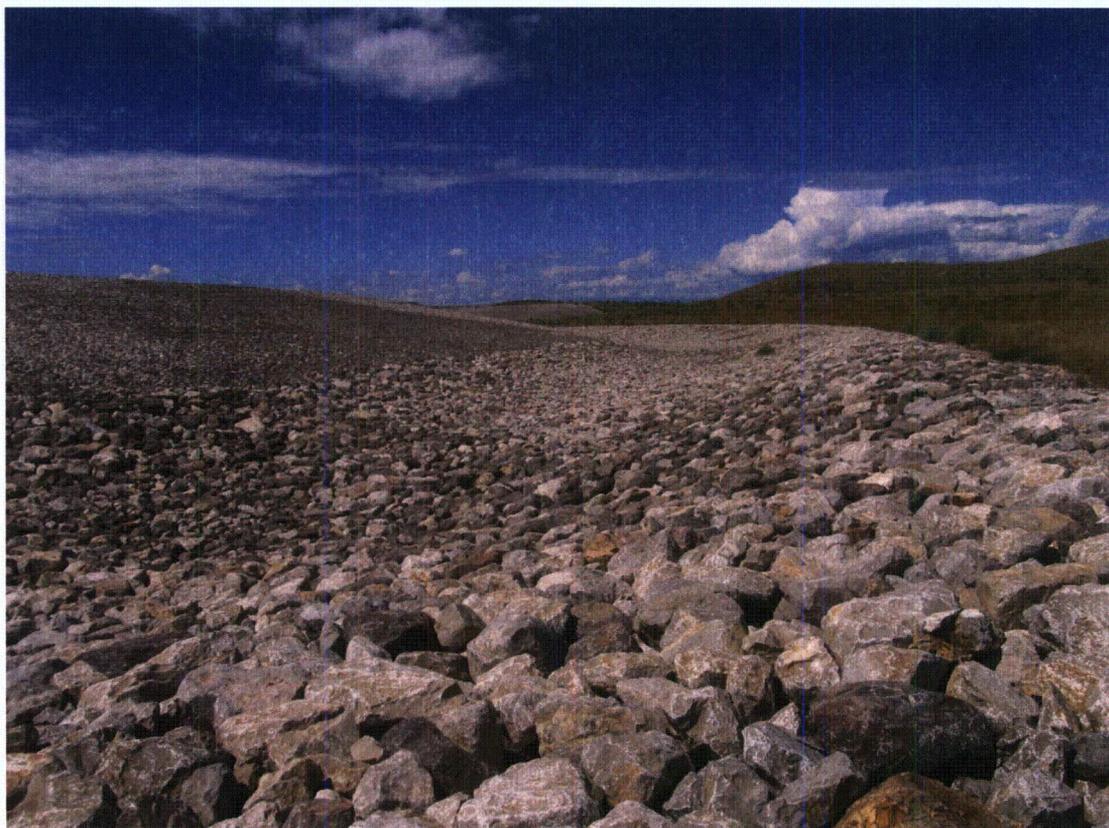
MAY 8/2014. PL-9. Diversion Channel No. 1.

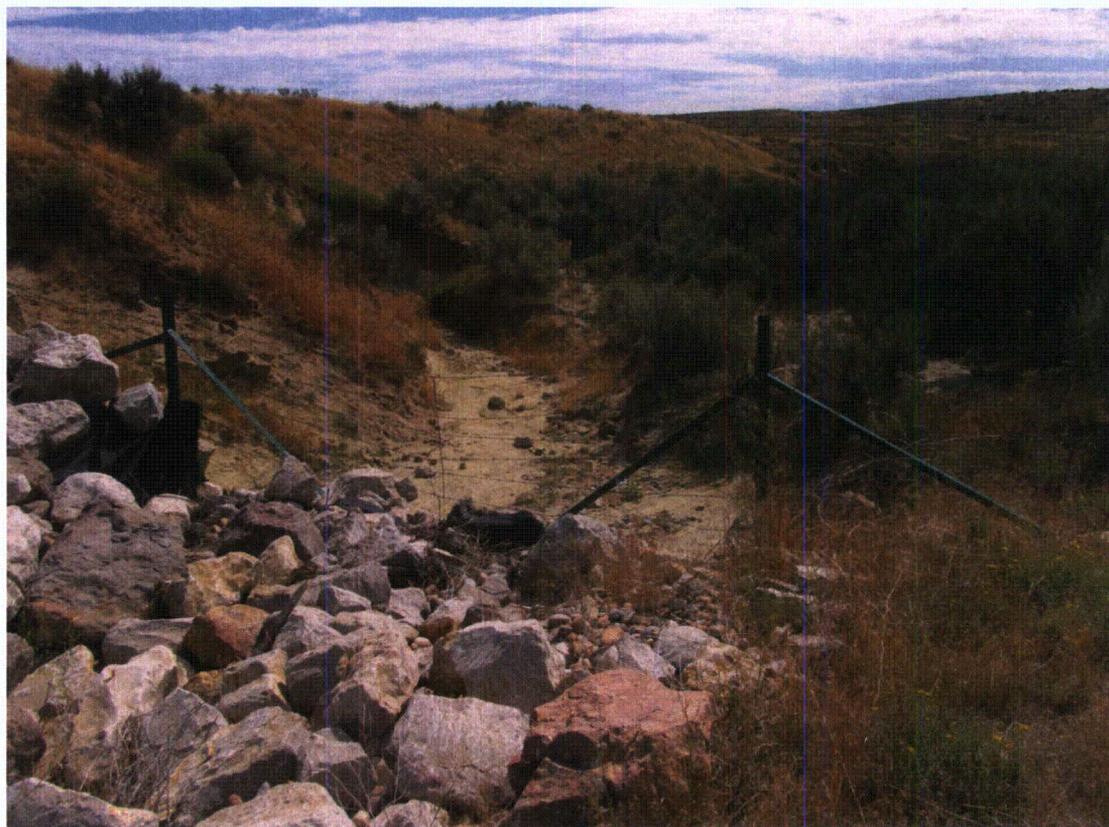
MAY 8/2014. PL-10. Outlet of Diversion Channel No. 1.

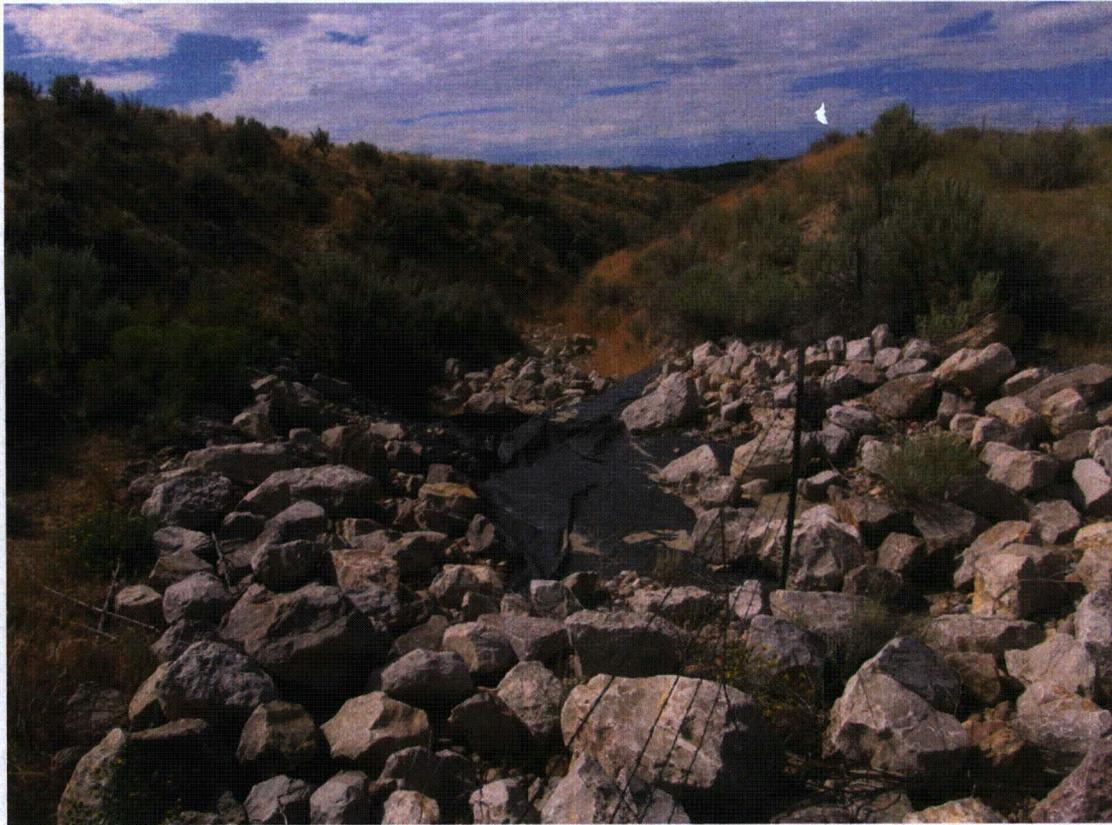
MAY 8/2014. PL-11. Outlet of Swale No. 1.

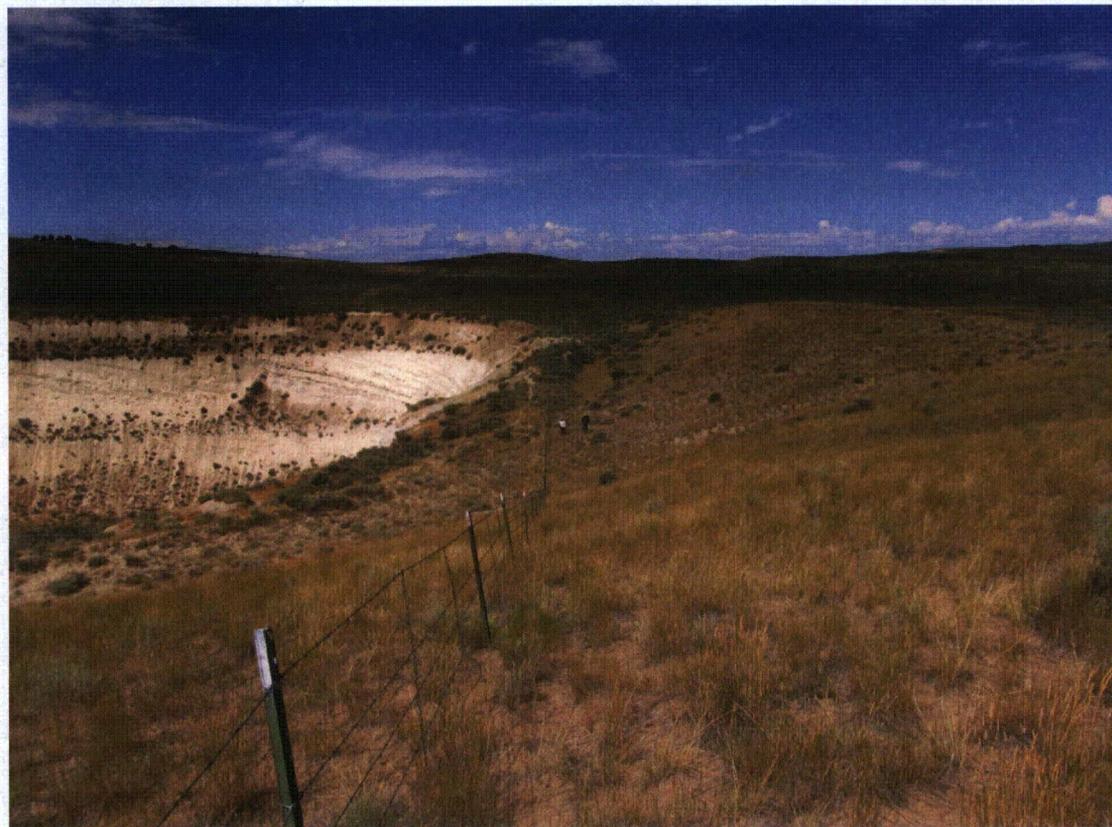
MAY 8/2014. PL-12. Perimeter fence and north end of Johnson Pit along south property boundary.
