12.0 Mexican Hat, Utah, Disposal Site

12.1 Compliance Summary

The Mexican Hat, Utah, Uranium Mill Tailings Radiation Control Act (UMTRCA) Title I Disposal Site was inspected on April 15, 2014. The disposal cell was in excellent condition. A broken perimeter fence strand was repaired. No additional maintenance needs or cause for a follow-up inspection was identified.

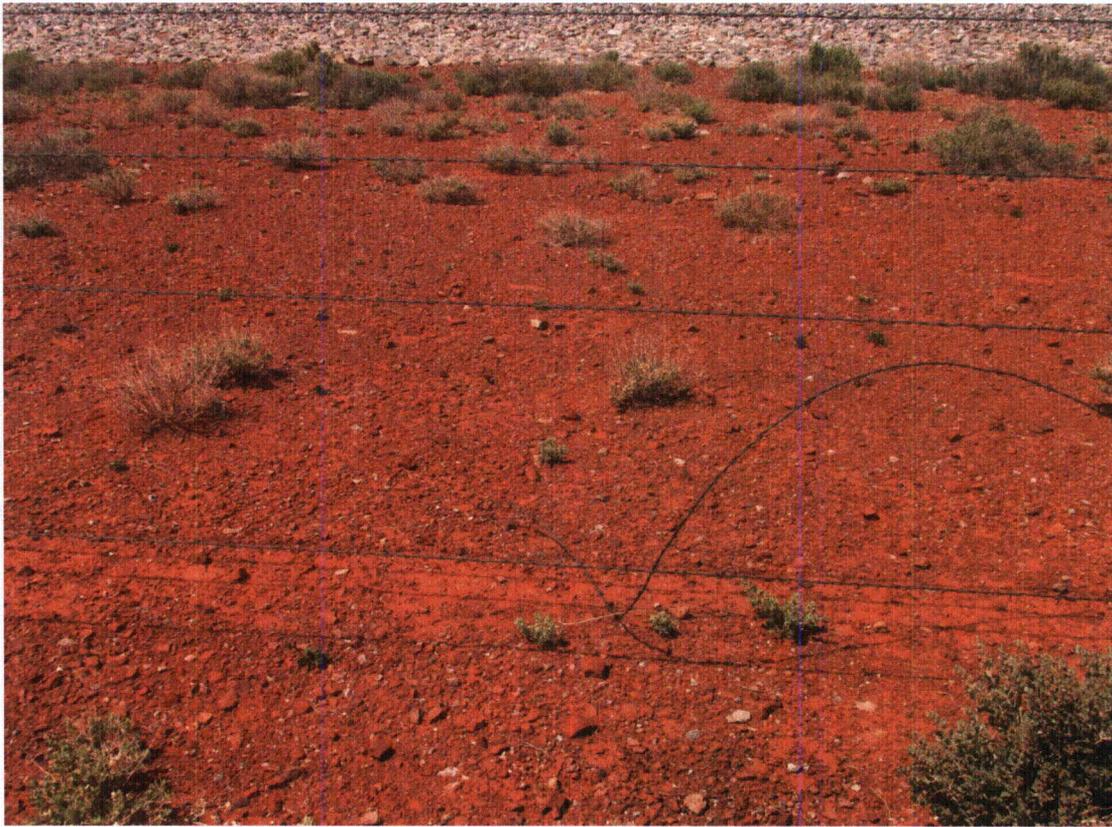
12A A barbed-wire perimeter fence is located between the disposal cell features and the site boundary and was in good condition. Periodically, the fence is damaged by livestock, erosion, or vandalism and requires repair. A single strand was broken near the east toe drain (PL-1 and PL-2). The broken strand was repaired.

HAT 4/2014. PL-1. Broken fence near east toe drain.

A broken strand of the cell perimeter fence was repaired. No other maintenance needs were identified.

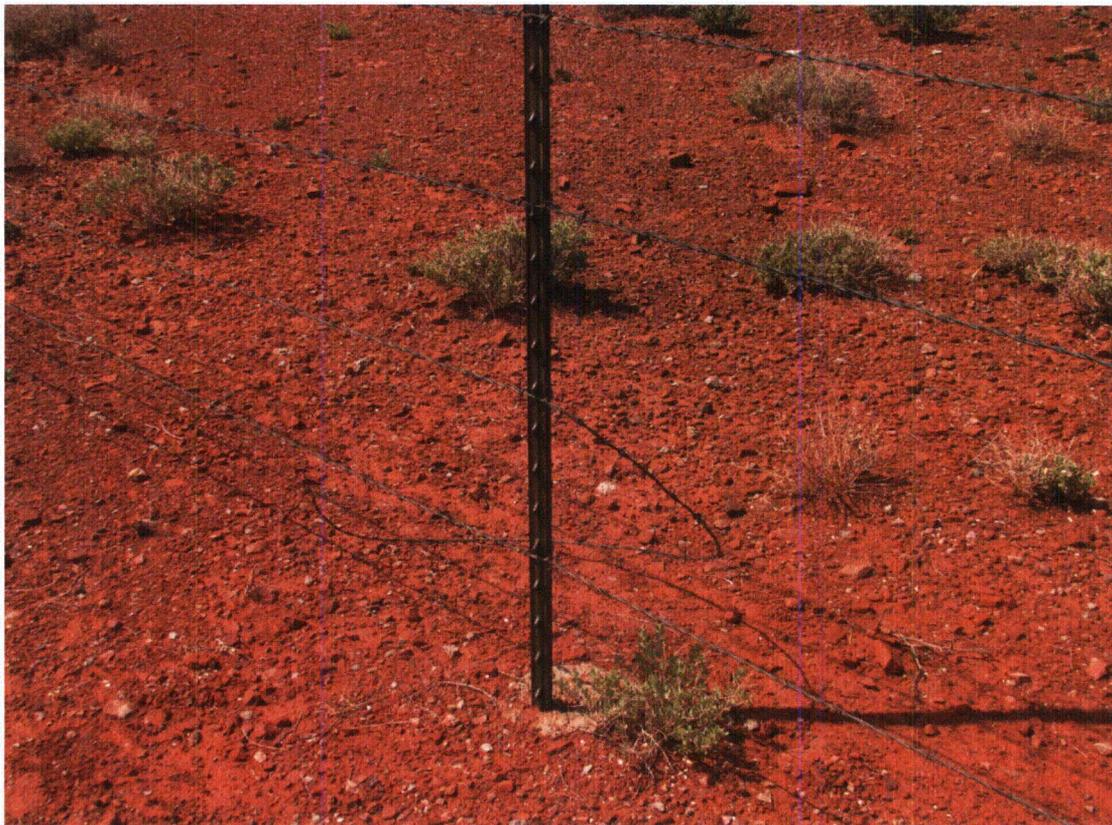
HAT 4/2014. PL-2. Broken fence near east toe drain.

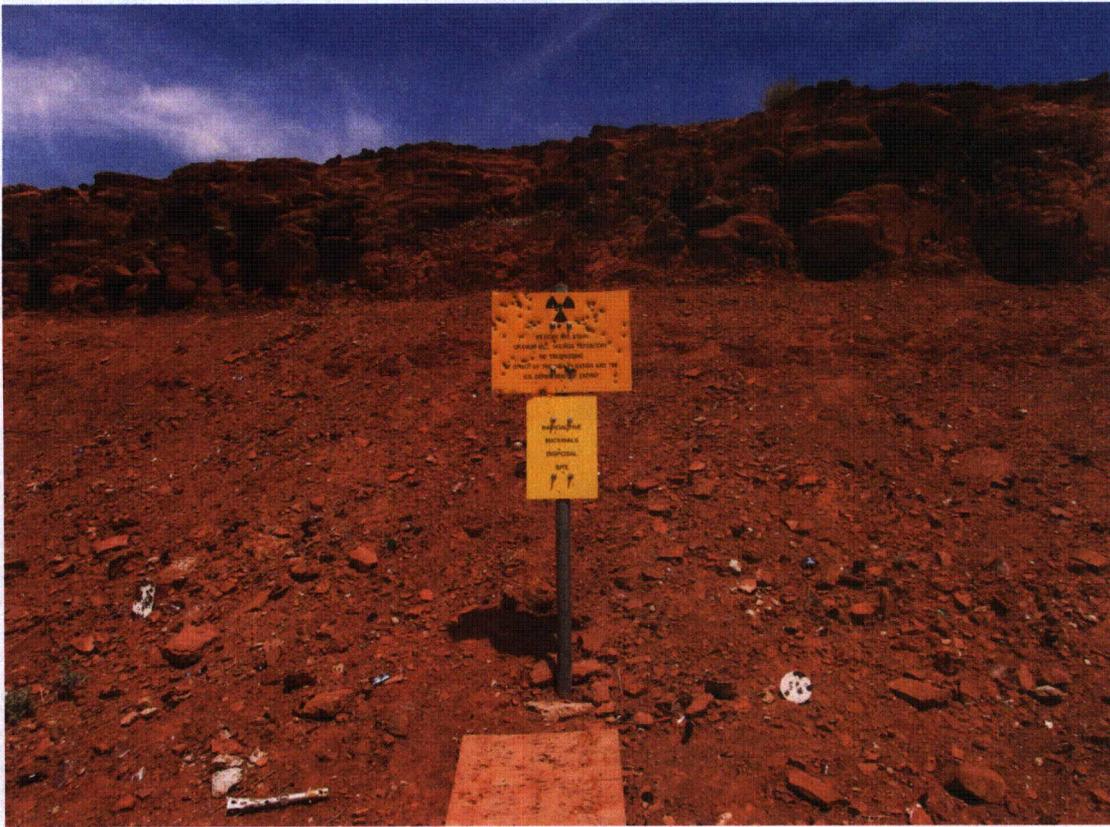
The site has 43 perimeter sign locations positioned along the site boundary. Each location has a pair of signs: an upper property ownership/no-trespassing sign and a lower sign identifying the site as a radioactive materials disposal site. The signs are attached to steel posts set in concrete. Several signs have bullet damage but remain legible (PL-3).

HAT 4/2014. PL-3. Perimeter sign P20 with bullet holes.

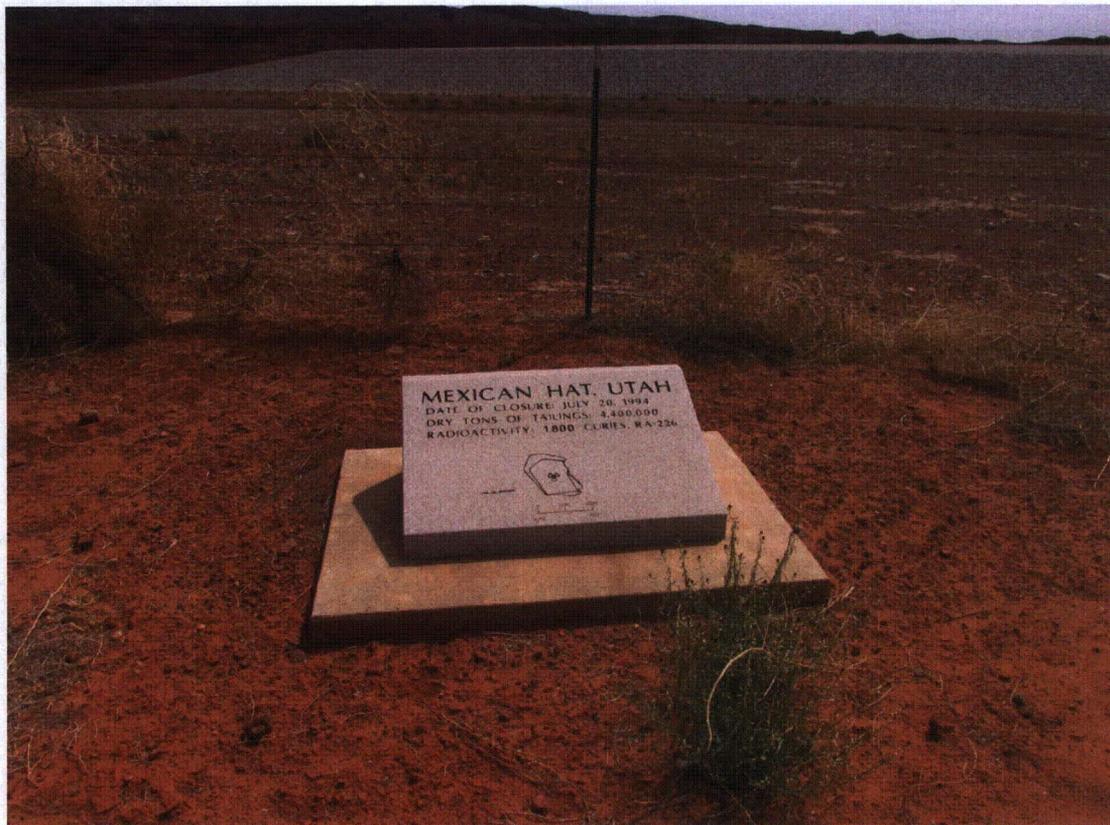
Two granite site markers are on the site. Site marker SMK-1, inside the perimeter fence near the entrance gate, was in good condition (PL-4). Its concrete base has several minor cracks, but repairs are not necessary at this time. Site marker SMK-2, on the disposal cell top slope, was in excellent condition (PL-5).

HAT 4/2014. PL-4. Site marker SMK-1 near entrance gate.

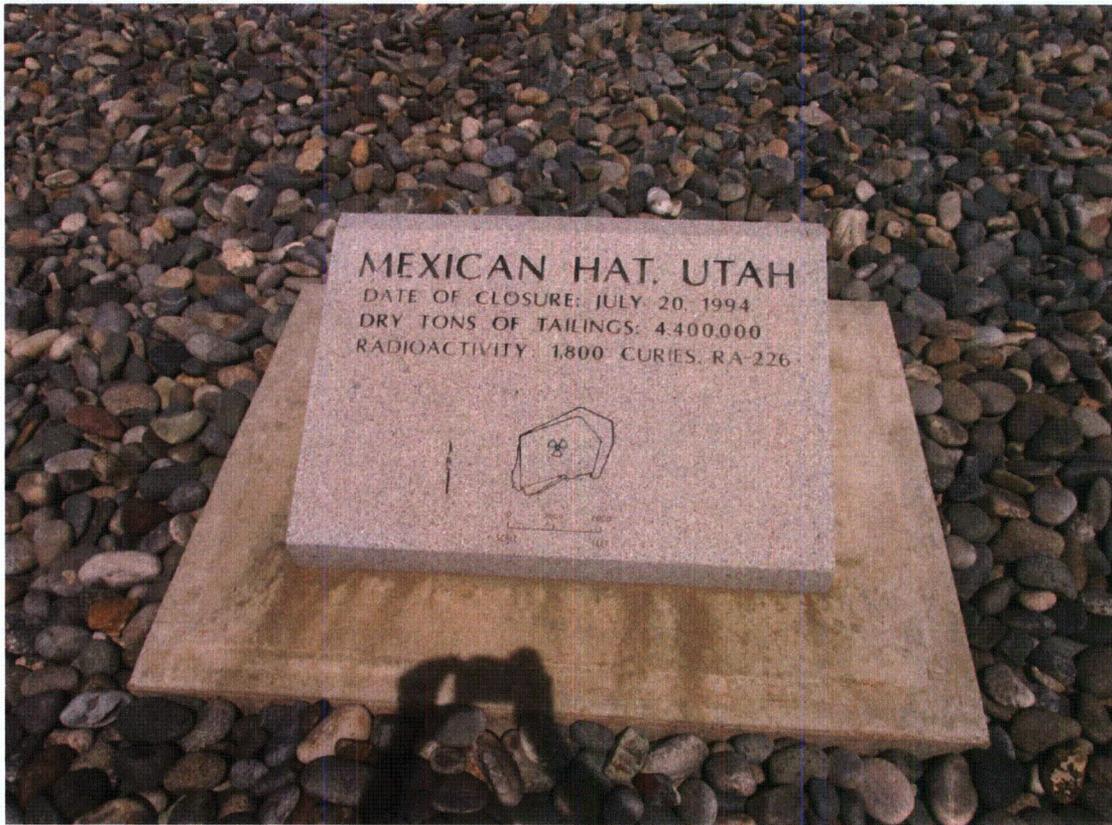
HAT 4/2014. PL-5. Site marker SMK-2 on disposal cell top slope.

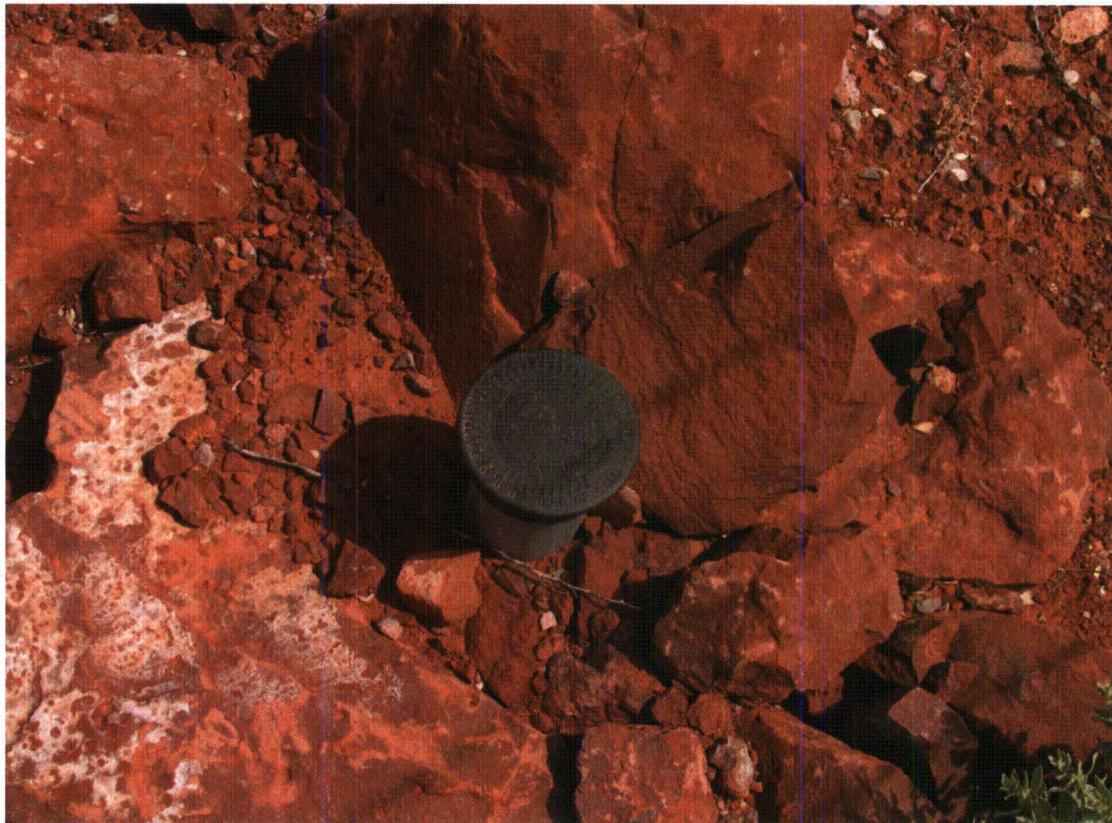
Twelve boundary monuments mark the site boundary. Five survey monuments were installed for survey control during cell construction. All of the monuments were in good condition (PL-6).

HAT 4/2014. PL-6. Survey monument SM-4.

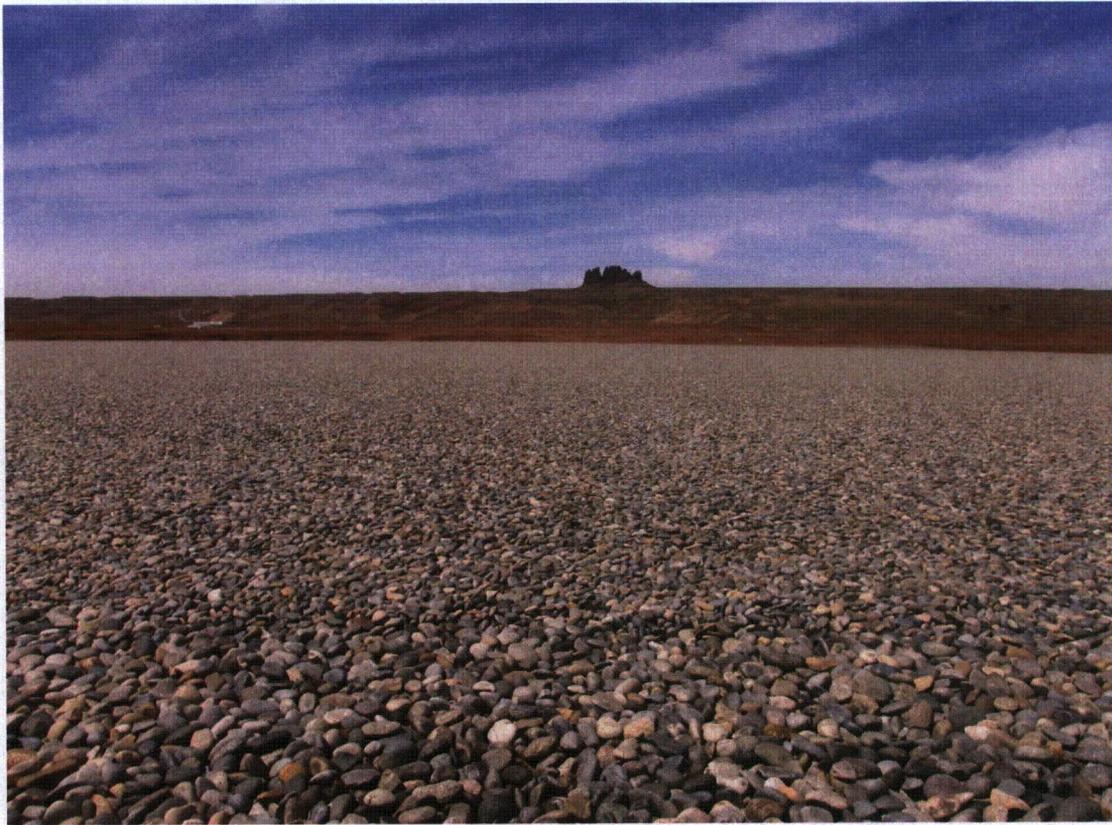
The top slope of the disposal cell was in excellent condition (PL-7 and PL-8). Inspectors found no evidence of differential settling, cracking, erosion, or burrowing. All visible components of the riprap-armored disposal cell top and side slopes were functioning as designed.

HAT 4/2014. PL-7. View west across disposal cell top slope.

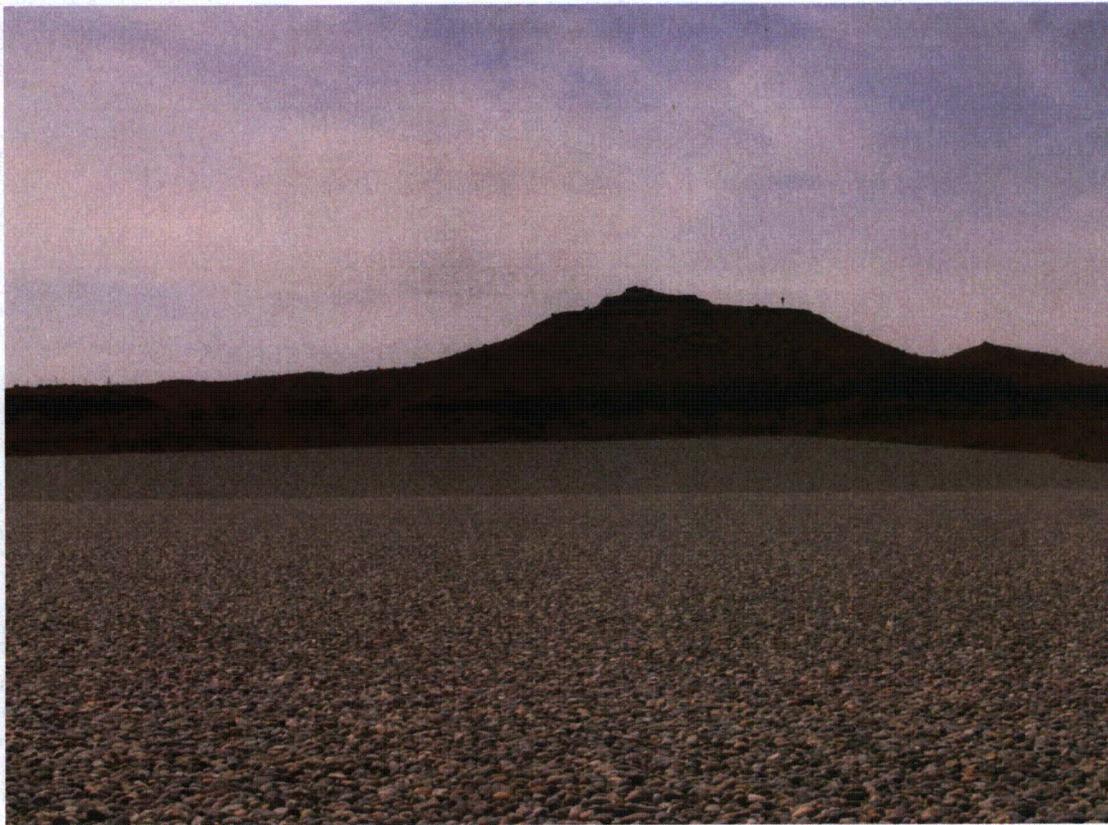
HAT 4/2014. PL-8. South portion of disposal cell top slope.

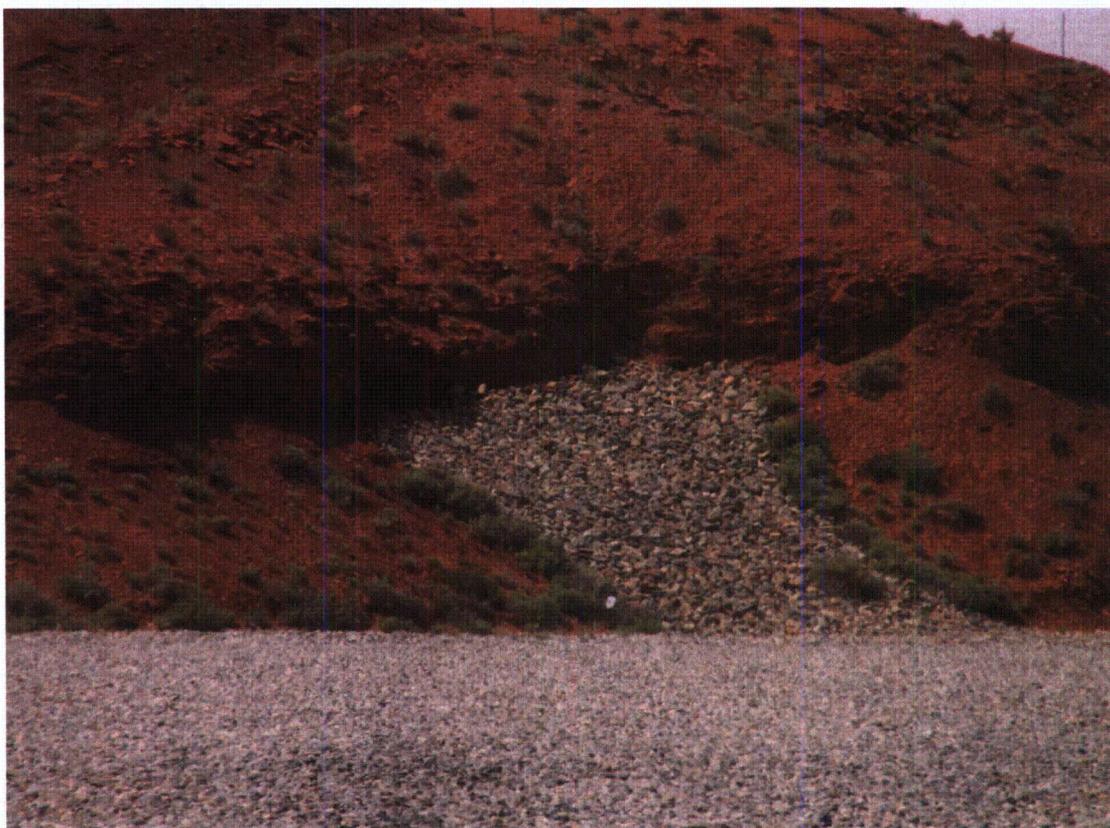
There was no noticeable increase of sloughed red country rock and soil along the south apron (PL-9). Because the apron in this area is immediately adjacent to the base of the steep rocky cliff face along the southern edge of the disposal cell cover, it is expected that sediment and unstable rock from the cliff face will continue to fall onto the apron. The accumulated material is not impacting the function of the apron but this area will continue to be monitored.

HAT 4/2014. PL-9. Erosion protection along south apron.

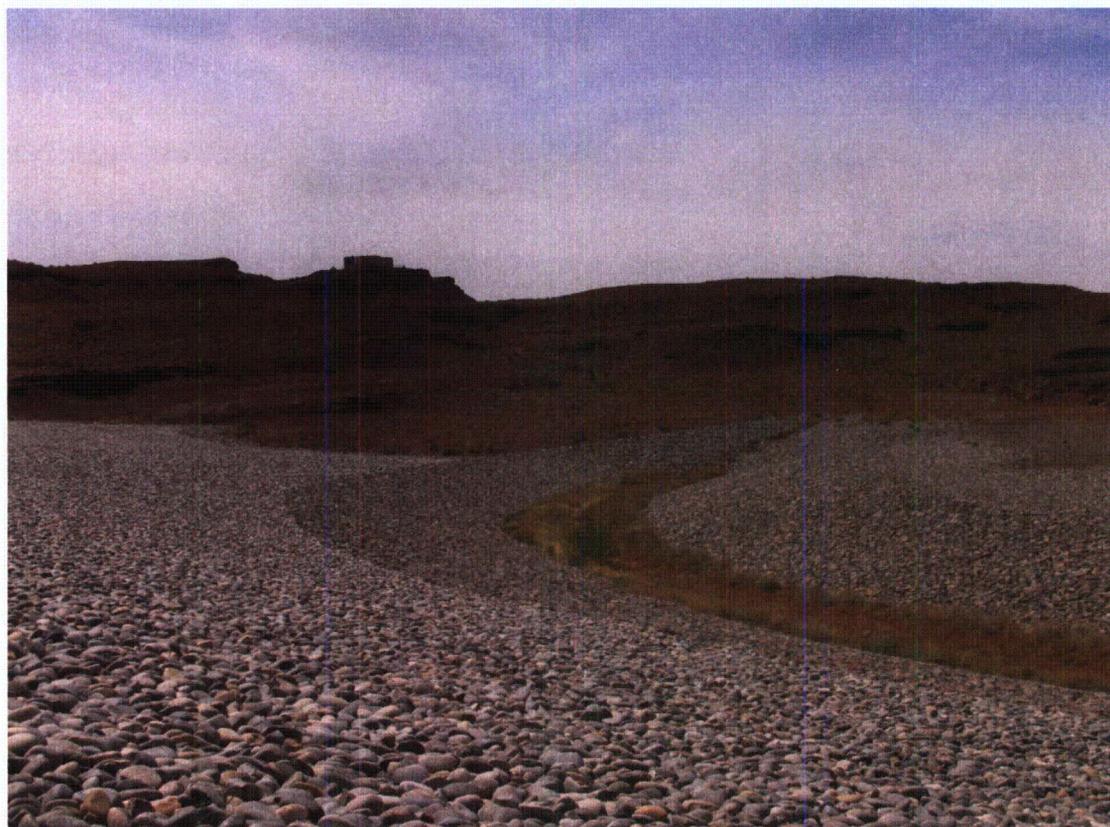
The disposal cell toe drains and diversion channels were in excellent condition and functioning as designed. Upgradient offsite areas continue to erode and transport sediment onto the site and into the west diversion channel (PL-10). The sediment accumulation has promoted the growth of vegetation in the channel, including perennial grasses and annual weeds; however, the sediment and vegetation are not affecting the performance of the diversion channel.

HAT 4/2014. PL-10. Upgradient portion of west diversion channel.

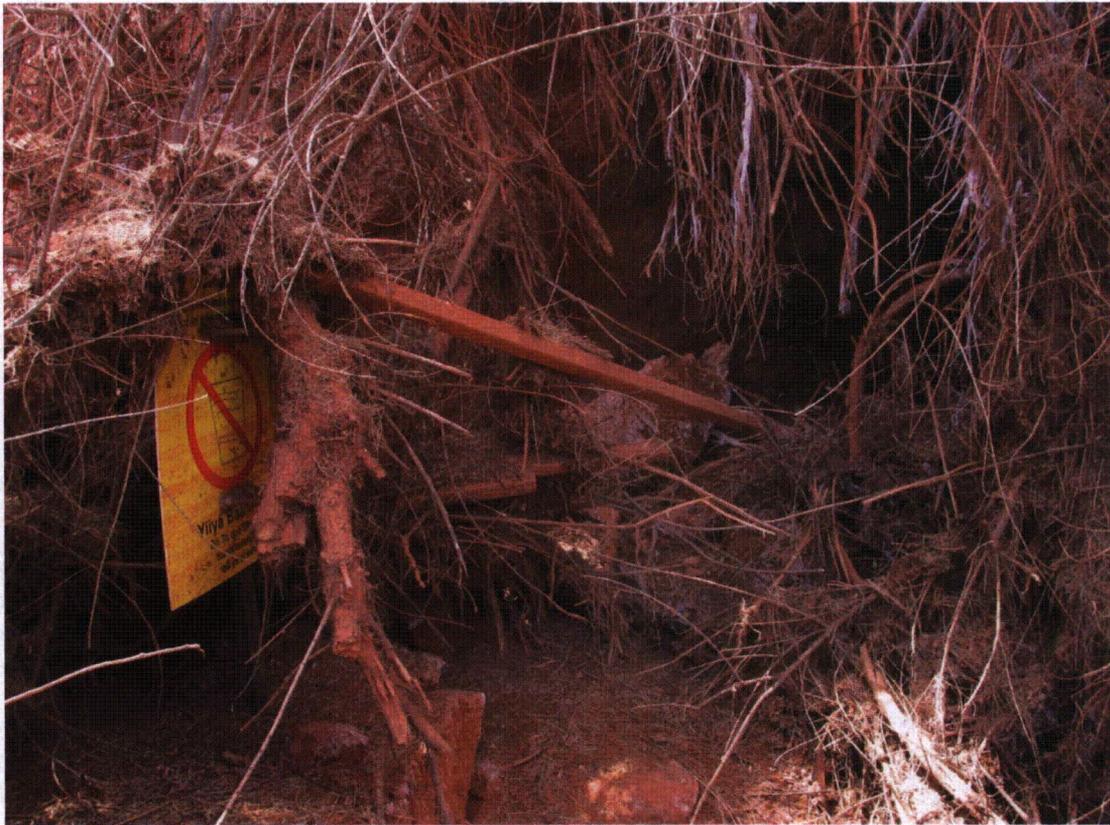
12B Since 2010, seep flow has been observed only at upgradient (background) seep 0248. This seep area was moist and only dripping water was observed, and it was impacted by the collapse of overhanging rock. The remaining seeps, all considered to be hydraulically downgradient of the site, were dry with no indication of recent moisture. No sampling was warranted because there were no significant increases in water flow at the seeps. Table 12-2 provides observations and qualitative descriptions of seep flows, along with a reference to photographic documentation.

HAT 4/2014. PL-11. Seep 0248 with sloughed rock and sediment.

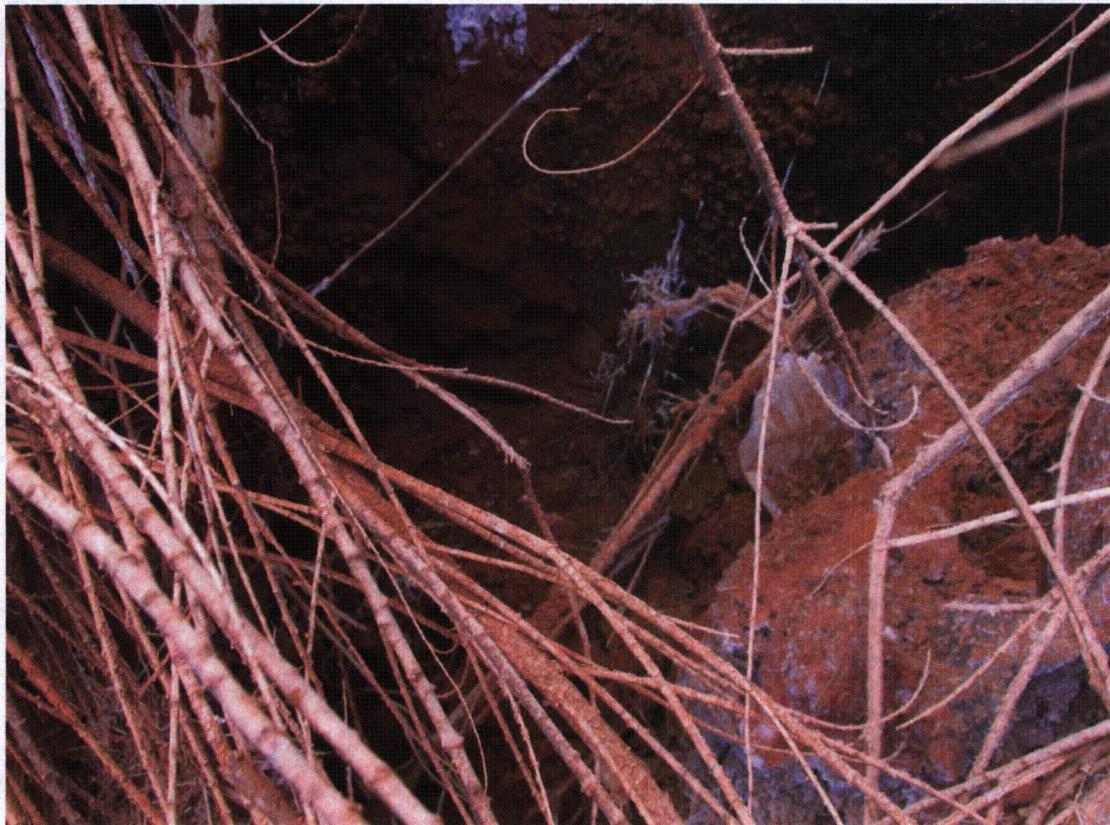
HAT 4/2014. PL-12. Seep 0248 (moist soil and dripping water).

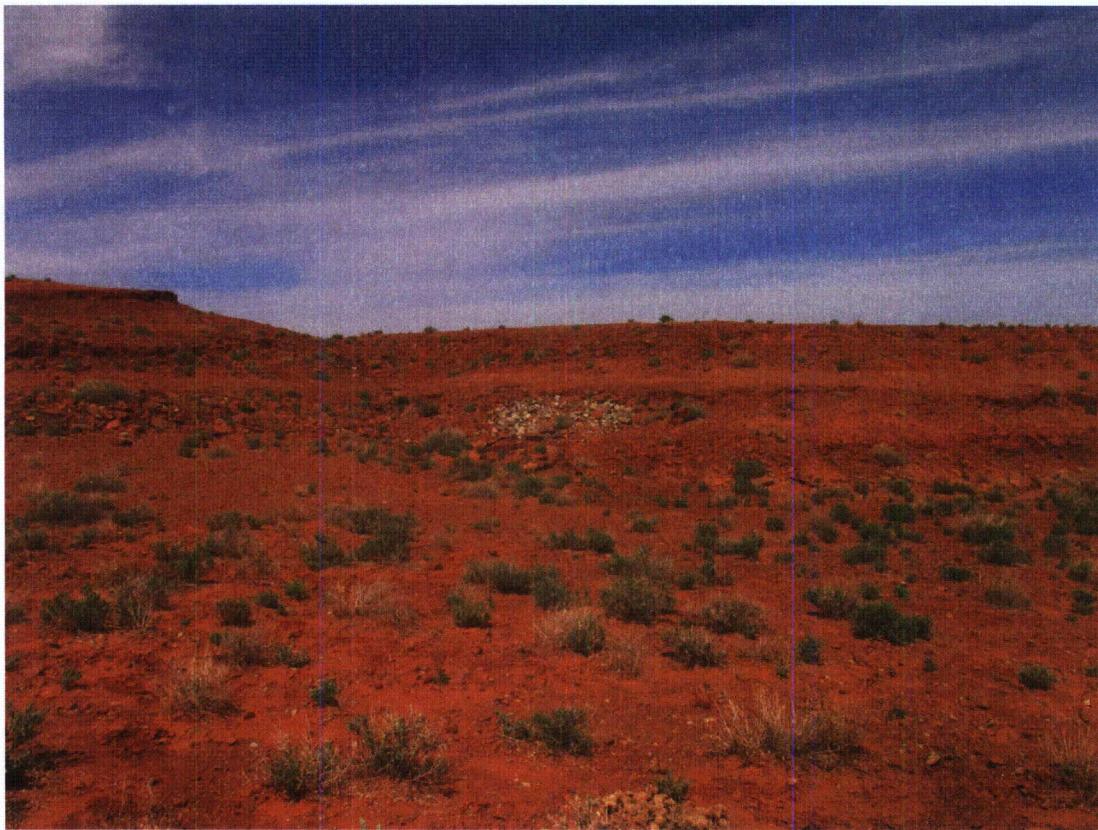
HAT 4/2014. PL-13. Seep 0249 (dry).

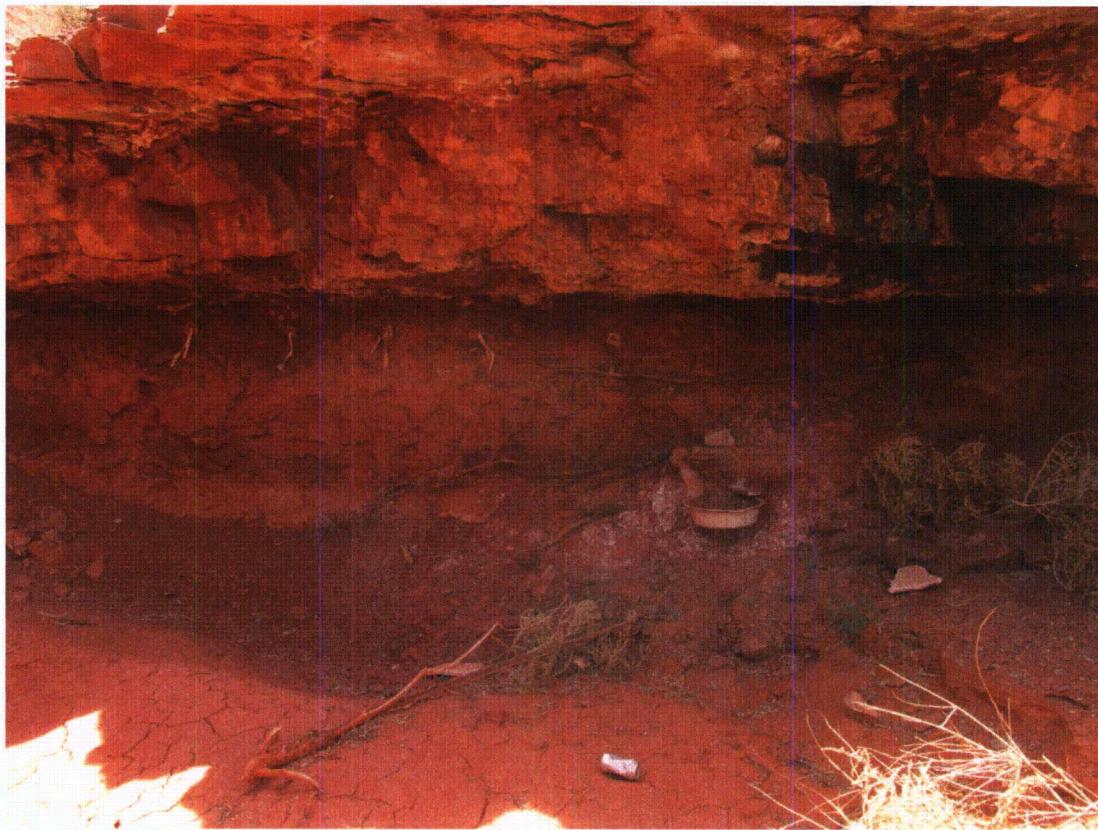
HAT 4/2014. PL-14. Seep 0254 (dry).

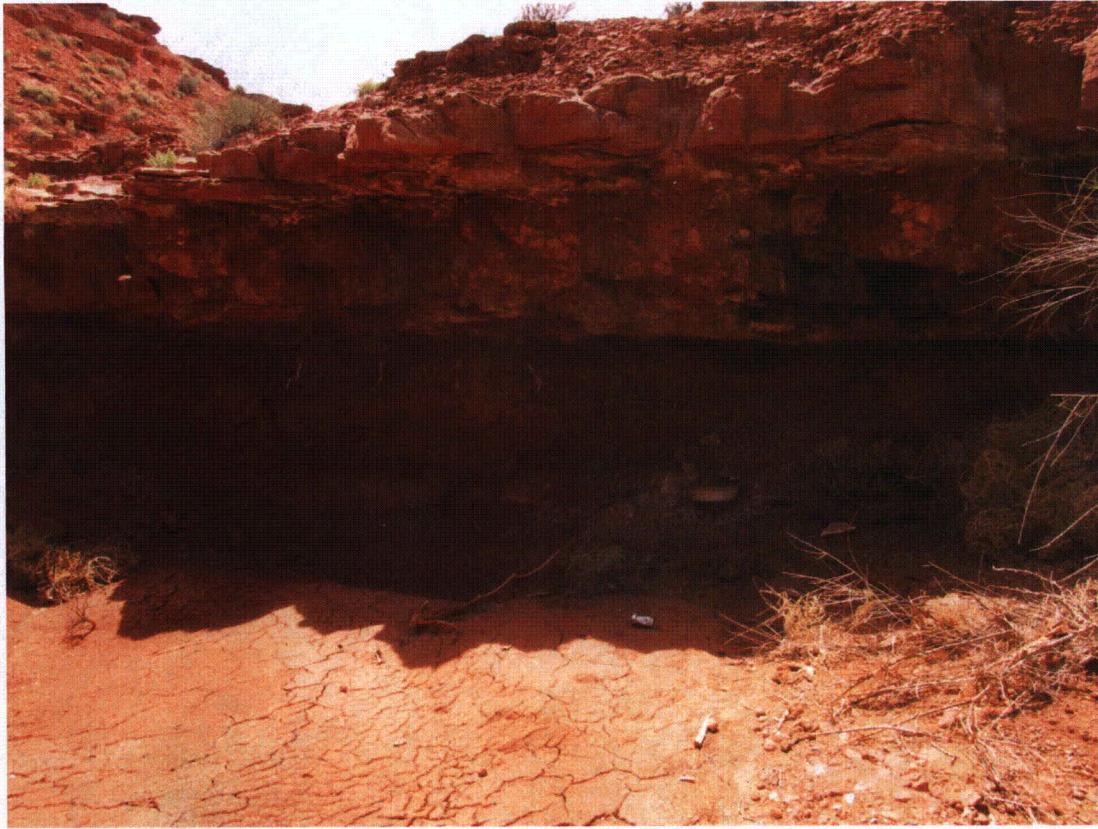
HAT 4/2014. PL-15. Seep 0254 (dry).

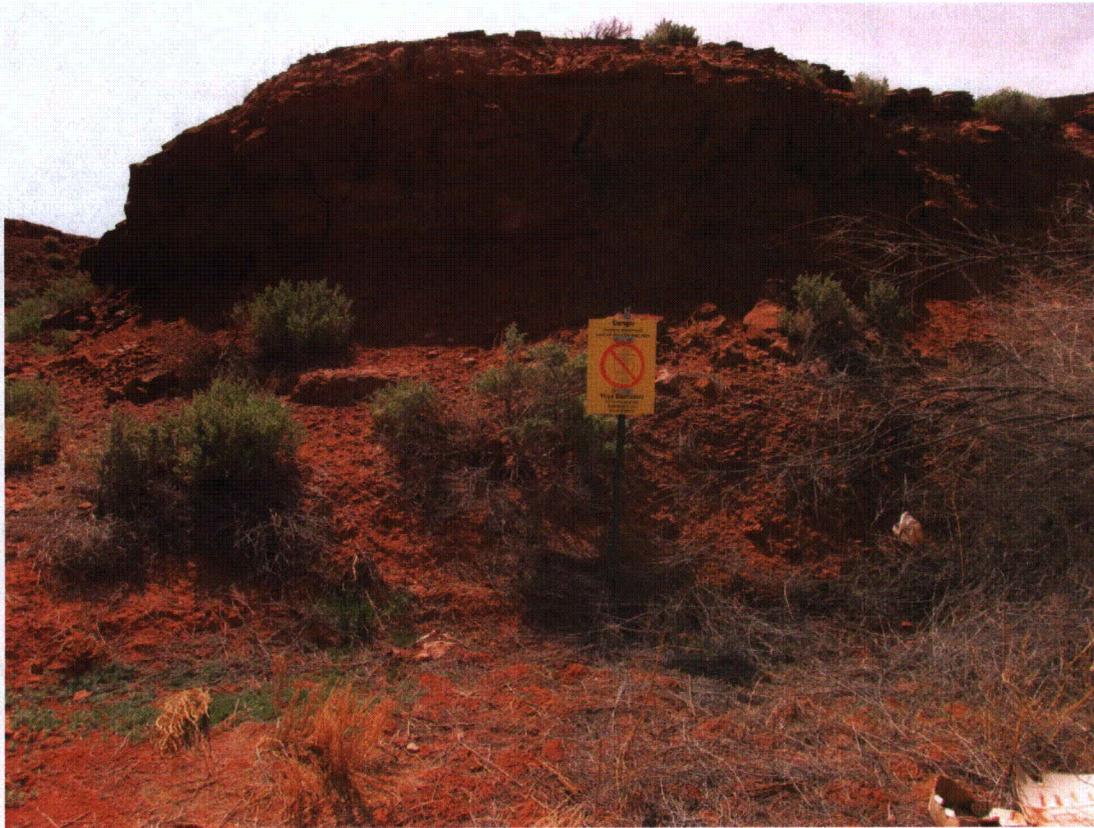
HAT 4/2014. PL-16. Seep 0264 (dry).

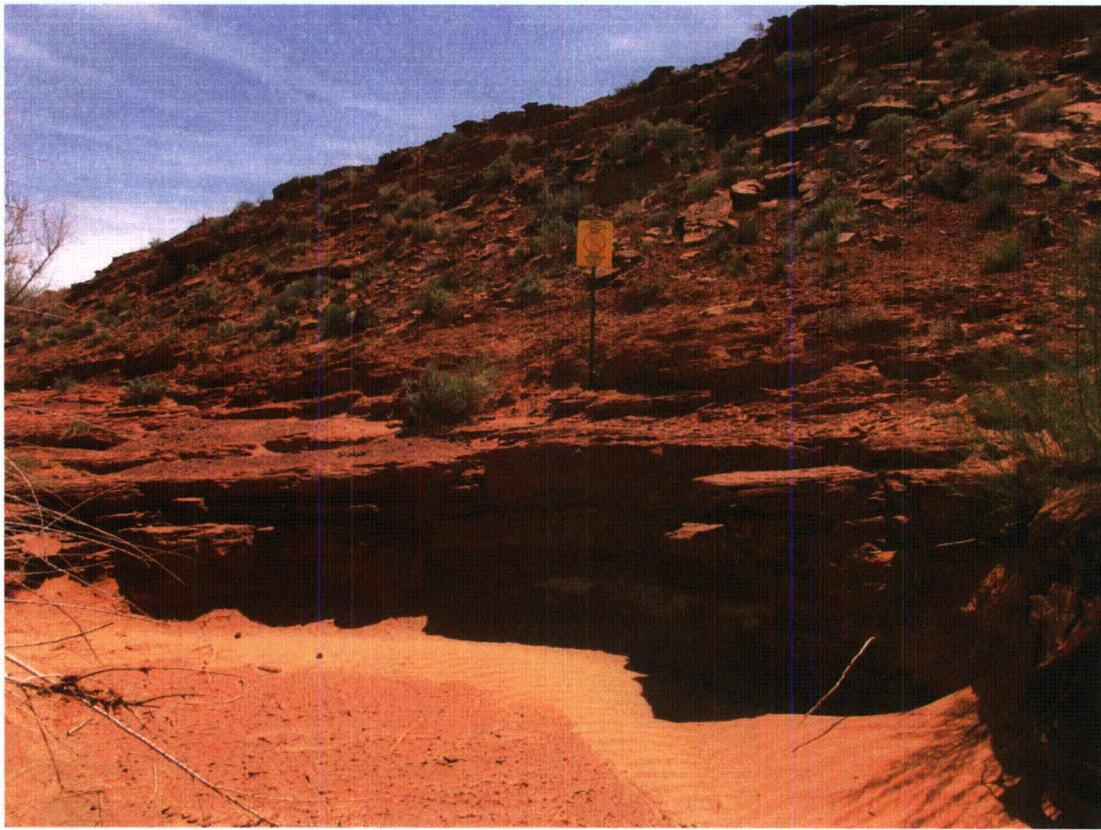
HAT 4/2014. PL-17. Seep 0922 (dry).

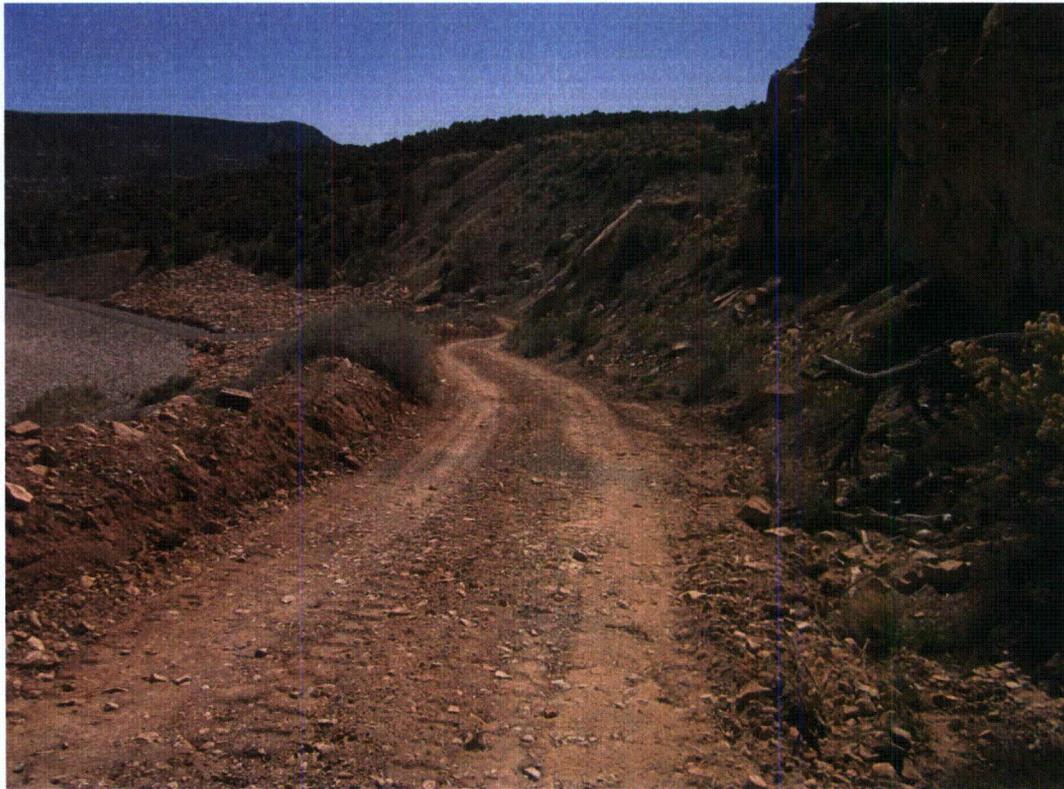
The disposal cell access road along the northwest side of the site was repaired in March 2014 (PL-1). Repairs included removing fallen rocks, placing new gravel, and regrading the road; the road was in excellent condition (PL-2). Two gates where the cell access road crosses the property boundary near boundary monument BM-9 were in good condition.

NAD 5/2014. PL-1. Repaired section of cell access road (image from March 2014 erosion repairs).

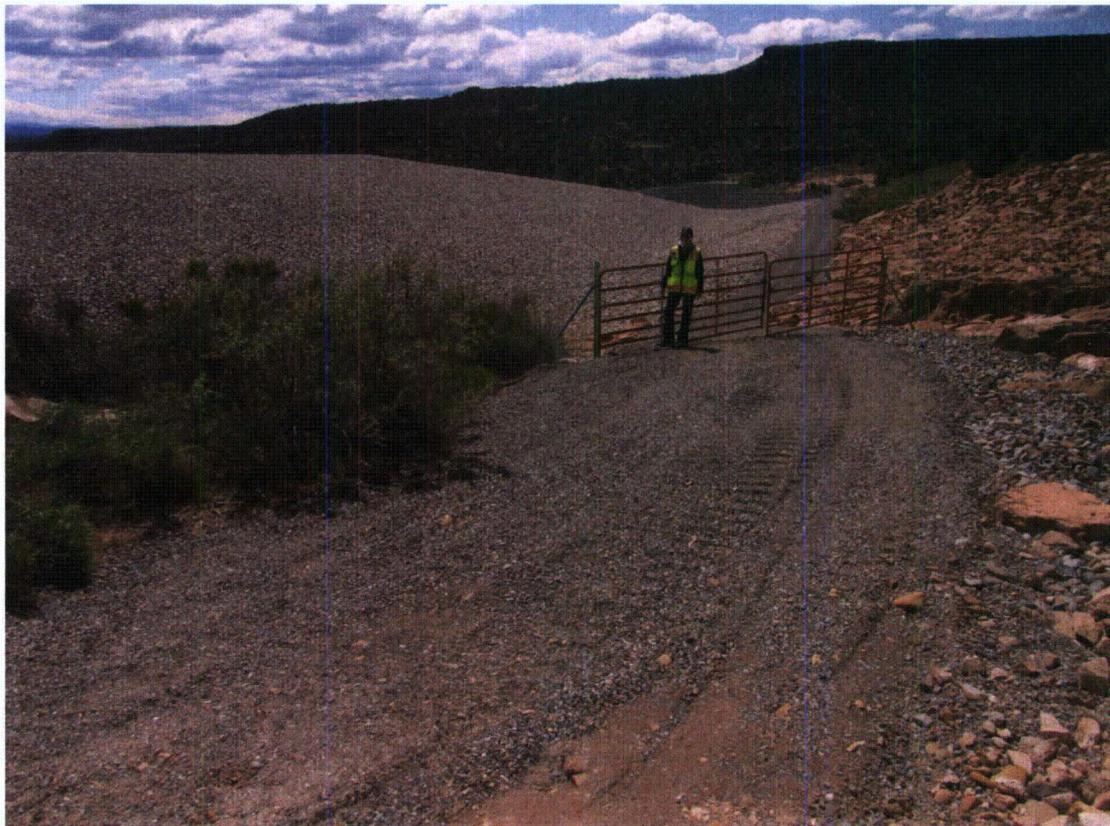
NAD 5/2014. PL-2. Repaired access road at gate near boundary monument BM-9.

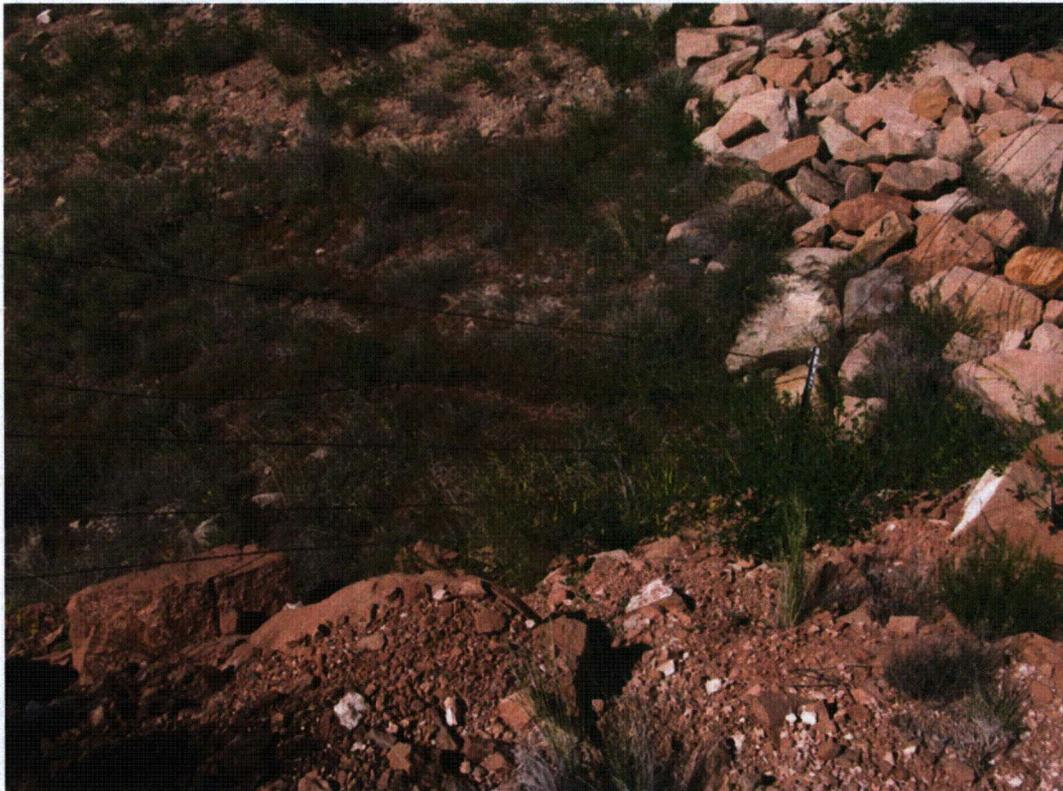
A barbed-wire stock fence encloses the site. Overall, the fence is in good condition. Loose strands are present at several locations but do not impair the function of the fence (PL-3); they will be repaired when other site repairs are necessary.

NAD 5/2014. PL-3. Perimeter fence with loose strand at south corner of site.

The disposal cell access road was repaired and boulders were removed from the toe drains. Loose fence strands will be repaired when other site maintenance is necessary. No other maintenance needs were identified.

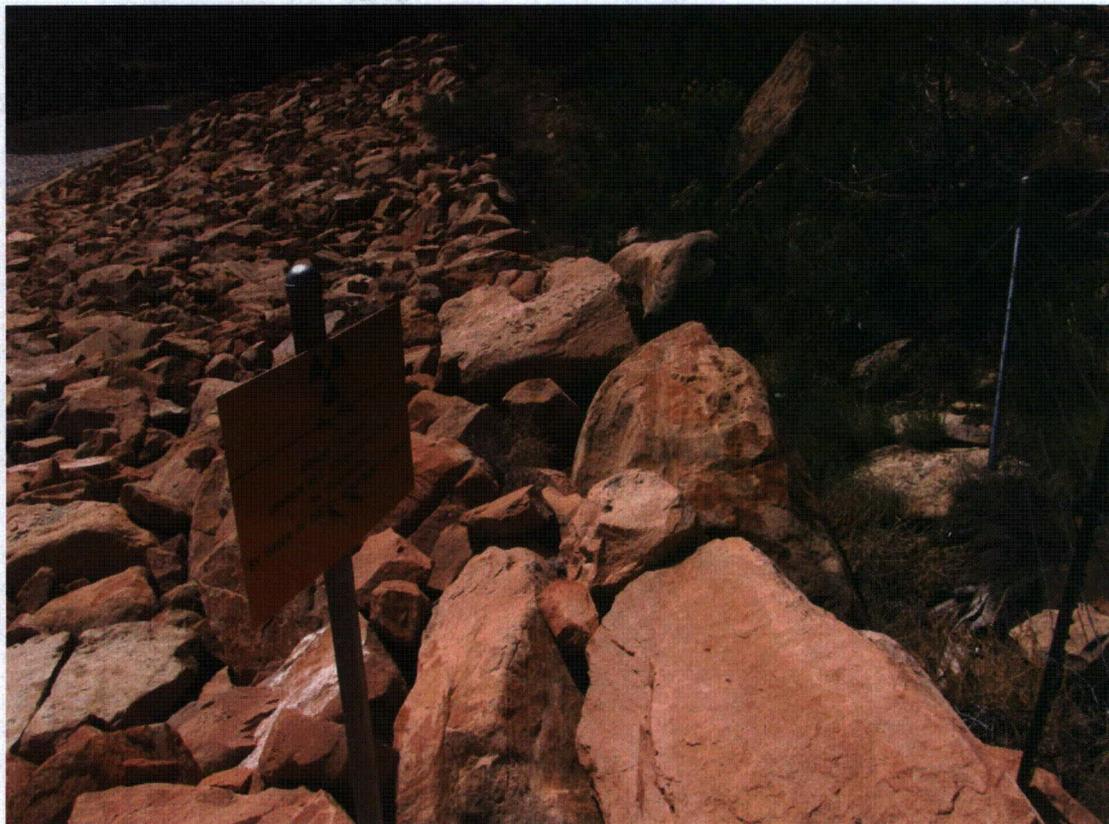
Perimeter signs mounted on steel posts are set approximately 5 feet inside the perimeter fence (PL-4). Perimeter sign P2 has bullet damage but remains legible. The other 24 perimeter signs were in good condition.

NAD 5/2014. PL-4. Perimeter sign P17; boundary monument BM-10 in vegetation between rocks and fence.

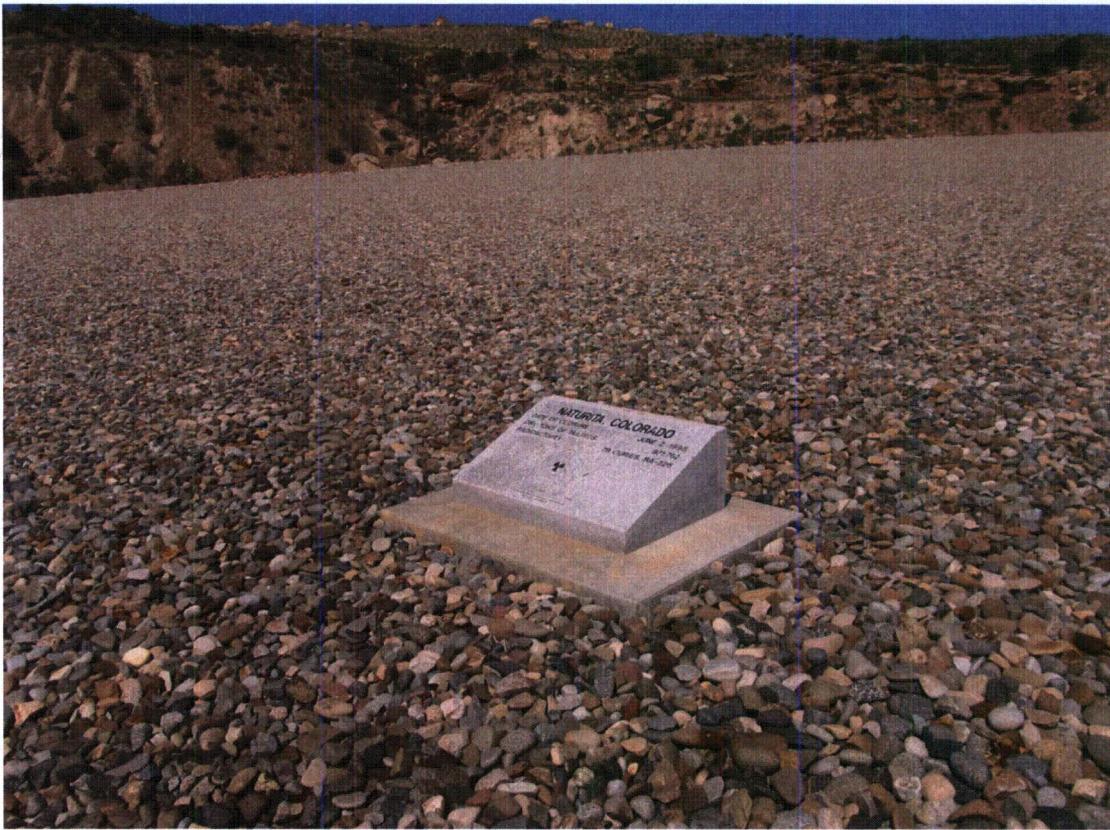
Two granite site markers identify the site. Site marker SMK-1 is set just inside the entrance gate, and site marker SMK-2 (PL-5) is on the top slope of the disposal cell. Both markers were in good condition.

NAD 5/2014. PL-5. Site marker SMK-2 on top of disposal cell.

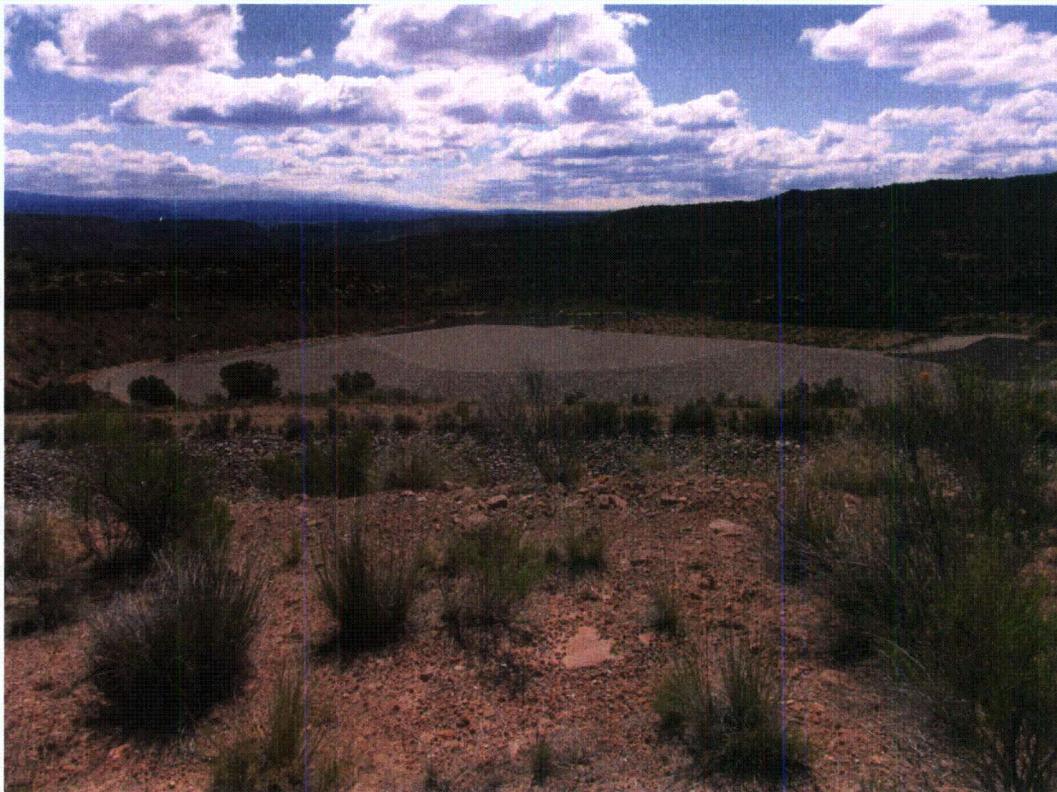
Rock covers the 2-acre top of the disposal cell and the approximate 8 acres of side slopes (PL-6). The rock is rounded, with larger rock on the side slopes than on the top. The rock-covered surfaces were in excellent condition. A small area on the southwest side of the disposal cell was noted during the 2013 inspection as being slightly higher than the surrounding cell sides (shown as an area to be watched in Figure 13-1). This area, which may be a feature left from final rock placement, was inspected in 2014 but no change was evident. No degradation or significant vegetation was identified on the cell.

NAD 5/2014. PL-6. Disposal cell.
