12.0 Mexican Hat, Utah, Disposal Site

12.1 Compliance Summary

The Mexican Hat, Utah, Uranium Mill Tailings Radiation Control Act (UMTRCA) Title I Disposal Site was inspected on April 15, 2014. The disposal cell was in excellent condition. A broken perimeter fence strand was repaired. No additional maintenance needs or cause for a follow-up inspection was identified.

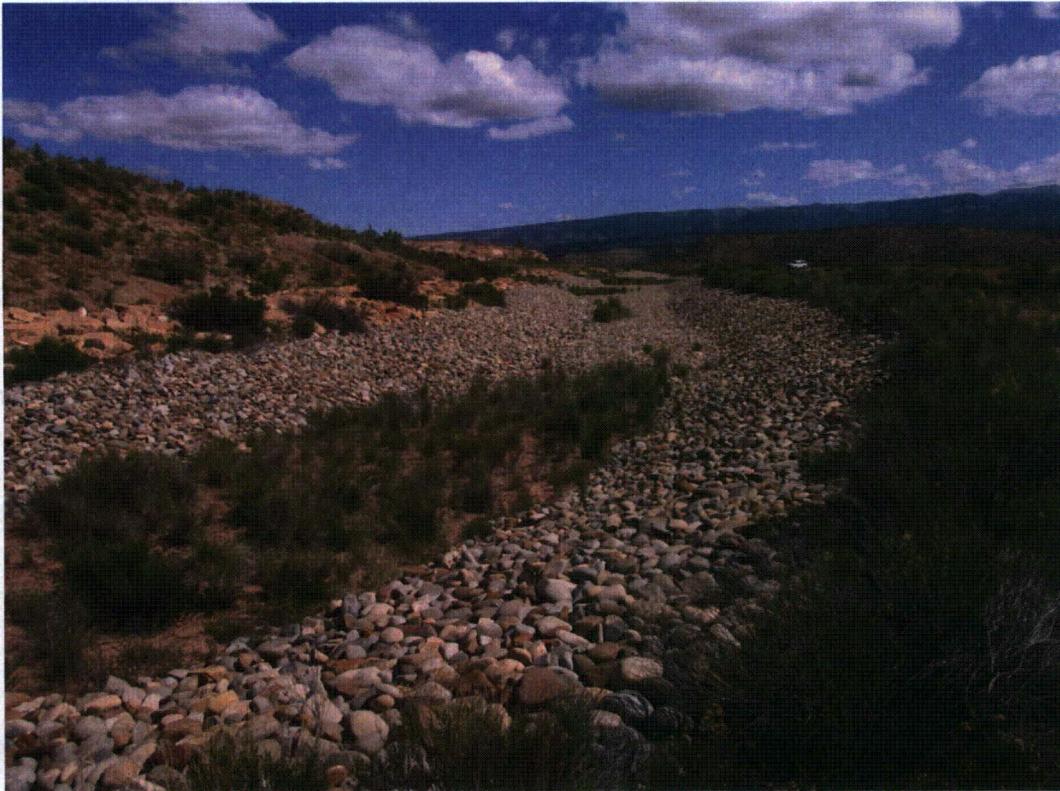
A riprap-armored interceptor channel, upgradient and northwest of the disposal cell, diverts storm water and snowmelt run-on to the northeast under County Road EE22. Some erosion has occurred outside the property uphill from perimeter sign P23 and between perimeter signs P22 and P23 resulting in deposition of sediment in the channel (PL-7). The channel is in good condition, however, and the current sediment accumulation and associated vegetation do not impair the function of the channel.

NAD 5/2014. PL-7. Sediment and vegetation in interceptor channel.
