17.0 Slick Rock, Colorado, Disposal Site

17.1 Compliance Summary

The Slick Rock, Colorado, Uranium Mill Tailings Radiation Control Act (UMTRCA) Title I Disposal Site was inspected on May 13, 2014. The site was in good condition. A damaged perimeter sign was replaced. Inspectors identified no other maintenance needs or cause for a follow-up inspection.

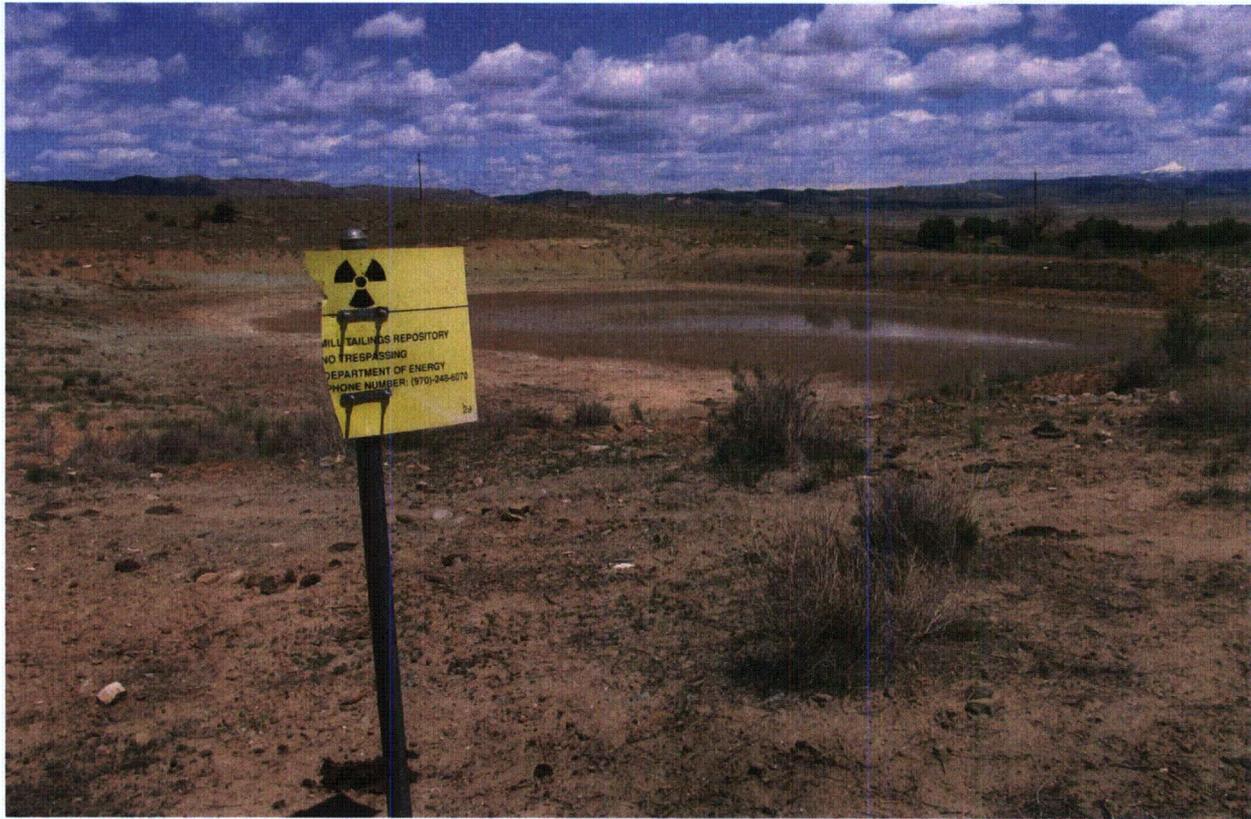
Thirty-two perimeter signs, designated P1 through P32, are spaced at approximately 200-foot intervals around the site. The signs, attached to steel posts set in concrete, are 5 feet inside the site boundary. Most signs were in good condition, although some cracking of the printed overlay is beginning to appear on several signs. Damaged perimeter sign P29 (PL-1) was replaced.

SRK 5/2014. PL-1. Perimeter sign P29 and retention pond.

Damaged perimeter sign P29 was replaced. No other maintenance needs were identified.

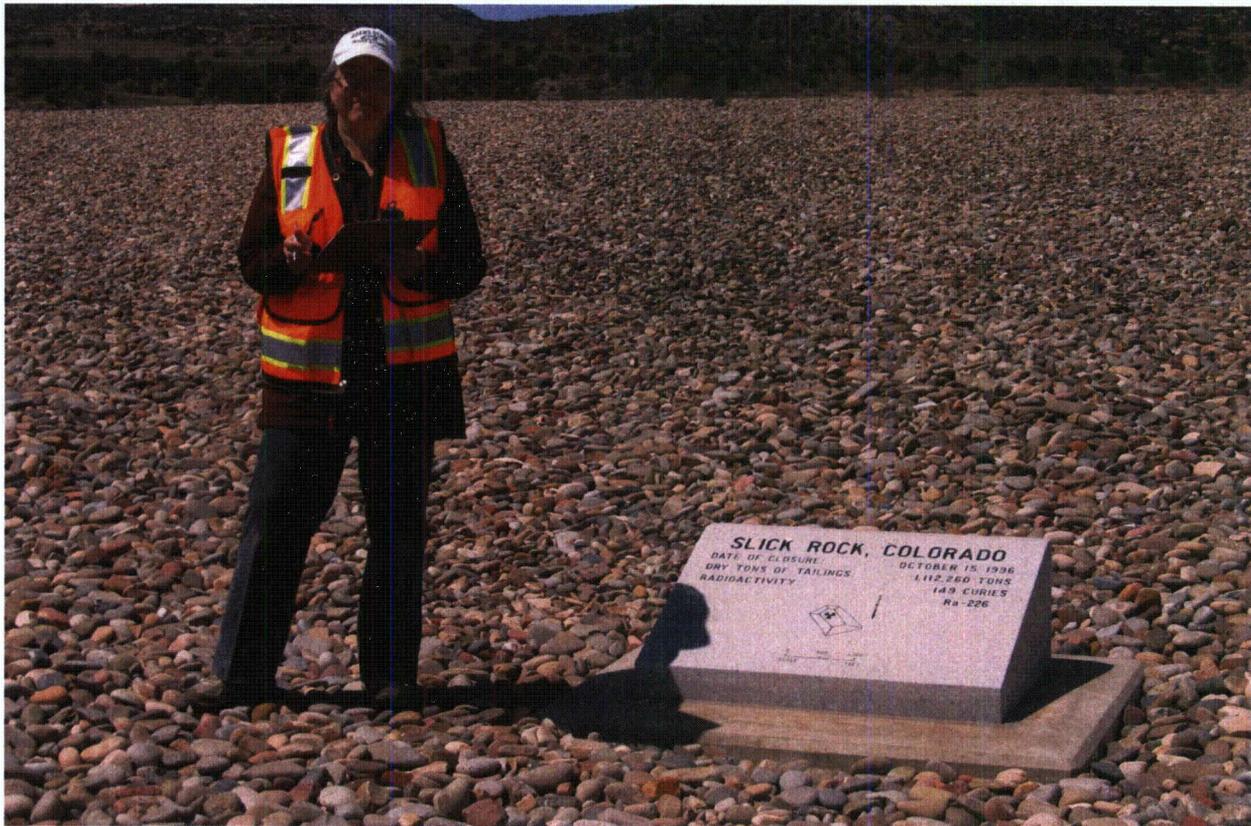
The two granite site markers, SMK-1 near the entrance gate and SMK-2 (PL-2) on top of the disposal cell, were in excellent condition. Erosion near SMK-1 is being monitored and will be repaired if it impacts the integrity of the site marker.

SRK 5/2014. PL-2. Site Marker SMK-2 on top of disposal cell.

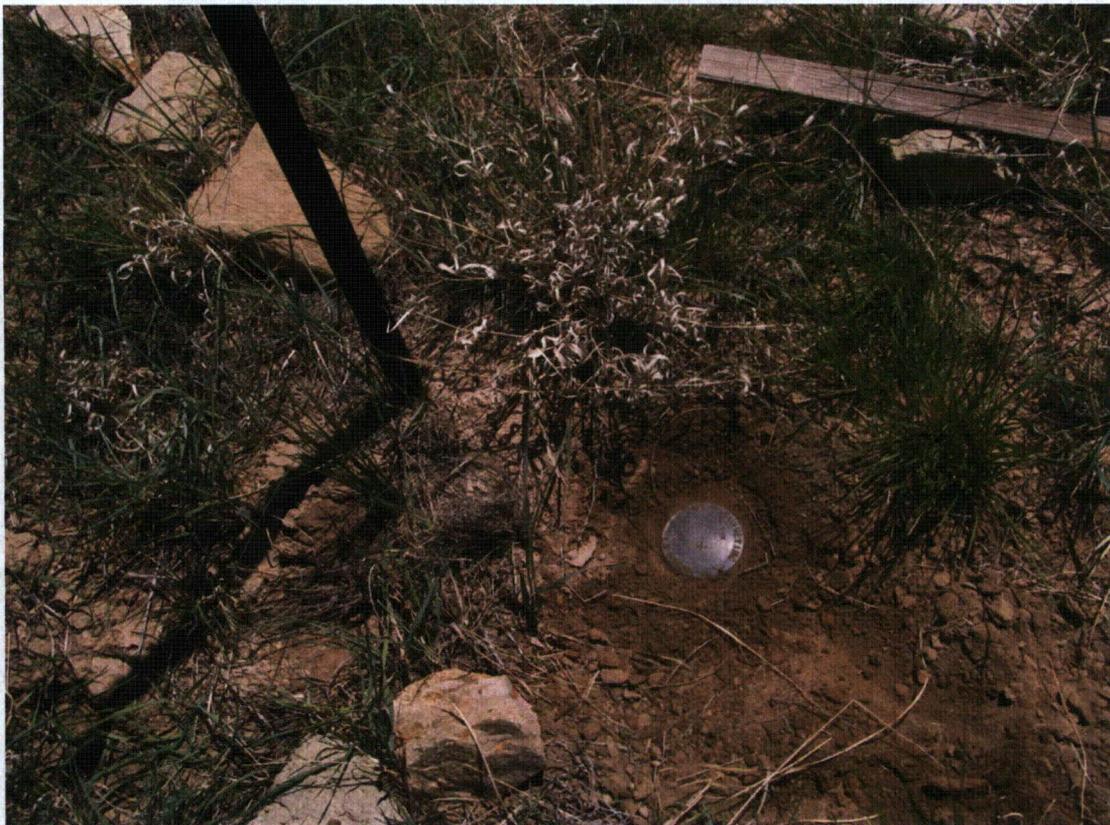
Six boundary monuments define the corners of the site boundary. Three onsite survey monuments are also monitored (PL-3). All observed boundary and survey monuments were in good condition.

SRK 5/2014. PL-3. Survey monument SM-2.

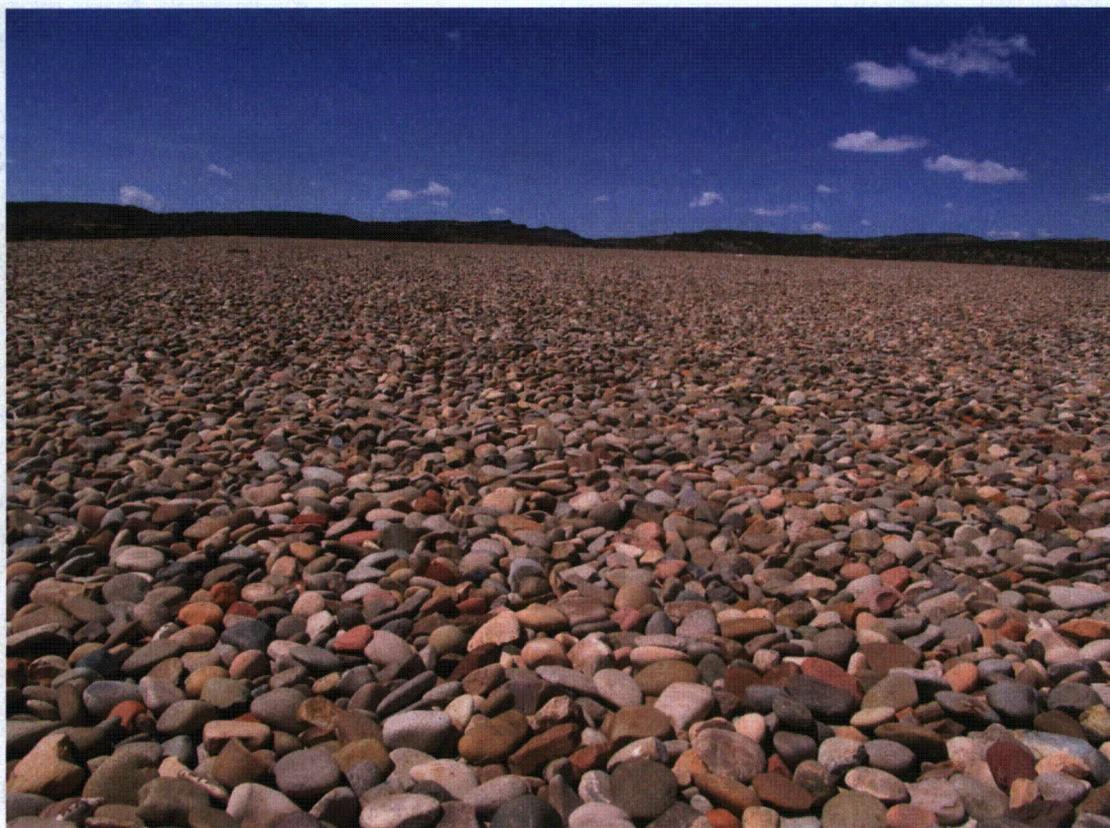
Rock covering the disposal cell, key trench, and apron is rounded cobble- and pebble-sized material. The rock was in excellent condition (PL-4). No evidence of settling, slumping, or erosion was seen on any of the rock-covered surfaces of the disposal cell or the key trench. No deep-rooted plant species were observed on the surface of the cell.

SRK 5/2014. PL-4. Top of disposal cell.

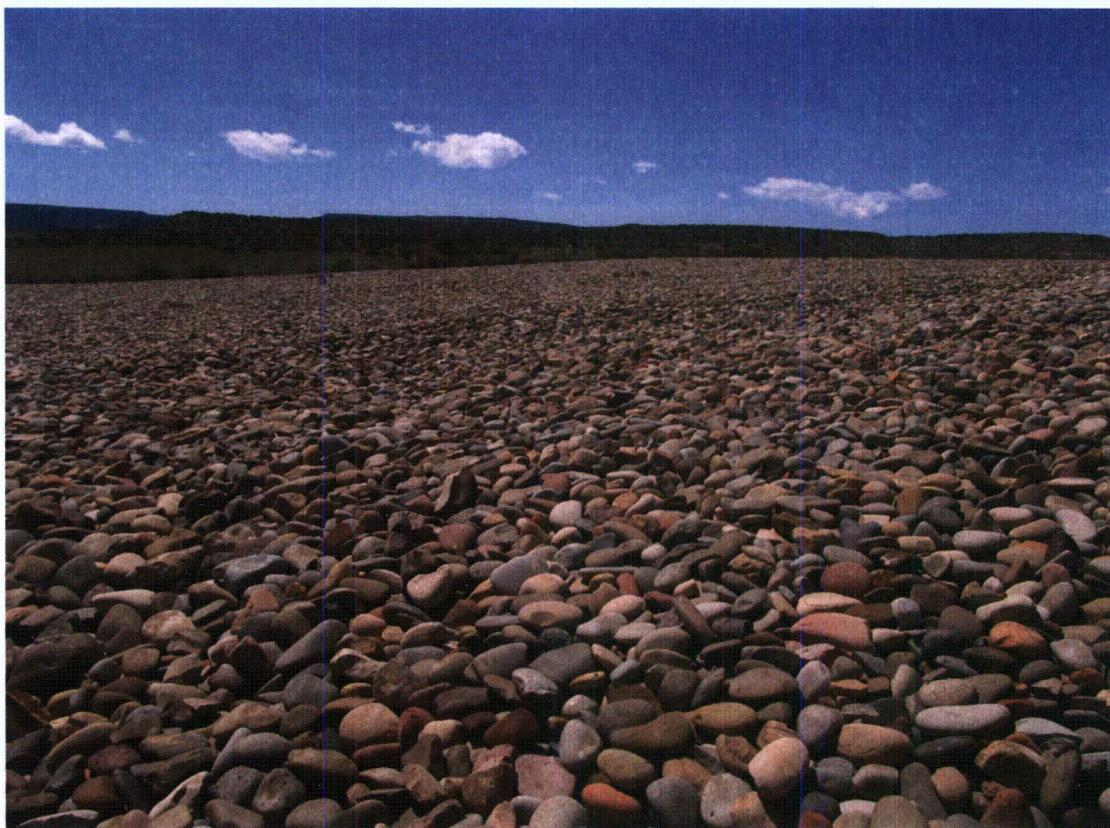
The rock apron has a linear disturbance that may indicate possible erosion under the rock. The feature is about 2–3 inches deep, 2 feet wide, and 50 feet in length (PL-5). This feature does not impact the performance of the apron but will continue to be monitored.

SRK 5/2014. PL-5. Apron; linear disturbance in center.

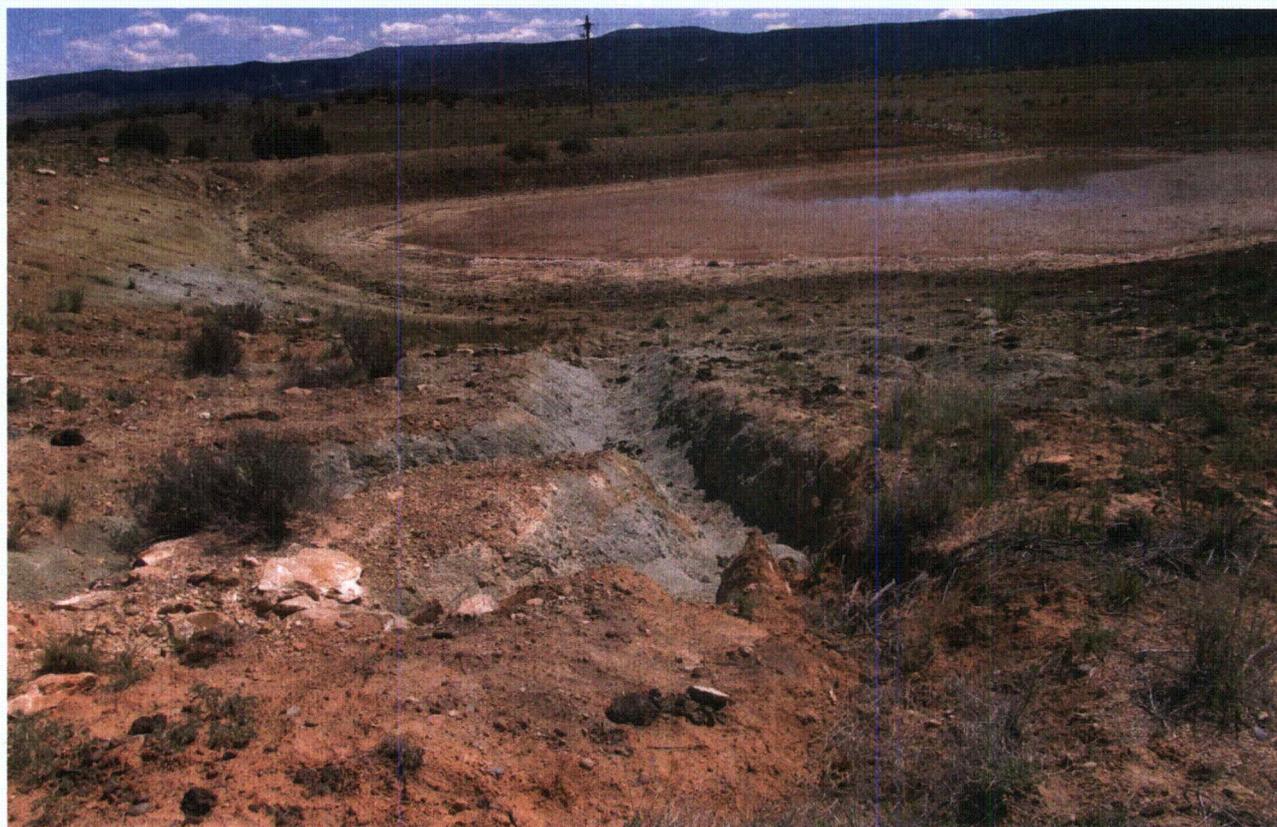
SRK 5/2014. PL-6. Bedrock erosion near northwest corner of retention pond.

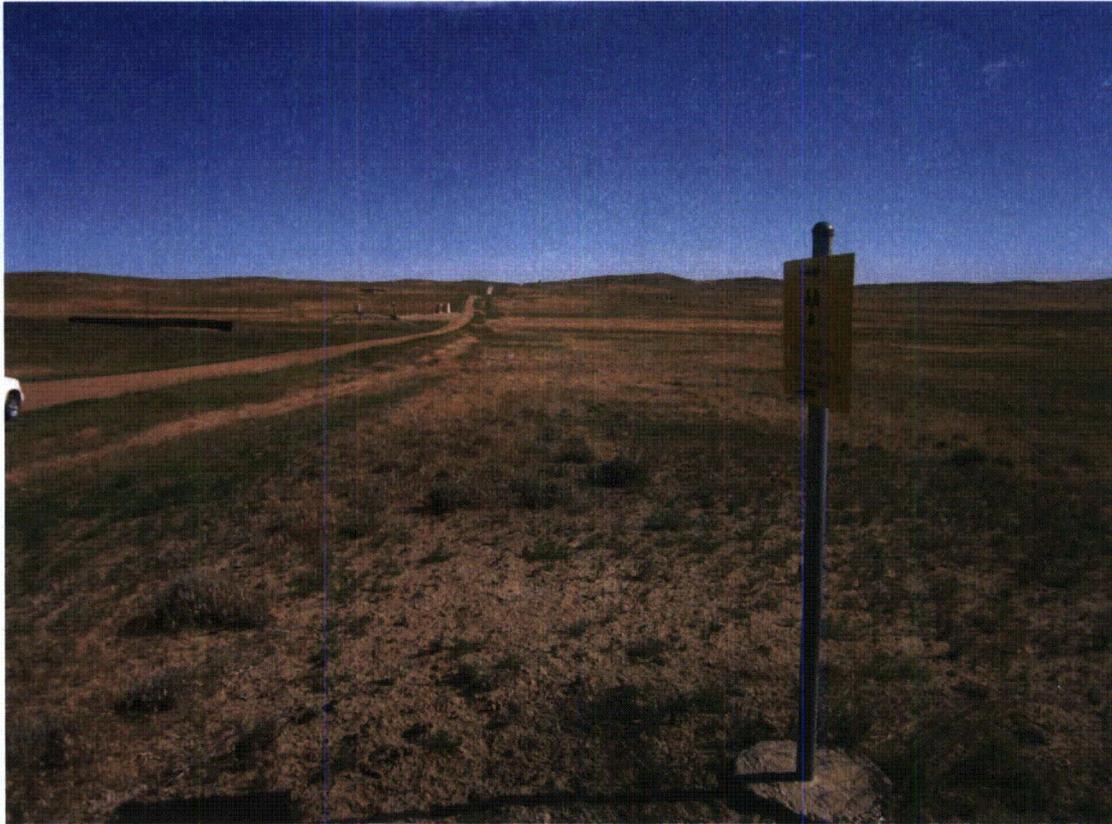
Access to the site is via State Highway 95 from Glenrock or State Highway 93 from Douglas, to County Road 31, and onto the Hornbuckle Ranch road. Site access is maintained through perpetual easements across the Hornbuckle Ranch. The road to the site is graded and hard-packed and is maintained by the ranch. The road was in good condition (PL-1). The entrance sign, on the east side of the road, was in good condition.

SPK 6/2014. PL-1. Site access road near perimeter sign P10.

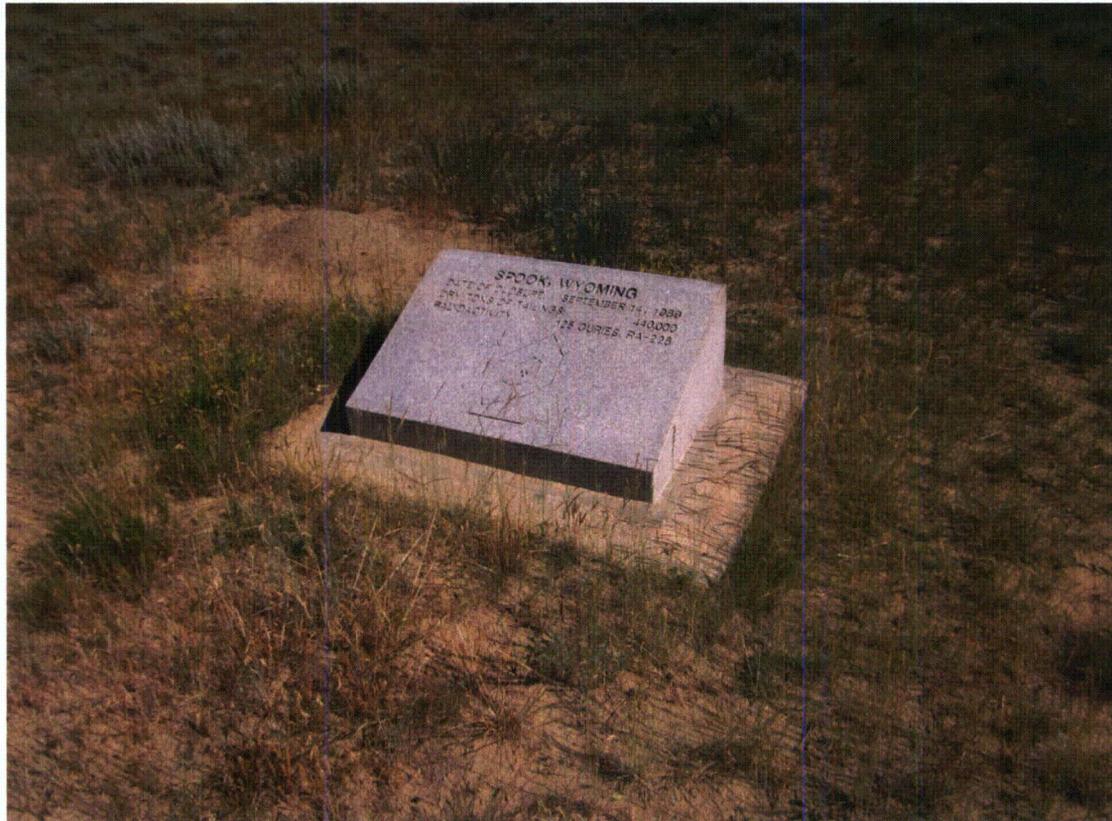
Two granite site markers identify the site. Site marker SMK-2 was in excellent condition (PL-2). The concrete base of site marker SMK-1 is damaged due to spalling but is stable (PL-3); there were no apparent changes from the previous year.

SPK 6/2014. PL-2. Site marker SMK-2.

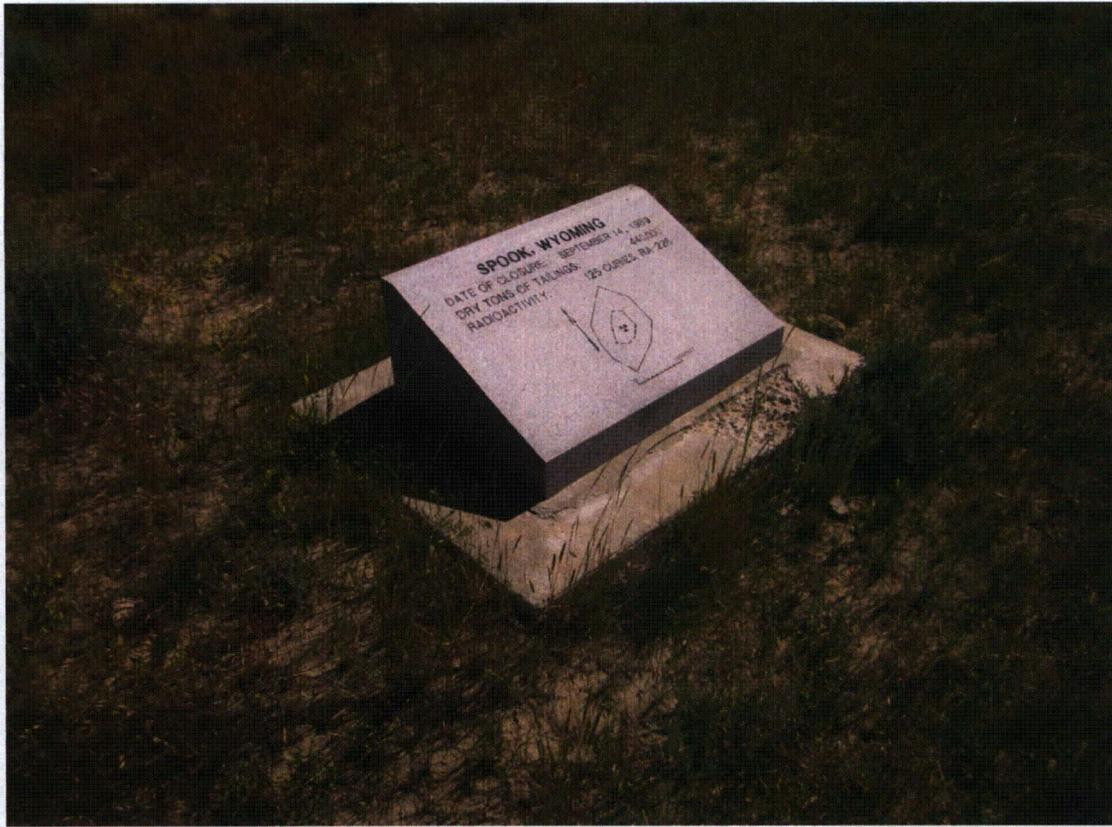
SPK 6/2014. PL-3. Site marker SMK-1; concrete base spalling but stable.

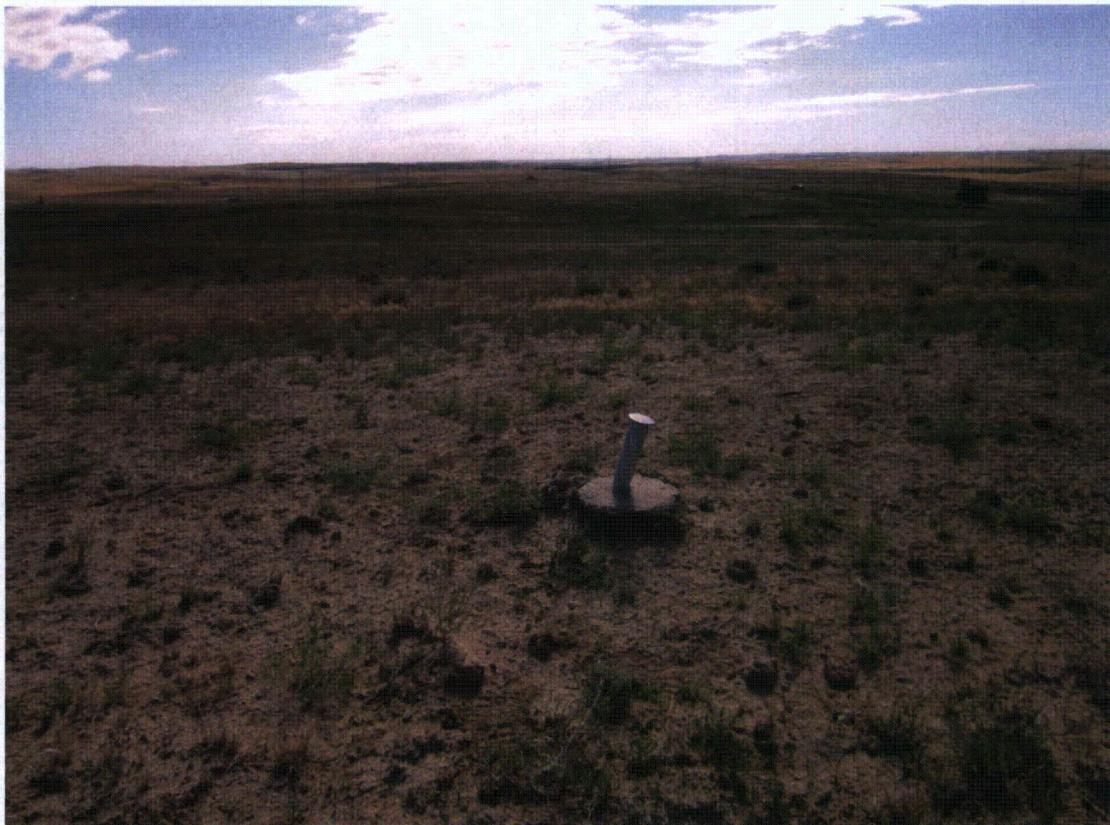
Eight boundary monuments and three survey monuments are present at the site. Wind erosion has exposed the concrete base for boundary monument BM-6 (PL-4). During this inspection that monument was noted as being bent. It may have been inadvertently damaged by a vehicle when covered by snow. A t-post will be installed to mark its location. Even though bent, it was stable and repair is not warranted. The other monuments were in excellent condition.

SPK 6/2012. PL-4. Bent boundary monument BM-6.

Delaminated perimeter signs will be replaced during the next inspection. A t-post will be placed adjacent to bent boundary monument BM-6 to identify its location when buried by snow. No other maintenance needs were identified.

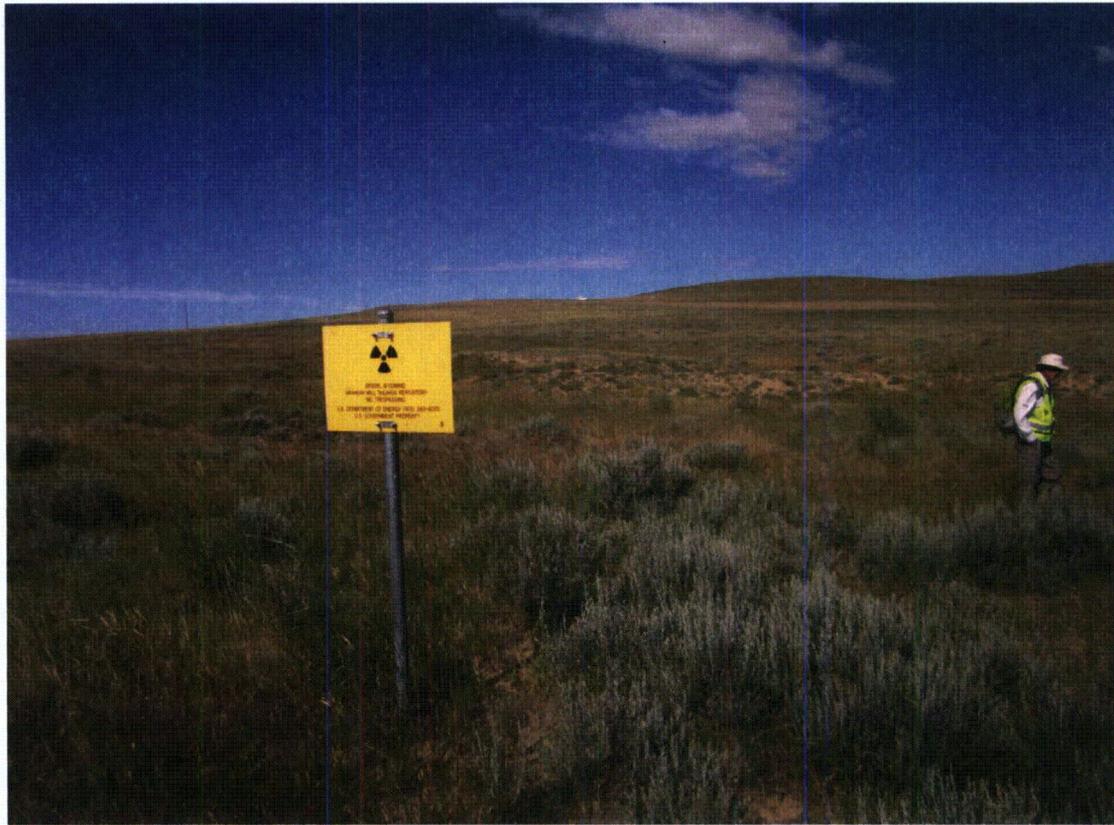
The site is unique among Title I sites in that tailings were encapsulated in the bottom of an open pit mine and covered with 40–60 feet of clean fill and topsoil. Therefore, many of the observations and concerns routinely associated with above-grade disposal cells—such as the quality of the riprap and the stability of side slopes—do not apply to this site. The surface of the 5-acre disposal cell, completed in 1989, was in excellent condition. No evidence of settling was observed over the former mine pit. Vegetation on the cell cover, consisting of grasses and forbs, was healthy and indistinguishable from that growing on the remainder of the site and on the surrounding ranch land (PL-5).

SPK 6/2014. PL-5. Healthy vegetation near perimeter sign P5.

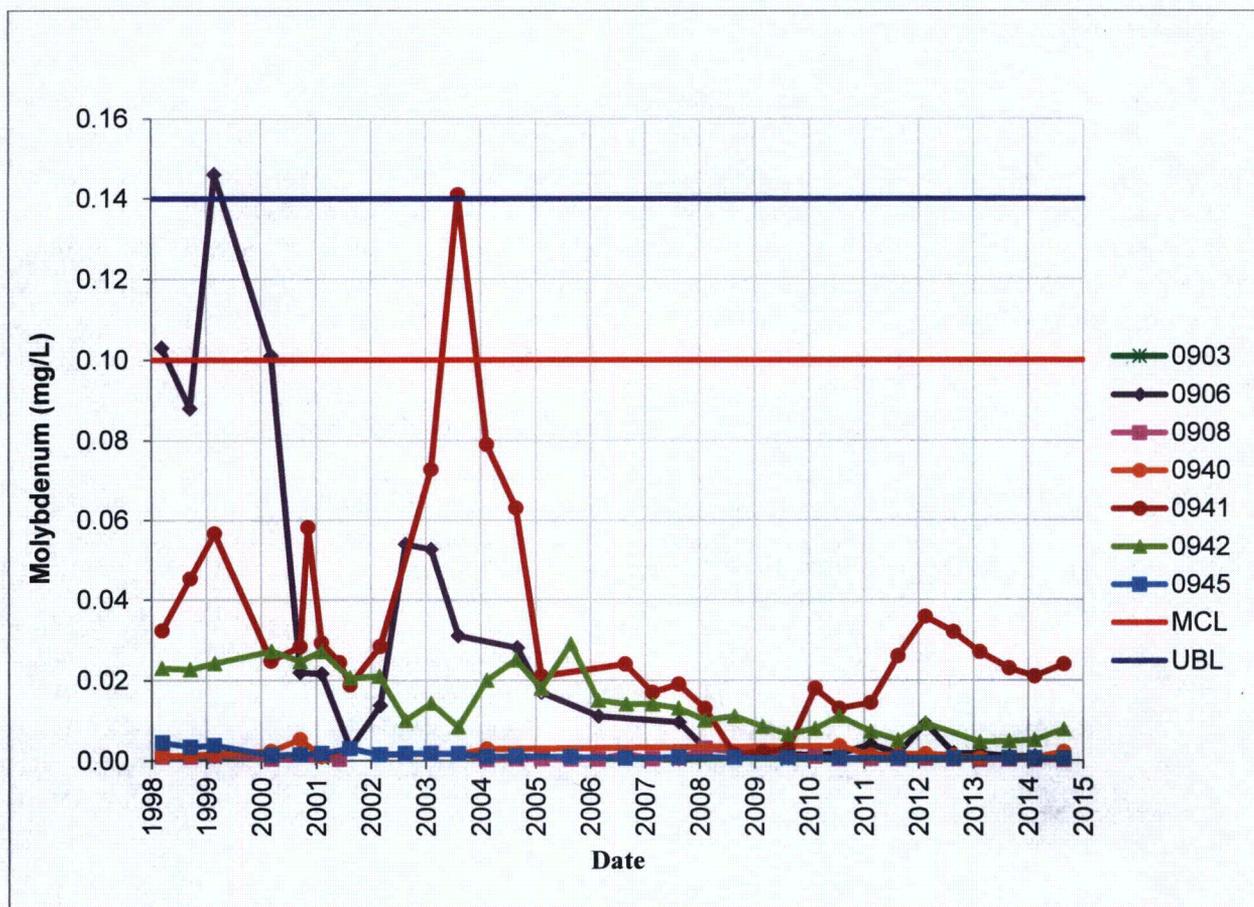
Figure 19-2. Time-Concentration Plots of Molybdenum in Groundwater at the Tuba City Disposal Site

Figure 19-2 shows the time-concentration plot for molybdenum. As has been the case since 2004, molybdenum concentrations in groundwater were below both the 0.10 milligram per liter (mg/L) MCL and the 0.14 mg/L UBL in all wells (Figure 19-2). Molybdenum concentrations in westernmost downgradient well 0908 and in distal downgradient well 0903 (approximately 1,250 feet south of the site perimeter) continue to be comparable to concentrations in background well 0945.

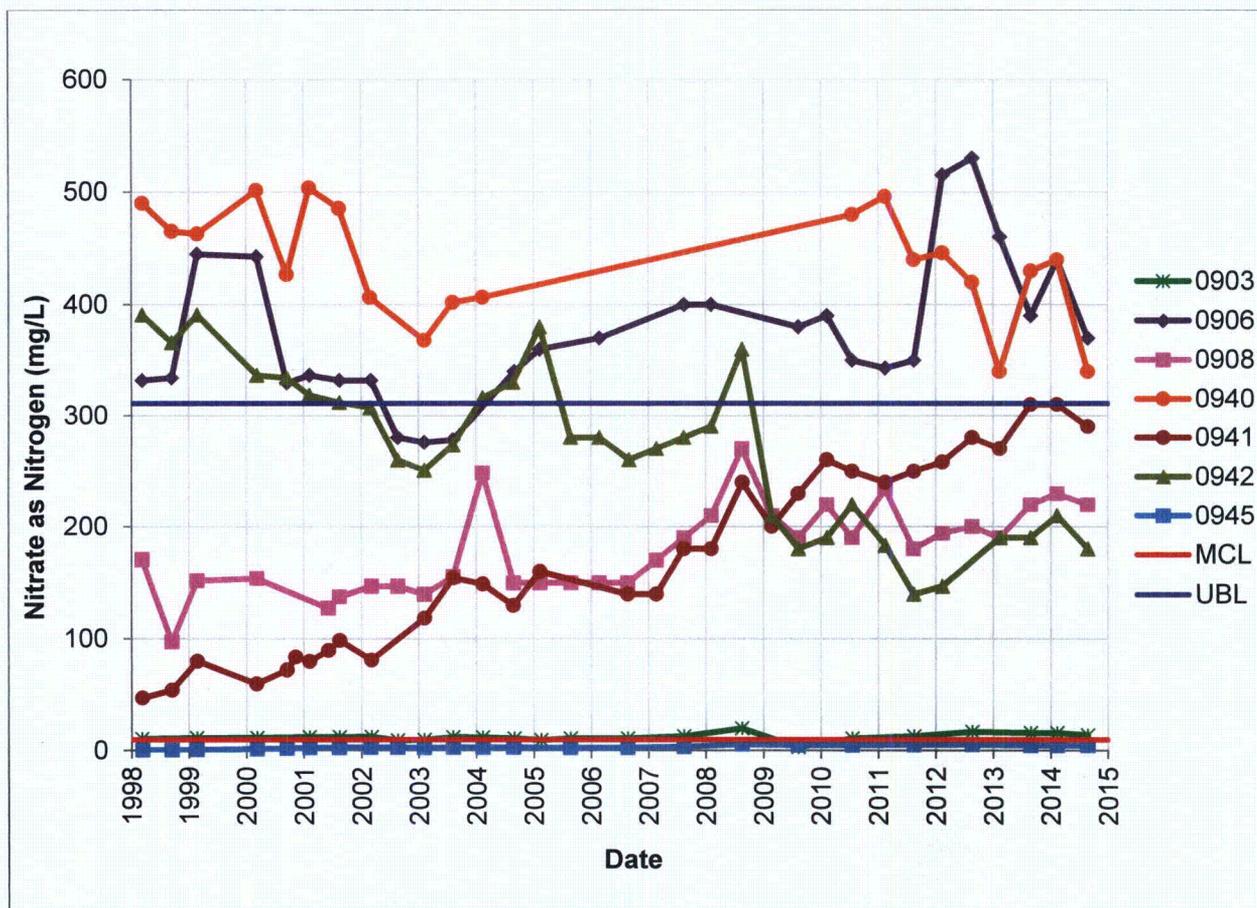
Figure 19-3. Time-Concentration Plots of Nitrate in Groundwater at the Tuba City Disposal Site

Since 1998, nitrate concentrations in all evaluative monitoring wells except background well 0945 and distal well 0903 have significantly exceeded the 10 mg/L MCL (Figure 19-3). Exceedances of the 311 mg/L UBL have only been observed at wells 0906 (currently 370 mg/L), 0940 (currently 340 mg/L), and 0942 (last exceedance in August 2008). Nitrate concentrations in well 0941 have increased fairly steadily from 47 mg/L in March 1998 to 290 mg/L in August 2014. Well 0941 is centrally located within a dense extraction well network (PL-4), so historical pumping in this area may account for some (or all) of this observed increase. Nitrate concentrations have exhibited a downward trend in well 0942 since 1998. There are no apparent trends in the remaining wells. Nitrate concentrations in distal downgradient well 0903, although slightly above background and frequently exceeding the MCL (14 mg/L in August 2014), remain significantly below the UBL.

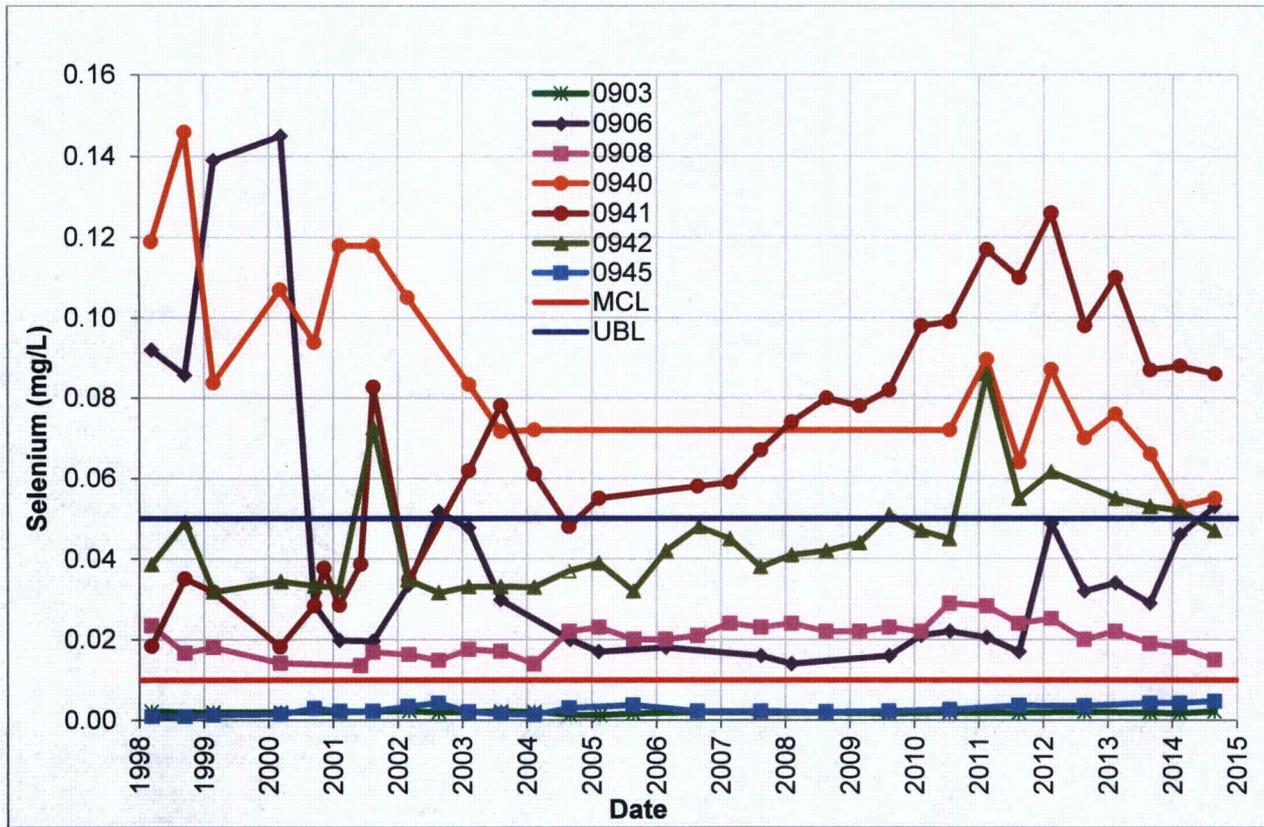
Figure 19-4. Time-Concentration Plots of Selenium in Groundwater at the Tuba City Disposal Site

Selenium concentrations have historically exceeded the 0.01 mg/L MCL in all wells except background well 0945 and distal well 0903 (Figure 19-4). Concentrations have exceeded the 0.05 mg/L UBL only in wells 0906, 0940, 0941, and 0942, immediately downgradient of the disposal cell. As observed for nitrate, selenium concentrations have increased in well 0941 from 0.018 mg/L in 1998 to 0.09–0.13 mg/L in recent years. Selenium concentrations in distal well 0903 have consistently been below both the UBL and the MCL and, since late 2004, below levels measured in background well 0945.

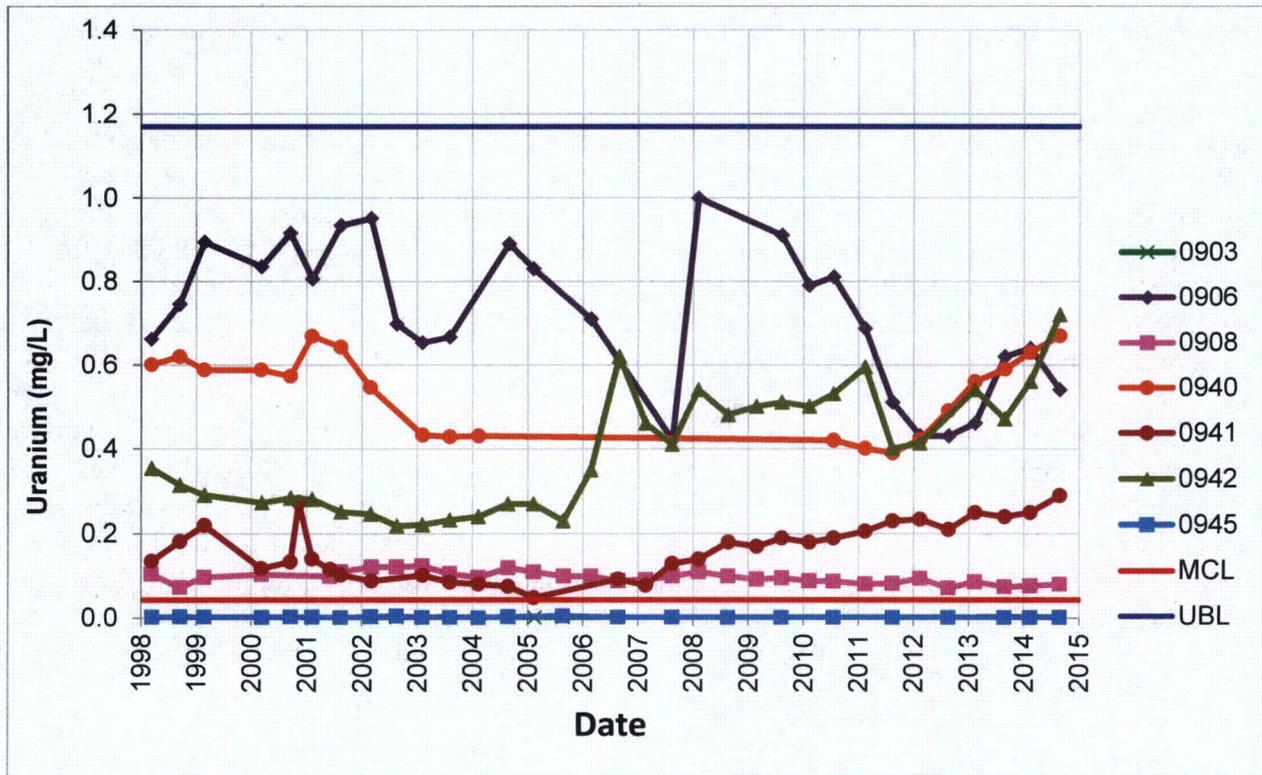
Figure 19-5. Time-Concentration Plots of Uranium in Groundwater at the Tuba City Disposal Site

In 2014, uranium concentrations in groundwater exceeded the 0.044 mg/L MCL but remained below the 1.17 mg/L UBL in all downgradient wells (except for distal well 0903, which was below the MCL). This has been the case historically, as shown in Figure 19-5. Concentrations in background well 0945 and distal well 0903 are comparable and remain below the MCL. As observed for nitrate and selenium, uranium concentrations in central downgradient well 0941 have increased gradually since 2005 (from about 0.05 mg/L to 0.29 mg/L). Uranium concentrations in wells 0906 and 0942 have fluctuated greatly at times, perhaps due to pumping of the extraction wells.

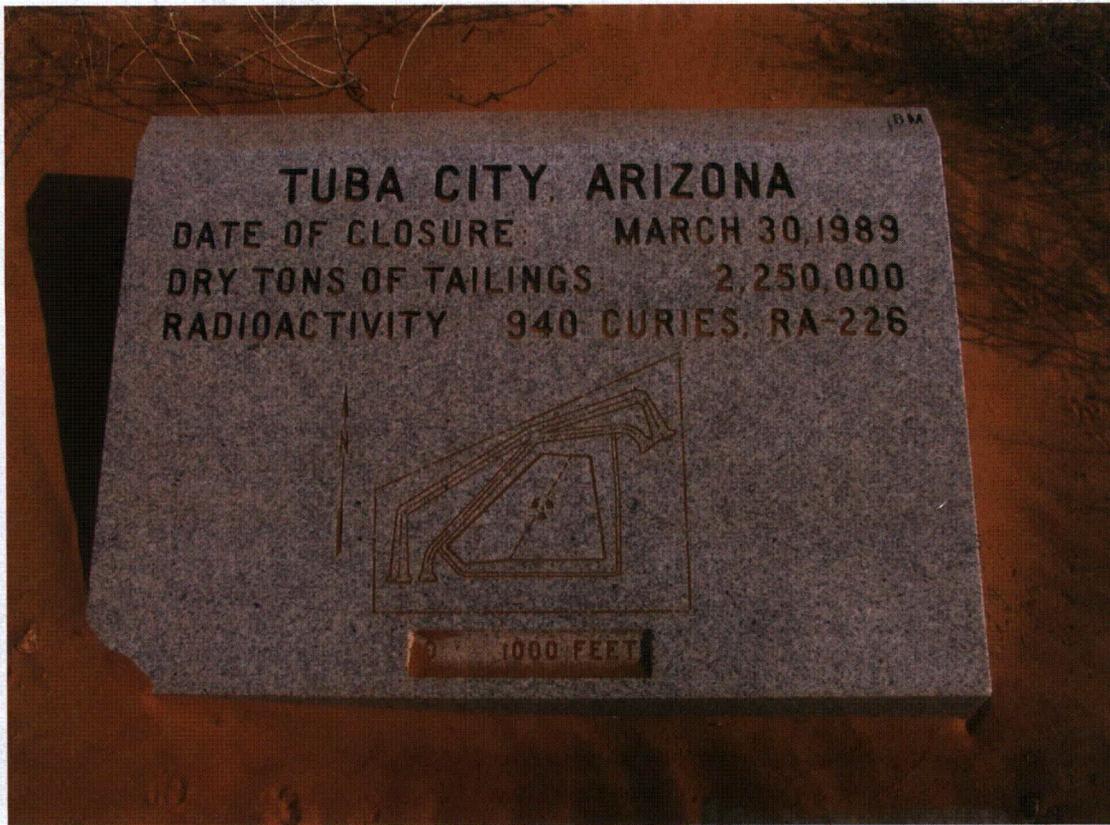
The two granite site markers, one just inside the site entrance gate (PL-1) and the other on top of the disposal cell (PL-2), were in good condition.

TUB 4/2014. PL-1. Site marker SMK-1.

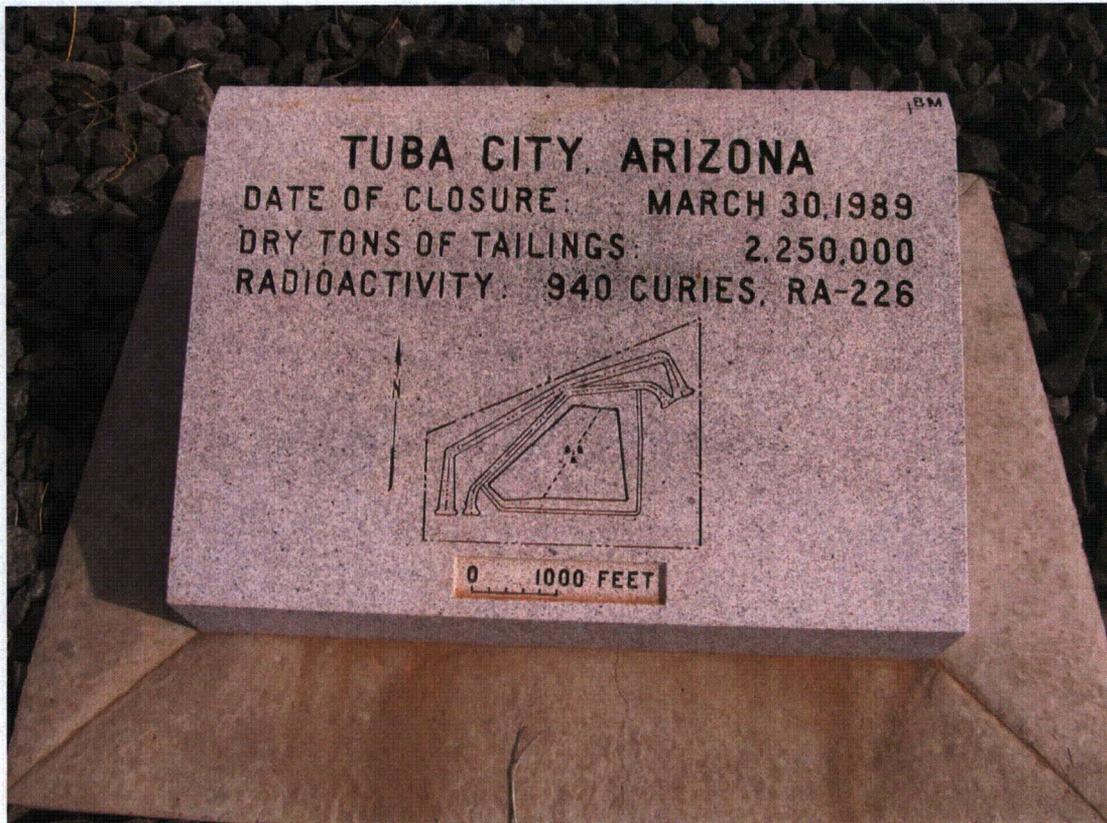
TUB 4/2014. PL-2. Site marker SMK-2.

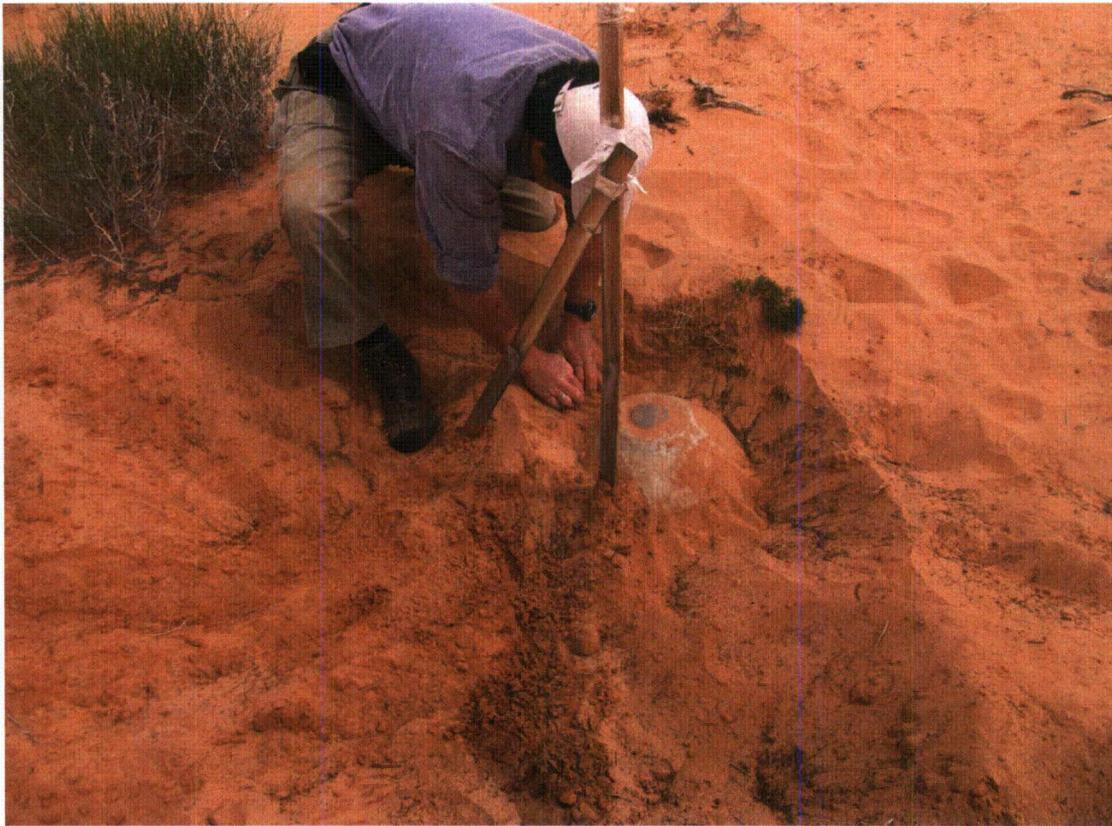
The survey and boundary monuments that were observed were in good condition. Boundary monument BM-1, at the southwest corner of the site, was buried by windblown sand (PL-3).

TUB 4/2014. PL-3. Uncovered boundary monument BM-1.

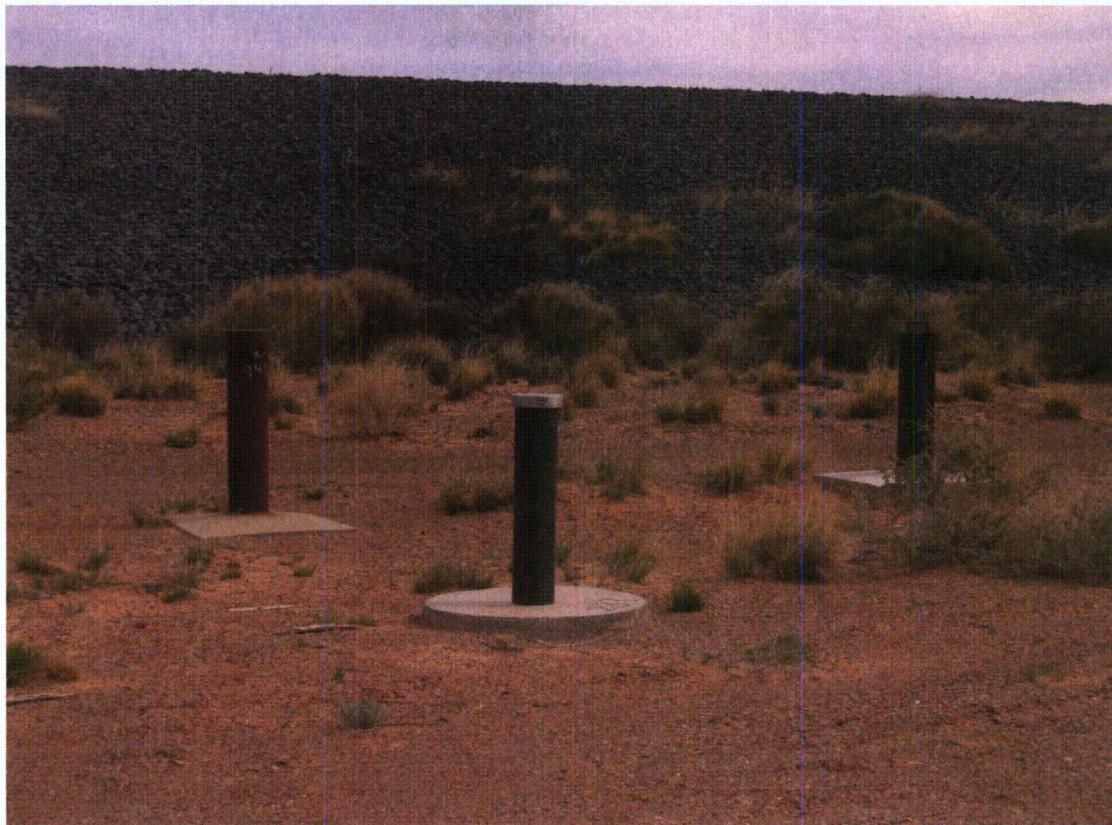
Seven wells constitute the cell performance monitoring network: 0903, 0906, 0908, 0940, 0941, 0942, and 0945. Five wells inside and immediately adjacent to the site were in good condition and locked (PL-4). Upgradient background well 0945 and distal downgradient well 0903 were inspected during semiannual groundwater sampling events and were in good condition.

TUB 4/2014. PL-4. Well cluster at downgradient well 0941.

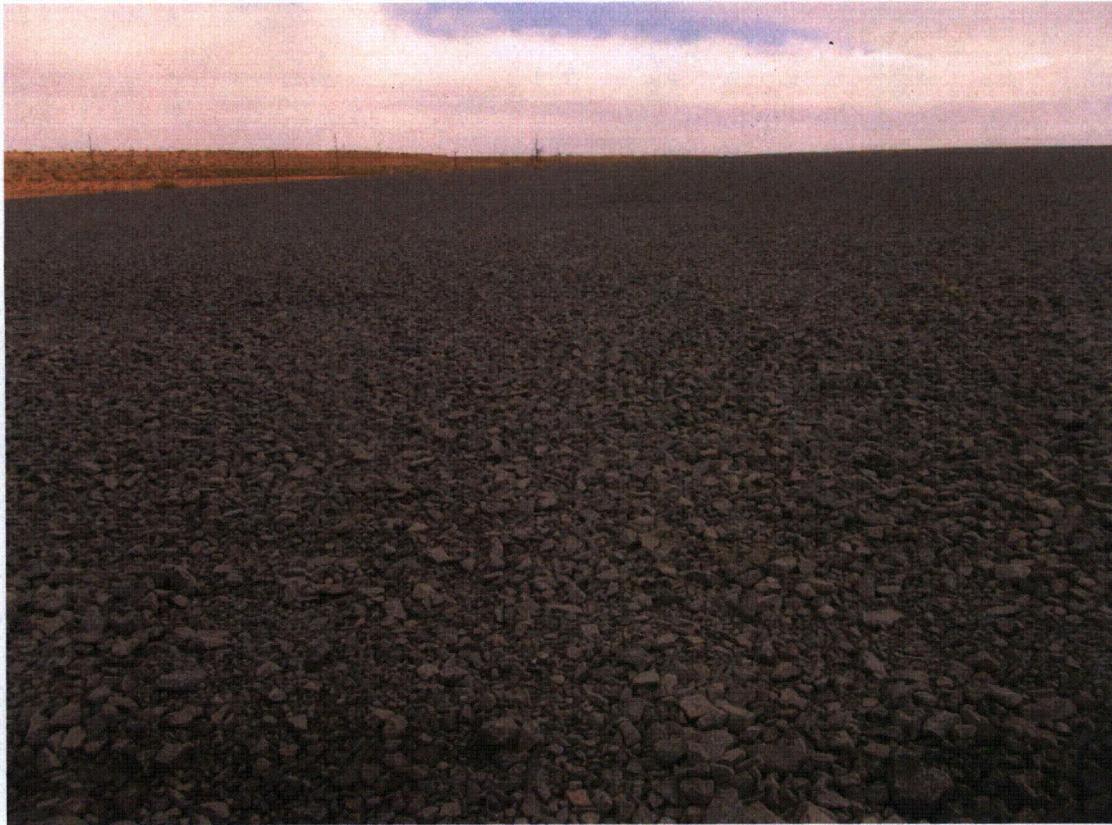
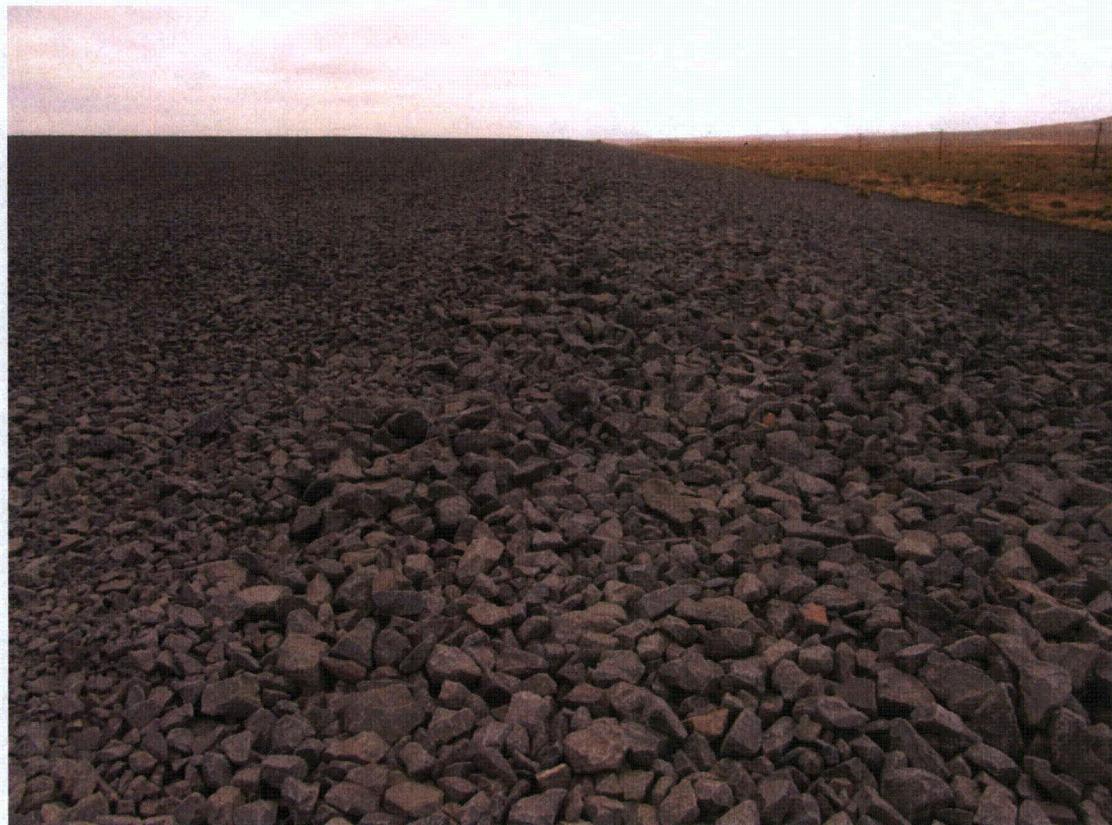
The disposal cell is covered with riprap to control erosion. The rock cover material was in excellent condition and showed no signs of deterioration. No evidence of differential settlement or slumping was observed, and all visible components of the disposal cell and cover were in excellent condition (PL-5 and PL-6).

TUB 4/2014. PL-5. Disposal cell top slope.

TUB 4/2014. PL-6. Disposal cell top and south side slopes.
