17.0 Slick Rock, Colorado, Disposal Site

17.1 Compliance Summary

The Slick Rock, Colorado, Uranium Mill Tailings Radiation Control Act (UMTRCA) Title I Disposal Site was inspected on May 13, 2014. The site was in good condition. A damaged perimeter sign was replaced. Inspectors identified no other maintenance needs or cause for a follow-up inspection.

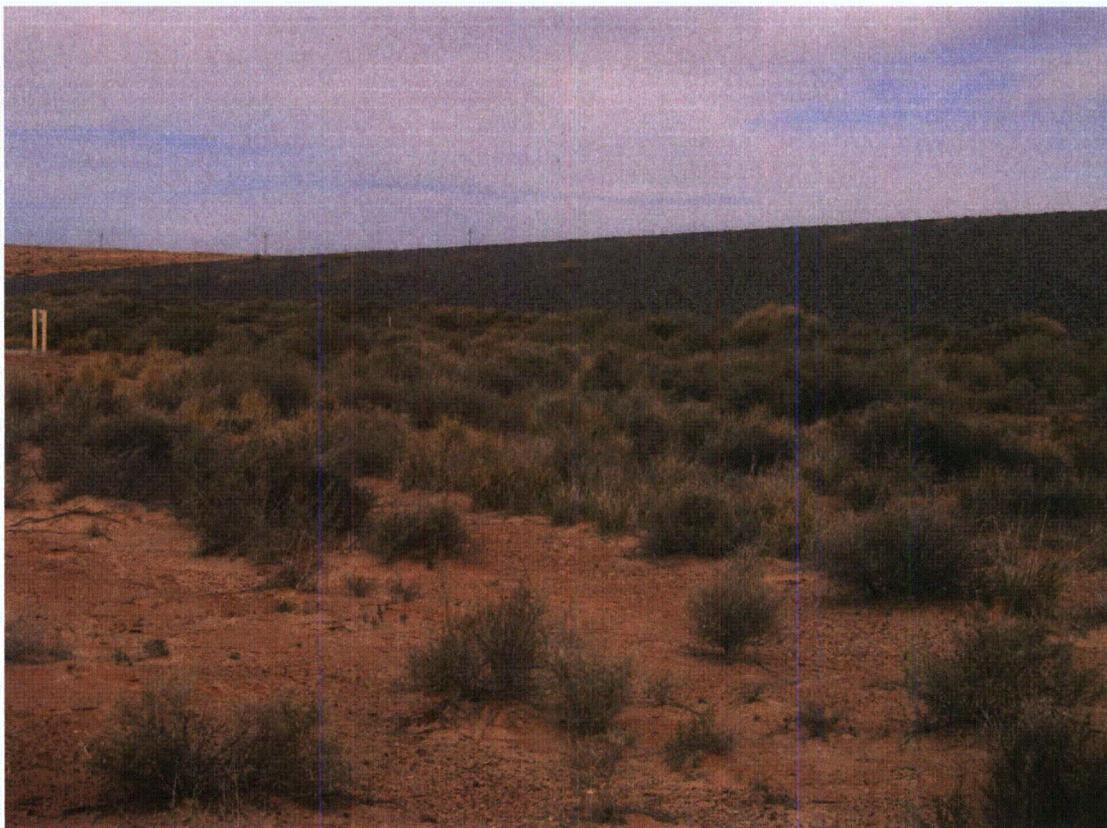
In accordance with the LTSP, deep-rooted vegetation, primarily saltbush, is removed from the cell cover or controlled to prevent potential penetration of the radon barrier. Periodic application of herbicide has been very effective in controlling deep-rooted vegetation growth on the cell cover. Only a few small shrubs were noted during the 2014 inspection. Scattered patches of grass and annual weeds also grow on the cell top and side slopes; however, these shallow-rooted plants are not a concern. Windblown sand continues to accumulate on the rock-covered surfaces, providing a favorable environment for plant growth (PL-7).

TUB 4/2014. PL-7. Vegetation on south side slope of disposal cell.

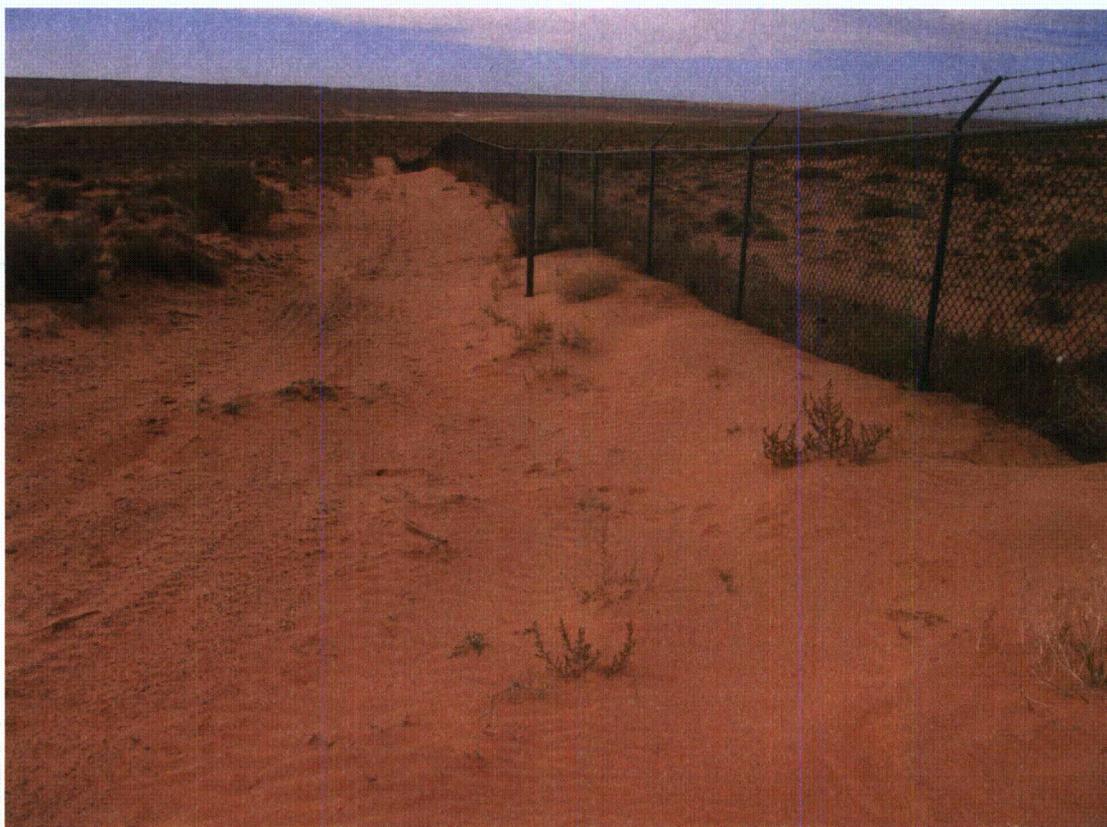
The apron drainage ditch at the base of the disposal cell and the diversion channel, both located along the north and northwest sides of the cell, were in good condition. Windblown sand deposition continues to be monitored at the site because unstable dunes in outlying areas can contribute to sand accumulation along fence lines (PL-8), in the diversion channel, and in the rock cover of the disposal cell.

TUB 4/2014. PL-8. Sand accumulation along west perimeter fence line.

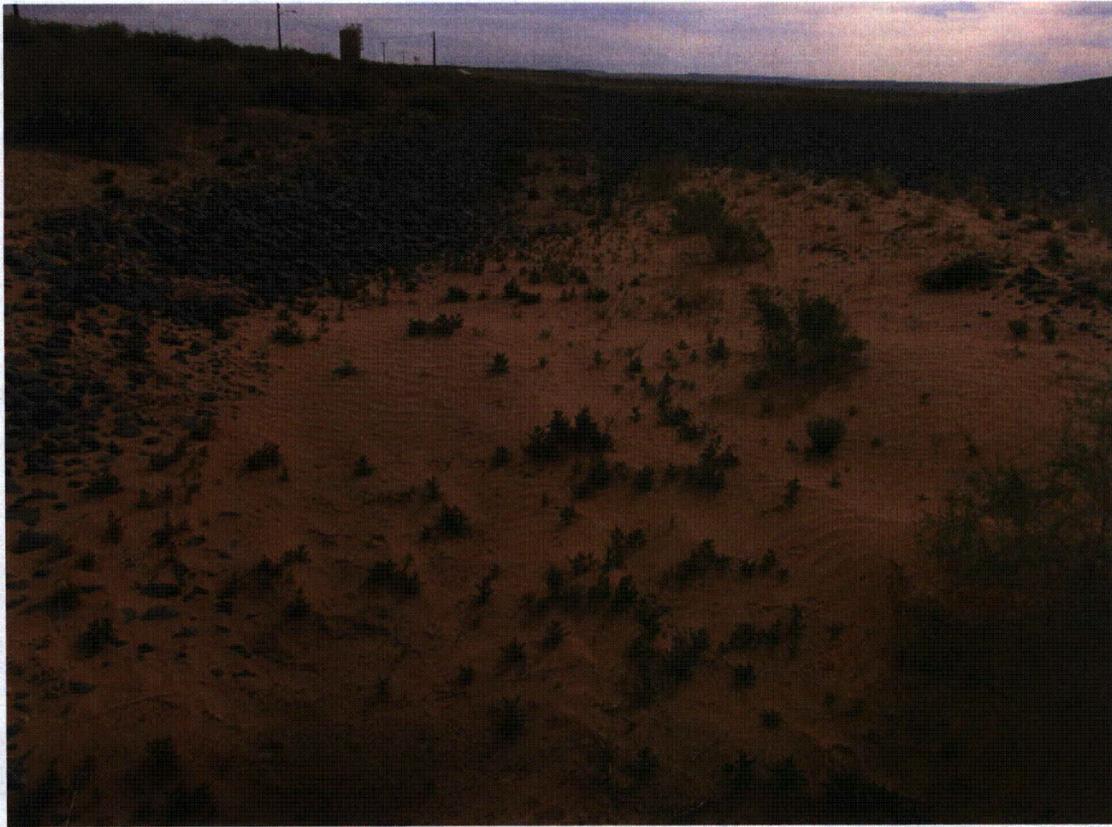
TUB 4/2014. PL-9. Windblown sand in diversion channel near flow divide.

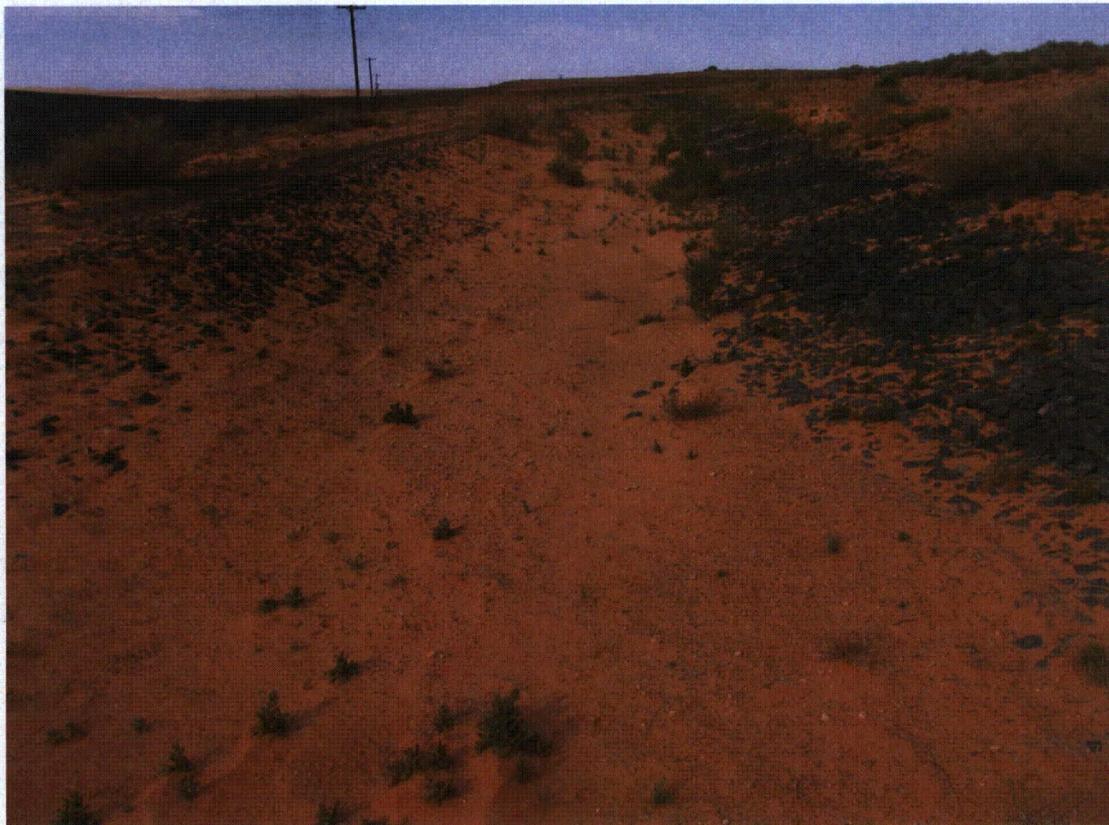
TUB 4/2014. PL-10. Windblown sand in diversion channel.

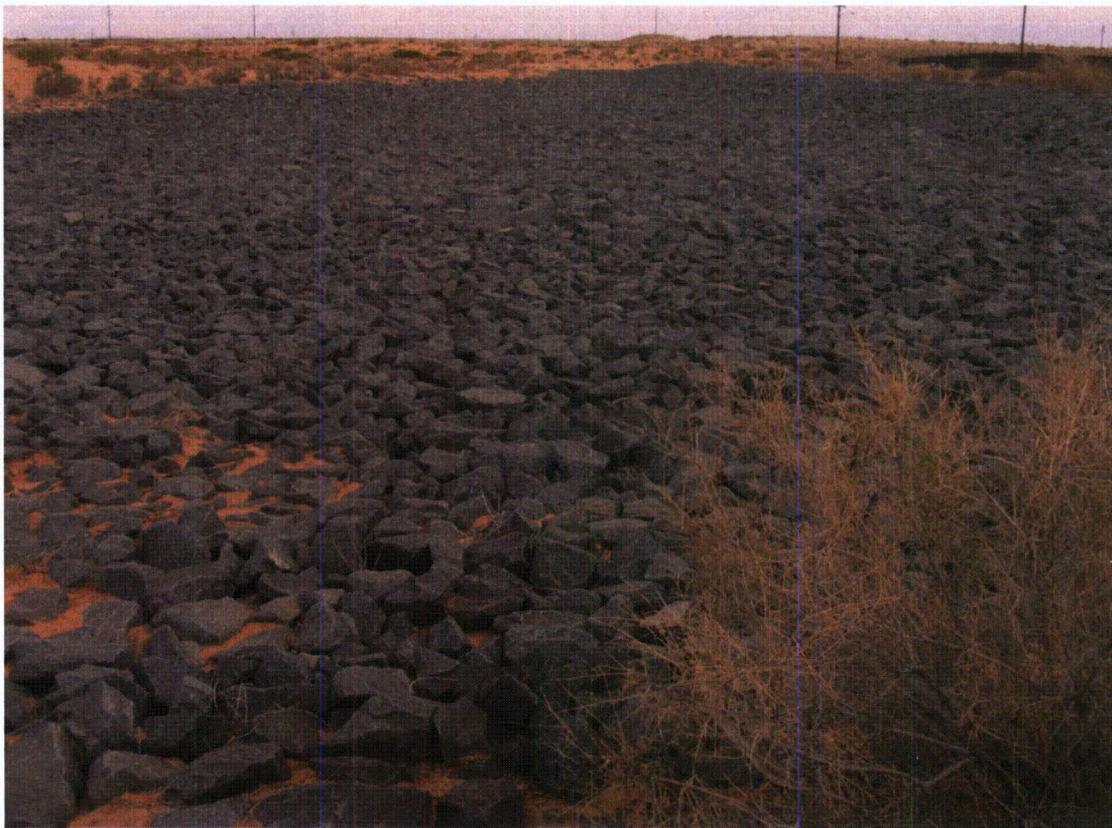
TUB 4/2014. PL-11. Upgradient view of diversion channel from southwest outlet.

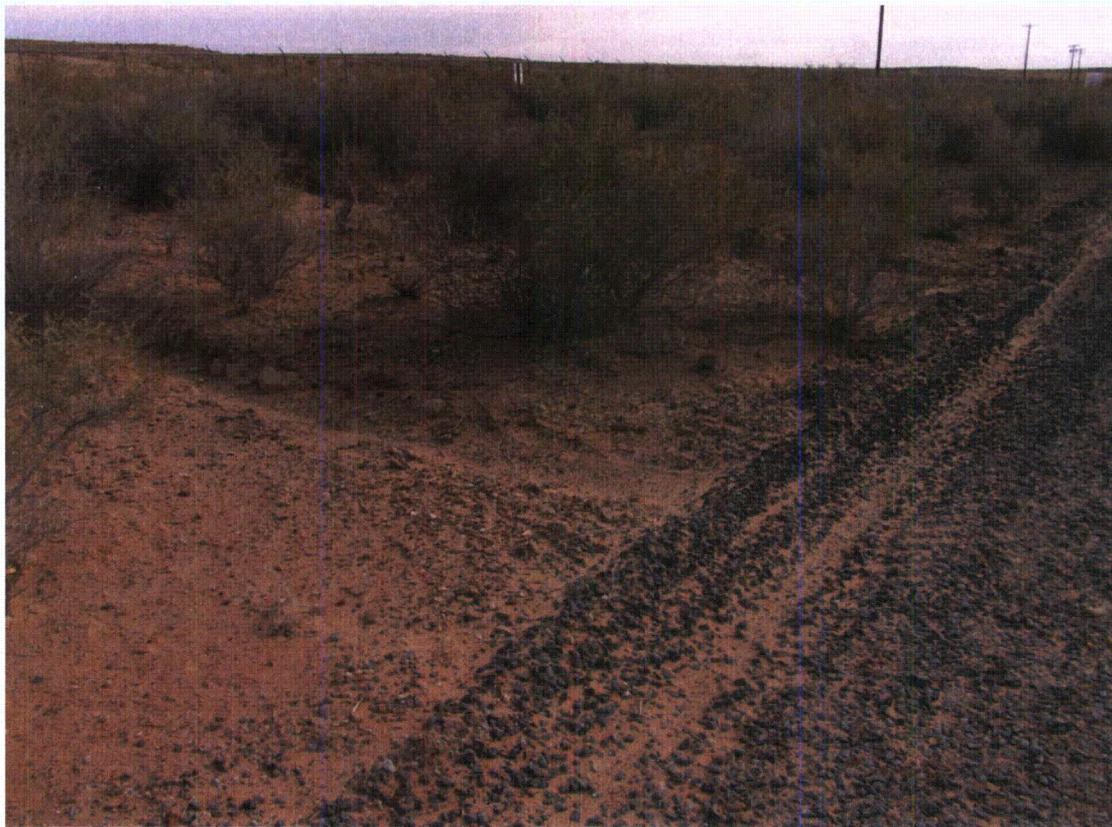
Erosion along the site access road north of the diversion channel appears to have stabilized (PL-12). Erosion repairs in the same area also were in good condition (PL-13).

TUB 4/2014. PL-12. Stabilized erosion upgradient of site access road.

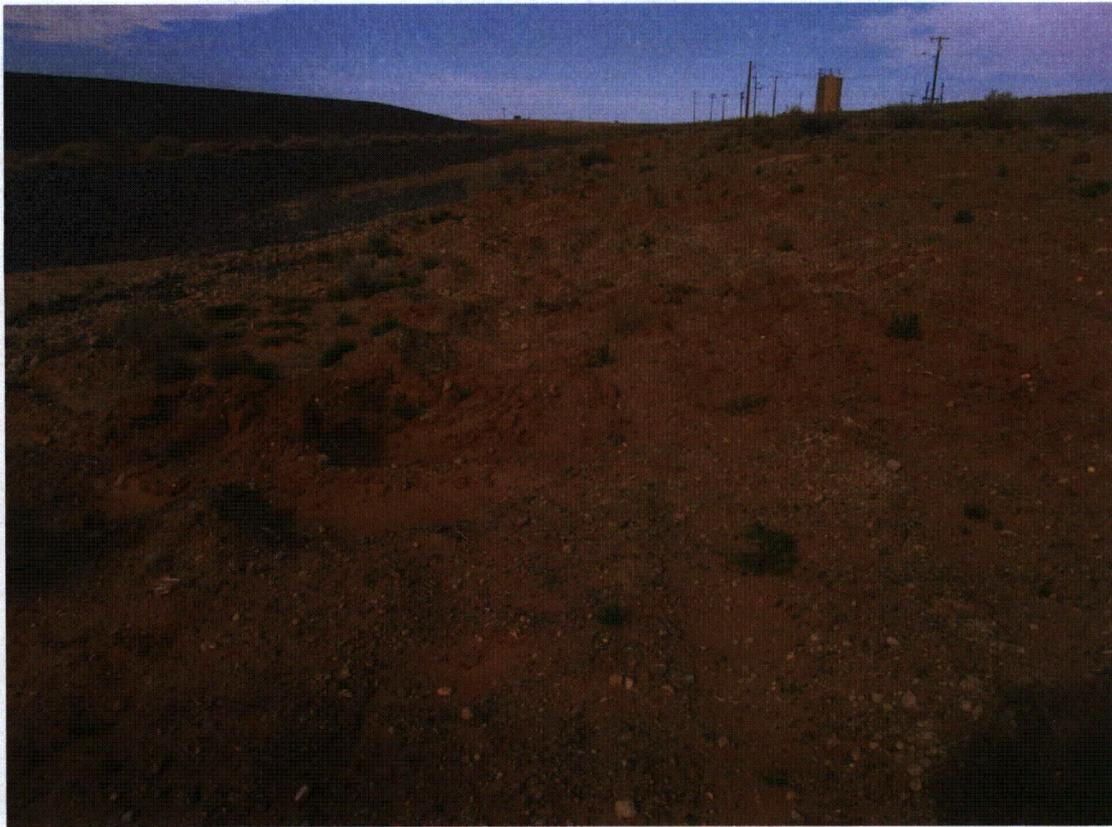
TUB 4/2014. PL-13. Erosion repair area.
