**Appendix 2**  
**2014 Inspection of Diversion Channel**

Oscar Paulson  
Sweetwater Uranium Facility  
Kennecott Uranium Company  
P.O. Box 1500  
Rawlins, WY 82301-1500

RE: 2014 INSPECTION OF DIVERSION CHANNEL

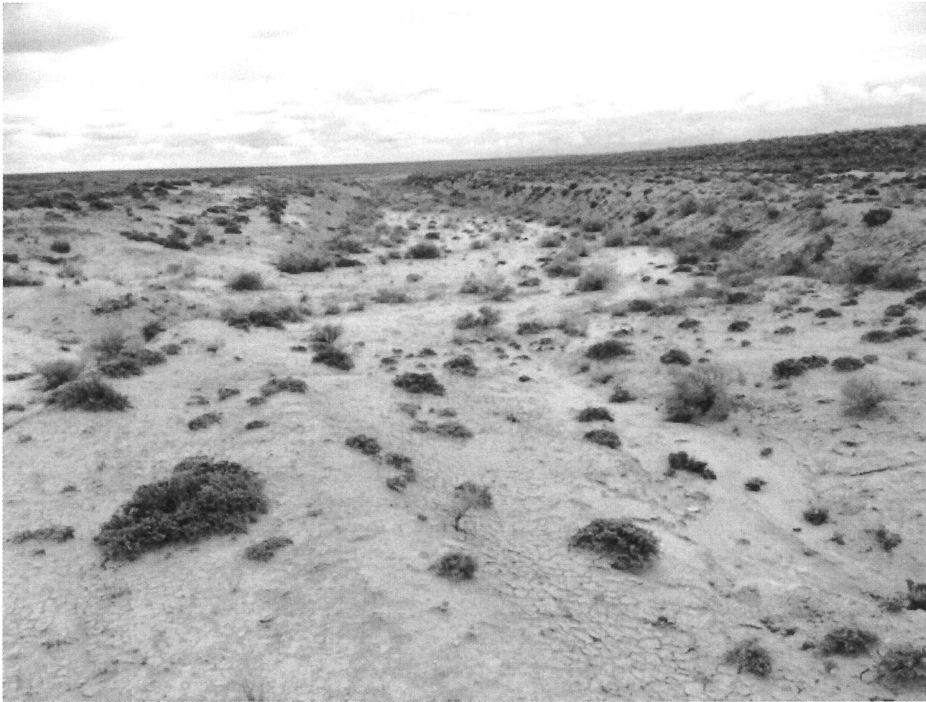
**Photograph 1 Reach 1, June 2014**

**Reach 1.** This most upstream reach is about 350 feet in length and is characterized by the deposition of sand derived from headcutting that has occurred at the entrance to the channel. The amount of headcutting appears similar to that presented in photographs from 2012 and 2013. The banks of the channel in this reach, with the exception of the entrance itself, are stable. The top of the channel still appears to capture the flow, as designed. Photographs 1 and 2 were taken in the area of Reach 1.

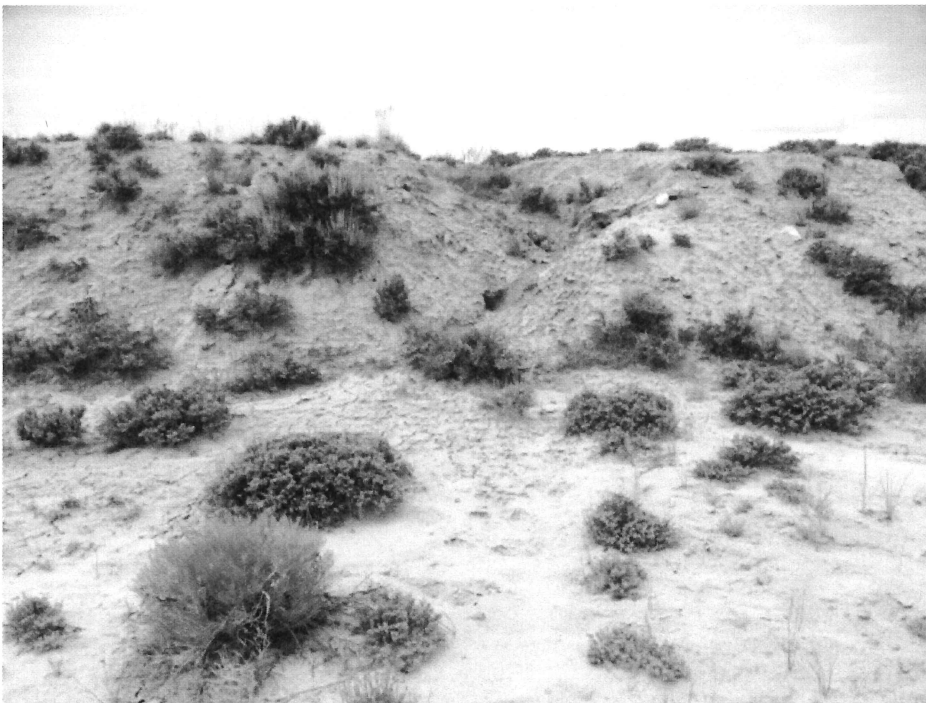
**Photograph 2 Channel entry, June 2014**

**Reach 2.** The second reach is approximately 150 feet in length. It has a shallow, definable, channel that meanders across the channel bottom (Photograph 2). Outside of the definable flow channel this reach has more vegetation on the bed than the first reach, which provides some control against erosion. The banks in this reach exhibit only minor erosion.

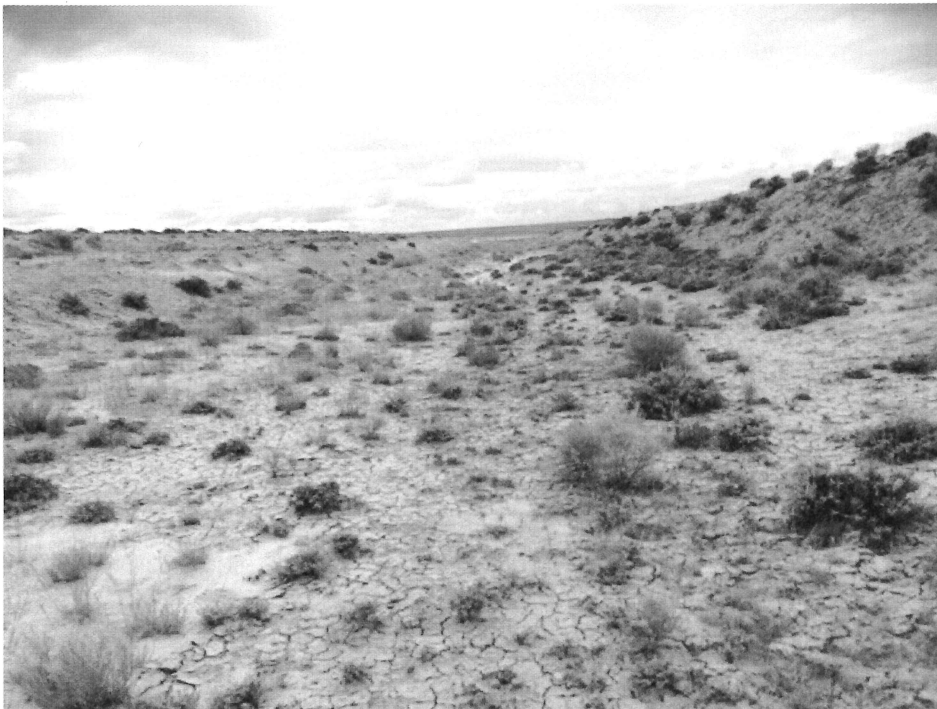
**Photograph 4    Reach 3, June 2014.**

**Reach 3.** Reach 3 is approximately 470 feet long, has the greatest percentage of channel bed covered by vegetation, and has no observable low flow channel. The banks of this reach have several locations where water enters the channel from the side, creating some rill erosion with consequent deposition of bank sediments. These localized influences have no impact on the overall functionality of the channel. The lack of a flow channel is seen in Photograph 4.

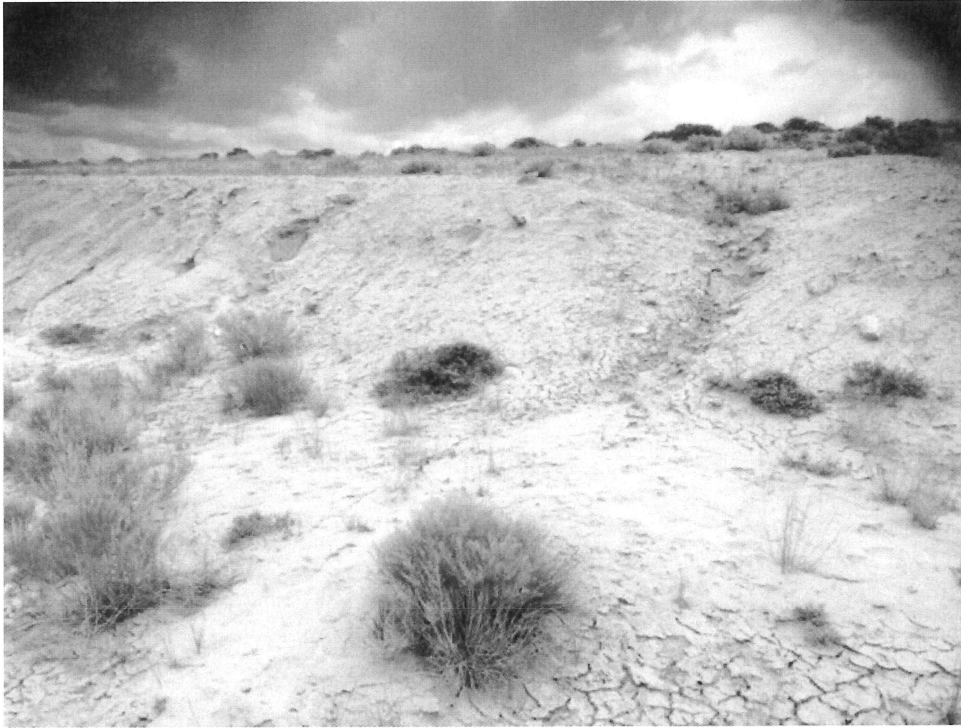
**Photograph 5** Reach 4, embankment rills, June 2014

**Reach 4.** Reach 4 is about 460 feet in length. This reach has experienced some rill erosion along the banks where local runoff enters the channel, as in Reach 3. It has less bed vegetation than Reaches 2 and 3, and has a shallow low flow channel. Examples of rills are shown in Photographs 5 and 6.

**Bank Erosion.** Bank erosion throughout the length of the diversion channel occurs as localized rilling where runoff flows into the channel (Photographs 5, 6). Broader, lateral migration from flows within the channel is not occurring.

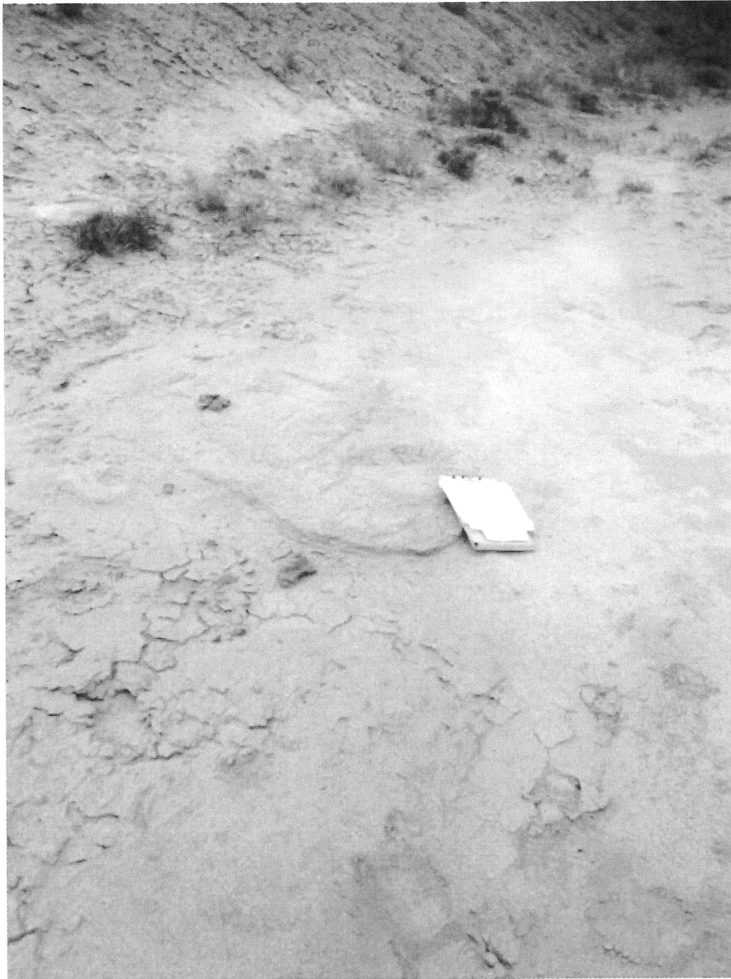
**Photograph 7 Bedrock outcrop, Reach 5, June 2014**

**Reach 5.** This most downstream reach, about 470 feet in length, begins near the location of an isolated sandstone outcrop (Photograph 7). This outcrop acts as an erosional benchmark; if it were to be covered with sediment this would be evidence of deposition, and if it were to become more exposed this would be evidence of scour. The outcrop remains little changed from previous observations. Reach 5 downstream of the outcrop has more grass in its bed and little evidence of a low flow channel. The banks are shorter in this reach, and exhibit localized, minor rill erosion.
