**2014 Inspection of Tailings
Impoundment Embankments**

Oscar Paulson
Sweetwater Uranium Facility
Kennecott Uranium Company
P.O. Box 1500
Rawlins, WY 82301-1500

RE: 2014 INSPECTION OF TAILINGS IMPOUNDMENT EMBANKMENTS

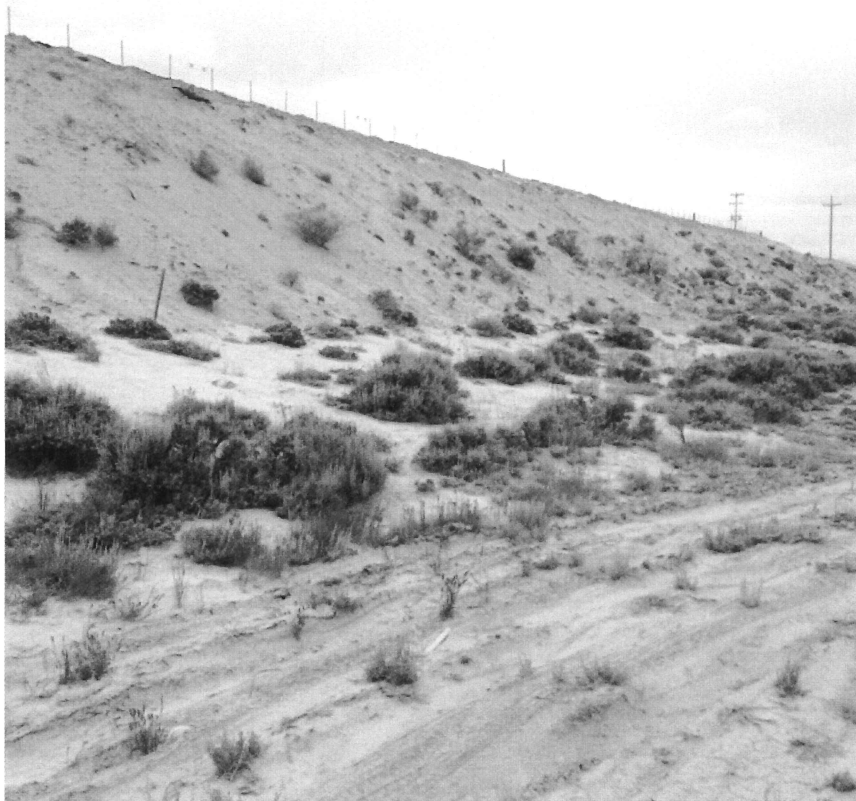
Photograph 1 Exterior of the west embankment.

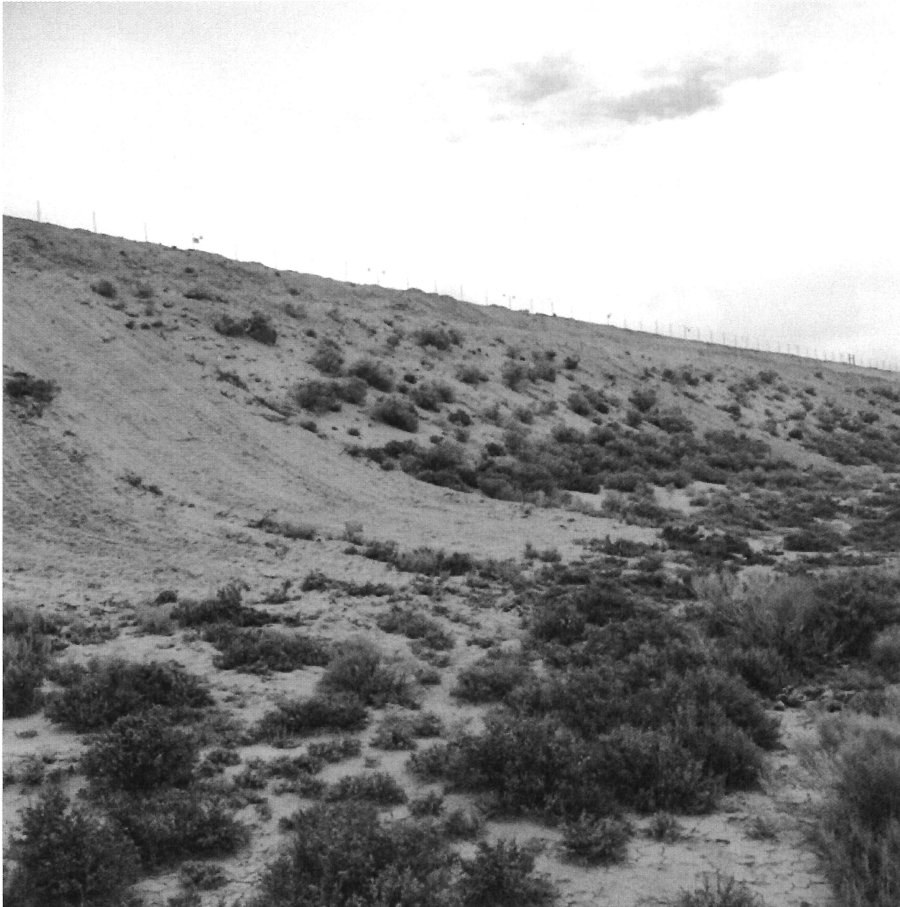
Photographs 2 Exterior of the south embankment.
Note: Areas where rills were repaired on the embankment's outside slope with the bulldozer are visible on the left side of the image.

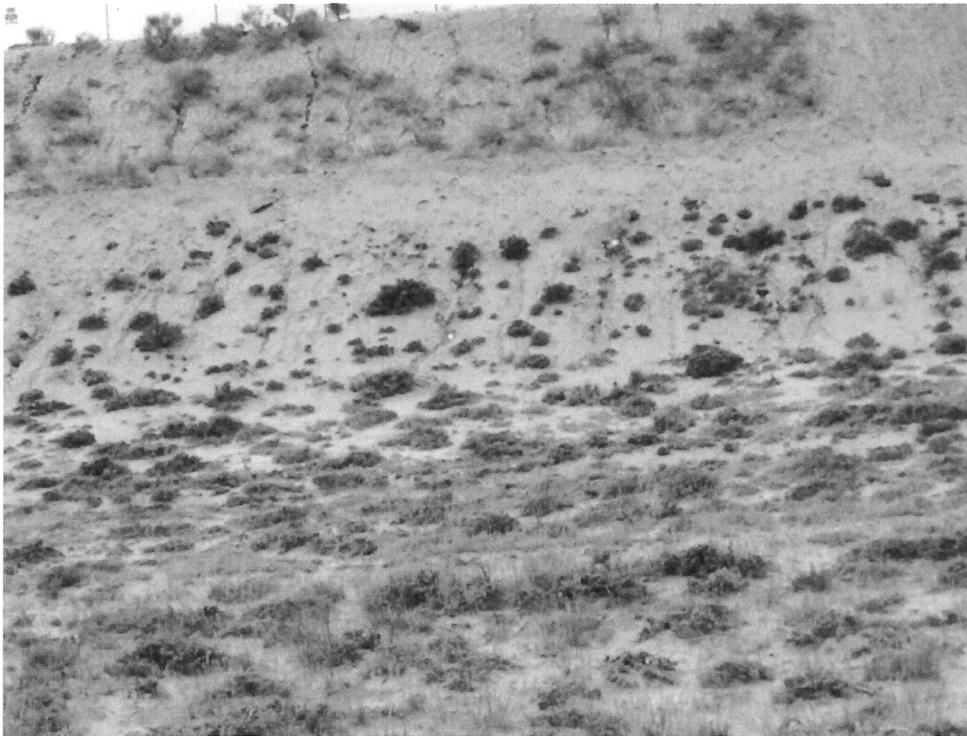
Photographs 3 Exterior of the east embankment, minor rills.

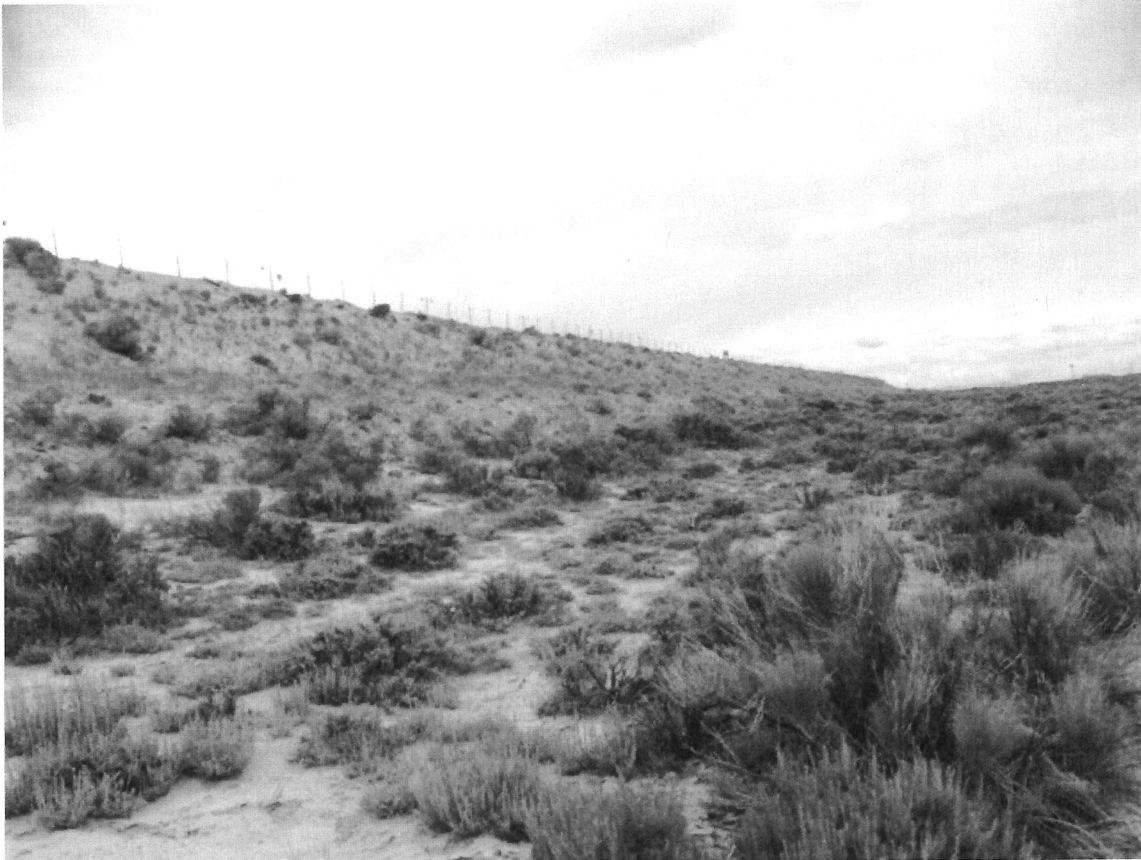
Photograph 4 Exterior of the north embankment.
