Edwin I. Hatch Nuclear Plant - Unit 2
Feedwater Pipe to Inconel Extension Piece
Full Structural Weld Overlay
Nondestructive Examination Results - Spring 2015 Outage (2R23)

**Edwin I. Hatch Nuclear Plant - Unit 2
Feedwater Pipe to Inconel Extension Piece
Full Structural Weld Overlay
Nondestructive Examination Results - Spring 2015 Outage (2R23)**

Subject: Evaluation of Edwin I. Hatch Nuclear Plant Unit 2 Feedwater System Weld
2B21-1FW-12AA-8 Full Structural Weld Overlay Surface Examination
Requirements

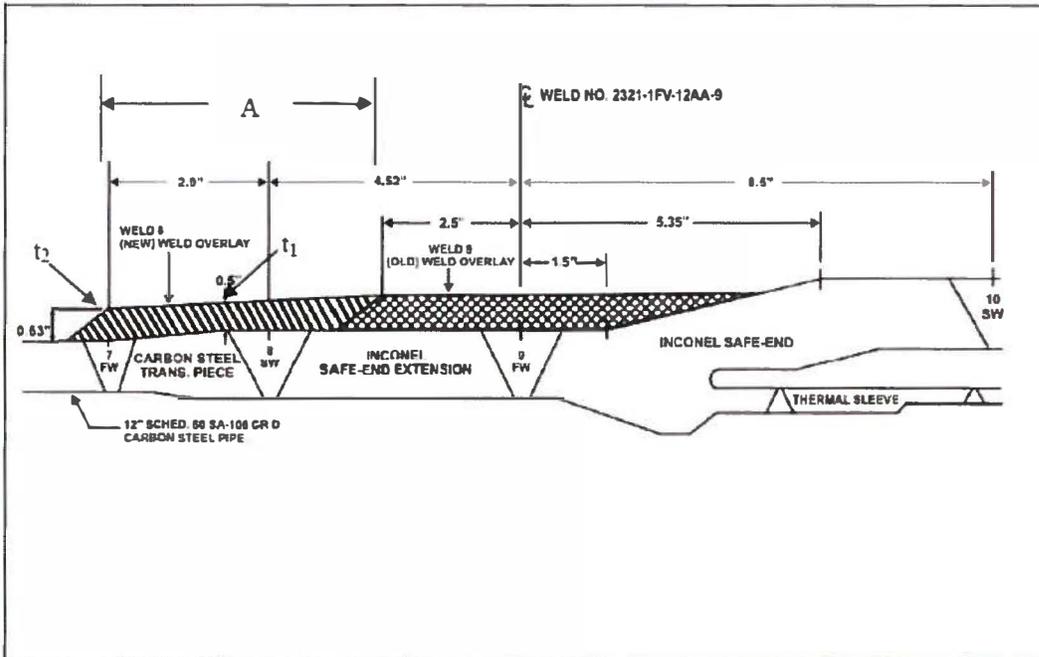
Figure 1: Weld Overlay Design Sketch for Weld #8 [9]]²

The weld overlay design was completed by SI in 2008 and 2009 [7], [8]. Figure 1, excerpted from Reference [9], illustrates the weld overlay design. The FSWOL of 2B21-1FW-12AA-8 was completed using a high-chromium nickel-base weld filler material (Alloy 52M) and abuts a pre-existing nickel-base Alloy 82 weld overlay of adjacent weld 2B21-1FW-12AA-9. The overlaid components include the safe end extension (Alloy 600), a carbon steel transition piece (SA-508 Cl. 1), feedwater system piping (SA-106 Grade B carbon steel) and welds 2B21-1FW-12AA-8 (Alloy 182) and 2B21-1FW-12AA-7 (ferritic similar metal weld). [8]

² Note: A typographical error exists in this SI Drawing. The carbon steel feedwater system piping is identified as SA-106 Gr. D. The correct grade is Gr. B. A revision of this SI drawing will correct this error. This typographical error has no impact on the FSWOL analysis since the correct material grade was used in the analysis.
