DOMINION NUCLEAR CONNECTICUT, INC.
MILLSTONE POWER STATION UNIT 3
10 CFR PART 21 REPORT OF BINDING IN ABB K-LINE BREAKER SECONDARY
CLOSE LATCHES (PART NUMBER 716610K01)

**DEFECT IDENTIFIED IN ABB K-LINE BREAKER
SECONDARY CLOSE LATCHES (PART NUMBER 716610K01)**

**MILLSTONE POWER STATION UNIT 3
DOMINION NUCLEAR CONNECTICUT, INC.**

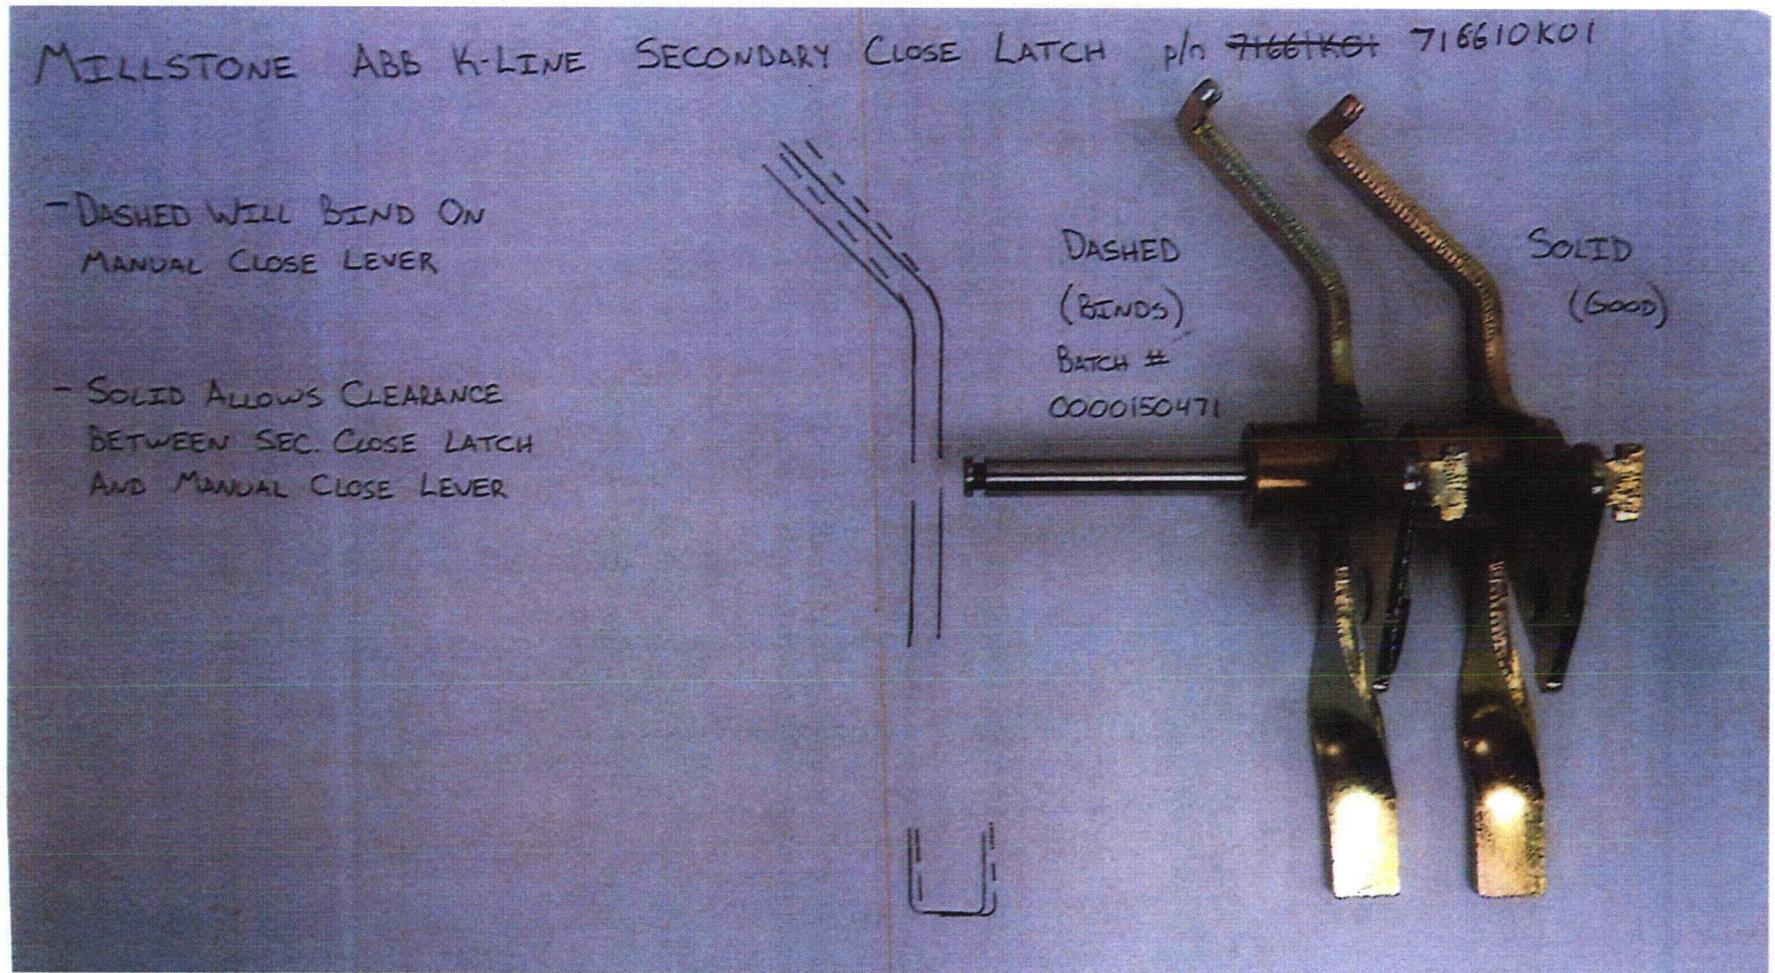
Figure 1

On January 12, 2015, during the overhaul of an ABB K600 load center circuit breaker at Millstone Power Station Unit 3 (MPS3), a defect in a new safety-related secondary close latch (Part No. 716610K01, Batch No. 0000150471) was identified when the secondary close latch did not fit properly into the breaker mechanism. The vertical piece on the front edge of the latch was contacting the manual close lever. Upon closer inspection, it was found that the angle of the bend in the secondary close latch was not correct, causing it to bind on the manual close lever when actuated. When the manual close lever was actuated, it would also bind due to the secondary latch pressing it into the left mechanism side sheet. If a defective secondary close latch was installed in the circuit breaker, the circuit breaker would still close on demand but would not stay open following a trip signal. A picture of one of the defective latches, including a schematic of the incorrect bend angle, is provided in Figure 1.

For this type of breaker, after opening, the closing spring charging motor runs to charge the closing springs and configure the breaker for the next closing demand. With a stuck or bound secondary close latch, the breaker would trip open on demand, the springs would recharge, and the breaker would reclose. If the trip

signal was still present, the breaker would trip again and reclose again. This cycle would continue until the charging motor failed or the associated control power fuses blew. The safety significance of this condition is that circuit breakers credited to open and isolate failed components, protect electrical containment penetrations, prevent emergency diesel generator overloading, or perform other opening control functions, would not perform their intended safety function.

DNC determined that the defect meets the criteria of a substantial safety hazard since it could prevent a circuit breaker from staying open following a trip signal and thereby result in a failure of the circuit breaker to perform its intended safety function.

Defective ABB K-Line Secondary Close Latch

The defective latch identified during the breaker overhaul was replaced with a conforming latch from the warehouse and the breaker tested successfully.
