Re: St. Lucie Unit 2
Docket No. 50-389
Response to Request for Additional Information Regarding the Spring 2014 Steam
Generator Tube Inspections

RESPONSE TO REQUEST FOR ADDITIONAL INFORMATION
REGARDING THE SPRING 2014 STEAM GENERATOR TUBE
INSPECTIONS

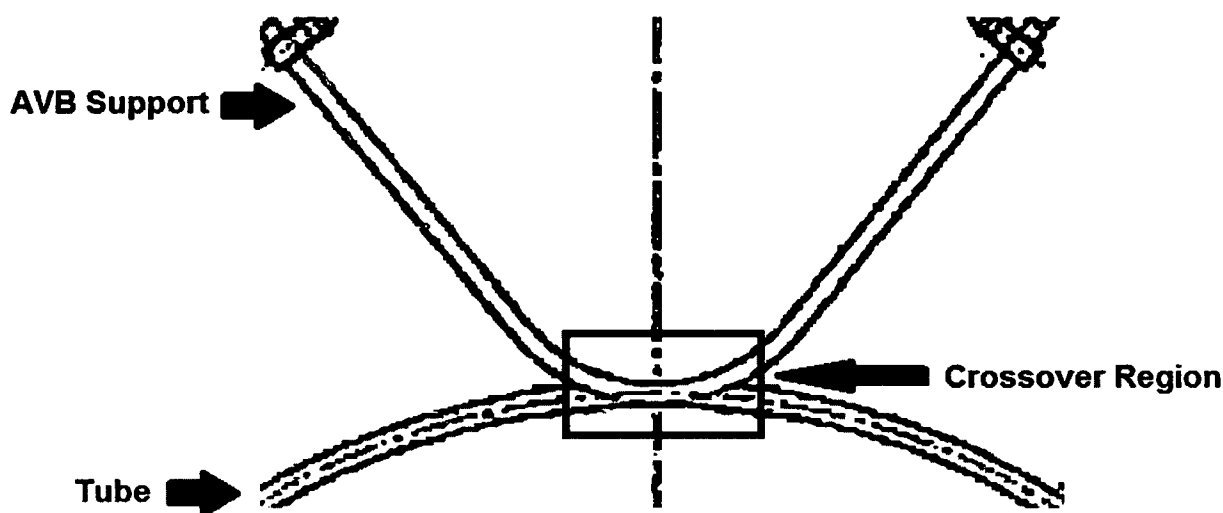
The indication referred to in RAI-7 is located in the St Lucie Unit-2, steam generator A (SG-A), tube Row 41 Column 154. To clarify, note that the tube was plugged because the indicated depth measurement using the +Point probe was 41% TW, as discussed in Note 4 of Section "e" of the SL2-21 SG Tube Inspection Report (ML 14279A237), not because it had a short axial length. The indication was reported as a single volumetric indication (SVI) at location AV3 +2.02".

This indication is at a location where the top of the U-bend is in close proximity to the bottom of the AVB bar. This location is referred to as the "crossover region" as shown in the sketch below.

The SVI is due to mechanically-induced wear occurring between the tube and AVB support. Normally, this indication would be reported and sized as a wear indication, but it was conservatively reported as an "SVI" to give it a unique reporting code in the database. The short axial length of the indication (0.15") is most likely attributed to tube-to-AVB contact over a short span in the "crossover region" as shown in the sketch above.
