GNRO-2015/00019

April 08, 2015

SUBJECT: Licensee Event Report (LER) 2015-001-00 Automatic Actuation of the
Reactor Protection System (RPS) Due to a Main Turbine Trip
Grand Gulf Nuclear Station
Docket No. 50-416
License No. NPF-29

4. TITLE
Automatic Actuation of the Reactor Protection System (RPS) Due to a Fault in the Protective Relaying Circuitry on the "B" Main Transformer.

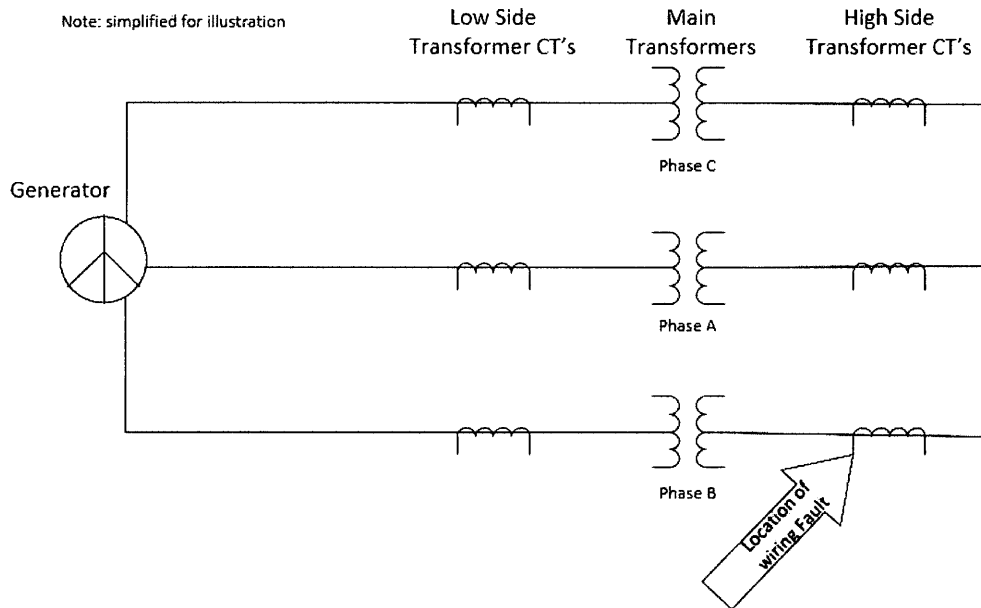
The high voltage side (500kV) CT wiring is normally grounded in the 801 panel in the control room. An unintentional, high voltage CT wiring ground developed inside the conduit mounted on top of "B" main transformer. The high voltage CT provides input to the transformer differential relay located in the control room. The differential relay is a protective relay that compares the difference in power between the high voltage side and low voltage side (22kV) of the transformer. The transformer is protected by actuation of the transformer differential relay and generator trip.

1. A ground developed on the high voltage CT wire inside the conduit on top of the transformer. This ground created circulating ground currents between the normal ground in the control panel and the fault location on top of the transformer. This current caused localized heating that resulted in melting the other wiring in the conduit.
2. The change in current through the high voltage CT, without a change in the low voltage CT current, was detected by the transformer differential relay, resulting in relay actuation and subsequent generator trip.

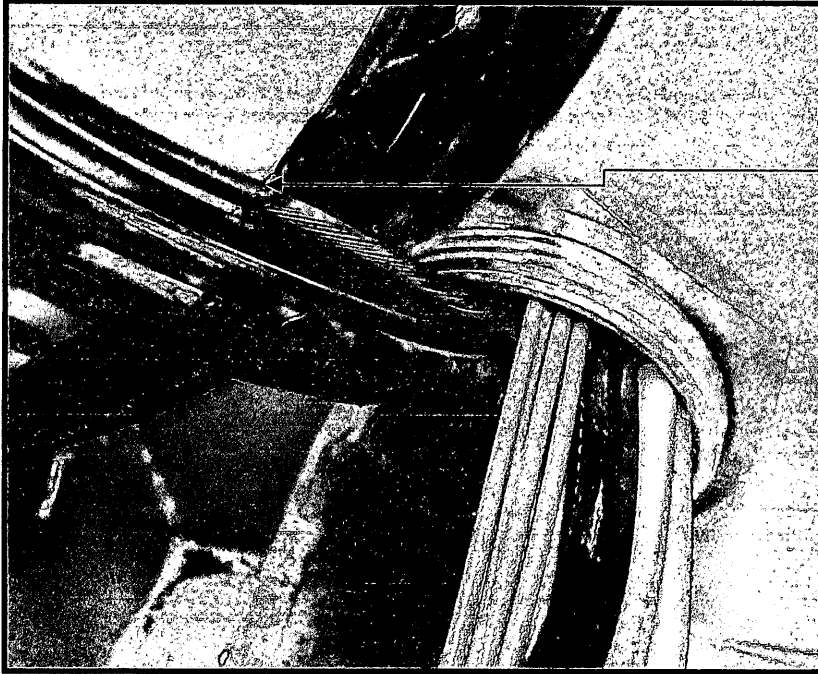
On Saturday, February 7, 2015, at 1856 hours central time the Grand Gulf Nuclear Station Unit 1 experienced a full load rejection due to a fault in the current transformer circuit on the "B" main transformer. Faulted wiring in a pull box resulted in a ground on the current transformer (CT) [XCT]. This ground was sensed by the transformer differential current relay and its magnitude was sufficient to create a trip signal to the main generator, creating a full load reject. The figures on pages 4 and 5 of this LER are provided as a visual aid to show the ground and damaged wiring.

Damaged wiring was in pull box #3.

The faulted cables and other similar cables were determined and alternate wiring and conduit was installed. The extent of condition involved replacing the wiring and conduit for the protective circuitry on both the high voltage and low voltage sides on all three recently installed single phase main transformers.

Corrective actions were taken to replace wiring and conduit
