RESEARCH REACTOR CENTER

SUBJECT: Written communication as required by University of Missouri
Research Reactor Technical Specification 6.1.h(2) regarding a
deviation from Technical Specifications 3.2.a and 3.4.c

Licensee Event Report No. 15-01 – March 21, 2015
University of Missouri Research Reactor

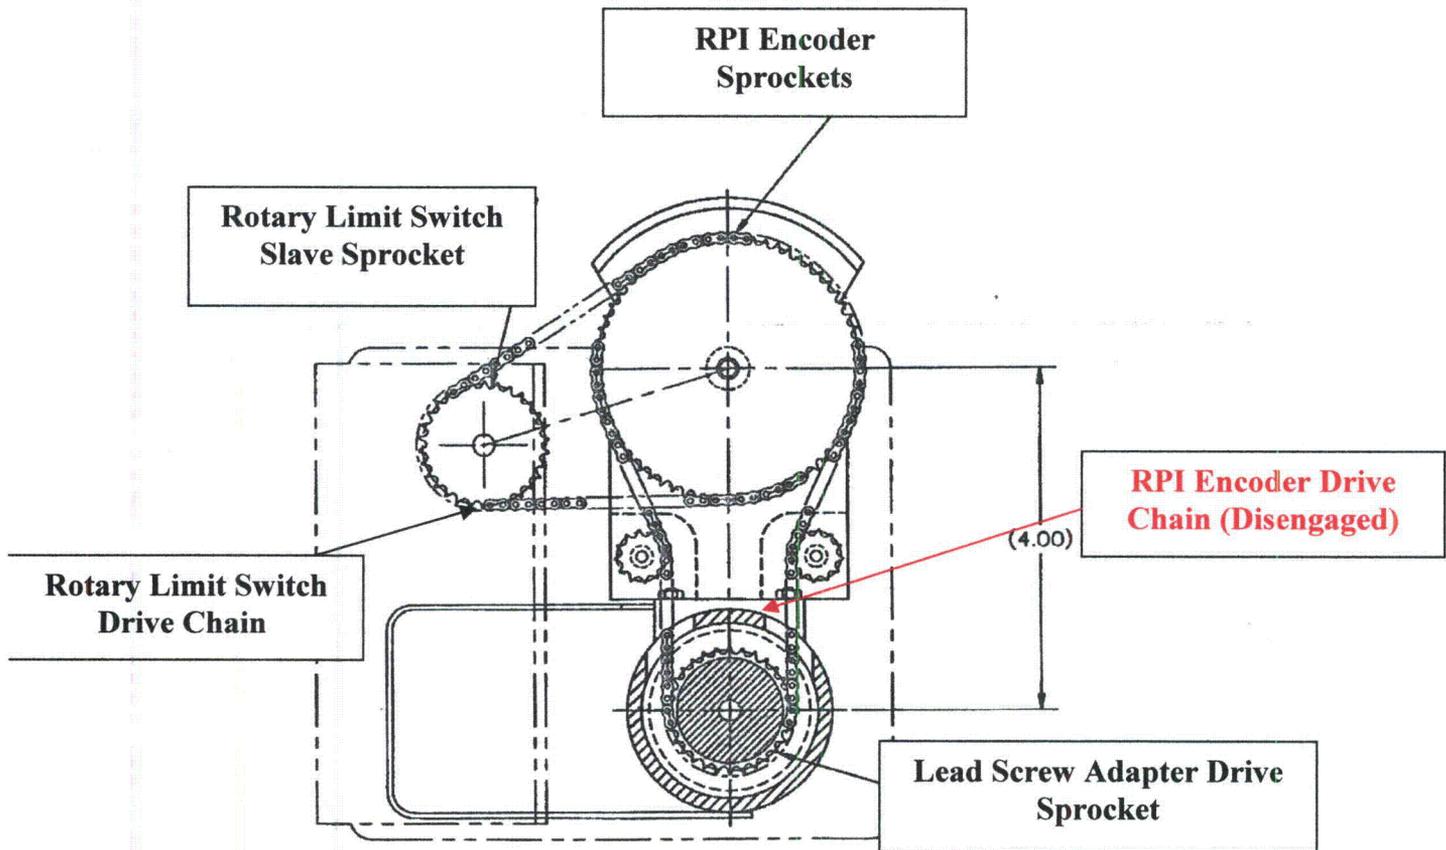
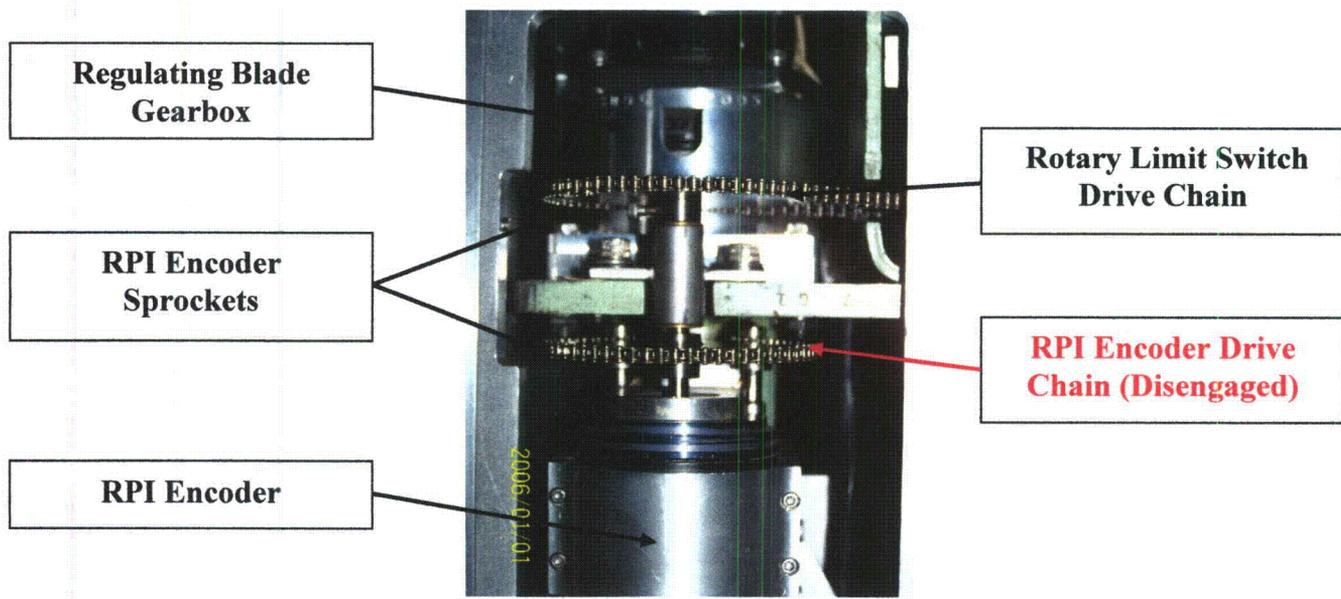
Regulating Blade Drive Assembly

After the reactor was shut down and secured, the regulating blade drive mechanism was removed for inspection and troubleshooting. It was determined that a sufficient minor misalignment had occurred over an extended period of time to allow the chain tension to vary slightly with the rotational motion of the RPI encoder sprockets. This lack of a correct, consistent tension allowed the drive chain to disengage from the RPI encoder sprocket.

The reactor was shut down by manual scram when it was determined that the regulating blade was inoperable. After the reactor was shut down and secured, the regulating blade drive mechanism was removed for inspection and repairs. A complete alignment was performed on the chain drives and sprocket assemblies for the regulating blade RPI encoder, rotary limit switch assembly, regulating blade drive assembly, and idler arms. Chain tension was adjusted on all drive chains after the alignments were completed. The shaft bushings supporting the RPI encoder sprockets were also replaced. The "Regulating Blade Operation And Rod Run-In Function Test" portion of form FM-57, "Long Form Startup Checksheet," were completed satisfactorily to verify proper operation of the regulating blade rotary limit switch assembly and regulating blade RPI.

To prevent further failures of this type, more detailed instruction will be provided during the performance of FM-57, "Long Form Startup Checksheet," as to the type of inspections required. This will ensure that a check of regulating blade chain tension is performed at least weekly.
