SUBJECT: STAFF ASSESSMENT OF CRACKING IN UNISOLABLE SECTIONS OF HIGH PRESSURE INJECTION MAKEUP LINES AT OCONEE NUCLEAR STATION, UNITS 2 AND 3 AND OTHER BABCOCK AND WILCOX PLANTS  
(TAC NO. M98454)

ASSESSMENT ON THE OCONEE NUCLEAR STATION, UNITS 1, 2, AND 3  
HIGH PRESSURE INJECTION SYSTEM MAKEUP LINE WELD CRACK AND  
RELATED BABCOCK AND WILCOX OWNERS GROUP RESPONSE

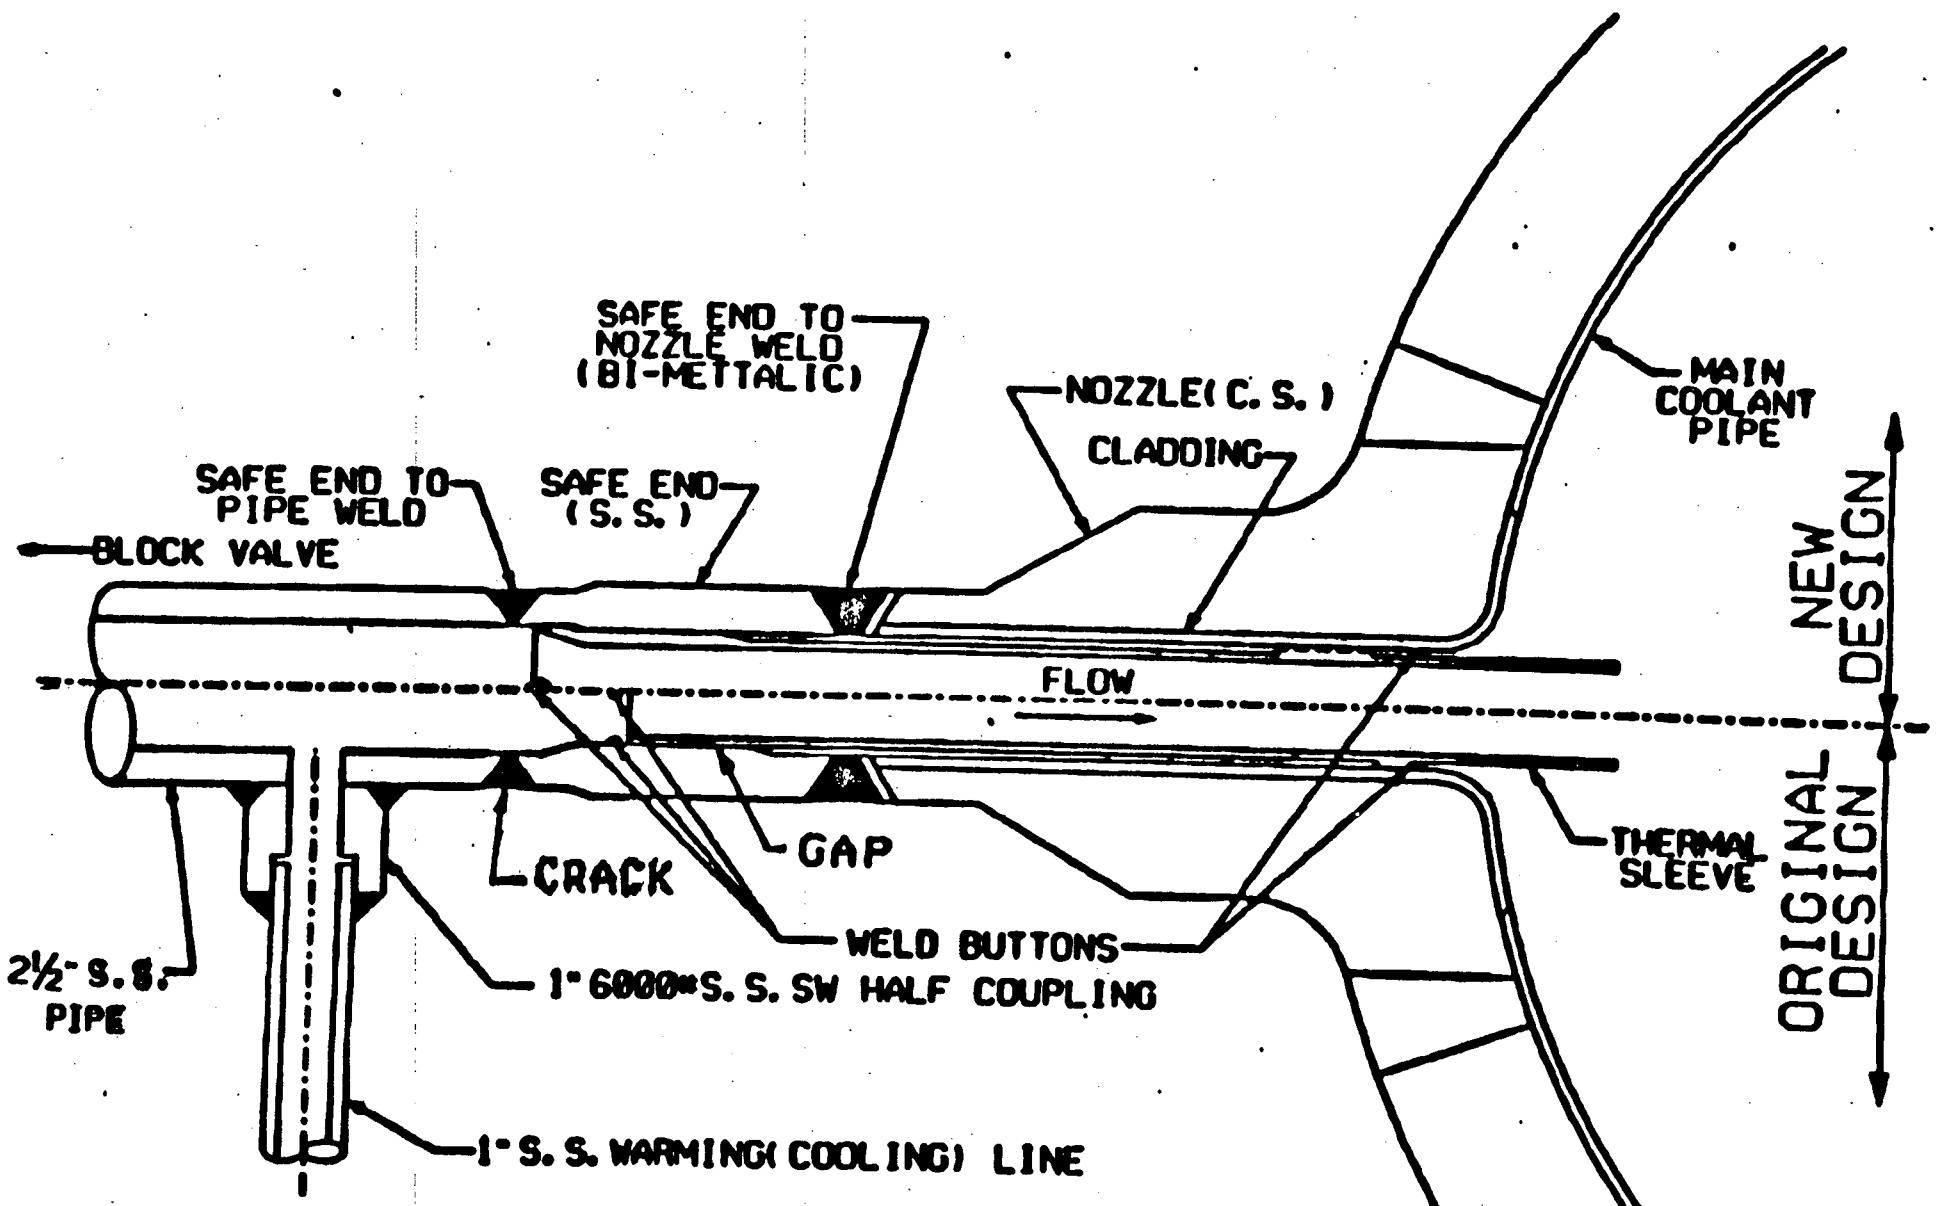
FIGURE 1 - THERMAL SLEEVE  
2A1, 2B1, 3A1, 3B1, 3B2

The Oconee 2A1 HPI/MU nozzle assembly consists of the HPI/MU 2.5-inch diameter pipe/safe-end/thermal sleeve (see attached Figure 1 - Original Design). The sleeve is attached by contact rolling to the inner surface of the safe-end. A 1-inch diameter "warming" line taps into the bottom of the HPI/MU pipe immediately upstream of the pipe/safe-end weld.

As corrective action, Duke replaced the cracked safe-ends and the safe-end/pipe welds in Oconee Units 2 and 3. The thermal sleeves were also replaced with an improved sleeve design, also shown in Figure 1 - Original Design. In addition, Duke assembled a Failure Investigation Process (FIP) team to determine the root cause of the event in Unit 2. The team concluded that Duke had failed to implement an effective HPI nozzle inspection program based on available industry recommendations, and had failed to effectively evaluate known problems (industry and in-house experience) and implement appropriate corrective actions from 1982 to the present. The FIP team published its findings in a report dated July 24, 1997 (Reference 6). The staff has examined this report and finds it thorough and complete.

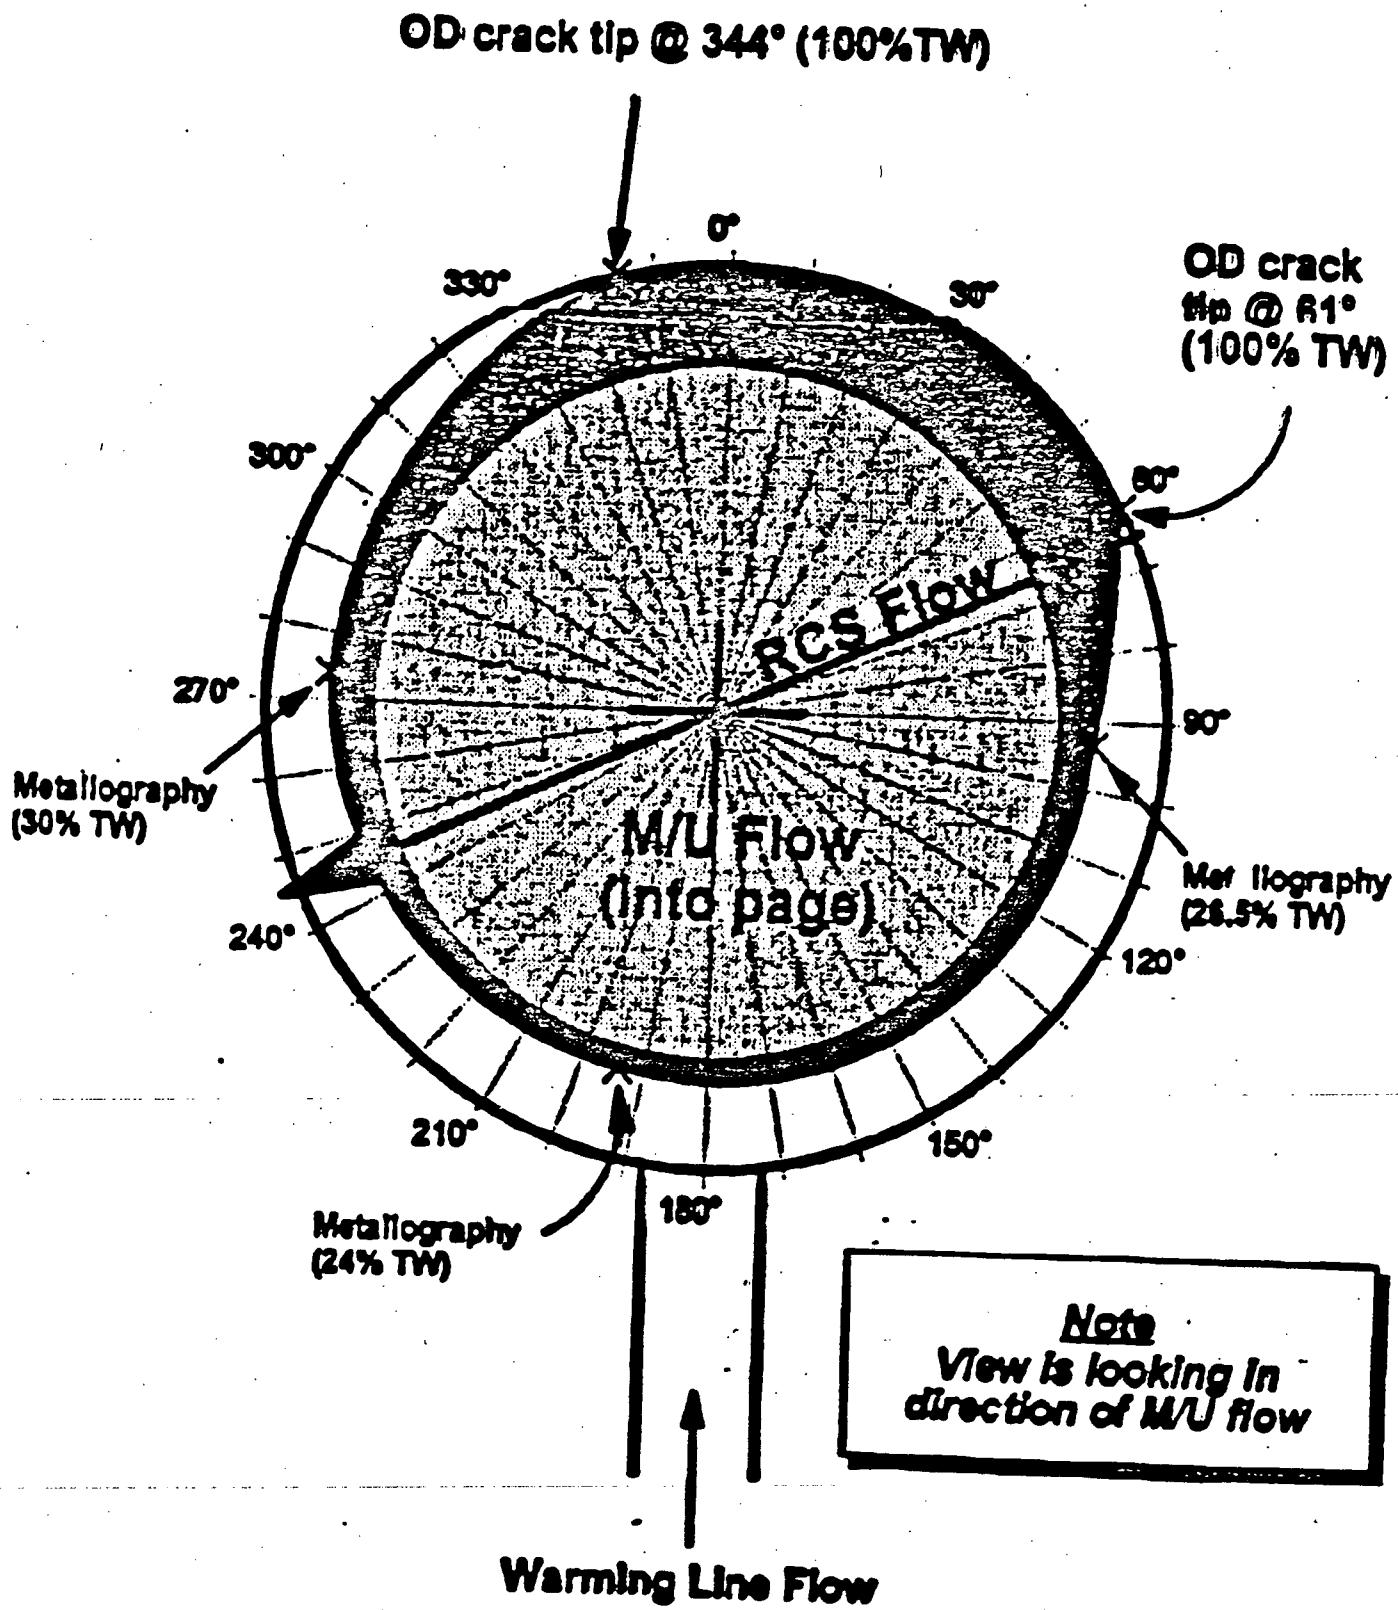
FIGURE 2

In Reference 3, Duke submitted the results of a metallurgical examination of the weld and determined that the crack consisted of a 360-degree inside surface flaw. The flaw depth increased gradually from about 30 percent into the wall until it became through-wall over a 77-degree arc length (see attached Figure 2). The examination also found a gap in the contact area between the thermal sleeve and the safe-end, indicative of loss of contact that caused the thermal sleeve in this line to loosen (see attached Figure 1). The thermal sleeve was found to be cracked with portions missing from the end that extends into the RCS flow path. Significant wear damage was also found at both the upstream (the rolled end) and the downstream end. In addition, small cracks were found in the pipe in the vicinity of the "warming" line nozzle.

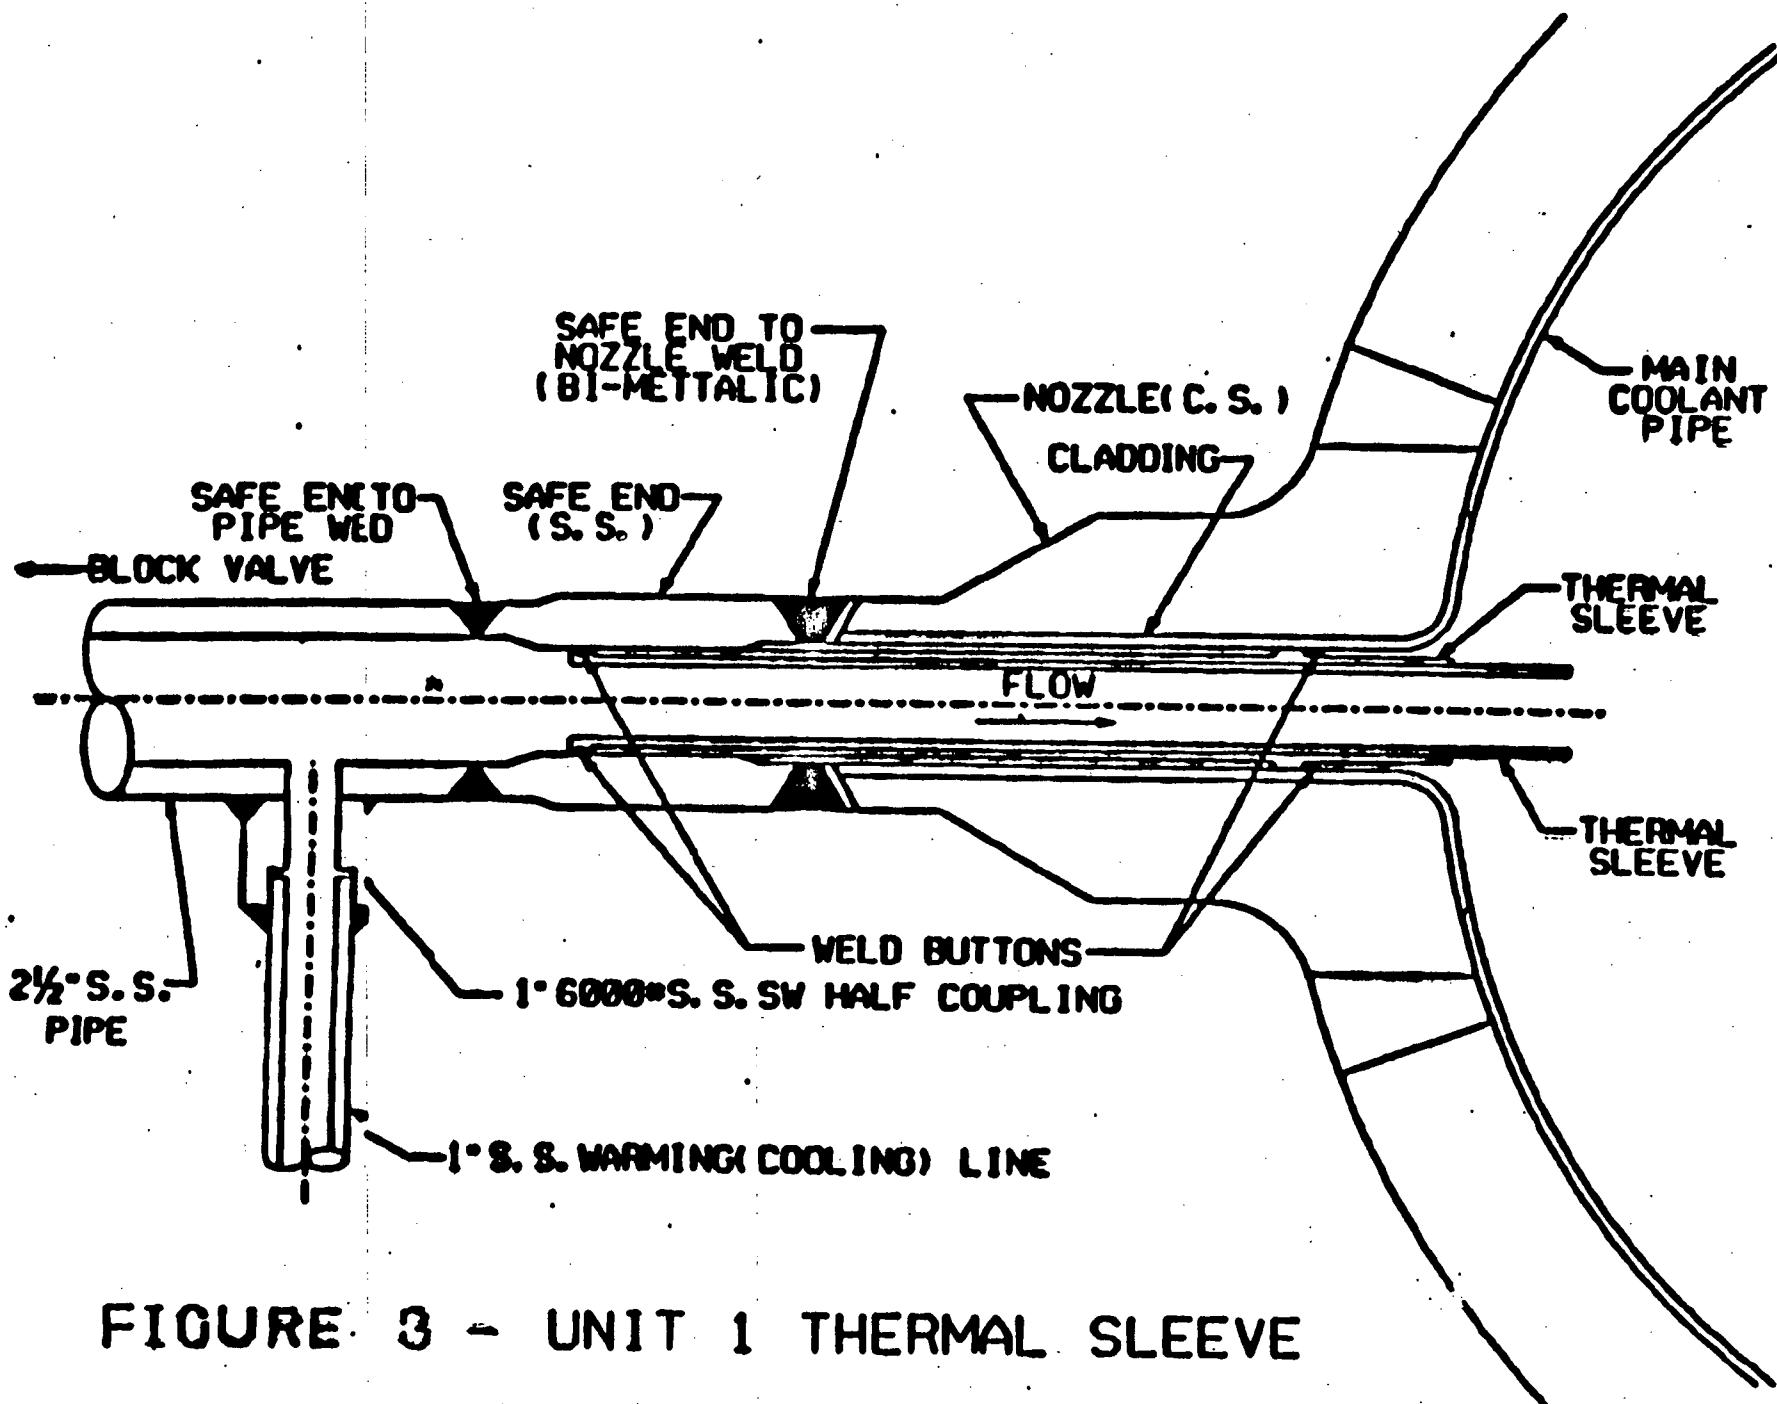
FIGURE 3 - UNIT 1 THERMAL SLEEVE

The Oconee Unit 1 nozzles have a double thermal sleeve design (see attached Figure 3). Radiographic inspection in the period from 1983 to 1989 indicated that no gap existed in three of the four thermal sleeves. A gap was found in the thermal sleeve in the 1B 2 HPI line, which had not grown during the inspection period. Advantages of the double thermal sleeve, as stated by Duke, include (1) greater stiffness, (2) greater thermal resistance, and (3) reduced flow area, with corresponding increased flow velocity. Duke concluded that this design resulted in the Unit 1 sleeves being less susceptible to thermal damage.
