Exelon Generation Company, LLC

Braidwood Station, Unit 2
Facility Operating License No. NPF-77
NRC Docket No. STN 50-457

Subject: Response to Request for Additional Information Regarding the Steam Generator Tube Inspection Report for Braidwood Station, Unit 2, Refueling Outage 17

Response to Request for Additional Information Regarding the Steam Generator Tube Inspection Report for Braidwood Station, Unit 2 Refueling Outage 17

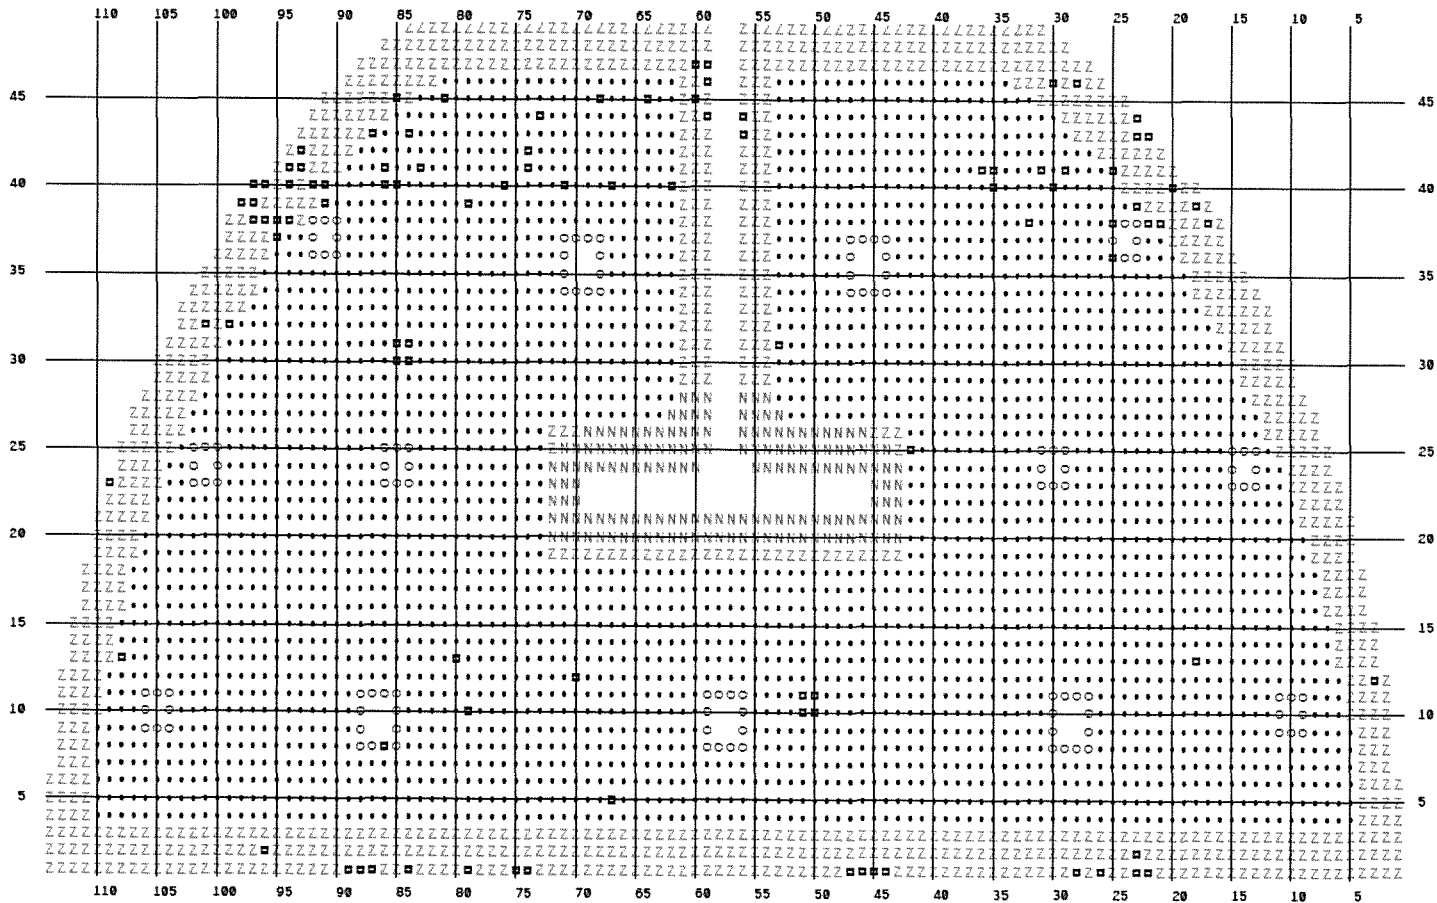
SG - A HOT LEG 3-TUBE PERIPHERY .610 ARRAY PROGRAM

Z 1025 TEST (01H - TSH -1")

N 160 TEST (03H - TSH -1")

□ 100 PLUGGED TUBE

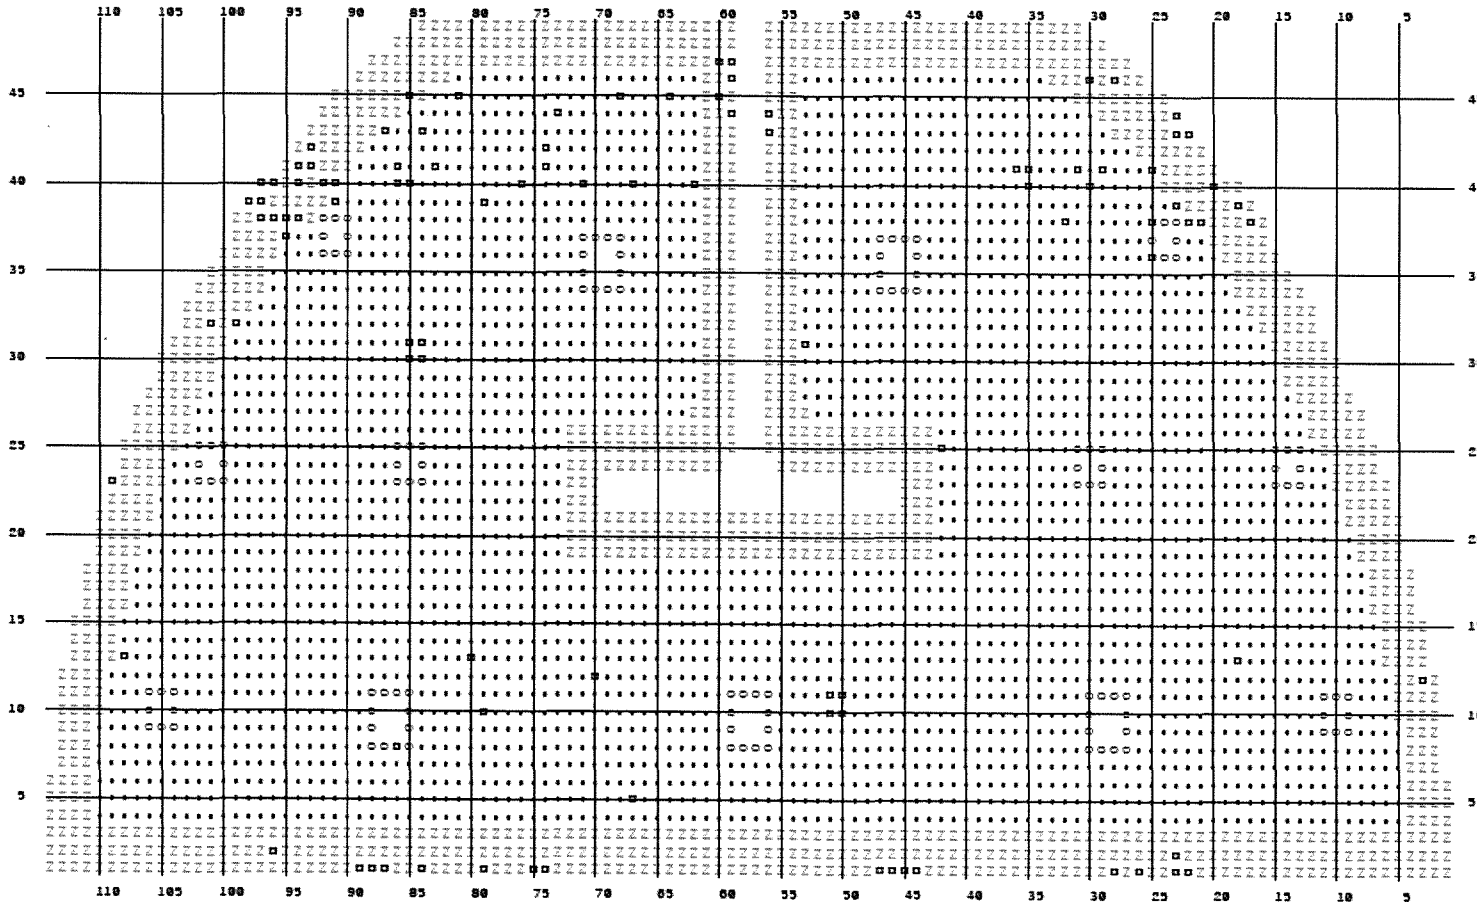
SG - A COLD LEG 3-TUBE PERIPHERY .610 ARRAY PROGRAM

Z 1185 TEST (01C - TSC -1")

□ 100 PLUGGED TUBE

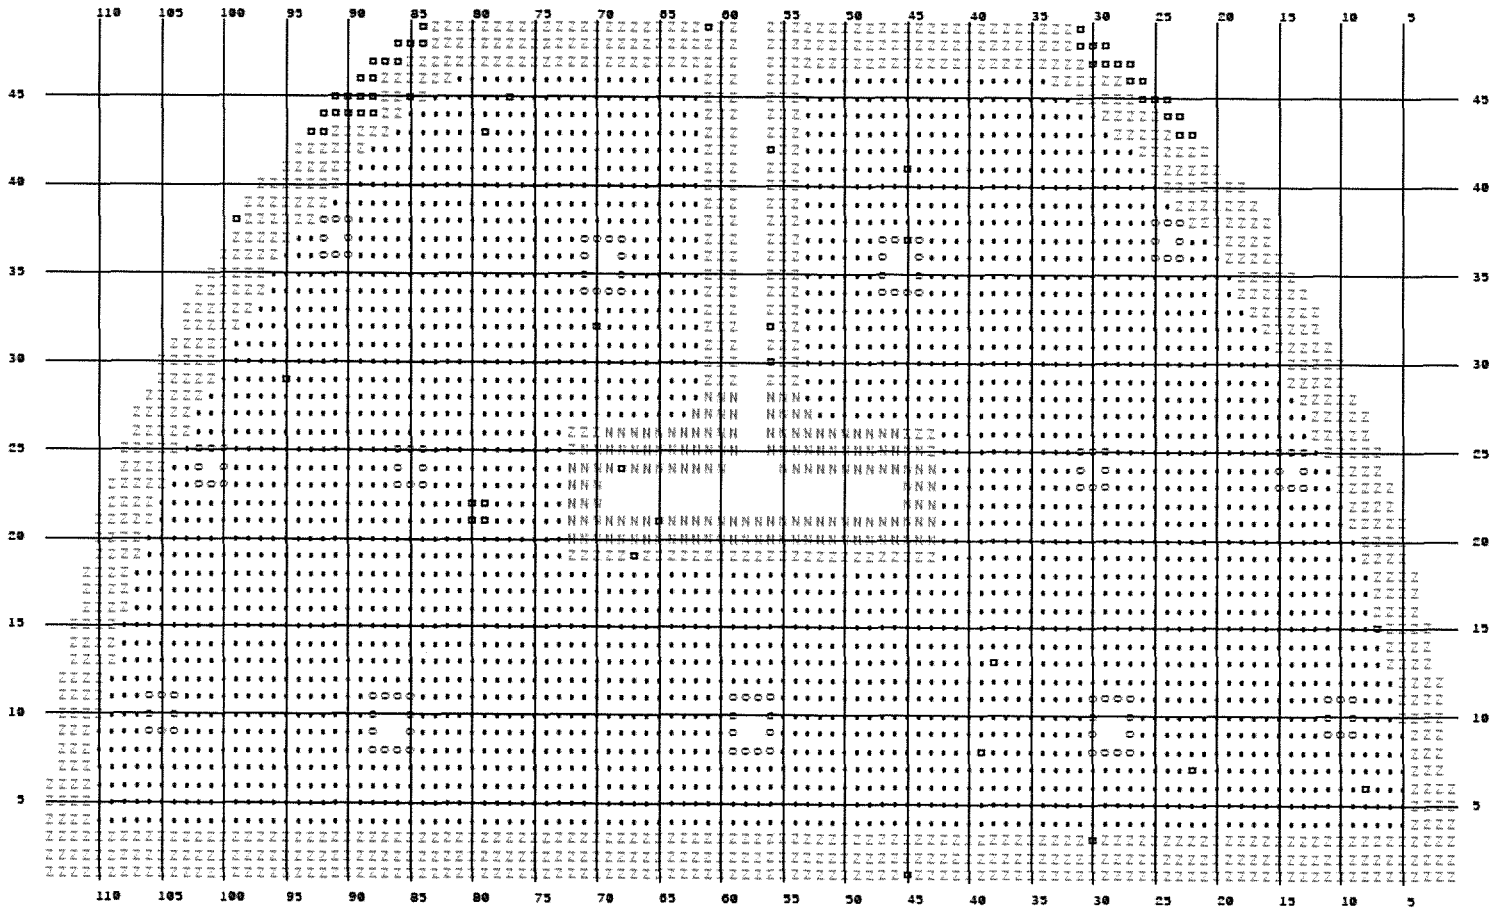
SG - B HOT LEG 3-TUBE PERIPHERY .610 ARRAY PROGRAM

Z 1036 TEST (01H - TSH -1")

N 158 TEST (03H - TSH -1")

□ 63 PLUGGED TUBE

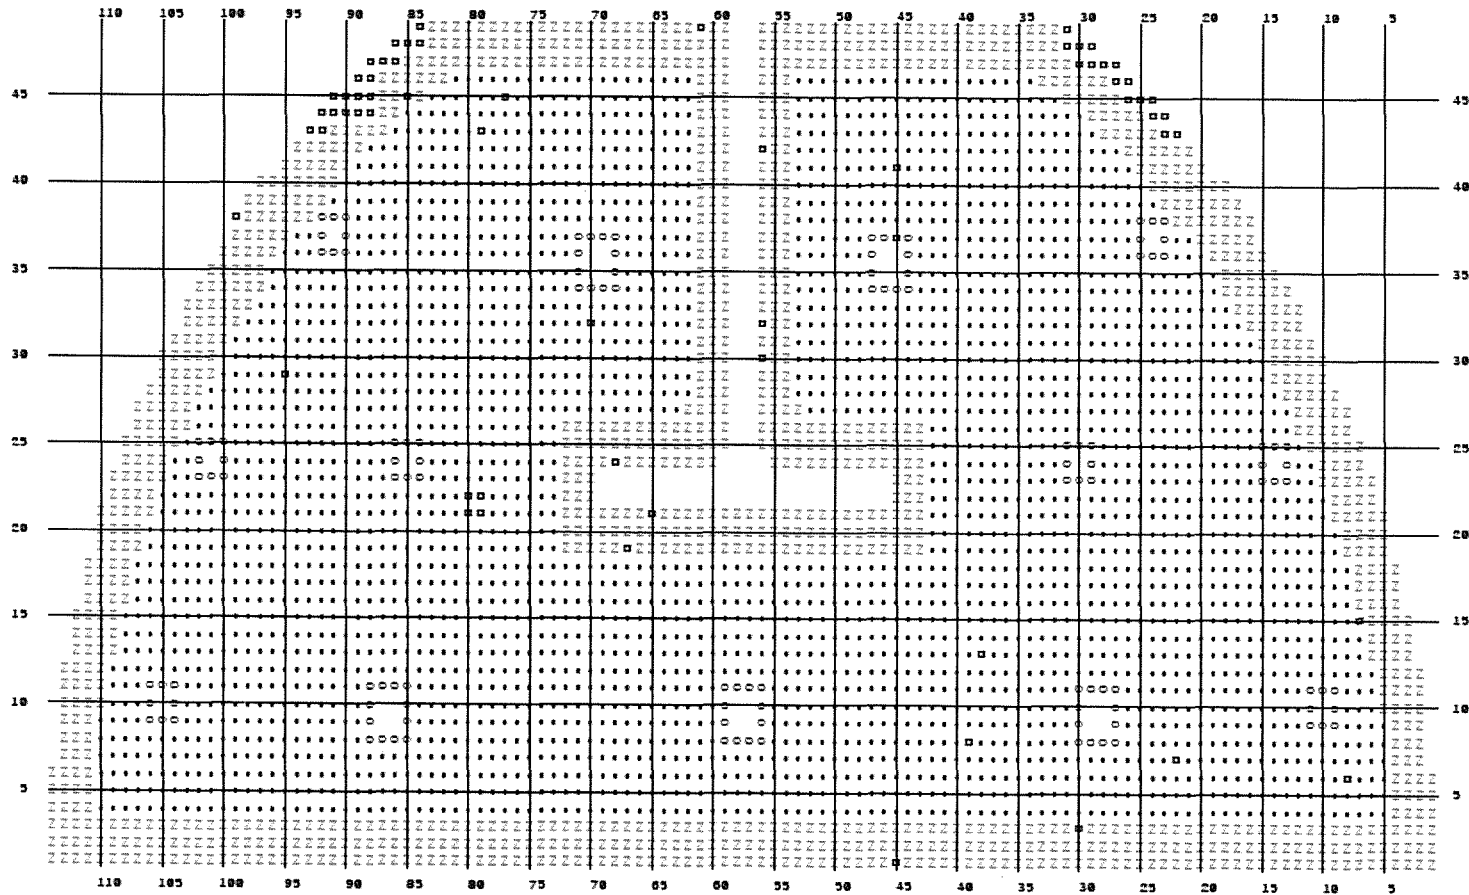
SG - B COLD LEG 3-TUBE PERIPHERY .610 ARRAY PROGRAM

Z 1194 TEST (010 - TSC -1*)

□ 63 PLUGGED TUBE

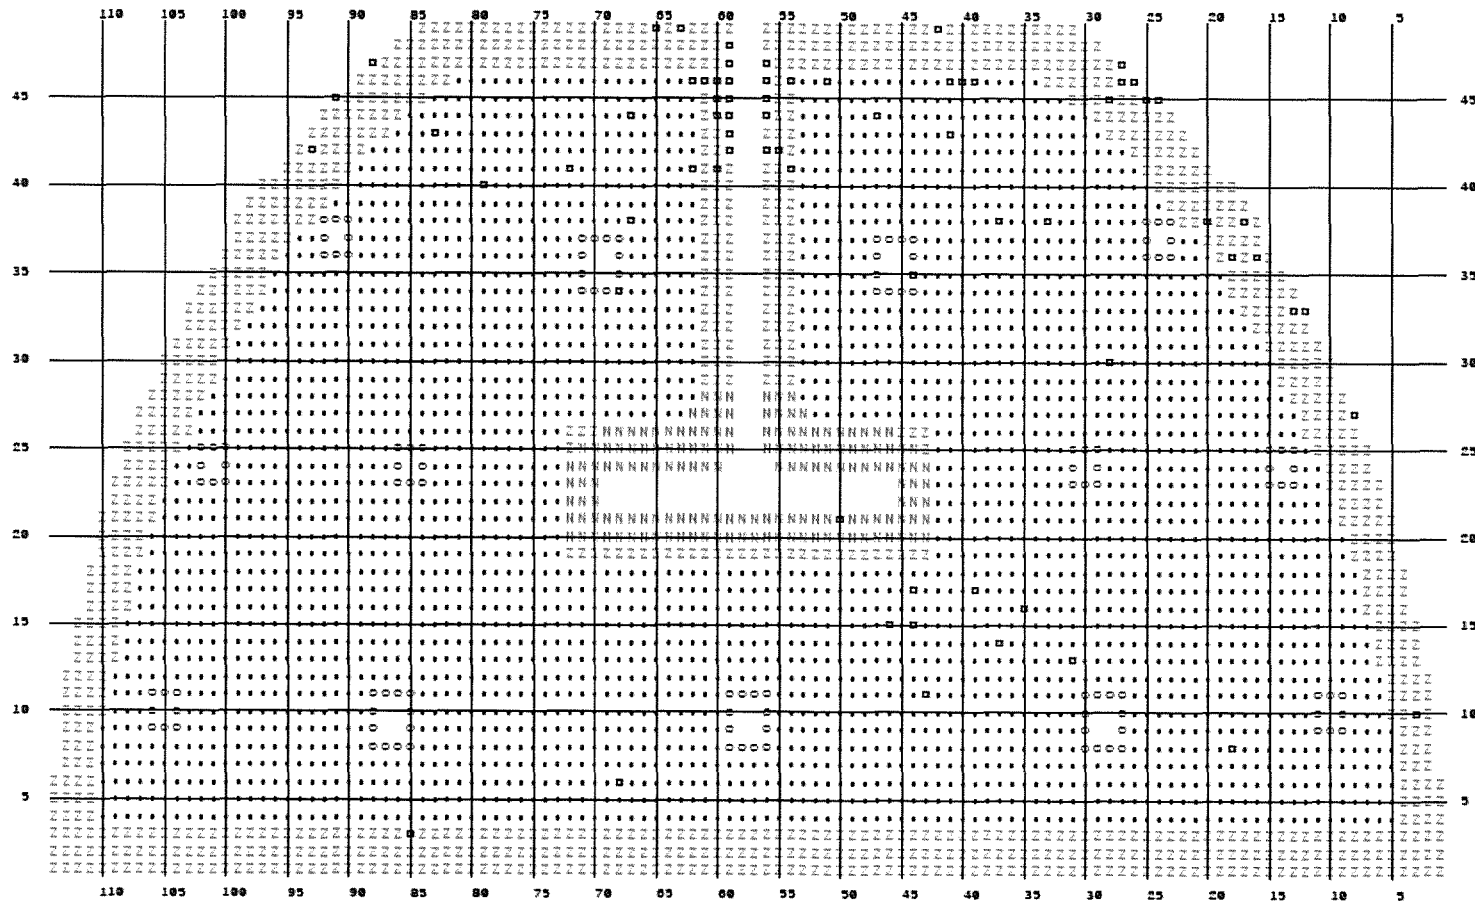
SG - C HOT LEG 3-TUBE PERIPHERY .610 ARRAY PROGRAM

Z 1041 TEST (01H - TSH -1")

N 159 TEST (03H - TSH -1")

□ 70 PLUGGED TUBE

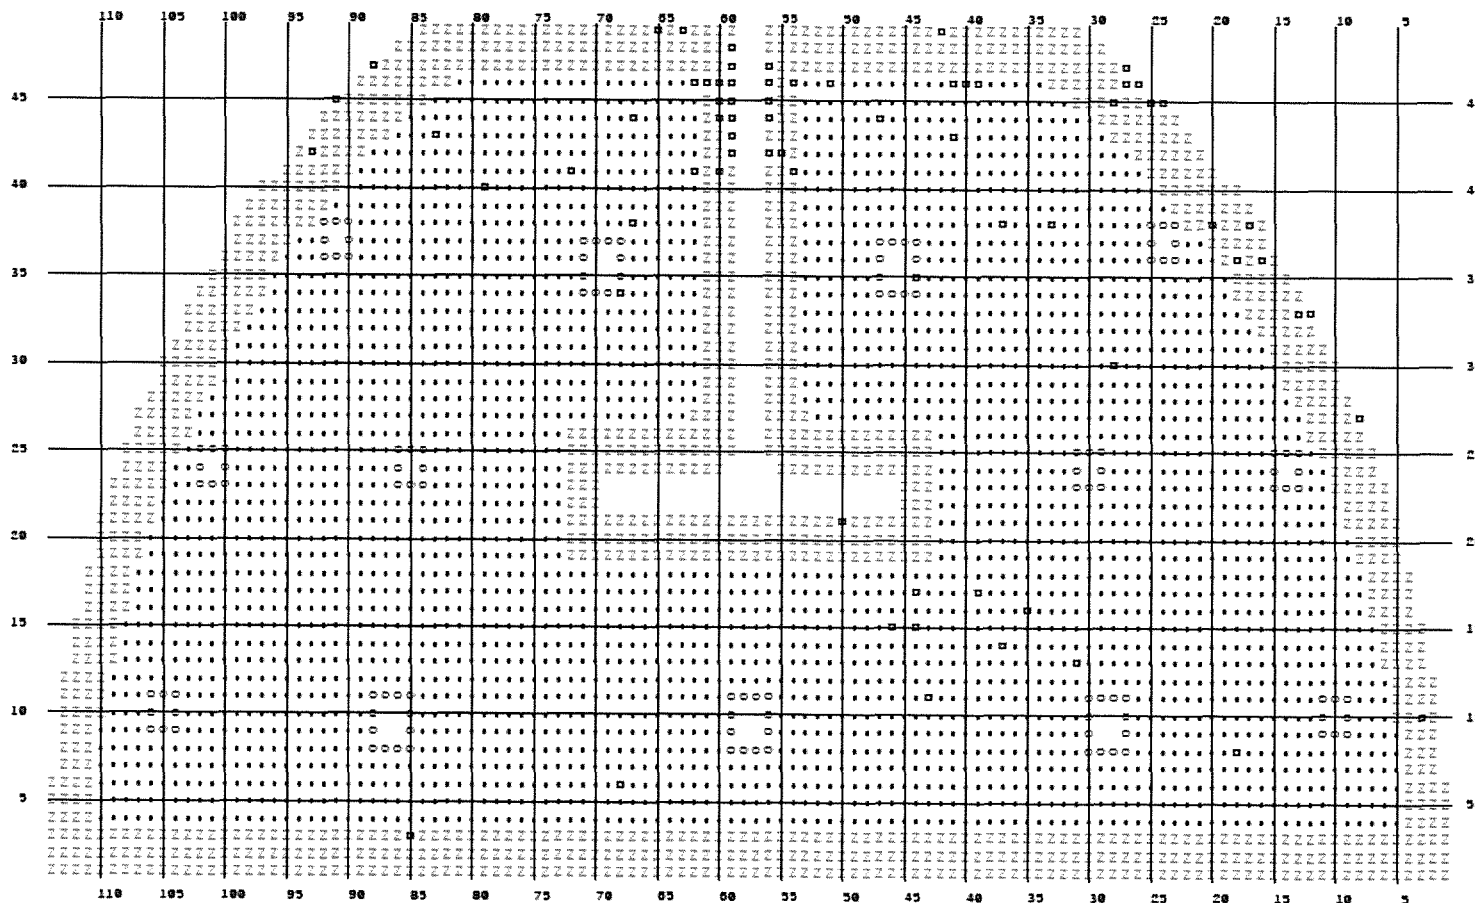
SG - C COLD LEG 3-TUBE PERIPHERY .610 ARRAY PROGRAM

Z 1200 TEST (01C - TSC -1")

□ 70 PLUGGED TUBE

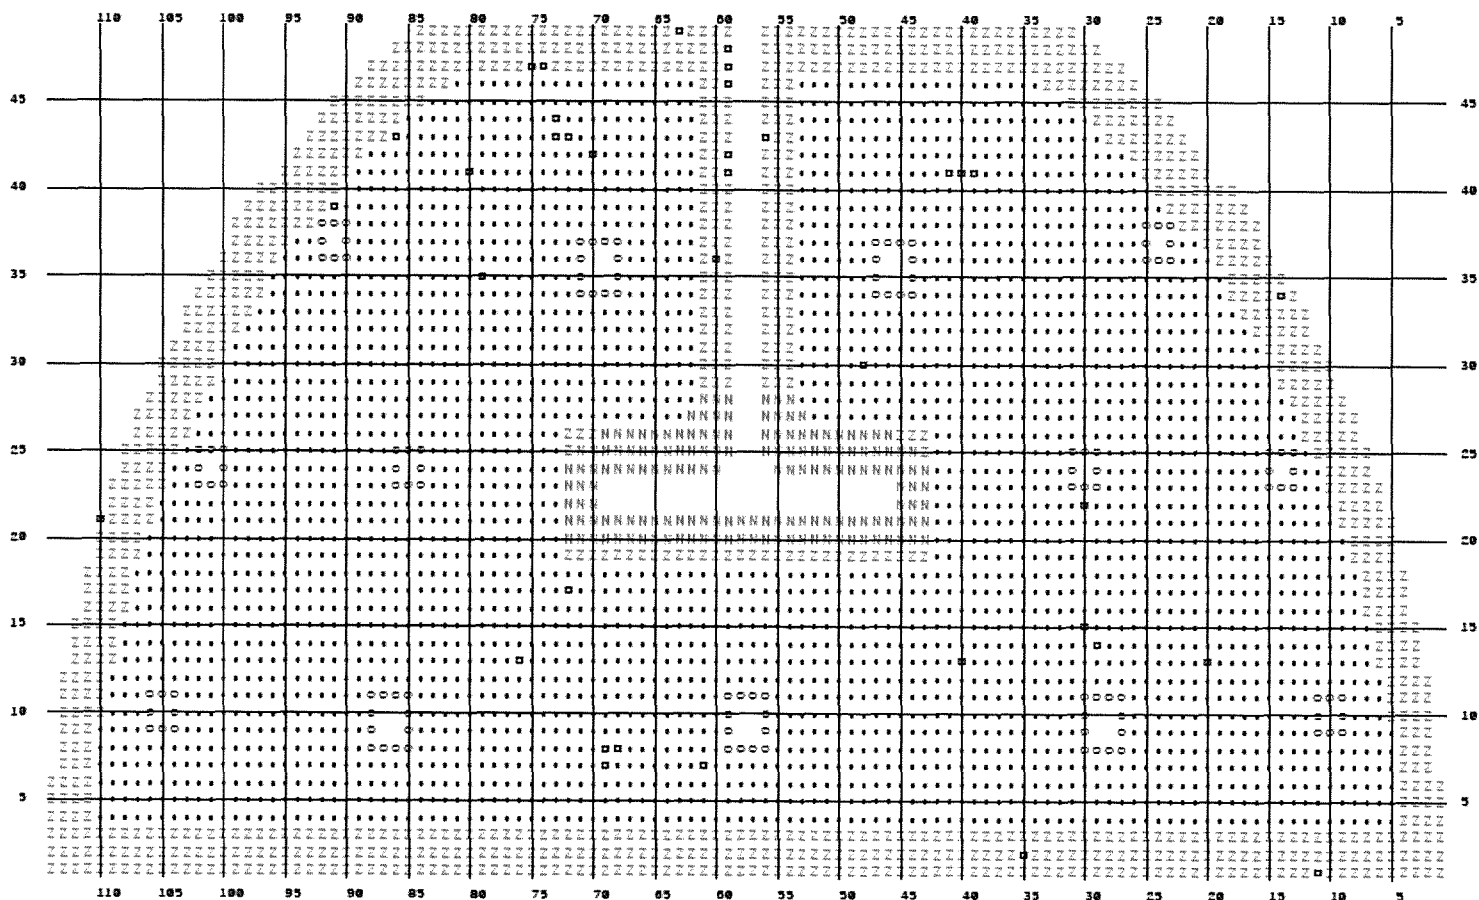
SG - D HOT LEG 3-TUBE PERIPHERY .610 ARRAY PROGRAM

Z 1068 TEST (01H - TSH -1")

N 160 TEST (03H - TSH -1")

□ 37 PLUGGED TUBE

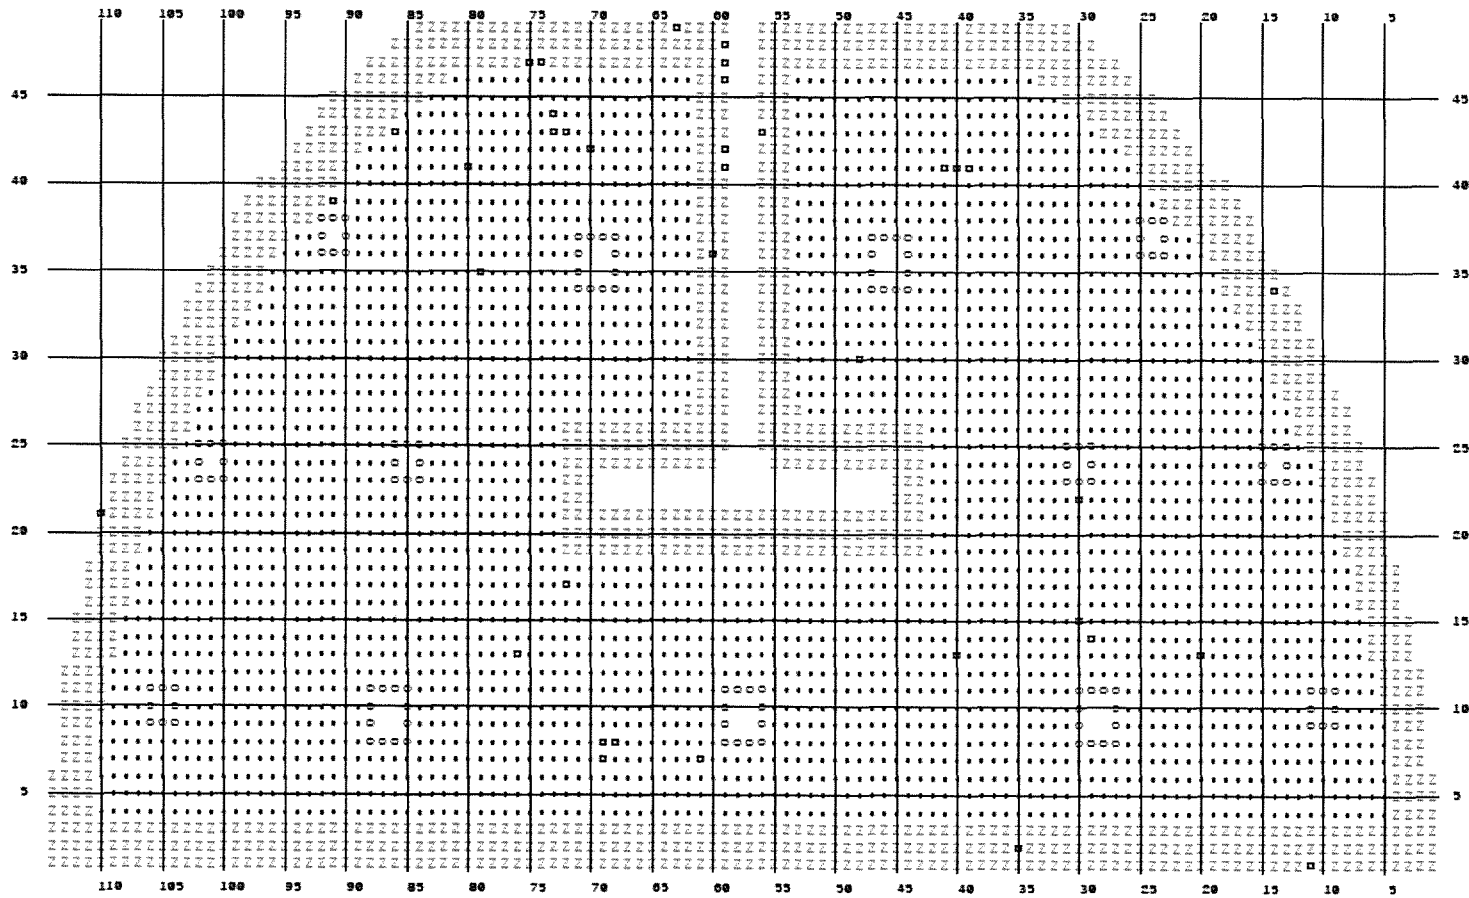
SG - D COLD LEG 3-TUBE PERIPHERY .610 ARRAY PROGRAM

Z 1228 TEST (01C - TSC -1")

□ 37 PLUGGED TUBE
