U.S. NUCLEAR REGULATORY COMMISSION

AUGMENTED INSPECTION TEAM (AIT) INSPECTION

Report No.: 50-269/97-11, 50-270/97-11, 50-287/97-11

Facility: Oconee Nuclear Station, Units 1, 2 & 3

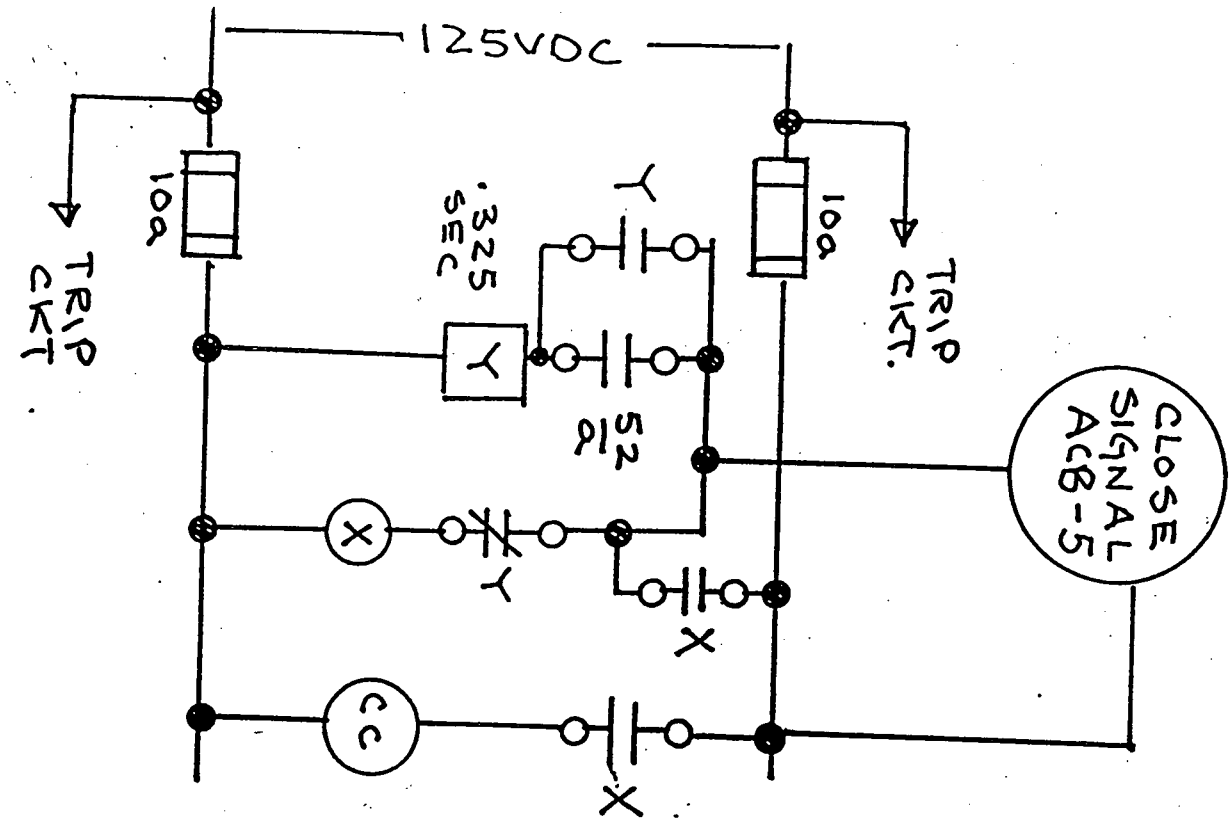
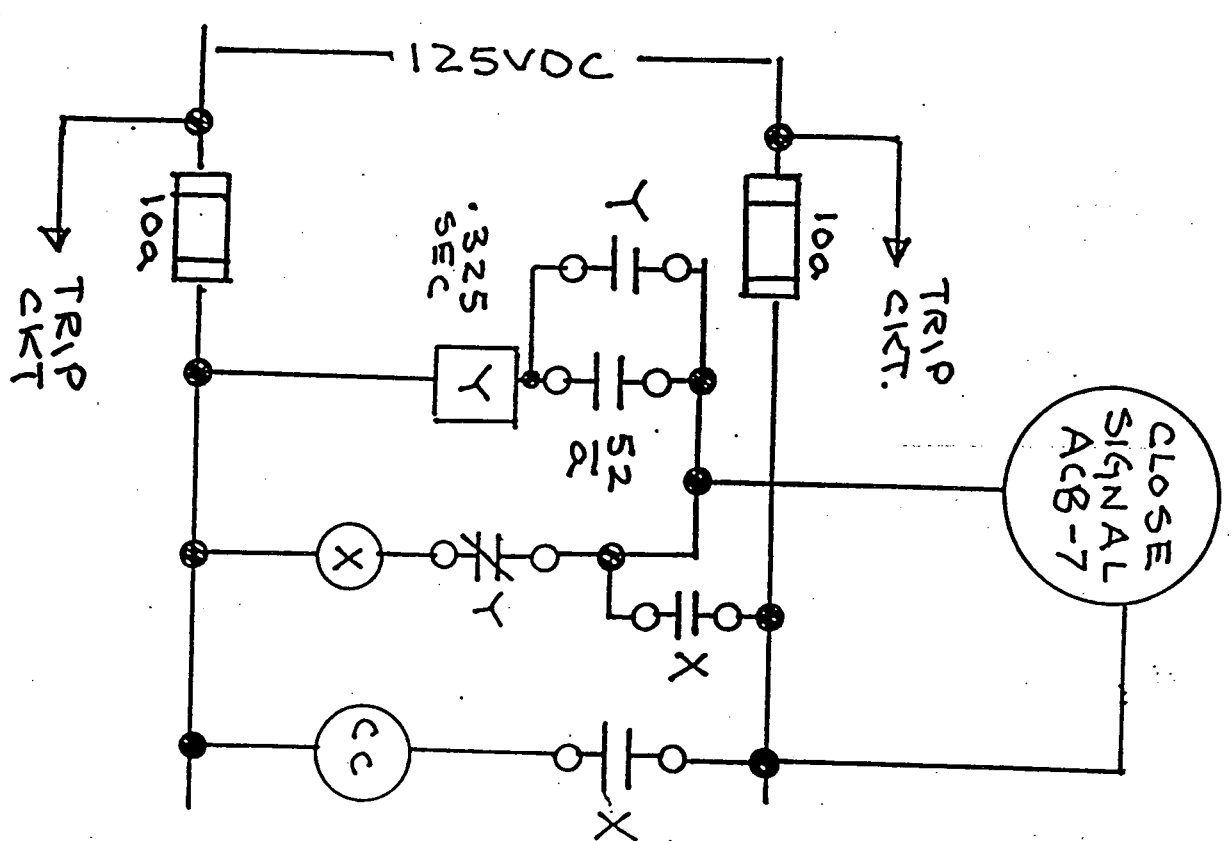
KEOWEE BREAKER ACB-5 AND -7
CLOSE CONTROL CIRCUIT

On the morning of June 24, 1997, FIP Team #2 began investigating the root cause of the 1X lockout and ACB 5 and ACB 7 failures. A schematic of the ACB-5 and ACB-7 close control circuit is provided in Attachment 7. Bench testing revealed that the timer for the "Y" coil in the closing circuit for ACB 7 operated well below its nominal setpoint of 0.325 seconds. Further bench testing on June 25, 1997, disclosed that the timer did not provide a long enough time delay to keep the closing coil energized to ensure closing and latching of the breaker. With the failed timer reinstalled in ACB 7, this

defect revealed the breaker closing mechanism to move back away from the closed position and the mechanical linkage to actuate a microswitch which would initiate the switchgear lockout relay. The time delay provided by the timer was estimated to be about 0.020 seconds.

The licensee had determined that the cause of the June 23, 1997, loss of auxiliary power event was the failure of the timer for the "Y" coil in ACB 7 leading to lockout of Switchgear 1X. Subsequently fuses in the closing coil circuits of ACB 7 and ACB 5 blew when the Keowee operator reset the lockout condition. On the morning of June 24, 1997, FIP Team #2 began investigating the root cause of the blown fuses in ACB 5 and ACB 7 circuitry. Through analysis of the control circuit design for these breakers and review of event sequence information (Keowee event recorder, operator interviews, etc.), the FIP team concluded that when the Keowee operator reset the lockout condition on Switchgear 1X, both ACB 5 and ACB 7 received automatic close signals since the control switches for the breakers were in the automatic position and their voltage permissives were satisfied. Since the control circuits for ACB 5 and ACB 7 are interlocked to prevent them from both being closed at the same time, both breakers received a trip signal as the opposite breaker approached the closed position. The quick tripping of the breakers did not allow enough time for the timers in the "Y" coil circuits to time out (even with the bad timer in ACB 7) resulting in the "X" relays in ACB 5 and ACB 7 not de-energizing the breakers' closing coils. The breakers remained in this "trip-free" condition with a current for the DB-50 closing coil of about 20 amps which was enough to blow the 10 amp fuse in each closing circuit of ACB 5 and ACB 7 in about 6 seconds. The licensee characterized this as an unanticipated circuit operation.

As discussed in Section O1.2 of this report, the licensee has revised the operator lockout response procedure. Discussions between the AIT and the licensee and specifically the FIP Team indicated that a hardware modification may be considered as a result of the above discussed failure mode and blown fuse history and the complexity of the X and Y anti-pump design. Potential effect of the "X" and "Y" relay anti-pump design is discussed in Section E2.2

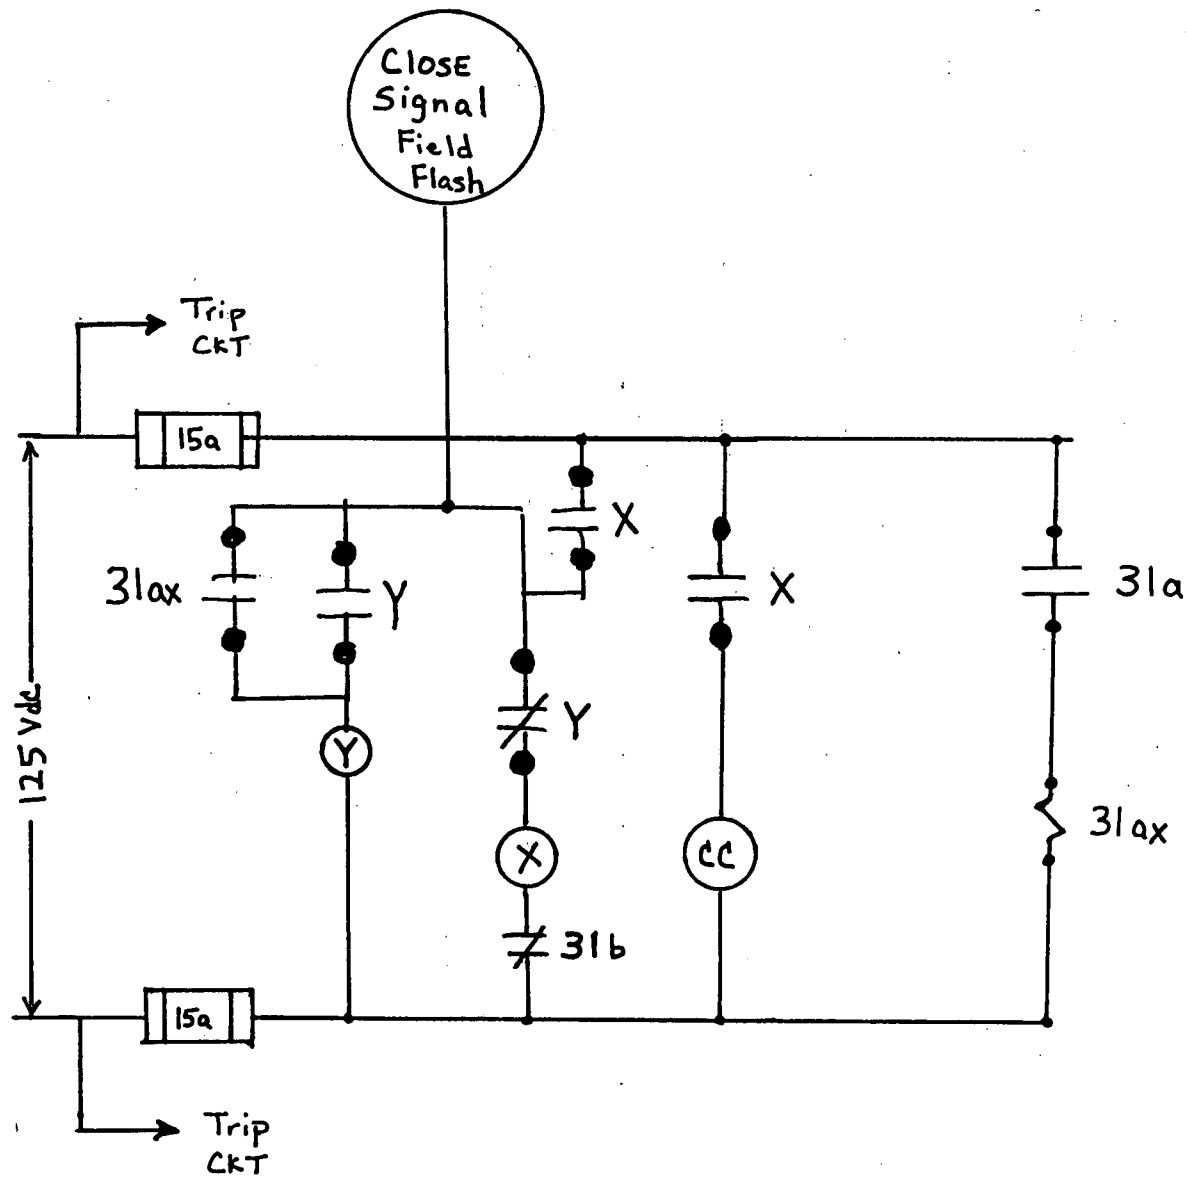
KEOWEE FIELD FLASH BREAKER
CLOSE CONTROL CIRCUIT

During the event, all control circuitry and equipment initially worked as designed. As generator voltage was building up, the 53 relay cycled between normal and trip. This caused the field flash breaker to cycle. The sequence of events recorder indicated the breaker tripped, closed and tripped; and the control power fuse blew 6 seconds after the final breaker trip. With the field flash breaker stuck open, and the generator voltage not yet at a level which could sustain self-excitation, the generator failed to achieve rated voltage.

In a post-event test recreating the conditions of the event, the current seen by the control circuit fuses in the field flash breaker 125 VDC control circuit was recorded. This recording showed that the current peaked at 38 amps. It was later found that the close coil, which would account for most of the current, (the other devices in the circuit have high impedance) had an internal defect. This defect caused the close coil to draw more current than would a close coil without a defect. The resistance of this defective close coil was measured to be 2.8 ohms, which was consistent with the 38 amps mentioned above.

As part of the post event trouble shooting, the licensee measured the current in the control circuit during a generator start. The measured current was 38 amps. The engineer evaluating the fuse application noticed that this value of current was not consistent with the information in the instruction book for the breaker which stated that the current draw of the standard close coil is 23 amps at nominal voltage. The engineer wrote a PIP (Problem Investigation Process) report. This caused the licensee to measure the resistance in the close coil for the Keowee Unit 1 field flash breaker. The licensee measured 2.8 ohms, which would correspond to 44.6 amps at 125 VDC. At that point, the close coil was removed and quarantined for analysis. The coil was sent to a test laboratory affiliated with Westinghouse Electric Corporation. Preliminary results of the analysis indicated that the coil was in fact a standard burden coil, and that a number of turns were shorted which accounted for the unusually low resistance and high current.
