**UNITED STATES
NUCLEAR REGULATORY COMMISSION**
REGION I
2100 RENAISSANCE BLVD., SUITE 100
KING OF PRUSSIA, PA 19406-2713

May 27, 2015

**SUBJECT: PILGRIM NUCLEAR POWER STATION – NRC SPECIAL INSPECTION REPORT
05000293/2015007; AND PRELIMINARY WHITE FINDING**

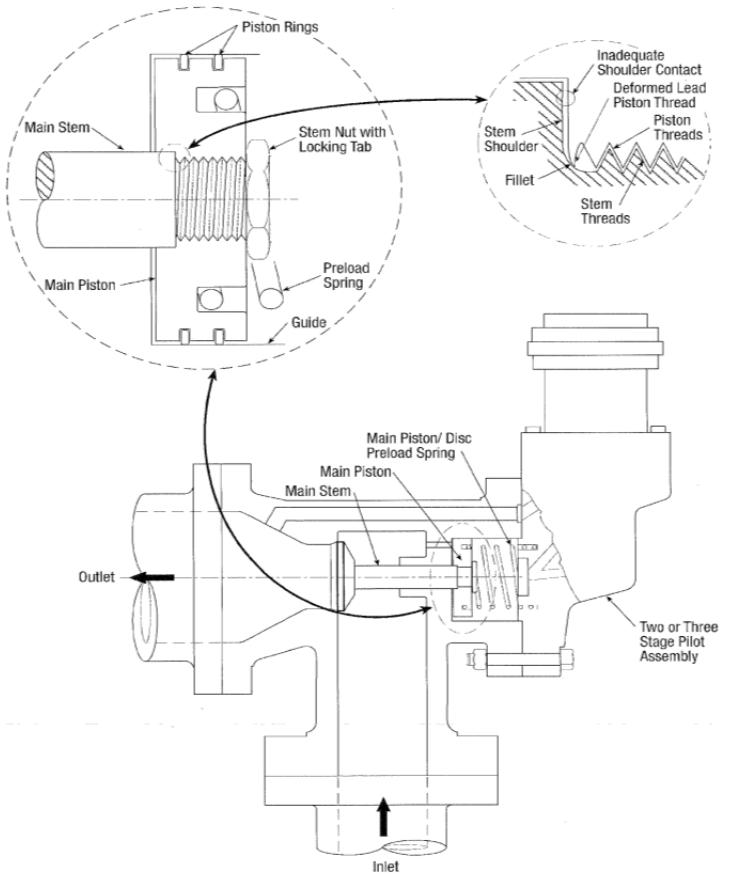
Diagram of Target Rock SRV from
NRC Information Notice 2003-01, "Failure
of Boiling Water Reactor Target Rock Main
Steam Safety/Relief Valve," dated
January 15, 2003

The 'C' SRV was subsequently sent to an offsite testing facility for as-found setpoint verification, low pressure testing, and an inspection of valve internal components. While the 'C' SRV satisfactorily stroked during both the setpoint test and additional low pressure (100 psig) actuation test at the testing facility, the inspection revealed notable damage to some internal valve main stage parts. Specifically, the main valve piston had indications of some scoring and the lower piston ring (two rings in total) was seized within the piston ring. The most noteworthy damage was wear (grooves) in the main operating cylinder liner where the operating piston rings rest while the valve is in its closed position. The cylinder liner wear resulted in resistance to valve operation in the open direction through contact with the operating piston rings. Upon the disassembly, the technicians noted that the piston was not tightly secured and the locking tab was slightly rotated out of its grooved position. In its normal/assembled condition, the main valve stem is threaded into the main piston, torqued, and is secured with a washer and stem nut with locking tab on the opposite side of the piston (See SRV figure below).

The assembly of the valve is such that the main stem is torqued to the piston (100 ft-lbs) and the stem nut is torqued to the threaded end of the main stem (50 ft-lbs). However, there has been prior operating experience, including an instance at PNPS in 2013, where the stem nut was found loose. Based on prior operating experience, there have been separate issues that may have contributed to torque relaxation or looseness at the stem/piston or stem nut interface. These included 1) inadequate stem shoulder contact at the main stem/piston interface, 2) inefficient test gag device that potentially allowed substantial internal valve impact during full pressure setpoint testing, and 3) a stem nut torque value that was less than optimal. It was not apparent that a single item alone was the cause for the identified issues. Further, based on historical operating and internal inspection data, internal wear problems were not assured even when the old style test gag device and lower stem nut torque existed (i.e., human performance/installation and specific in-service vibration levels may also have had negative impacts). The testing facility currently uses a re-designed test gag device to prevent a large impact force during the full pressure bench testing, and the vendor recommended an increased stem nut torque value (100 ft-lbs) in December 2013.

verification, and the 100 psig SRV lift were completed satisfactorily at the testing facility. However, disassembly and inspection of the valve's internal parts yielded similar results (e.g., operating cylinder liner wear) to that of the 'C' SRV. As a result of the as-found inspection results of the 'A' and 'C' SRVs, Curtiss-Wright Flow Control Company, Target Rock Division, issued Interim 10 CFR Part 21 Interim Report (EN 50900) on March 17, 2015, due to the potential to induce a defect during the testing of the relief valve model (three stage Target Rock Model 0867F).

During the shutdown following the January 27, 2015, reactor scram, Entergy replaced both the 'A' and 'C' SRVs with refurbished and certified replacement SRVs. Both were tested with the new test gag design. The 'A' SRV was refurbished prior to the stem nut torque value change so it was torqued to 50 ft-lbs, and the stem nut for the 'C' SRV, refurbished later, was torqued in accordance with revised instructions and was torqued to 100 ft-lbs. With respect to the 'B' and 'D' SRVs, which operated satisfactorily during the transient, they had both previously been tested prior to their May 2013 installation and both had a 50 ft-lb torque applied to the stem nut.
