Part 21 (PAR)

PART 21 - DEFECTIVE CIRCUIT BREAKER SECONDARY CLOSE LATCH

Subject: 10 C.F.R. Part 21 Notification of Deviation re. K-Line Circuit Breaker Secondary Close Latch

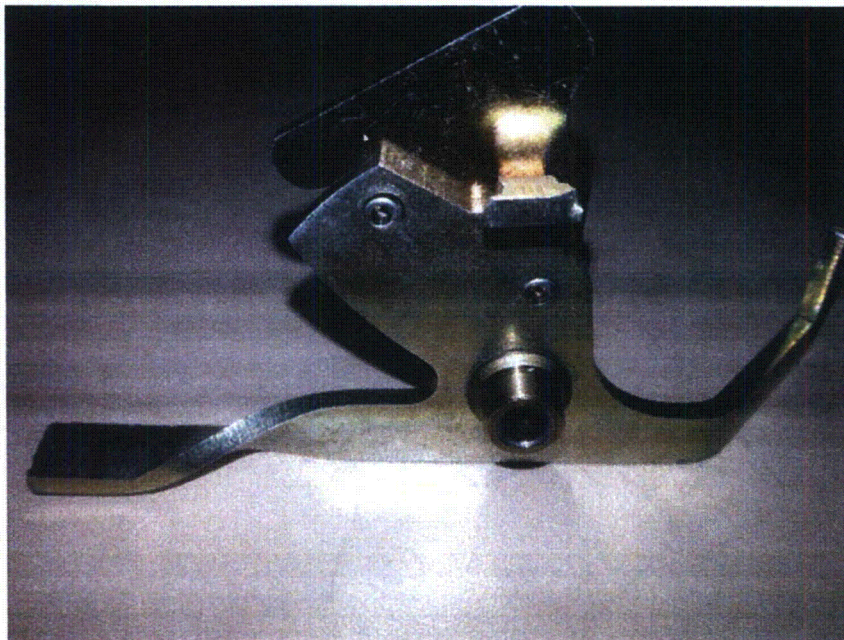
Figure 1 - Secondary Close Latch

1. This letter provides notification of a failure to comply with specifications associated with a secondary close latch, part number 716610K01 (see Figure 1), used in K-Line 225/800 and 1600/2000 amp electrically operated Model 7 circuit breakers. This does not affect previous models of these same breakers that have not been upgraded to include the interlocking primary and secondary close latches. It also does not affect manually operated K-Line breakers or K3000/4000 circuit breakers. Information is provided as specified in 10 C.F.R. 21 paragraph 21.21(d) (4).

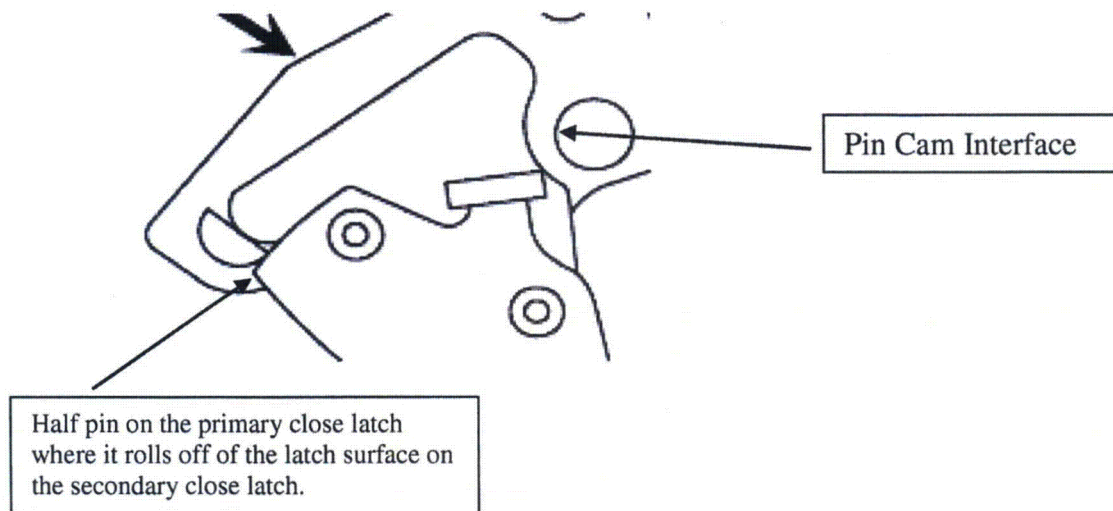
Figure 2 – Pin Cam Interface

During installation of a primary close latch and subsequent bench testing at a nuclear utility, mechanical binding was observed between the primary and secondary close latches. This binding prevented the breaker from operating. Inspection of both latches by ABB showed that the issue lies with the secondary close latch. It was determined that the secondary close latch dimension from the centerline of the hub that the latch rotates about, to the edge of the secondary latch surface with the half pin on the primary latch, was oversized. The failure to comply condition of binding was identified when replacing latches and verified with a calculated dimension.

The additional length from the center of the hub in the secondary close latch to the corner of the latch surface caused an interference between the pin cam interface and the half pin on the primary close latch, where it rolls off of the latch surface on the secondary close latch. (see Figures 2 & 3)

- a. Develop a method for testing primary and secondary close latches together to ensure proper operation when obtained as components. (Action complete)
- b. Quarantine all primary and secondary close latches in Florence until they can be tested as pairs. (Action Complete)
- c. All future sales of the primary and secondary close latches will be as matched sets that have been tested together at ABB. New part number for matched set – P/N: 716252T01 (Action Complete)

It is recommended that affected Licensees with this latch in inventory, ensure that bench testing is performed prior to installation to verify that the primary and secondary close latches work together, without any evidence of binding.

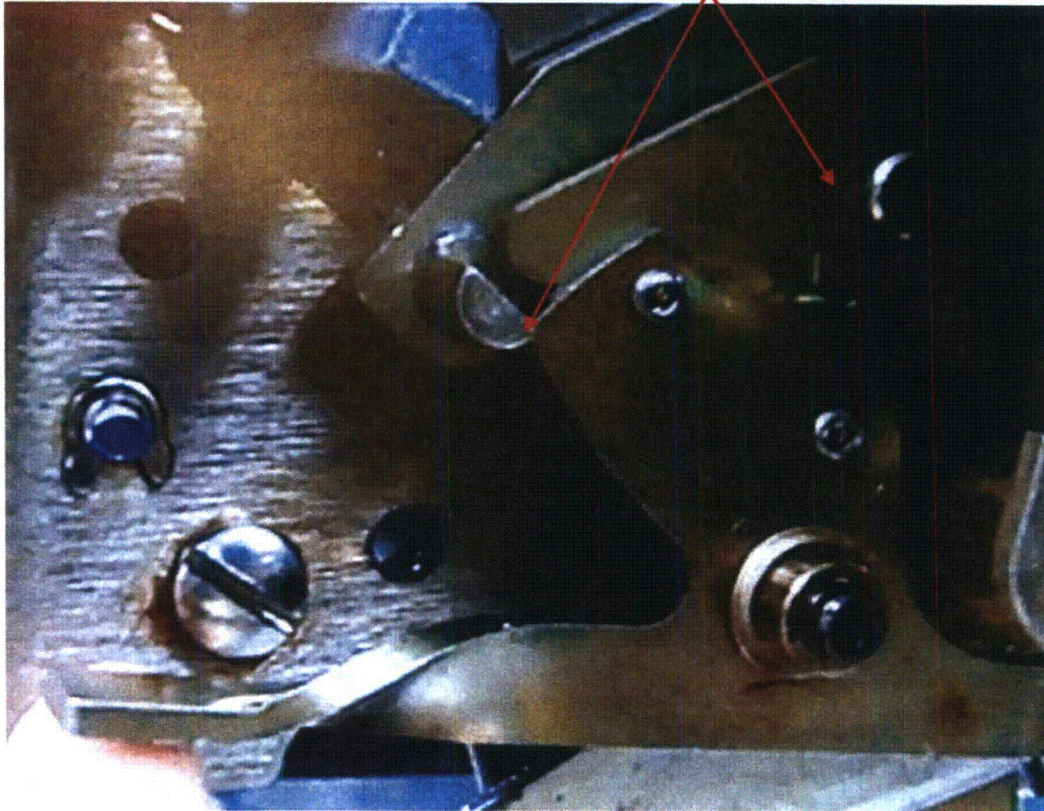
Figure 3 – Bound Condition Illustration

Bound condition shown below.
