ENCLOSURE 1

MFN 15-042 R0

Description of Evaluation

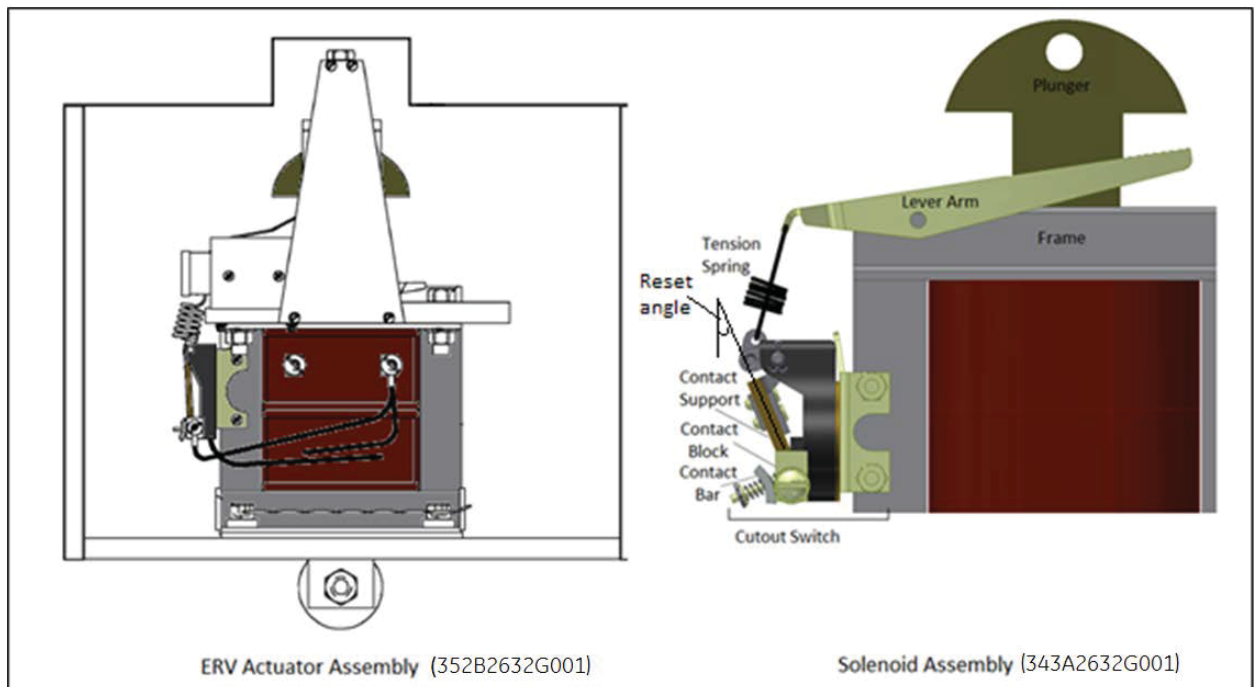
Figure 1 Actuator and Solenoid Assembly in the reset position

GEH provides various parts and components that are designed to actuate Electromatic Relief Valves (ERVs). The only manner in which these valves can be opened is from an electrical signal received by the actuator. The ERV Actuator Assembly contains the Solenoid Assembly which contains the cutout switch assembly as shown in Figure 1.

The cutout switch bypasses the secondary holding coil in order to develop the magnetic field energy to engage the plunger. When the plunger is fully seated the cut out switch is open allowing current flow thru the secondary coil providing additional inductance to be introduced into the circuit. Upon the actuation of the solenoid the plunger lowers and impacts the back end of the plunger lever arm. The lever arm pivots, raising the front end of the arm which is connected to the tension spring. This causes the contact support to rotate (clockwise in Figure 2) creating a gap between the contact blocks and the contact bar. The gap between the contact bar and the contact blocks removes the bypass of the secondary coil. The purpose of the secondary coil is to prevent burnup of the primary coil. When the electrical signal is removed the plunger lifts allowing the plunger lever arm to lift which releases the tension on the tension spring and allowing the torsion spring to close the contacts, resetting the actuator. The resetting force is provided by a torsion spring by F2 which may be seen in Figure 1. If the secondary coil is not bypassed before the actuation signal is received the actuator will fail to provide the force necessary to actuate its valve.
