ENCLOSURE 1

MFN 15-042 R0

Description of Evaluation

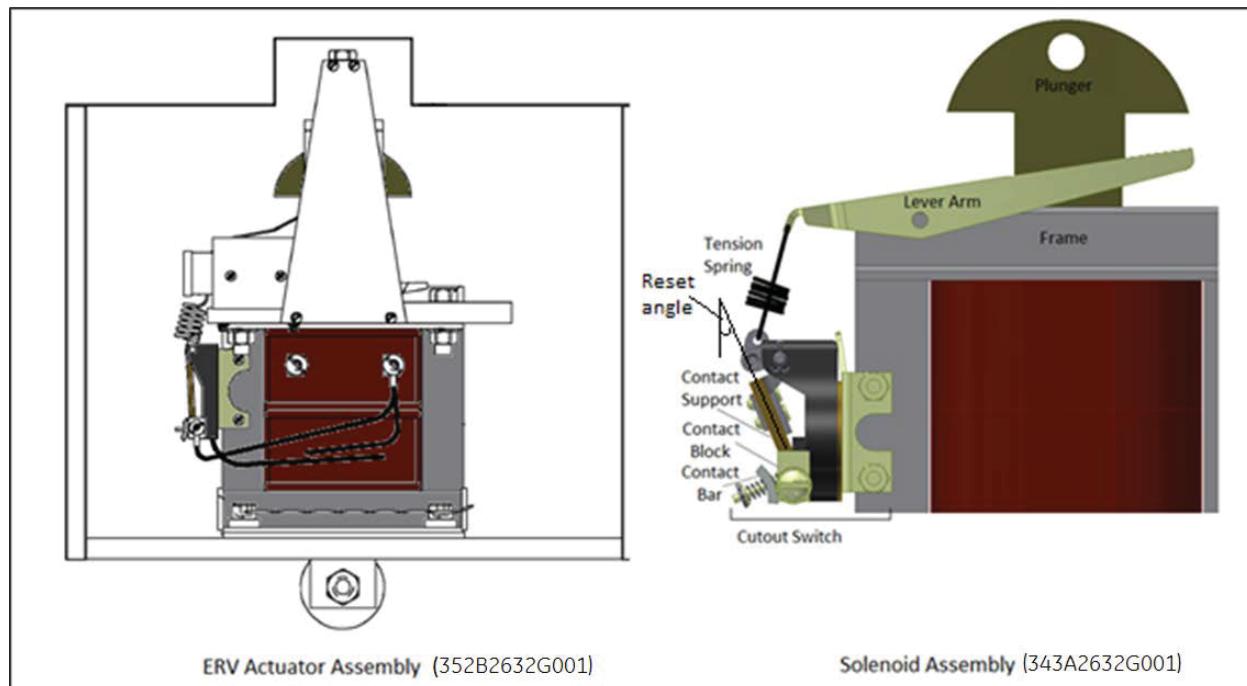
GEH provides various parts and components that are designed to actuate Electromatic Relief Valves (ERVs). The only manner in which these valves can be opened is from an electrical signal received by the actuator. The ERV Actuator Assembly contains the Solenoid Assembly which contains the cutout switch assembly as shown in Figure 1.

Figure 1 Actuator and Solenoid Assembly in the reset position

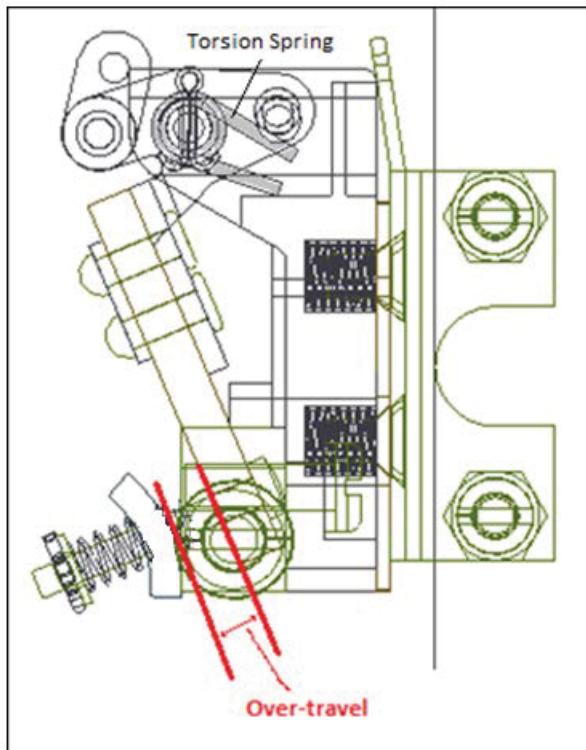
Figure 2 Over travel of cutout switch

Proper contact in the cutout switch is dependent on the reset angle. For discussion purposes the term reset angle refers to the angle of the contact support after the plunger lifts and the part resets. The solenoid assembly in Figure 2 is in the reset position therefore the contact support is in the reset angle. Unreliable performance occurs when the reset angle for a given part does not consistently ensure adequate contact. Conversely, reliability is achieved when the reset angle always ensures sufficient contact between the contact bar and the contact blocks.

If positive over travel has not been previously confirmed during maintenance activities, perform inspection at the next available opportunity to verify that the condition does not exist.

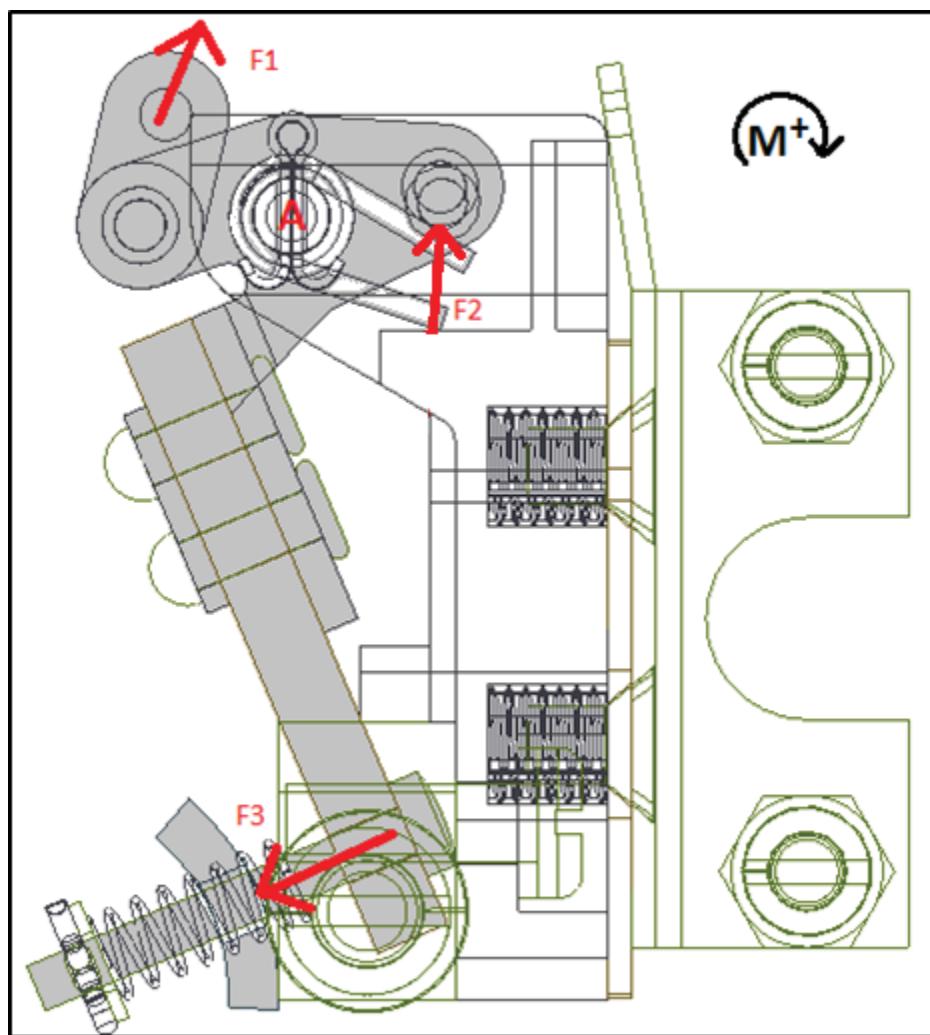
Figure 3

When a part resets there are four moments that determine the reset angle. Three of these are caused by the forces shown in Figure 3. The fourth is caused by friction. For a given part the moments caused by forces F₁, F₂, and, F₃ are only dependent on the angle of the contact support. Therefore any variance in the reset angle is due to variation of the moment due to friction in the part. The amount of over travel, as shown in Figure 1, is a good indication of the susceptibility of an assembly to unreliable operation. Positive over travel ensures proper contact is made despite frictional variation.
