UNITED STATES  
NUCLEAR REGULATORY COMMISSION

SUBJECT: NRC INSPECTION REPORT 40-8502/98-02

Report No. 40-8502/98-02

Facility: Irigaray Central Processing Facility

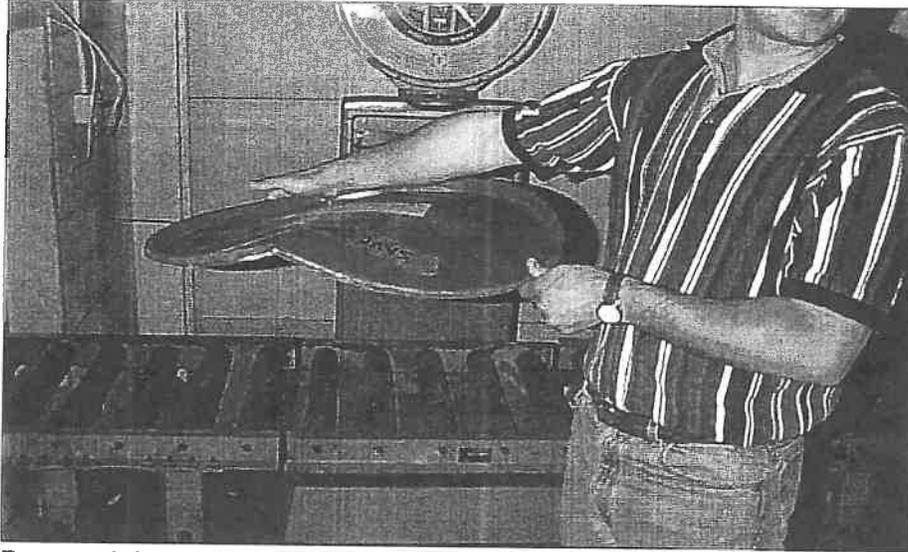
seal ring was sufficiently loose, pressurized gases in the drum were relieved. The force of the release blew yellowcake material out of the drum and onto the worker as well as into the drum room. The pressure relief was great enough not only to bend the drum lid but to cause yellowcake material to be ejected from the drum room through the two access doors. (The doors were normally closed but were not secured with any sort of latching assemblies.) The pressure release resulted in the ejection of about a fourth of the drum's contents, or roughly 200 pounds of yellowcake material.

An investigation was performed by the licensee to ascertain why the drum was pressurized because this type of incident had not occurred before. The licensee's investigation concluded that the incident was apparently caused by oxygen buildup in the drum. The oxygen was generated by the decomposition of hydrogen peroxide into water and free oxygen. (The licensee used hydrogen peroxide in the precipitation of the yellowcake product.) The operator inadvertently released this pressured oxygen following the removal of the drum seal. The actual pressure buildup in the drum could not be determined, but subsequent testing demonstrated pressure buildups in the range of 9-15 pounds per square inch.

**Damaged drum lid.**

Corrective actions taken by the licensee included revising the drum filling procedure to include a delay time prior to installation of the drum lid and associated seal. Revision 3 to Standard Operating Procedure IR-12, "Drypack - Yellowcake Drying and Drumming," added the instruction to not bolt the lid onto the drum for a minimum of three hours to avoid a pressure buildup in the drum. The licensee speculated that this revised method of drum filling and sealing should prevent a recurrence of the incident.

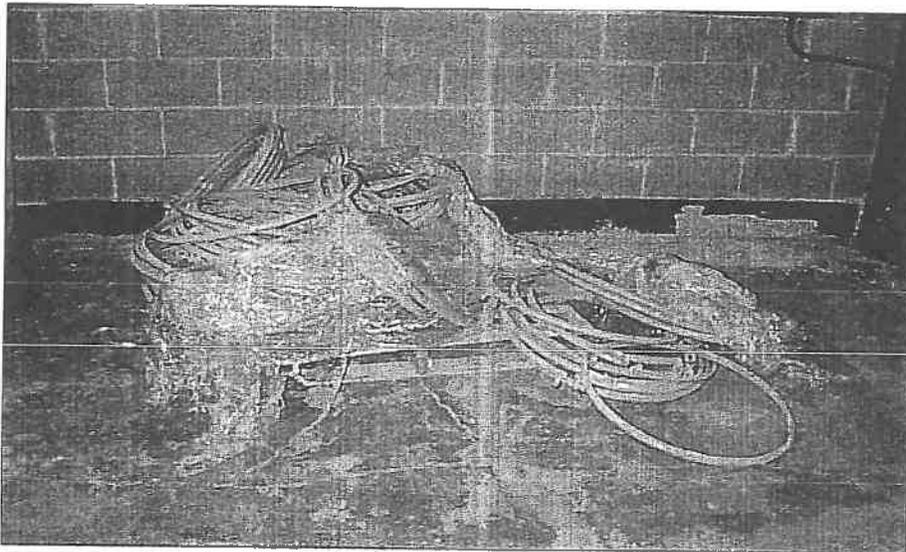
The licensee's review of the incident also revealed that these four drums had new gasket seals and metal seal rings. The licensee typically recycled the drums, including the drum seals, and replaced the rubber seals and seal rings only on an as-needed basis. The new seals apparently sealed the drums in a more efficient manner than the old, recycled seals. The new seals apparently inhibited the dissipation of the internal gas, preventing reduction in drum pressures more effectively than old seals.

**New/spare drum seal rings.**

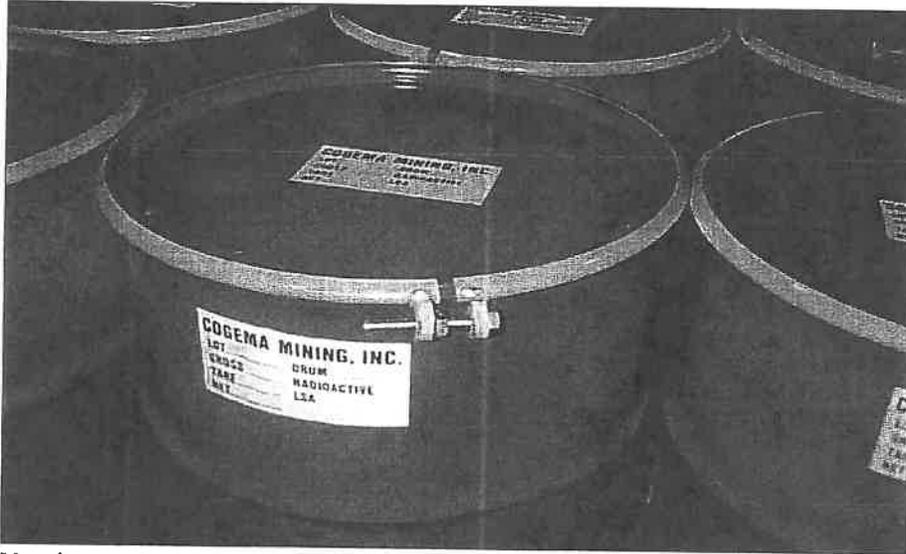
New/upgraded drum lid seal ring.

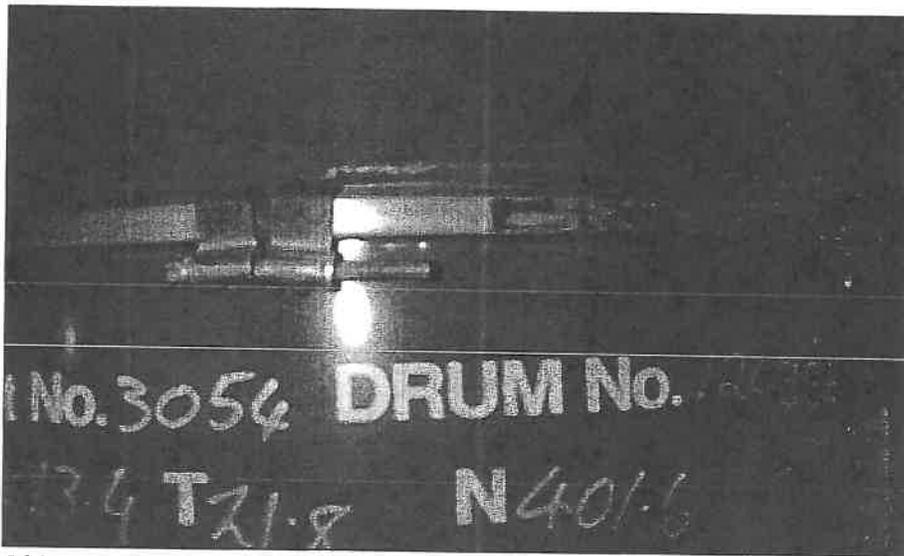
been installed with a recycled seal because the older seals would not inhibit gas dissipation as effectively as new seals.

Older drum seal ring.
