Part 21 (PAR)

PART 21 NOTIFICATION OF DEVIATION REGARDING COM-5 PROTECTIVE RELAY DEFECTIVE FRAME ASSEMBLY

Subject: 10 C.F.R. Part 21 Notification of Deviation regarding COM-5 Protective Relay -
Defective Frame Assembly

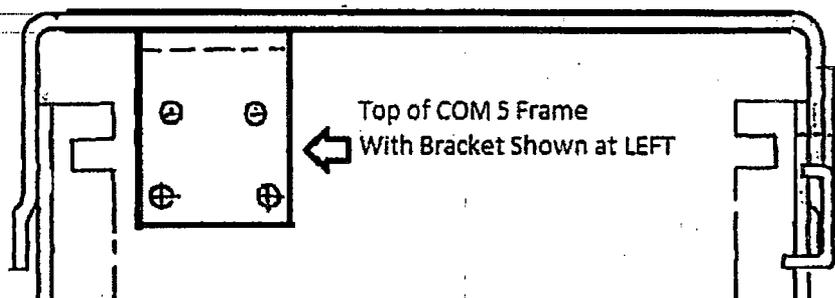
On April 30, 2015 ABB received a customer complaint regarding a COM-5 relay received with a bracket (ABB Part Number #3518A17H01) detached from the relay frame assembly (ABB Part Number #1456C92G01).

ABB's investigation determined that the bracket, which is spot-welded to the frame, can be detached from the frame using a relatively small amount of force. If the weld fails, the Indicating Contactor Switch (ICS) unit held by the bracket could inadvertently close, causing a false trip. The affected frame assemblies were manufactured by ABB on 9/25/2014 (Lot#: 45001414115) by an operator who incorrectly followed the inspection procedure required to verify the integrity of the resistance spot welds.

ABB recommends that the affected licensees evaluate their specific application and determine whether the deviation described in this notice affects their design basis. If it is determined that it does, the licensees should contact ABB to determine appropriate corrective action.

- ABB has improved existing inspection processes used to verify resistance spot welds.
- ABB has performed an extent of condition evaluation and determined that this issue is limited to this process.
