102-07068-DCM/SPD
June 26, 2015

Subject: **Palo Verde Nuclear Generating Station (PVNGS) Unit 3**
Docket No. STN 50-530 / License No. NPF 74
Licensee Event Report 2015-002-00

4. TITLE
Condition Prohibited by Technical Specification 3.0.4 Due to an Inoperable Atmospheric Dump Valve (ADV)

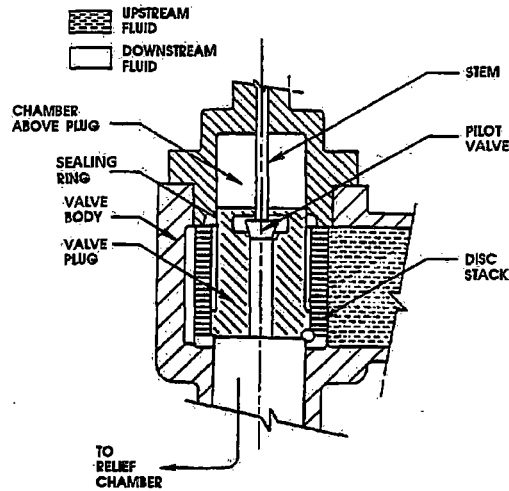
Figure 1

The ADV (Figure 1) is an angled flow control valve designed with a rising internal plug that exposes flow passages in a disk stack as the plug is moved up through the valve stroke length. The disk stack consists of a number of circular disks which form a

cylinder when stacked. Each disk is machined with labyrinth flow passages. As the valve is opened the plug rises up within the disk stack cylinder and steam flow passes from the valve inlet through the exposed labyrinth flow passages in the disk stack into the bore area and then to the outlet port on the valve body. The position of the plug within the disk stack bore determines flow by exposing more or less disk passages of the disk stack as the valve is positioned. This configuration permits relatively linear changes in steam flow rate relative to valve position.

The ADV is held closed by a combination of spring pressure and steam pressure (in the valve bonnet area) acting on the upper surface of the plug. An internal pilot valve is installed in the upper part of the plug which allows for depressurization of the valve bonnet area during valve opening. To limit steam leakage into the bonnet area of the valve, a set of sealing rings is installed in the upper part of the bore area between the plug and the valve body.
