SUBJECT: Unanalyzed and Unapproved Operation of James A. FitzPatrick

Via licensee event report dated June 29, 2015 (ML15180A207), the owner of the James A. FitzPatrick nuclear plant informed the NRC of a problem that workers introduced during a refueling outage last fall. This report stated:

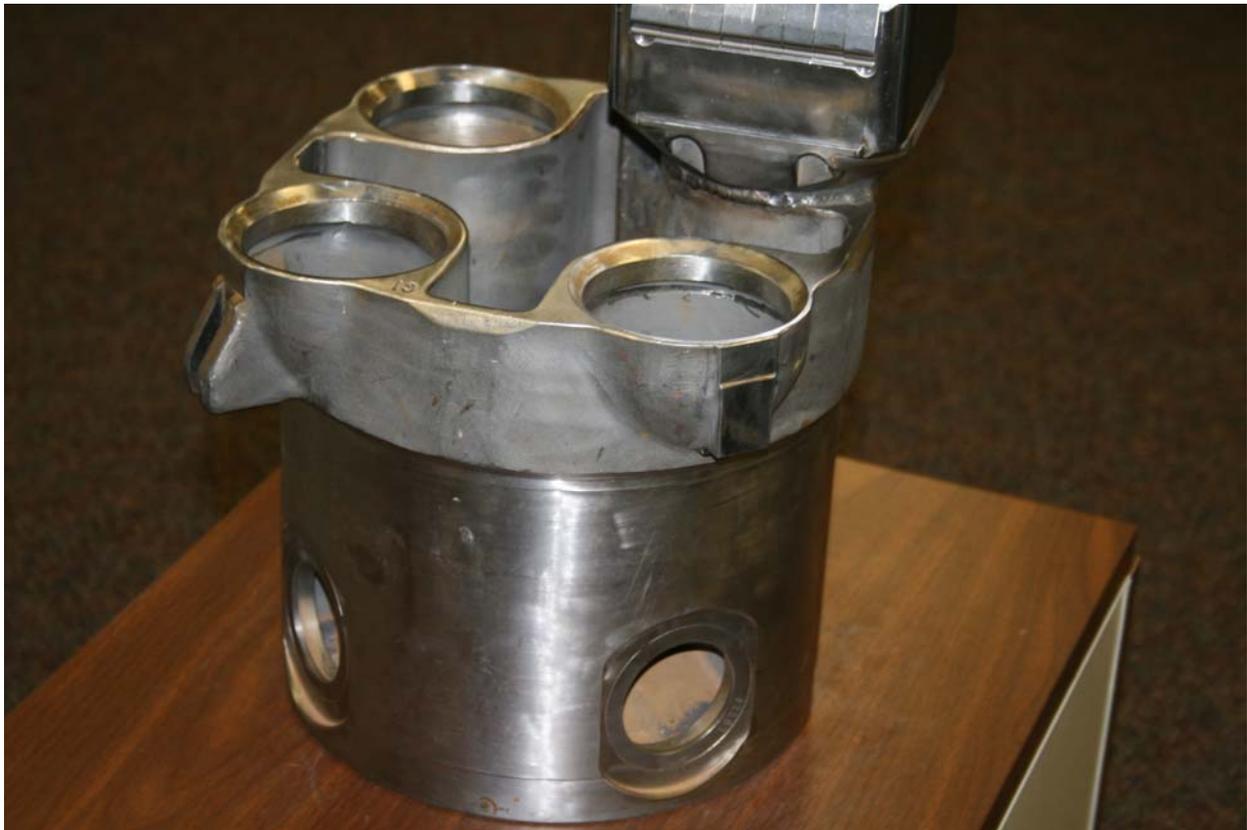
Figure 1 – Fuel Support Piece

- “The fuel support piece [in fuel cell 38-39] became elevated during last refueling outage (September 2014).”
- “The 38-39 FSP was elevated by approximately 1.5 inches and rotated counterclockwise by approximately 6 degrees.”
- “The coolant flow into each fuel assembly in cell 38-39 is partially obstructed by the elevated and offset FSP. A Thermal-Hydraulic evaluation by General Electric Hitach Nuclear Energy (GEH) for this condition estimated a flow reduction of 23.63%.
- “When the elevated FSP on cell 38-39 was identified the station enacted compensatory measures to maintain MCPR values within OLMCPR.”
- “Correction factor of 0.22 is applied to calculated MCPR vales at fuel cell location 38-39.”
- “The position of the FSP and fuel assemblies cannot interfere with control rod insertion.”

As illustrated in Figure 1, the fuel support piece has orifices that allow water to enter and flow through the four fuel bundles in the fuel cell. The orifices are specifically sized to provide a larger pressure drop than can be encountered by two-phase flow through the fuel cells. This design assures sufficient flow rate through even the highest power (and highest two-phase flow resistance) fuel bundles. The NRC has reviewed and approved the fuel design topical reports and the associated thermal-hydraulic computer codes that ensure adequate cooling is maintained cycle to cycle for different core configurations.

But the NRC has neither reviewed nor approved anything about partially obstructed orifices. The NRC has not reviewed and approved whatever method was used to estimate that the flow rate through the four fuel bundles in cell 38-39 is reduced by 23.63 percent. What if the actual flow reduction is greater? Could the fuel support piece misposition more so as to further reduce the flow rate? Is the 0.22 “correction factor” appropriate and bounding for all conditions during the remainder of operating cycle 22?

Picture of a fuel support piece with a mock fuel bundle loaded into one of four fuel bundle locations. The x-shaped region in the middle is where the control rod inserts the fuel cell from below. The two “fingers” that are supposed to rest on either side of the alignment pin on the lower core plate appear on the left side. Two of the holes in the lower portion of the fuel support piece that allow cooling water flow through the fuel bundles are shown.

Or, the NRC could require the licensee to shut down the reactor and restore the fuel support piece to the configuration that has been reviewed and approved by the NRC.
