SUBJECT: Forwards response to 820623 request for addl info re damage,  
 repair & replacement of auxiliary feedwater header. *586 RPT*

Subject: Oconee Nuclear Station  
Docket No. 50-287

ATTACHMENT A  
DUKE POWER COMPANY  
OCONEE NUCLEAR STATION  
UNIT 3  
AUXILIARY FEEDWATER HEADER  
DAMAGE, REPAIR AND REPLACEMENT

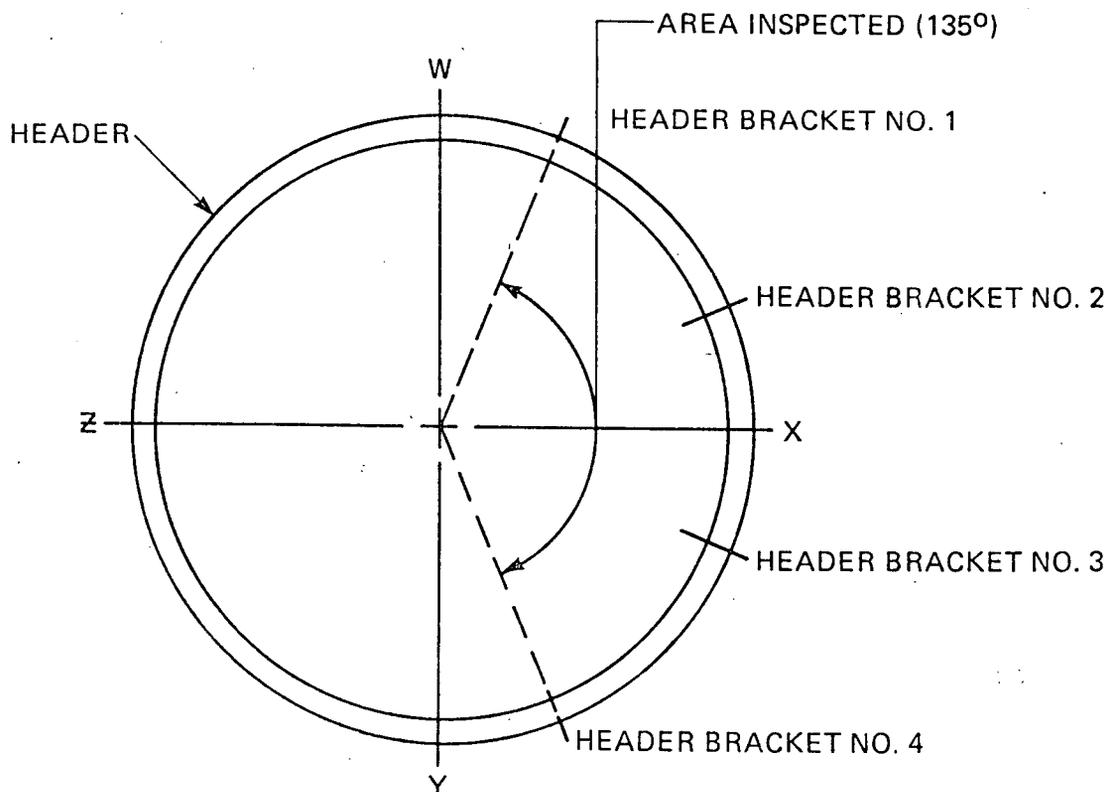
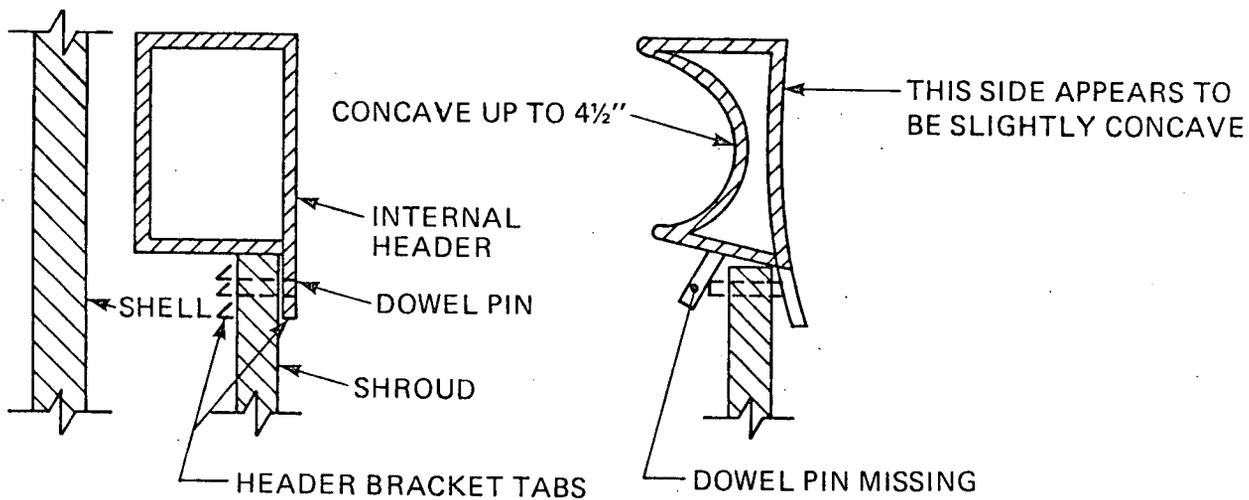
FIG. 2-1

With one exception, the inspection results from all three plants were generally similar. The outer vertical wall of the header was distorted inward toward the center of the generator, the support brackets were bent or damaged and the dowel pins were either out of position or missing. The exception was the presence of three holes in the parent metal plates of the headers at Oconee 3. Also, cracks were found in the corner welds of the headers at Oconee 3 and Rancho Seco.

TYPICAL DAMAGE FOUND DURING  
INITIAL VISUAL INSPECTIONS

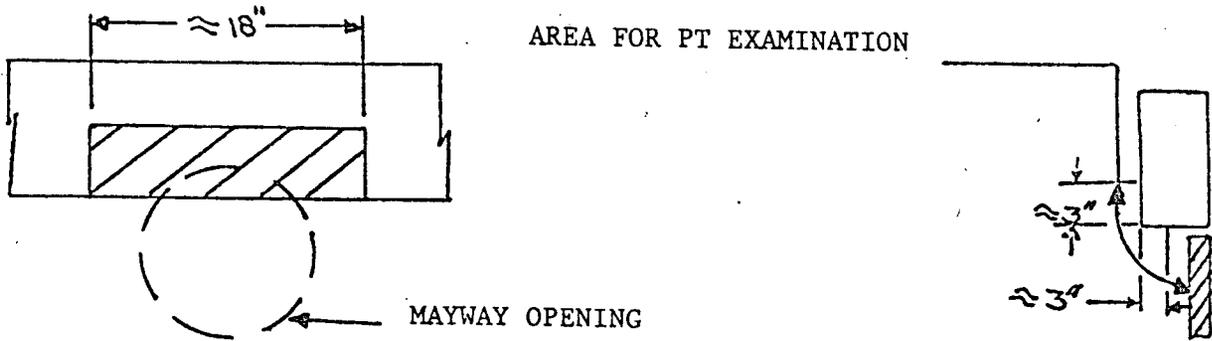
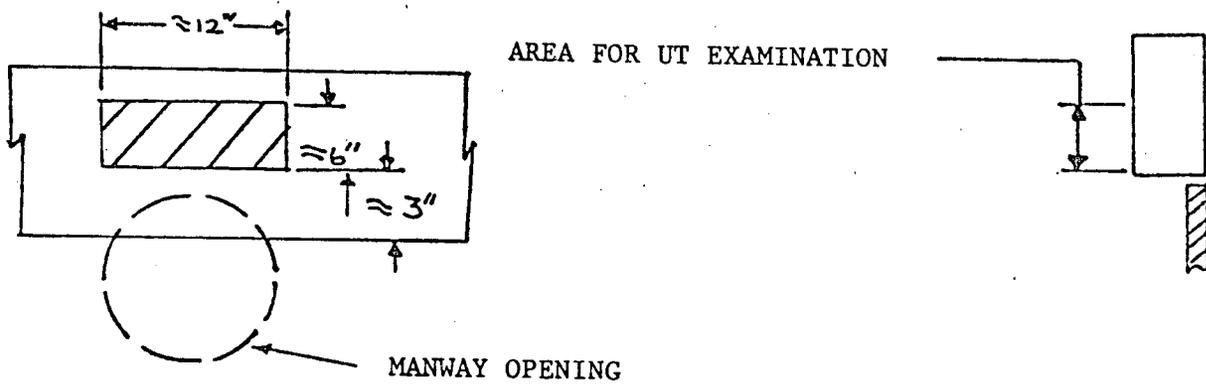
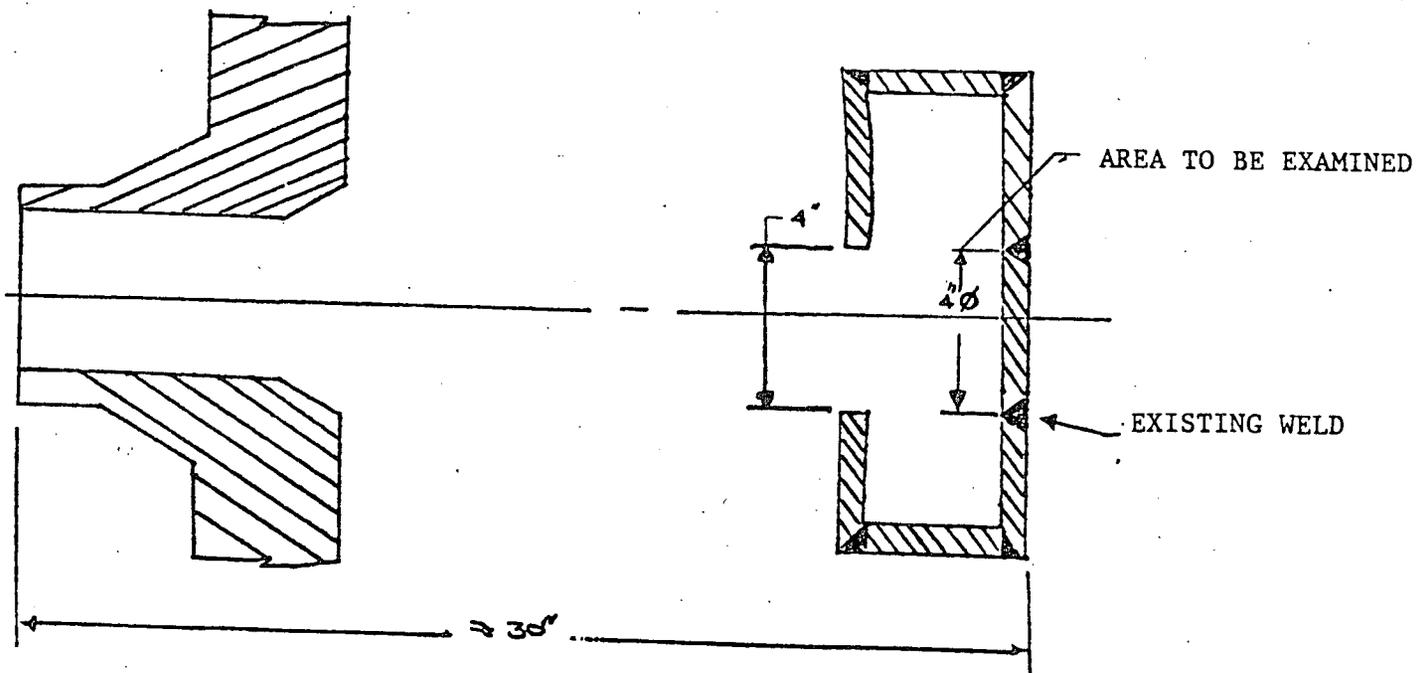
FIGURE 2-2B

To provide some basis for the adequacy of the remote TV inspections, additional UT and PT examinations were performed on selected portions of the SG 2 header. The worst deformation of all the internal headers at DB-1, Oconee-3 and Rancho Seco occurred on SG 2 at DB-1 near the manway opening. Consequently, the vertical outer header plate was ultrasonically tested in this area and a portion of the vertical plate, the lower plate, and connecting weld was dye penetrant tested. These tests showed that no cracks or other detrimental indications exist in the most severely deformed portion of the header. An additional dye penetrant test was performed on the back wall of the header through the AFW inlet nozzle. The PT showed no unusual indications. See Figure 2-2B for specific details of these inspections.

UT AND PT EXAMINATIONS OF  
DB-1 OTSG 1-2 MANWAY AND AFW NOZZLE

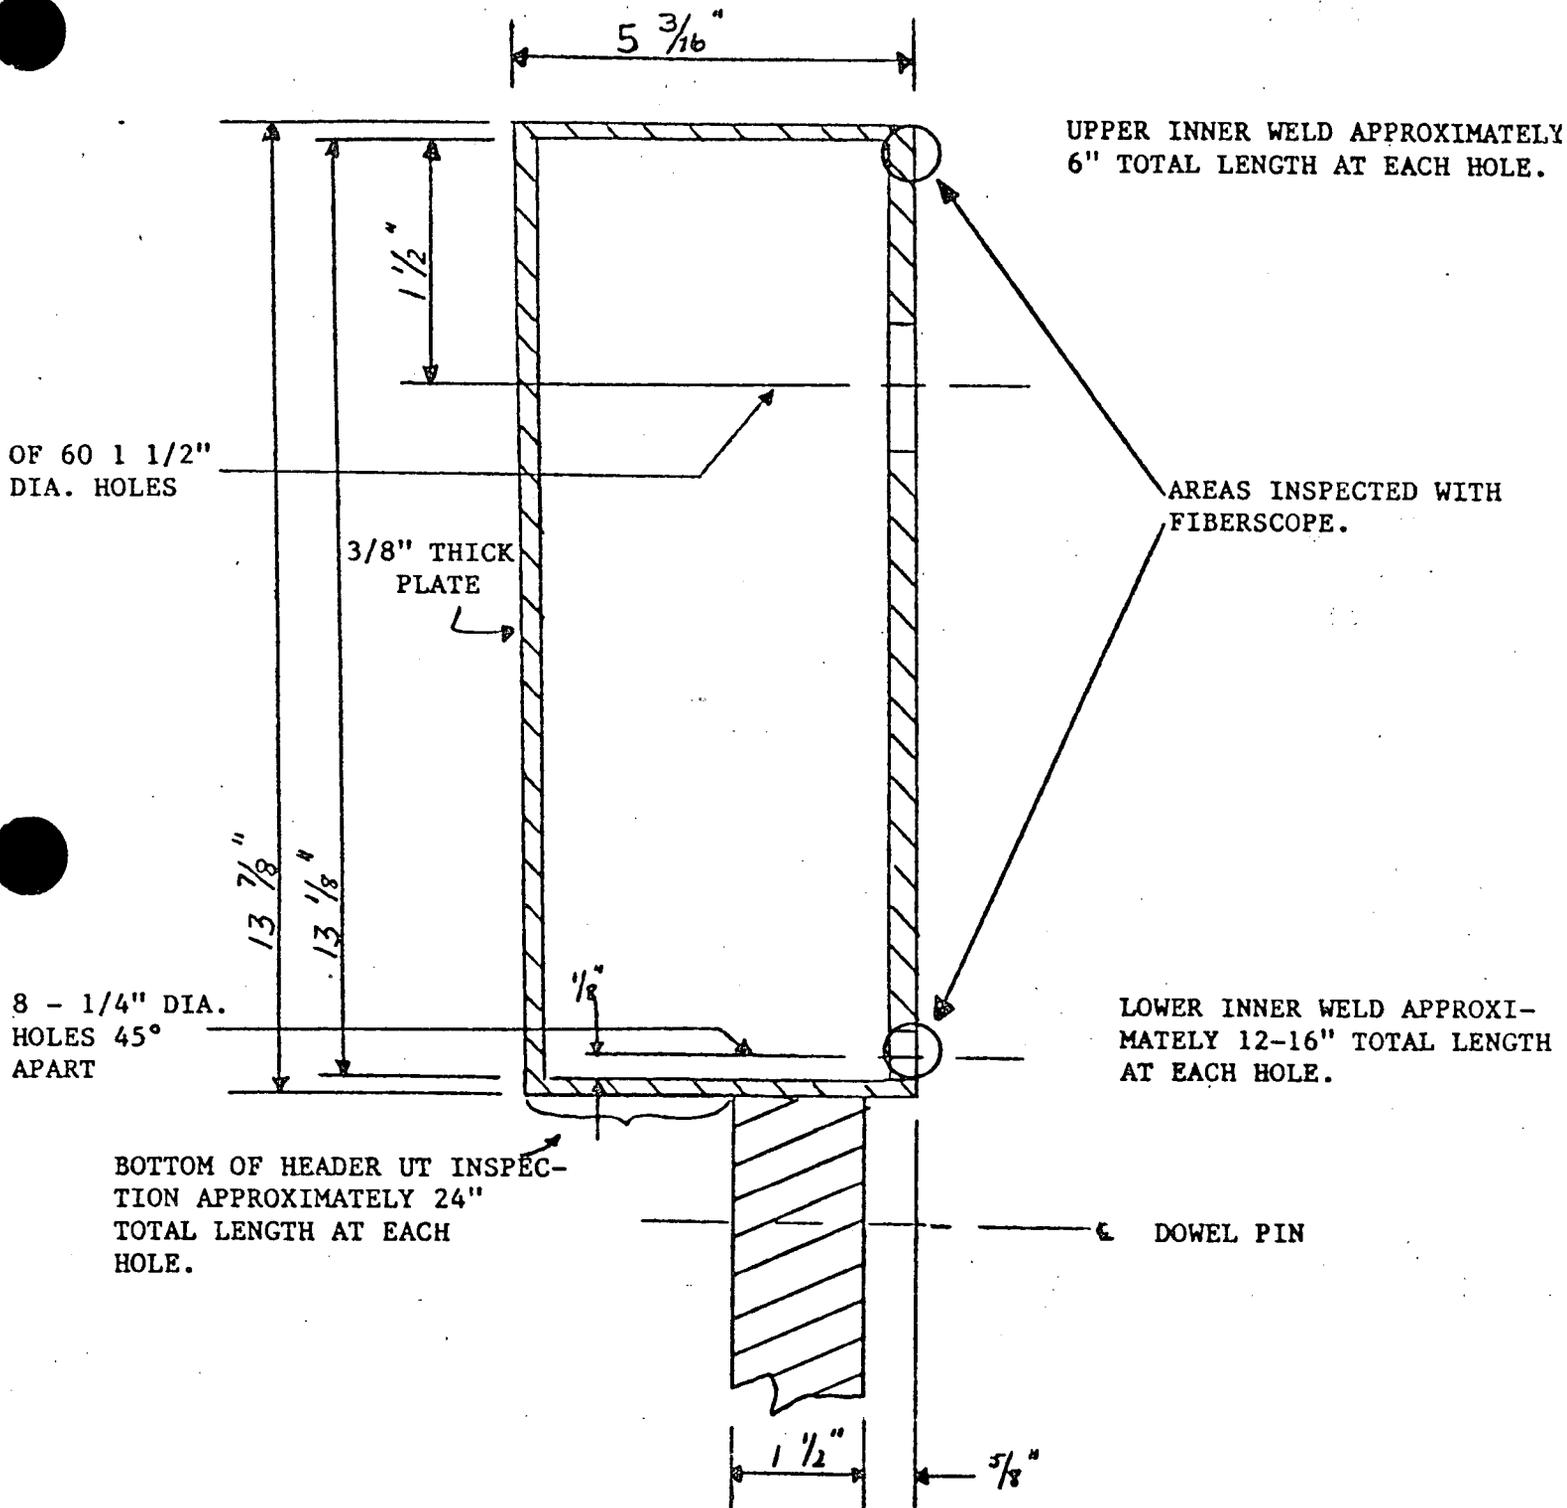
FIGURE 2-2C

Following the discovery of weld cracks at Oconee-3 and Rancho Seco, additional inspections were performed at each hole location. These inspections were very similar in method and quality to those done at Oconee-3 and would have detected cracks similar to those observed at Oconee. Using a fiber optics device through the shell and shroud holes, an examination of the welds connecting the inner vertical plate to the top and bottom plates was performed. Approximately 6 to 8 inches of the lower weld on either side of the hole, and about 6 inches of the upper weld at each hole were examined. These inspections showed the welds to be free of cracks or other significant defects. Figure 2-2C illustrates the areas inspected at each injection hole location.

INSPECTIONS PERFORMED AT  
EACH AFW INJECTION HOLE LOCATION

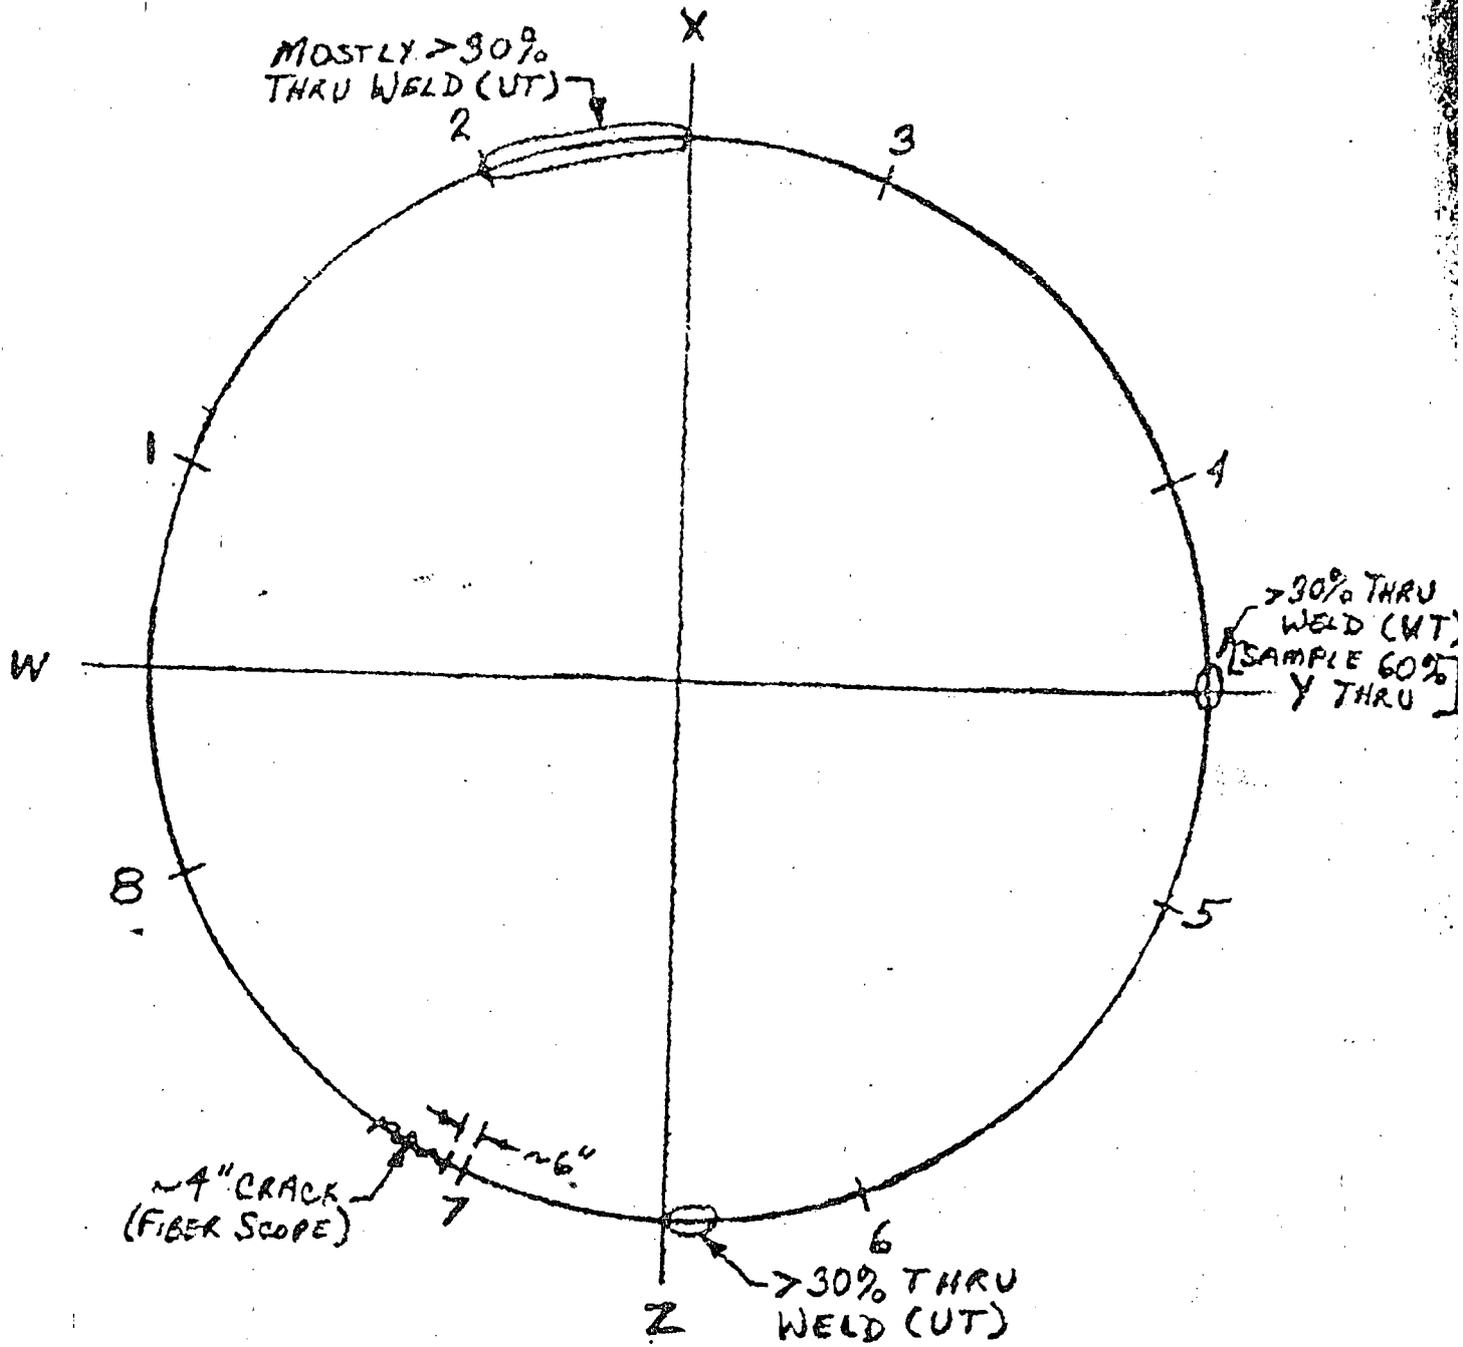
Figure 2-7  
 "A" AFW Header  
 Lower-Inner Corner Weld

During the preparations to rotate the A header to allow the hole in the bottom plate to be cut out for analysis, a crack was discovered in the lower inner corner weld of the header. Fiberscope inspections located 180 degrees apart while the header was rotated 180 degrees allowed a 360 degree inspection of the lower-inner corner weld. Visual and UT inspections were made of the lower-outer corner weld. Visual inspections were made on the majority of the upper inner weld. The upper outer weld was inspected visually in a few areas; however, the difficulty in inspecting this weld resulted in less than full inspection. (Due to the other weld cracks, the very conservative approach of assuming all corner welds were fully cracked was taken in the stabilization analysis and thus saved the additional radiation exposure which would have been required for full inspection of all welds prior to repair.) Figure 2-6 shows the as-designed header with the corner construction welds. Figure 2-7 through 2-10 show the areas of weld degradation on the A header. Figure 2-11 shows photographs of two weld samples cut from the A header showing the lack of fusion, lack of full penetration, and lack of lower plate weld prep. While construction drawings required a "V" shaped weld prep at the interface of the vertical and horizontal walls, the analyses show that only the vertical walls were prepped which resulted in an inconsistent weld pattern with areas of lack of fusion and lack of full penetration when the fit up was less than ideal. Those areas of these welds were simply inadequate to withstand the loads generated when the header was deformed during AFW initiations.

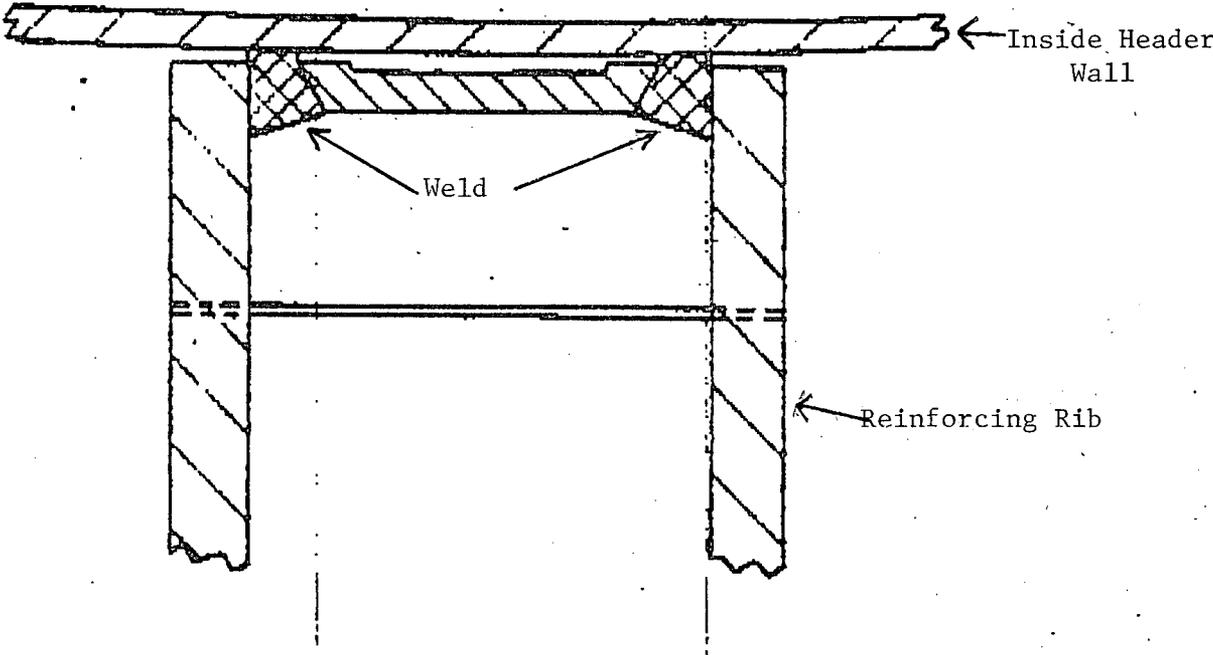
Figure 4.1G.  
REINFORCEMENT OF CORRODED AREA (Top View)

During initial inspection of the header a hole in the top of the header was discovered. To provide the greatest reinforcement for this area the header was rotated so that the hole could be positioned between two reinforcing ribs at an attachment point. During repair the inner wall of the header was determined to have a significant loss in wall thickness in this same area. Additional reinforcement consisting of a 3/8 inch plate was added over this area in the inner wall. Since the inner wall is most highly stressed there was no need to also put reinforcement over the top hole. The result is that in this area, with the reinforcement, there is 108% of the cross sectional area that would exist in an undamaged inner and top wall. Therefore it is concluded that this area of the header will be at least as strong as an uncorroded section. The reinforcement design is shown in Figure 4-1G.
