**From:** Waters, Roger M. [rwater1@entergy.com]  
**Sent:** Monday, July 22, 2013 10:53 AM  
**To:** Green, Kimberly  
**Subject:** the InfoGram on the Clevis Insert Cap Screws  
**Attachments:** AR2010-1804\_10-Year\_Reactor\_Vessel\_In-Service\_Inspection.pdf

IG-10-1

## REACTOR INTERNALS LOWER RADIAL SUPPORT CLEVIS INSERT CAP SCREW DEGRADATION

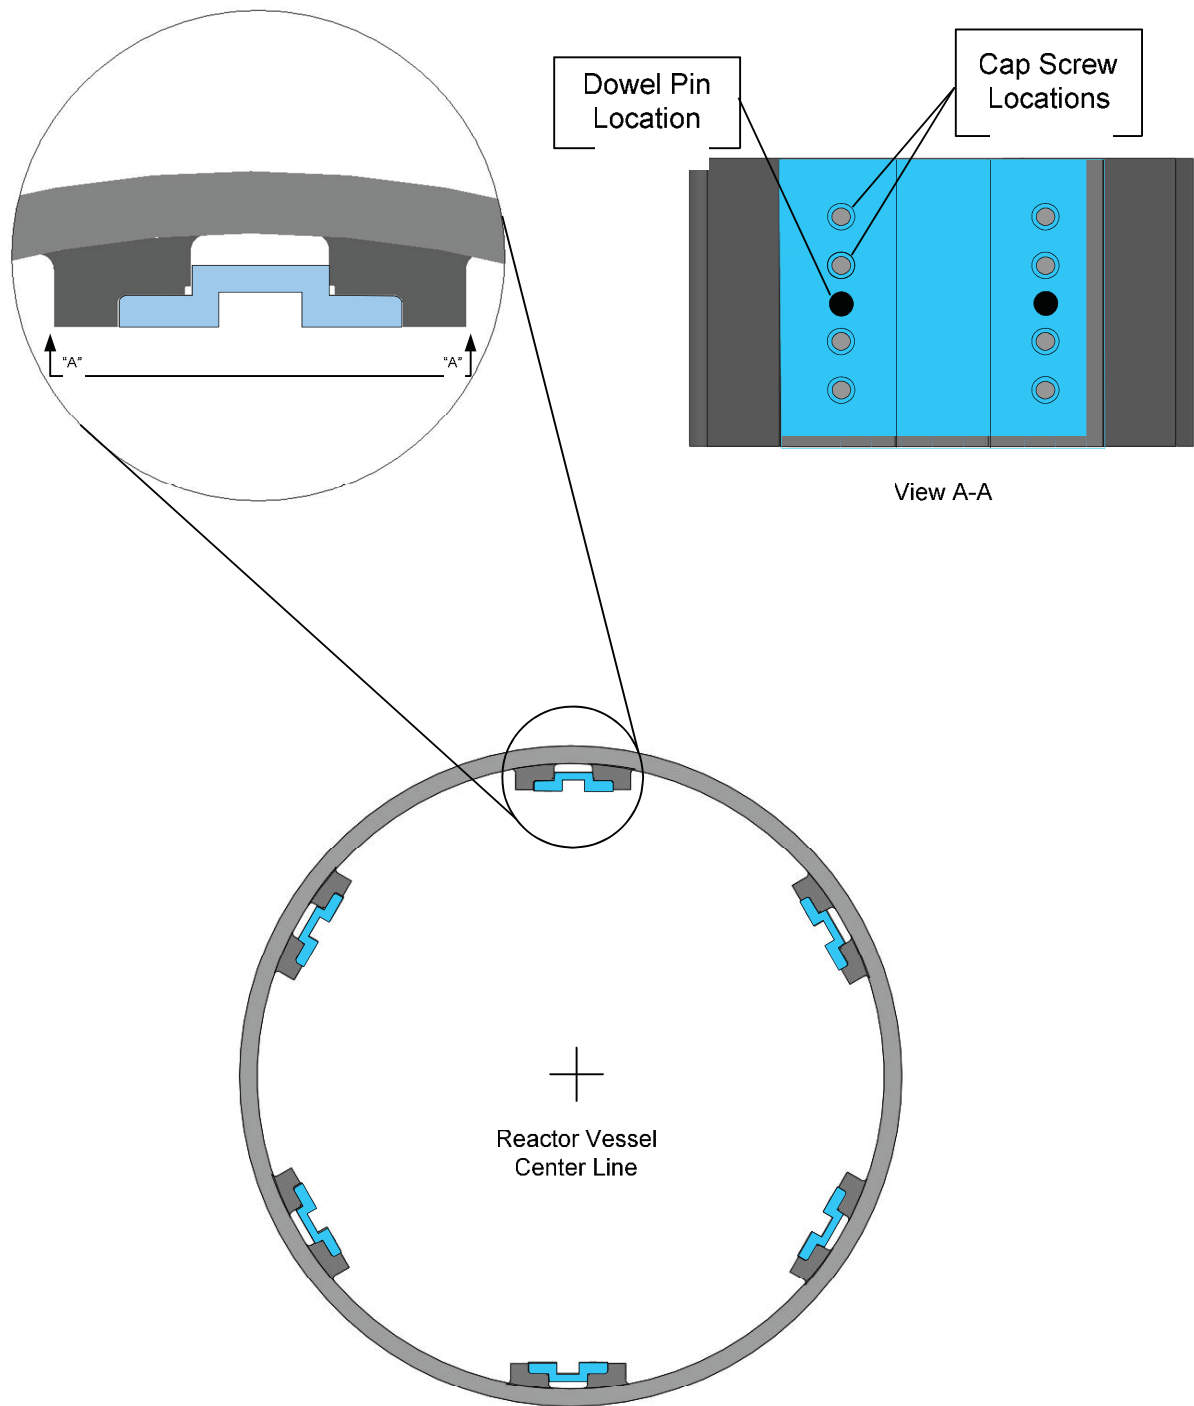
Figure 1. Radial Support Clevis Insert, Cap Screw and Dowel Pin Locations

During the March 2010 10-year in-service inspection (ISI) of the reactor vessel at D. C. Cook Nuclear Plant Unit 1, an anomaly was observed in the lower radial support clevis inserts. Figure 1 provides an overview of the radial support clevis insert configuration. At D. C. Cook Unit 1, each clevis insert features eight cap screws and two dowel pins which provide for retention of the insert. At a total of seven (of 48) cap screw locations, there was visual evidence that the cap screw head had detached from the shank. On one of the clevis dowel pins, the lock welds on the pin had broken and the pin was slightly rotated and displaced deeper into the insert. Reviews of video images from the previous 10-year ISI vessel inspection showed no indications of wear, fractures, or other anomalies with the clevis insert cap screws or dowel pins at any location.

Westinghouse is currently evaluating degradation mechanisms that could have contributed to the observed degradation. While not confirmed, the known susceptibility of Inconel X-750 to stress corrosion cracking and low temperature crack propagation is expected to be a contributor to the observed degradation.

Westinghouse also performed a detailed structural evaluation of the as-found condition of the clevis inserts. The analysis demonstrated the ability of the structure to function as required to meet criteria for one additional fuel cycle with no immediate physical modifications required. Westinghouse recommended that an inspection be performed at the next refueling outage and that appropriate actions be taken then for permanent repairs.
