SUBJECT: LER 88-006-00:on 880519,inadequate design analysis of high pressure injection in emergency core cooling sys sump.
 W/8 ltr.

FACILITY NAME (1) Oconee Nuclear Station, Unit 1	DOCKET NUMBER (2) 0 5 0 0 0 2 6 9 1	PAGE (3) 1 OF 0 7
---	--	----------------------

TITLE (4) Inadequate Design Analysis of the High Pressure Injection System in the Emergency Core Cooling System Sump Recirculation Mode

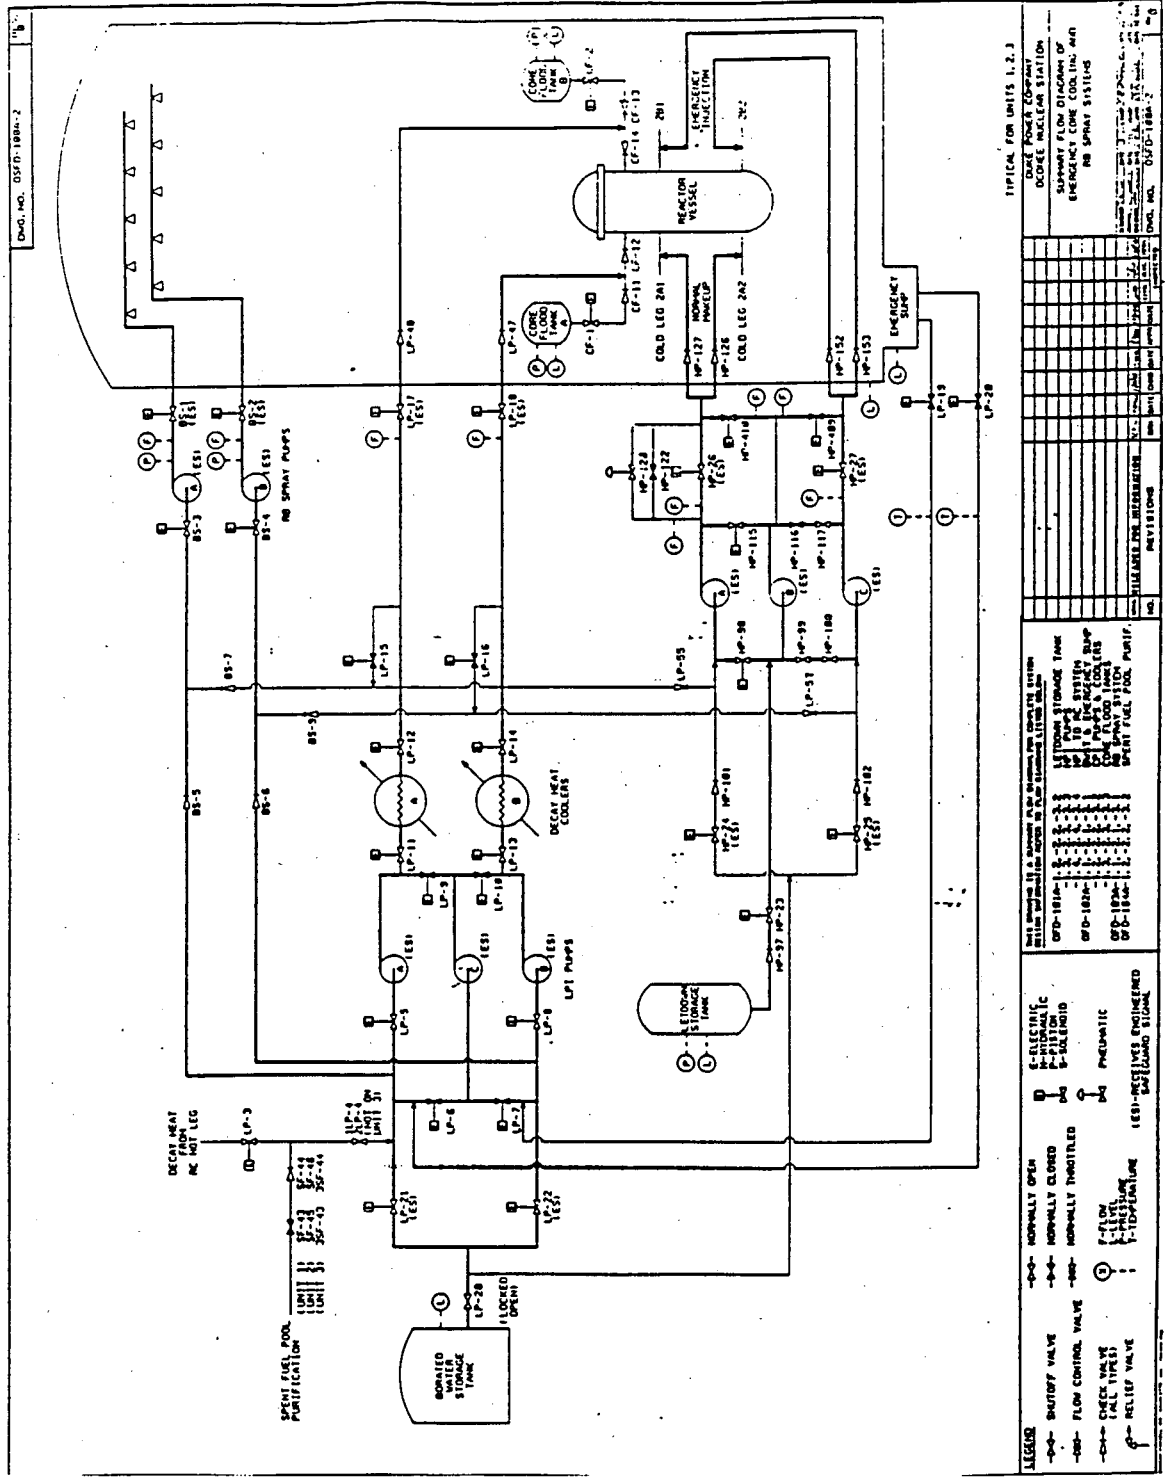
FIGURE 1
EMERGENCY CORE COOLING AND
REACTOR BUILDING SPRAY SYSTEMS

The HPI piggyback mode circulates coolant from the RB emergency sump, through the LPI pumps, through the HPI pumps, to the RCS. Like HPI, the RBS pumps may also take suction from the LPI pump discharge downstream of the LPI coolers (Decay Heat Removal Coolers) (see Figure 1).
