SUBJECT: LER 89-011-01: on 890618, Tech Spec 3.7 violated as result of defective procedure.

Subject: Oconee Nuclear Station
Docket Nos. 50-269, -270, -287
LER 269/89-11, Revision 1

TITLE (4)
Technical Specification 3.7 Was Violated as a Result of a Defective Procedure

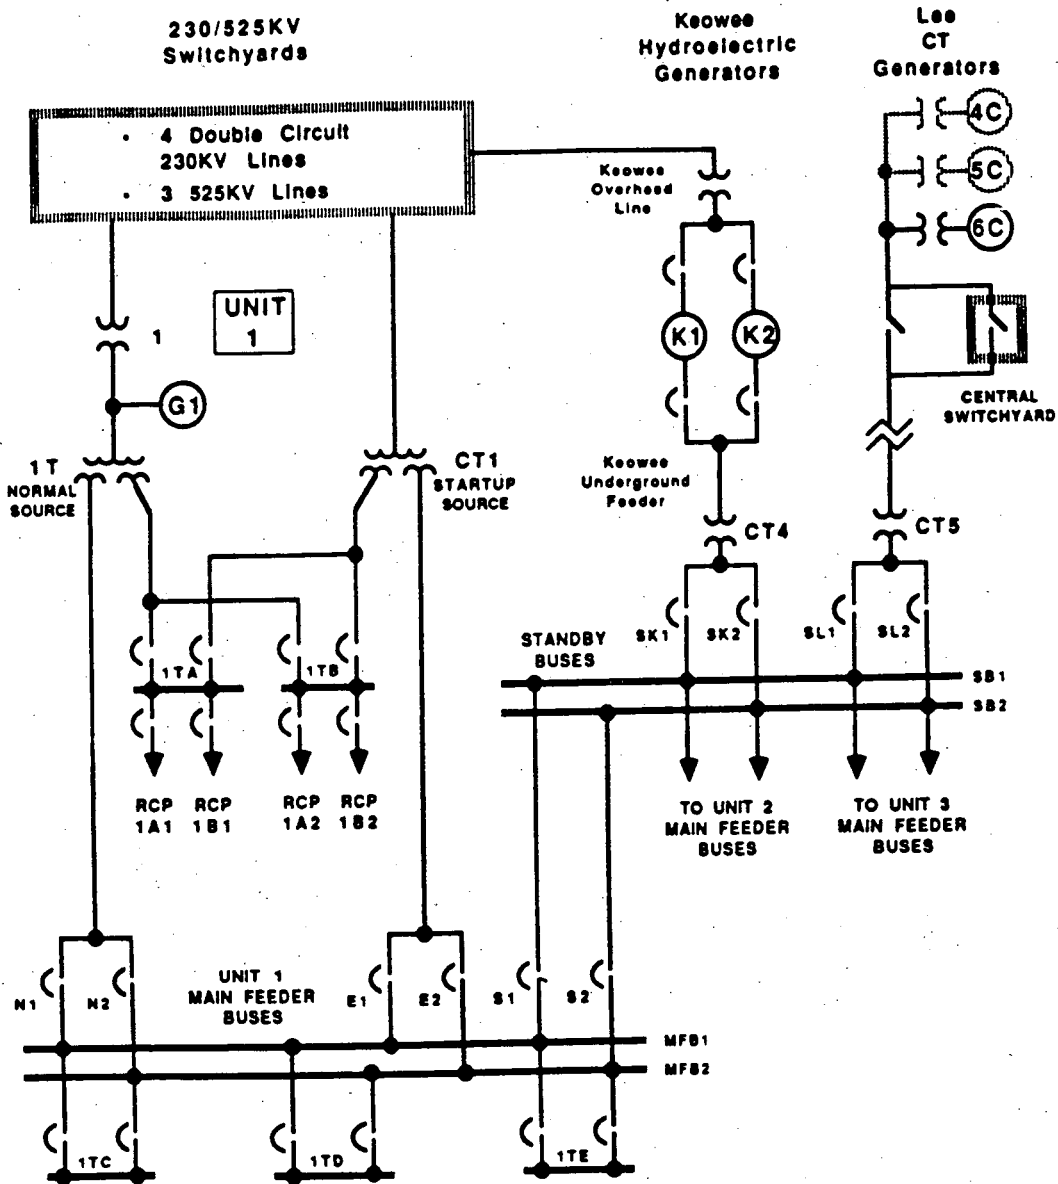
**OCONEE NUCLEAR STATION
Power System**

If both SK breakers are open with their respective AUTO/MANUAL transfer switches in manual while the Keowee overhead path is inhibited, potential scenarios exist where essential station auxiliaries may not receive sufficient power (see figure-page 10). In order to assess the impact of this evaluation, various scenarios need to be addressed.
