SUBJECT: LER 89-009-01: on 890607, mgt deficiency resulted in incorrect Tech Spec.

Subject: Oconee Nuclear Station
Docket Nos. 50-269, -270, -287
LER 269/89-09, Revision 1

TITLE (4) **A Management Deficiency Resulted in an Incorrect Technical Specification Which Allowed a Single Breaker Failure to Prevent the Emergency Power Switching Logic from Functioning**

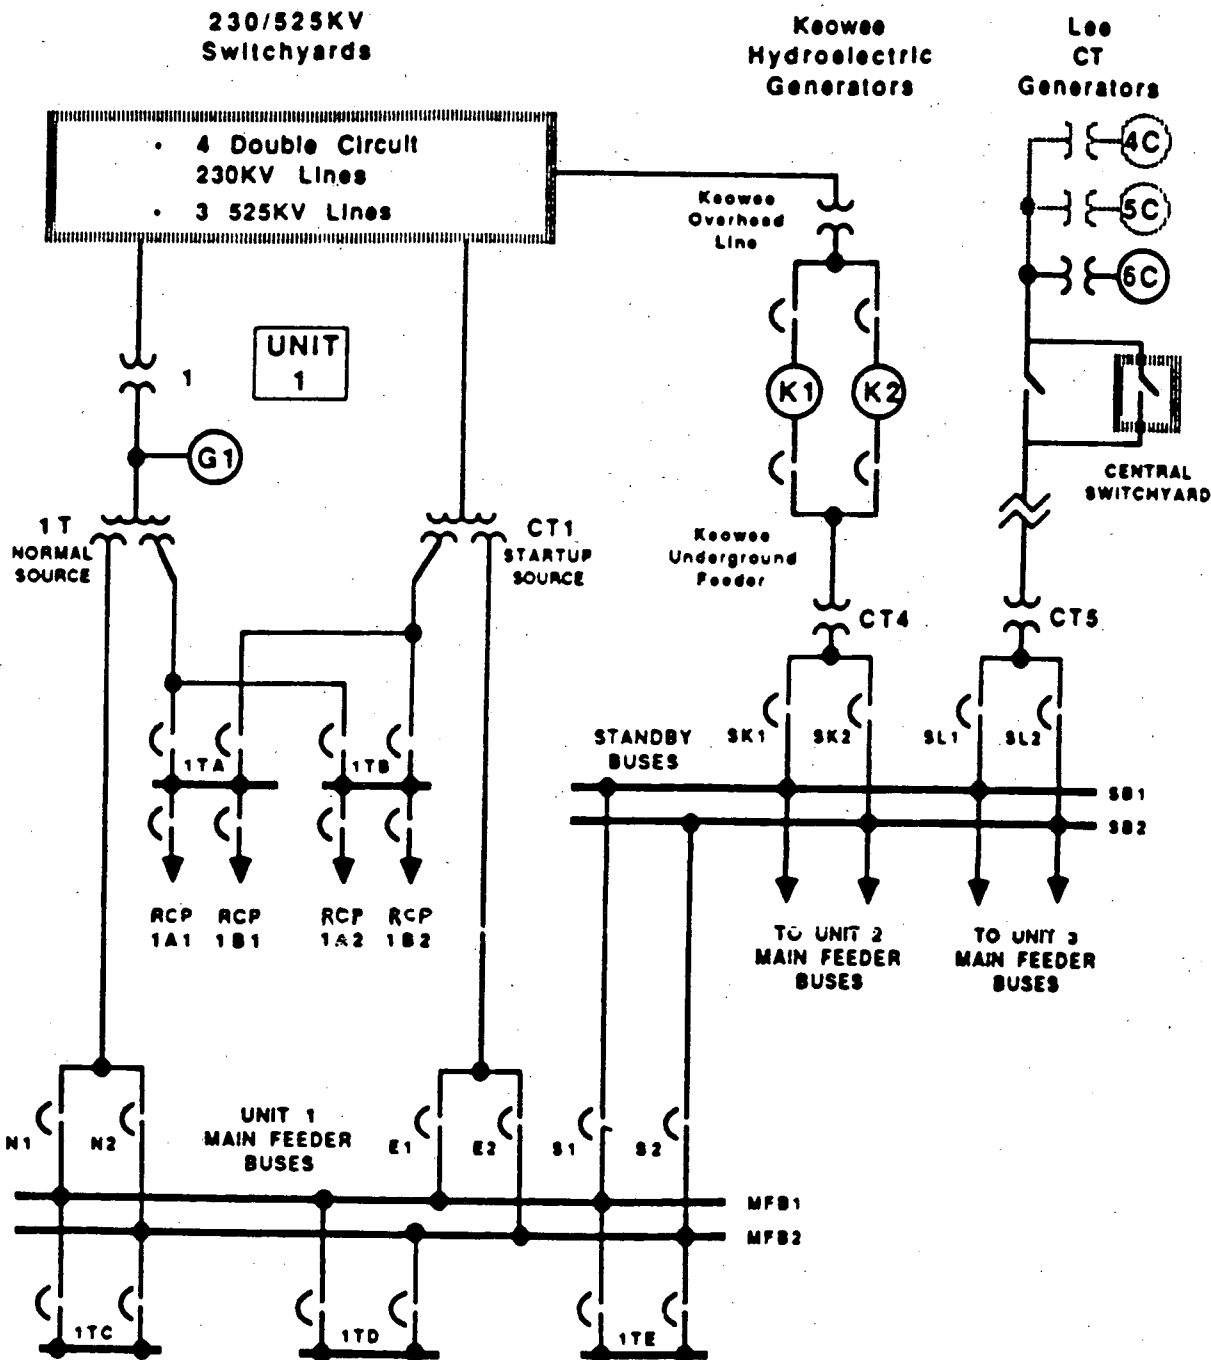
**OCONEE NUCLEAR STATION
Power System**

If the plant had been operating in the Technical Specification-allowed configuration of having one Standby Bus removed from service, then the plant's ability to mitigate a loss of coolant accident concurrent with a loss of off-site power would have been hampered by a single failure of the operable standby bus to main feeder bus (S) breaker (reference the attached drawing).

Remembering that the plant configuration of concern was the removal of one of the Standby Buses from service, the LOCA unit could then only be supplied from one Standby Bus and its corresponding SK and S breakers. At this point, if a failure of the operable S breaker was pre-existing or had occurred then the underground path would have been ineffective in supplying power to the main feeder bus. In this situation, the Retransfer to Startup Logic portion of the EPSL would not detect that the underground path had become ineffective because it still sensed sufficient voltage on the operable Standby Bus. This sensing of voltage would have falsely indicated to the EPSL that the underground path was providing power to a main feeder bus. At this time, manual operator action would have been required. (This result also applies if the S breaker control switches were in "manual" because the breakers would not have automatically closed and the EPSL would still have sensed voltage on the Standby Buses - regardless if one or both buses were in service.)
