# ACCELERATED DISTRIBUTION DEMONSTRATION SYSTEM

SUBJECT: LER 89-014-00: on 890921, overhead emergency power path rendered inoperable due to mgt deficiency.

Subject: Oconee Nuclear Station  
Docket Nos. 50-269, -270, -287  
LER 269/89-14

TITLE (4) **Overhead Emergency Power Path Rendered Inoperable Due to Management Deficiency When Certain PCBs Were Removed From Service**

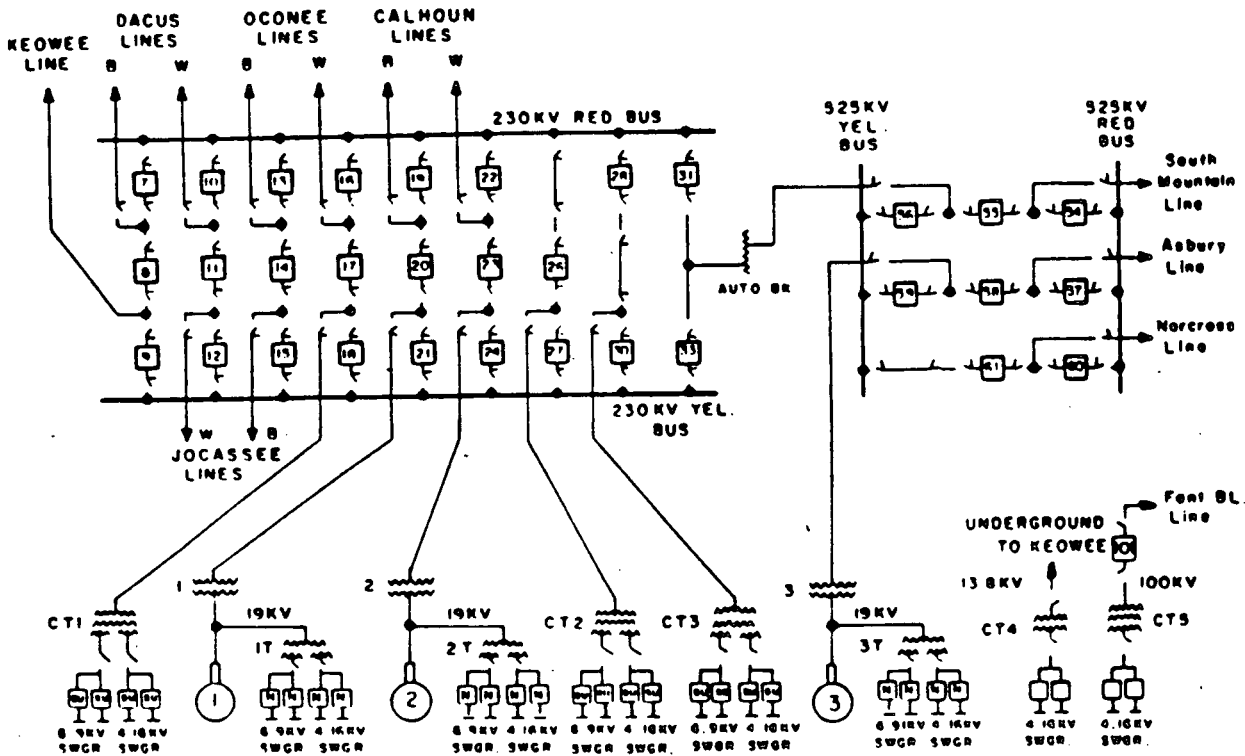
ATTACHMENT 1

The Oconee 230 KV switchyard [EIIS:FK] is an interface between the 230 KV Duke transmission line network and Oconee Units (reference attachment 1). Abnormal conditions in the 230 KV switchyard result in switching operations that are initiated by protective relaying. One of the protective relaying circuits is the External Grid Trouble Protective System [EIIS:EK]. This system is designed to monitor the voltage and frequency of both the red and yellow buses in the 230 KV switchyard. When this system detects abnormal conditions, it initiates a startup of the Keowee hydro units [EIIS:EK] and provides a path to provide emergency power from Keowee to the Oconee Startup transformers [EIIS:XFMR] CT-1, CT-2, and CT-3 by closing Power Circuit Breakers (PCBs) 9, 18, 27, and 30 and by tripping open PCBs 8, 12, 15, 17, 21, 24, 26, 28, and 33 to isolate the yellow bus from the grid.

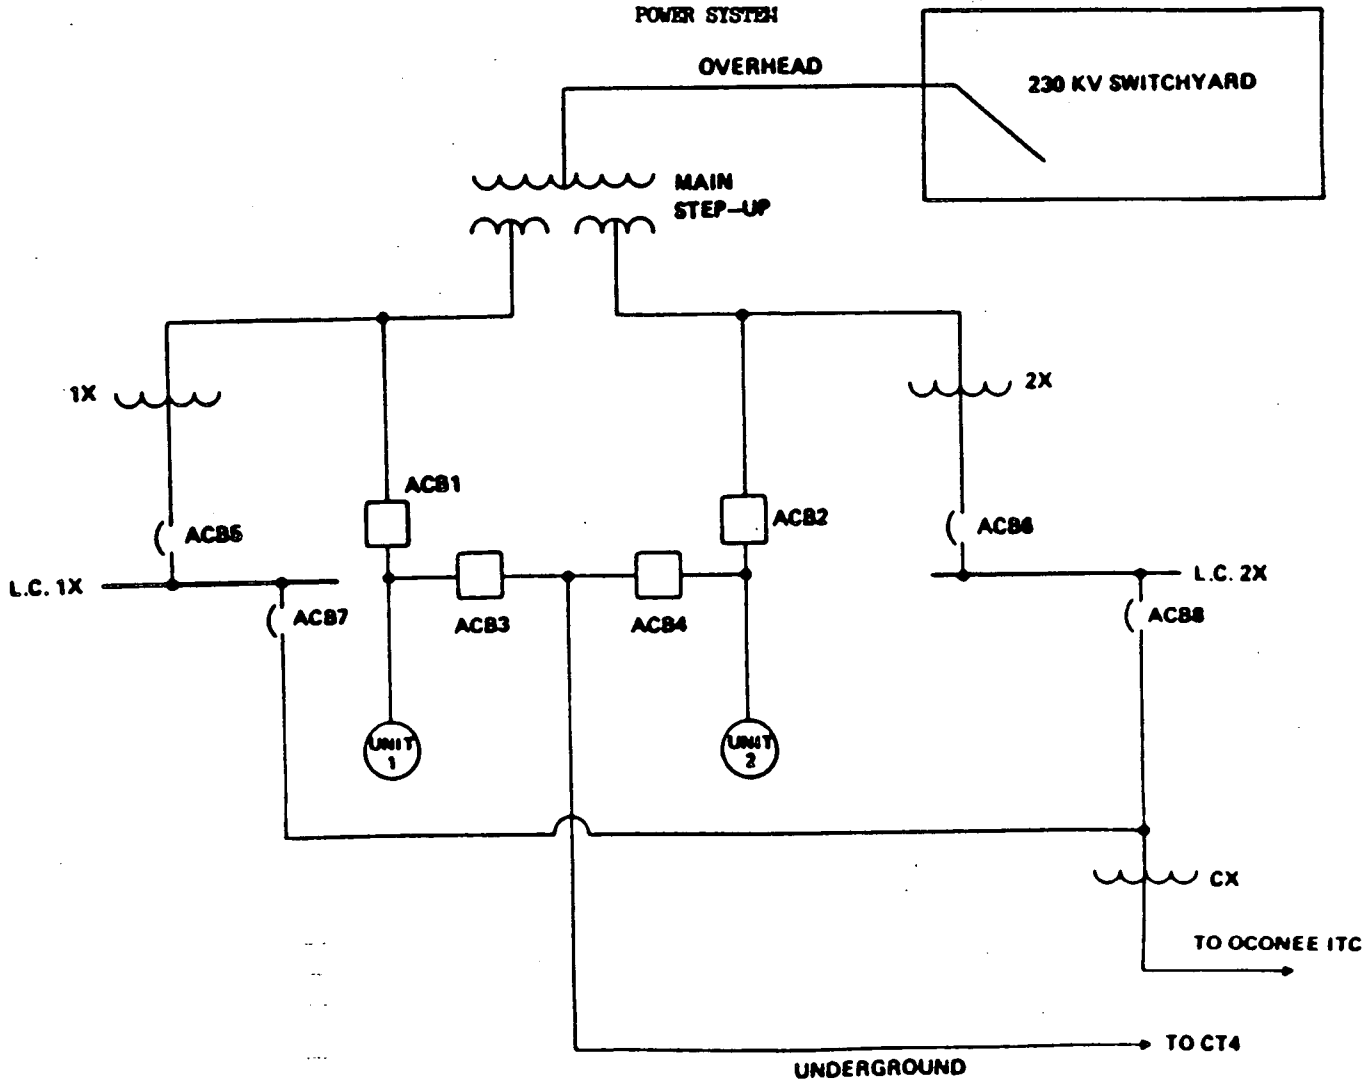
ATTACHMENT 2

On September 21, 1989 with Units 2 and 3 at 100% full power and Unit 1 at 75% full power, licensee trainees were discussing the operability of the Keowee auxiliary transformers 1X and 2X (reference attachment 2). This discussion was prompted due to the trainees recently completing training given by the Operations Support group on the Emergency Power Switching Logic [EIIS:EK] and a proposed revision to Technical Specification (TS) 3.7. In their discussion, they questioned how the removal of PCB-9 from service would affect the operability of transformers 1X and 2X as required by the proposed revision to TS 3.7. They concluded from their discussion that the auxiliary transformers (1X and 2X) would be rendered inoperable while PCB-9 was out of service because Air Circuit Breaker (ACB 1 or 2) would not close due to the "switchyard isolate complete" logic not being satisfied. Operations Manager 'A', responsible for switchyard operations, was then consulted on this matter. Operations Manager 'A' agreed with the trainees conclusion and stated that no further action was necessary since the Keowee backup auxiliary transformer (CX) was available and because all Oconee Units would then be under a Limiting Condition of Operation as required by TS 3.7.2 (a) due to the removal of PCB-9 from service. Operations Manager 'A' then contacted Design Engineering (DE) personnel accountable for electrical systems to determine if the removal of either PCBs 18, 27, and 30 (the other PCBs required to close on a switchyard isolation signal) from service could affect more than just that Oconee Unit's respective overhead emergency power path. DE concluded that disabling either PCB 18, 27, or 30 (Oconee Units' 1, 2, and 3 Startup transformer feeders, respectively) would not only disable the respective unit's overhead emergency power path, but it would disable the overhead emergency power path for all Oconee units. This situation would occur because the "switchyard isolate complete" logic would sense that the switchyard PCBs were not aligned to their required switchyard isolation position and therefore no automatic close permissive would be given to ACB-1 or 2 to allow either Keowee hydro unit to close onto the overhead emergency power path. Therefore, during periods while one Oconee unit was shutdown, maintenance or testing may have been performed on the shutdown Unit's respective startup feeder PCB (18, 27, or 30) while the requirements of TS 3.7.2 (a) were not met for any remaining Oconee units above 200 degrees Fahrenheit. It was subsequently concluded that when any of the other switchyard isolation PCBs (8, 12, 15, 17, 21, 24, 26, 28, and 33) are removed from service such that they are unable to operate to their

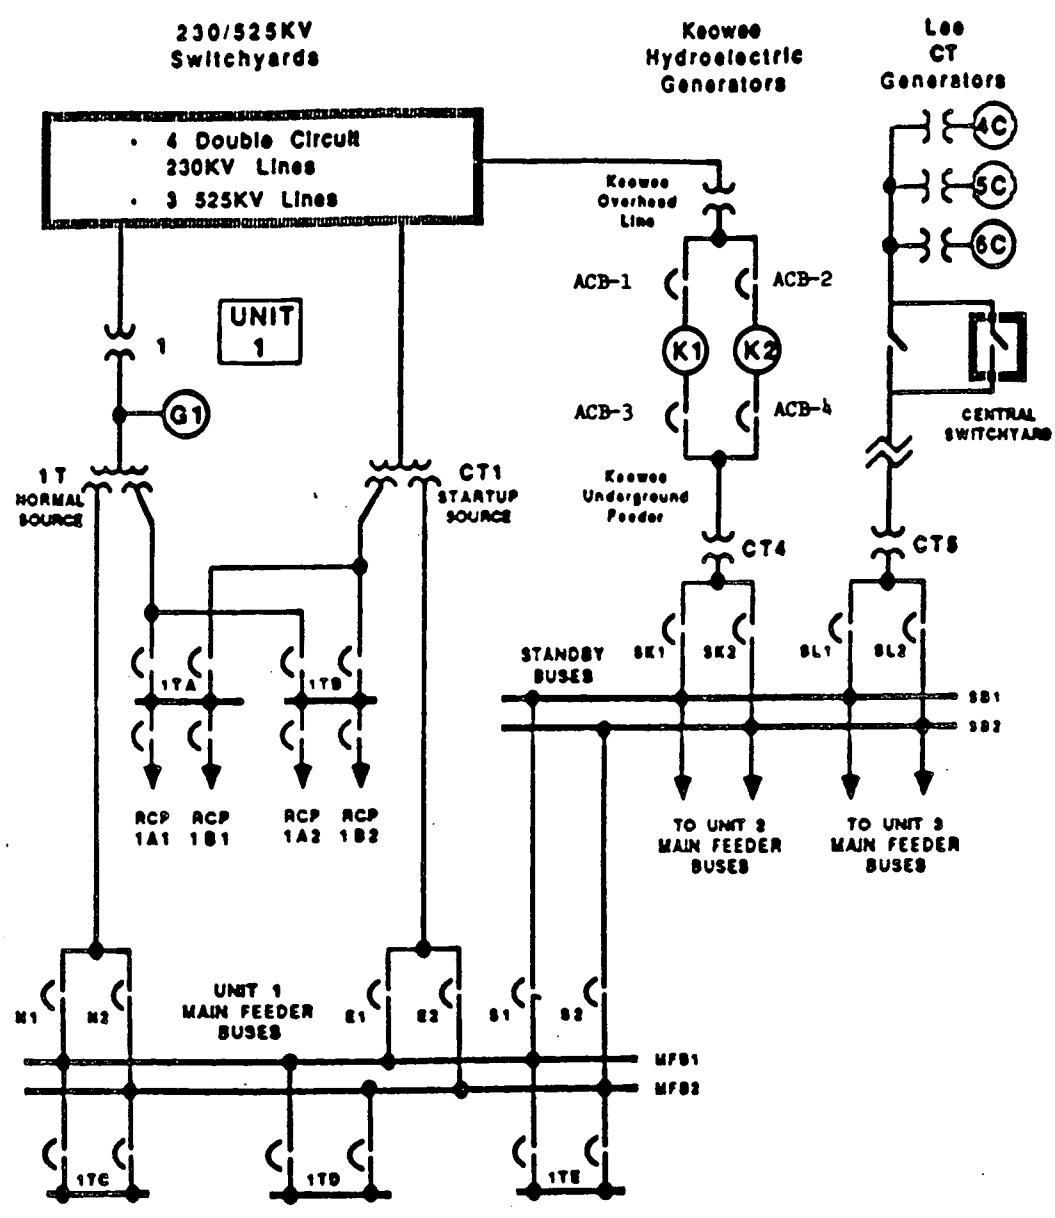
ATTACHMENT 3

If certain 230 KV switchyard Power Circuit Breakers (PCBs) are removed from service in such a way that they are disabled from operating, potential scenarios exist where essential station auxiliaries may not receive sufficient power (reference attachment 3). In order to evaluate the impact of this situation, two scenarios need to be addressed.
