SUBJECT: LER 90-004-00: on 900301, unanticipated sys interaction during
 undervoltage condition in 230 kV switchyard. W/9 ltr.

Subject: Oconee Nuclear Station
Docket Nos. 50-269, -270, -287
LER 269/90-04

FACILITY NAME (1) Oconee Nuclear Station, Unit 1	DOCKET NUMBER (2) 0 5 0 0 0 2 6 9	PAGE (3) 1 OF 1 3
--	---	-----------------------------

TITLE (4) **Unanticipated System Interaction During Undervoltage Condition In The 230KV Switchyard Results In Failure To Comply With Technical Specifications**

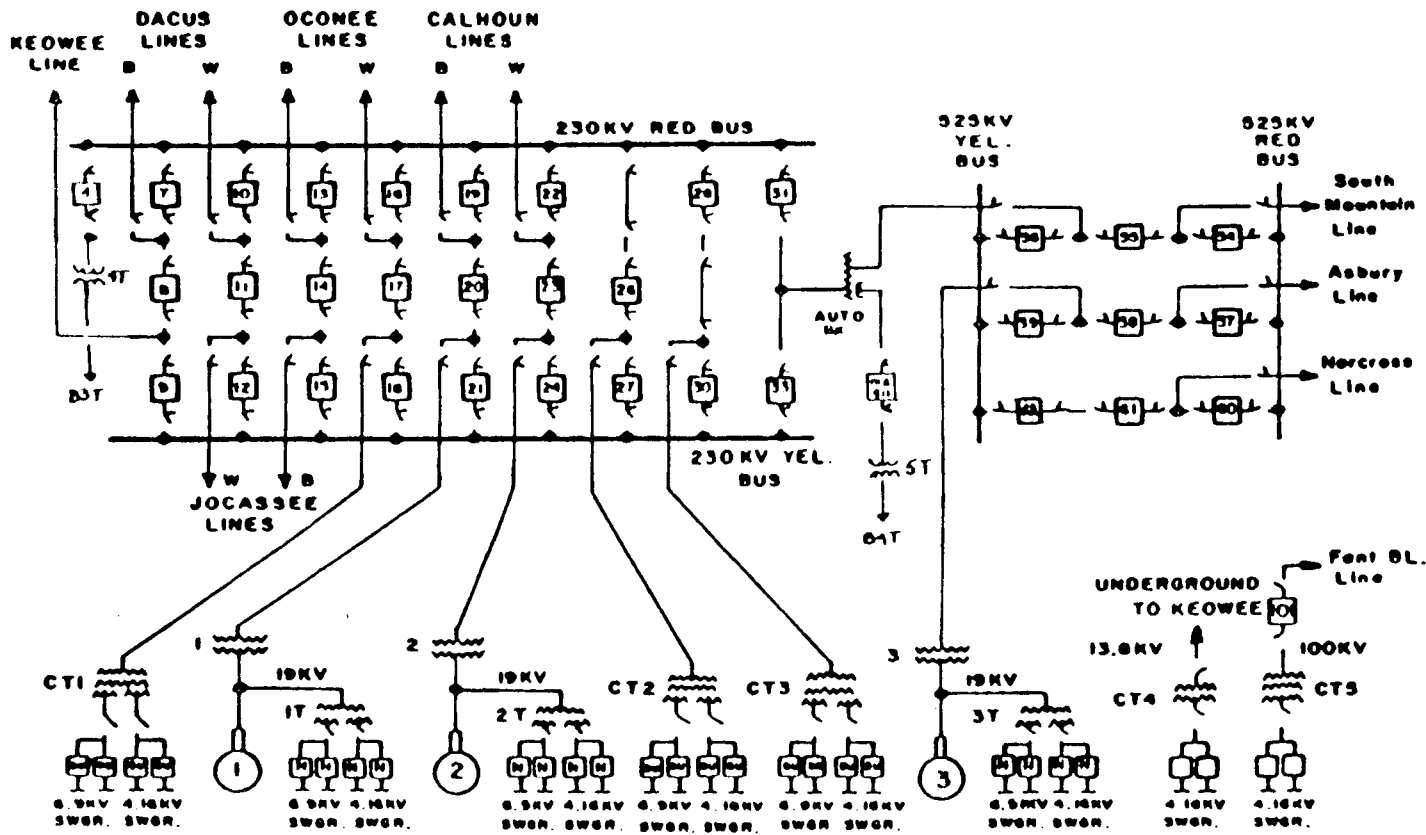
ATTACHMENT 1

The Oconee 230 kV Switchyard [EIIS:FK] is an interface between the 230 kV Duke transmission line network and Oconee Units (see Attachment 1 diagram). Abnormal conditions in the 230 kV Switchyard result in switching operations that are initiated by protective relaying. One of the protective relaying circuits is the External Grid Trouble Protection System [EIIS:EK]. This system is designed to monitor the voltage and frequency of both the red and yellow buses in the 230 kV Switchyard. When this system detects abnormal conditions, it initiates an automatic startup of the Keowee Hydro Units [EIIS:EK] and provides a path for emergency power from Keowee to the Oconee Startup Transformers CT-1, CT-2, and CT-3 via the 230 kV switching station. In order for this path (Keowee Overhead) to be established, several Power Circuit Breakers (PCBs) are closed and others are tripped open to isolate the yellow bus from the grid.
