SUBJECT: LER 90-005-00: on 900424, design deficiency/unanticipated interaction of sys results.

Subject: Oconee Nuclear Station
Docket Nos. 50-269, -270, -287
LER 269/90-05

TITLE (4) **Design Deficiency/Unanticipated Interaction of Systems Results in the Potential Closure of the Startup Transformer "E" Breaker on to a Degraded (Low Voltage) Switchyard**

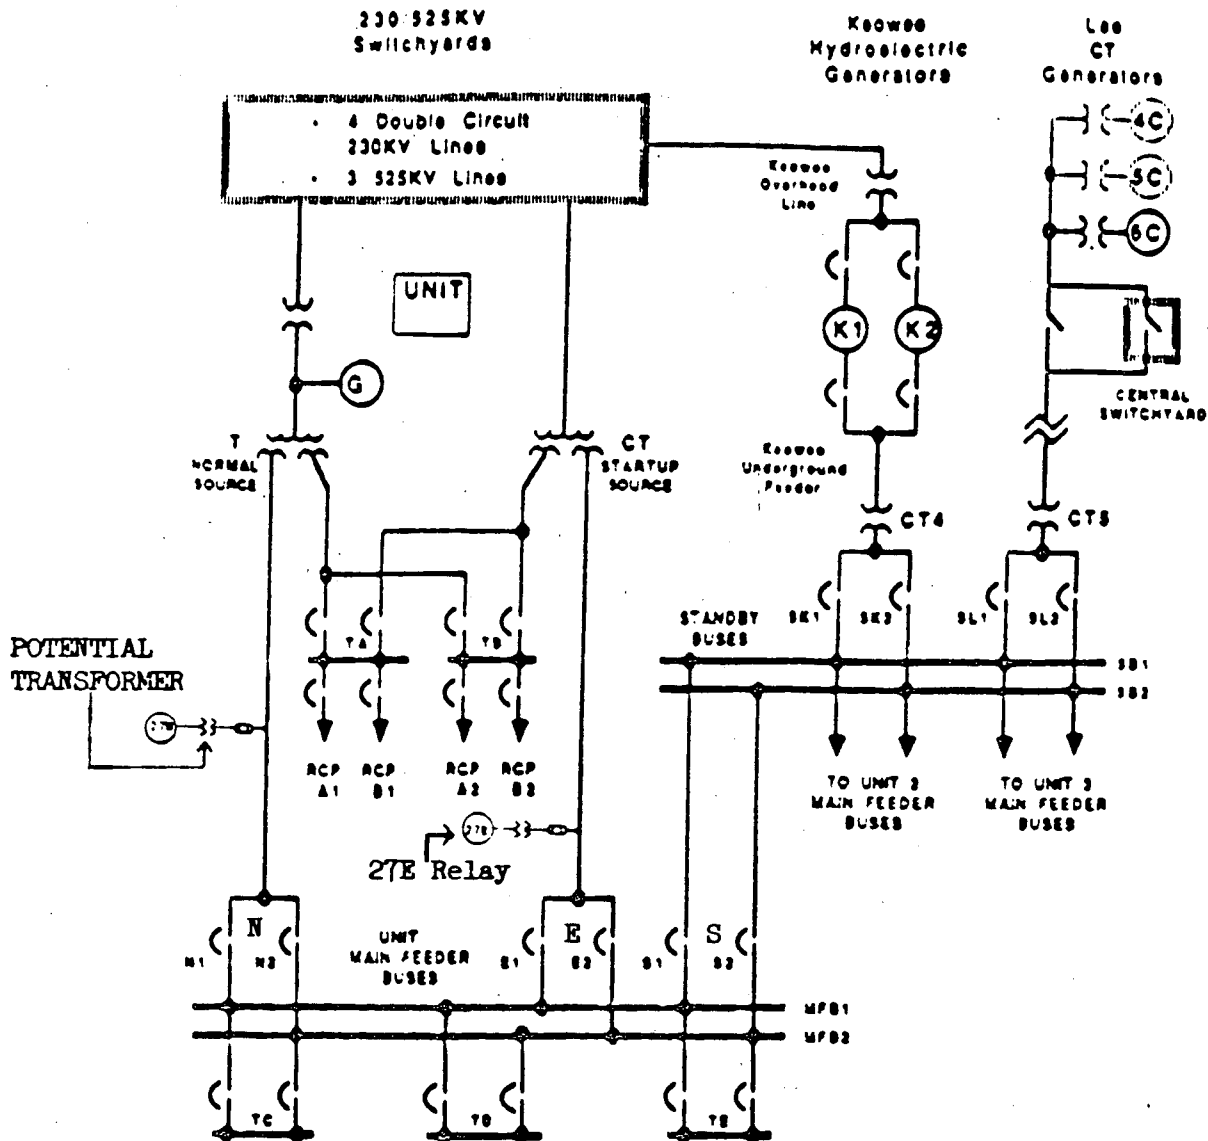
ATTACHMENT 1

During normal plant power operation, auxiliary power is supplied from the turbine generator (G)[EIIS:TB] via the Unit Auxiliary (T) Transformer [EIIS:XFMR] and the Normal Feeder (N) breakers (EIIS:BRK). During startup and shutdown, auxiliary power is supplied from the Oconee Nuclear Station (ONS) 230KV switchyard via the Startup (CT) Transformer and the Startup Feeder (E) breakers. On a unit trip, an automatic fast transfer occurs of the auxiliary loads from the T transformer to the CT transformer. In the event of a loss of power situation, an emergency power switching logic (EIIS:EK) automatically establishes a reliable power source, reduces unit/station load to a level within the capacity of the emergency power source, and transfers essential loads on the affected unit(s) to the emergency power source. The emergency power source is from either of two automatic sources, the Keowee Overhead (one Keowee hydroelectric generator through an isolated bus in the ONS switchyard and the CT transformer) or the Keowee Underground (the other Keowee hydroelectric generator through the CT4 transformer, the Standby buses, and the Standby (S) breakers). Emergency and shutdown loads can also be supplied manually from the Lee gas turbine generator via the CT5 transformer, the Standby buses, and the S breakers. (Refer to Attachment 1)
