SUBJECT: LER 90-007-00: on 900516, actuation of emergency safeguards sys due to defective procedure.

Subject: Oconee Nuclear Station
Docket Nos. 50-269, -270, -287
LER 269/90-07

TITLE (4)
Actuation of Emergency Safeguards System Due to Defective Procedure, Lack of Procedural Precautions

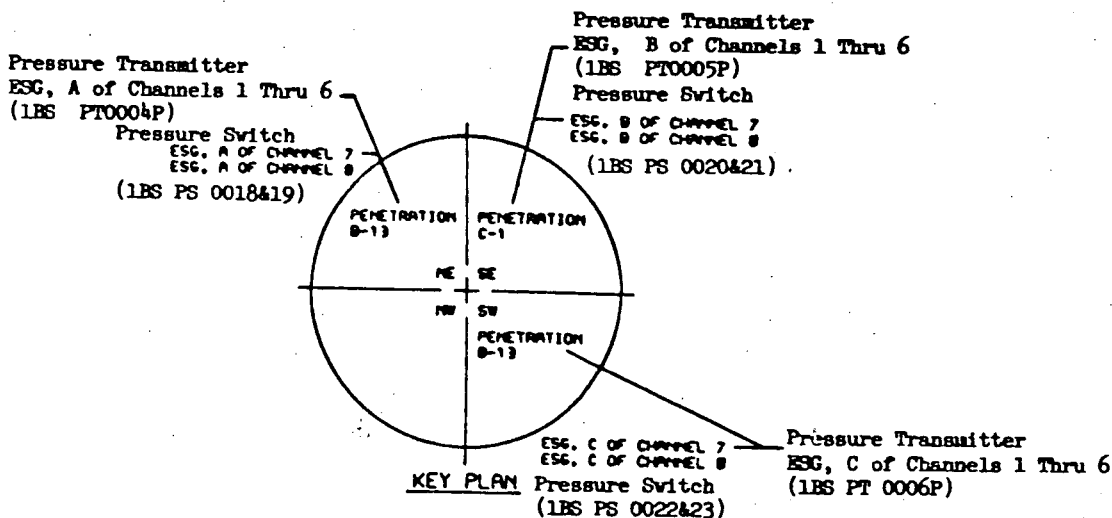
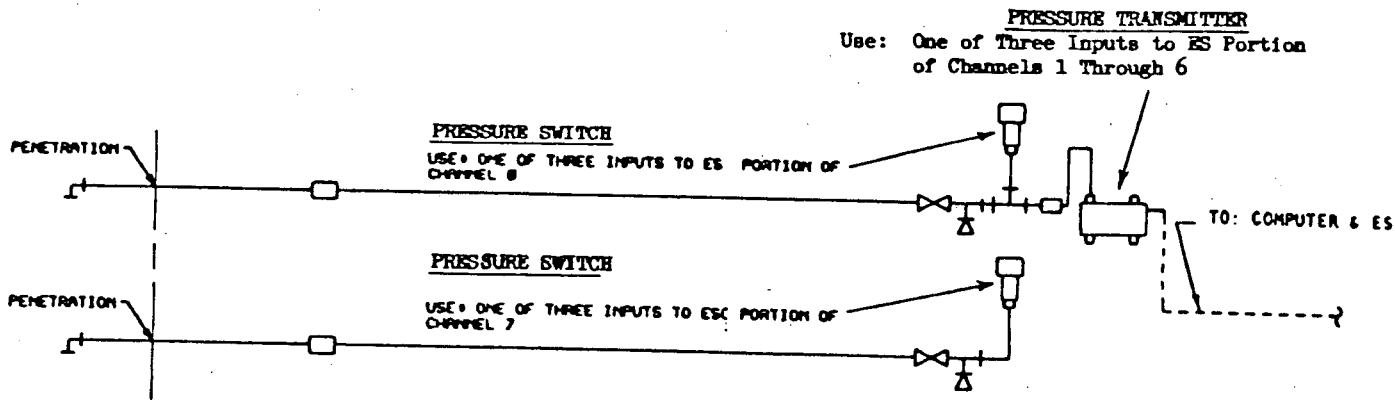
ATTACHMENT 1

On this same day, with the new pressure switches installed and electrically isolated, as required by the NSM procedure TN/1/A/2682/00/AK1, Performance Technicians proceeded to pressure test the switches and their associated tubing. At 1338 hours, the Performance Technicians pressurized switch 1BS PS0023 and pressure transmitter 1BS PT0006P causing the transmitter to send a signal through analog Channel C to digital ES Channels 1 through 6 and an alarm to the control room on analog Channel C. The Operators acknowledged the alarm but did not take action. The Operators stated that due to the alarms received on Channel A as a result of the I&E work and the close proximity of the alarm light locations on the panel for Channels A & C that they assumed that the alarm was caused, and would be reset, by I&E. At approximately 1418 hours, with ES analog Channel C tripped, the Performance Technicians pressurized switch 1BS PS0021 and pressure transmitter 1BS PT0005P causing the transmitter to send a signal through analog Channel B to digital ES Channels 1 through 6. This satisfied the two out of three trip logic and caused the unanticipated actuation of ES System Channels 1 through 6.

TYPICAL INSTRUMENT INSTALLATION

- 1) Procedures TN/1/A/2682/00/AK1 and TN/1/A/2682/00/AL1 were revised to include provisions to isolate the pressure transmitters during the testing.
- 2) The Production Specialist I, Accountable Engineer and Qualified Reviewer were cautioned to adequately review all aspects of a Nuclear Station Modification to insure that their procedures are correct.
