SUBJECT: LER 90-011-00: on 900627, boron dilution sys do not meet  
single failure design criteria due to design deficiency.  
W/9      ltr.

Subject: Oconee Nuclear Station  
Docket Nos. 50-269, -270, -287  
LER 269/90-11

TITLE (4) **Boron Dilution Systems Do Not Meet Single Failure Design Criteria Due to Design Deficiency, Unanticipated Interaction of Systems**

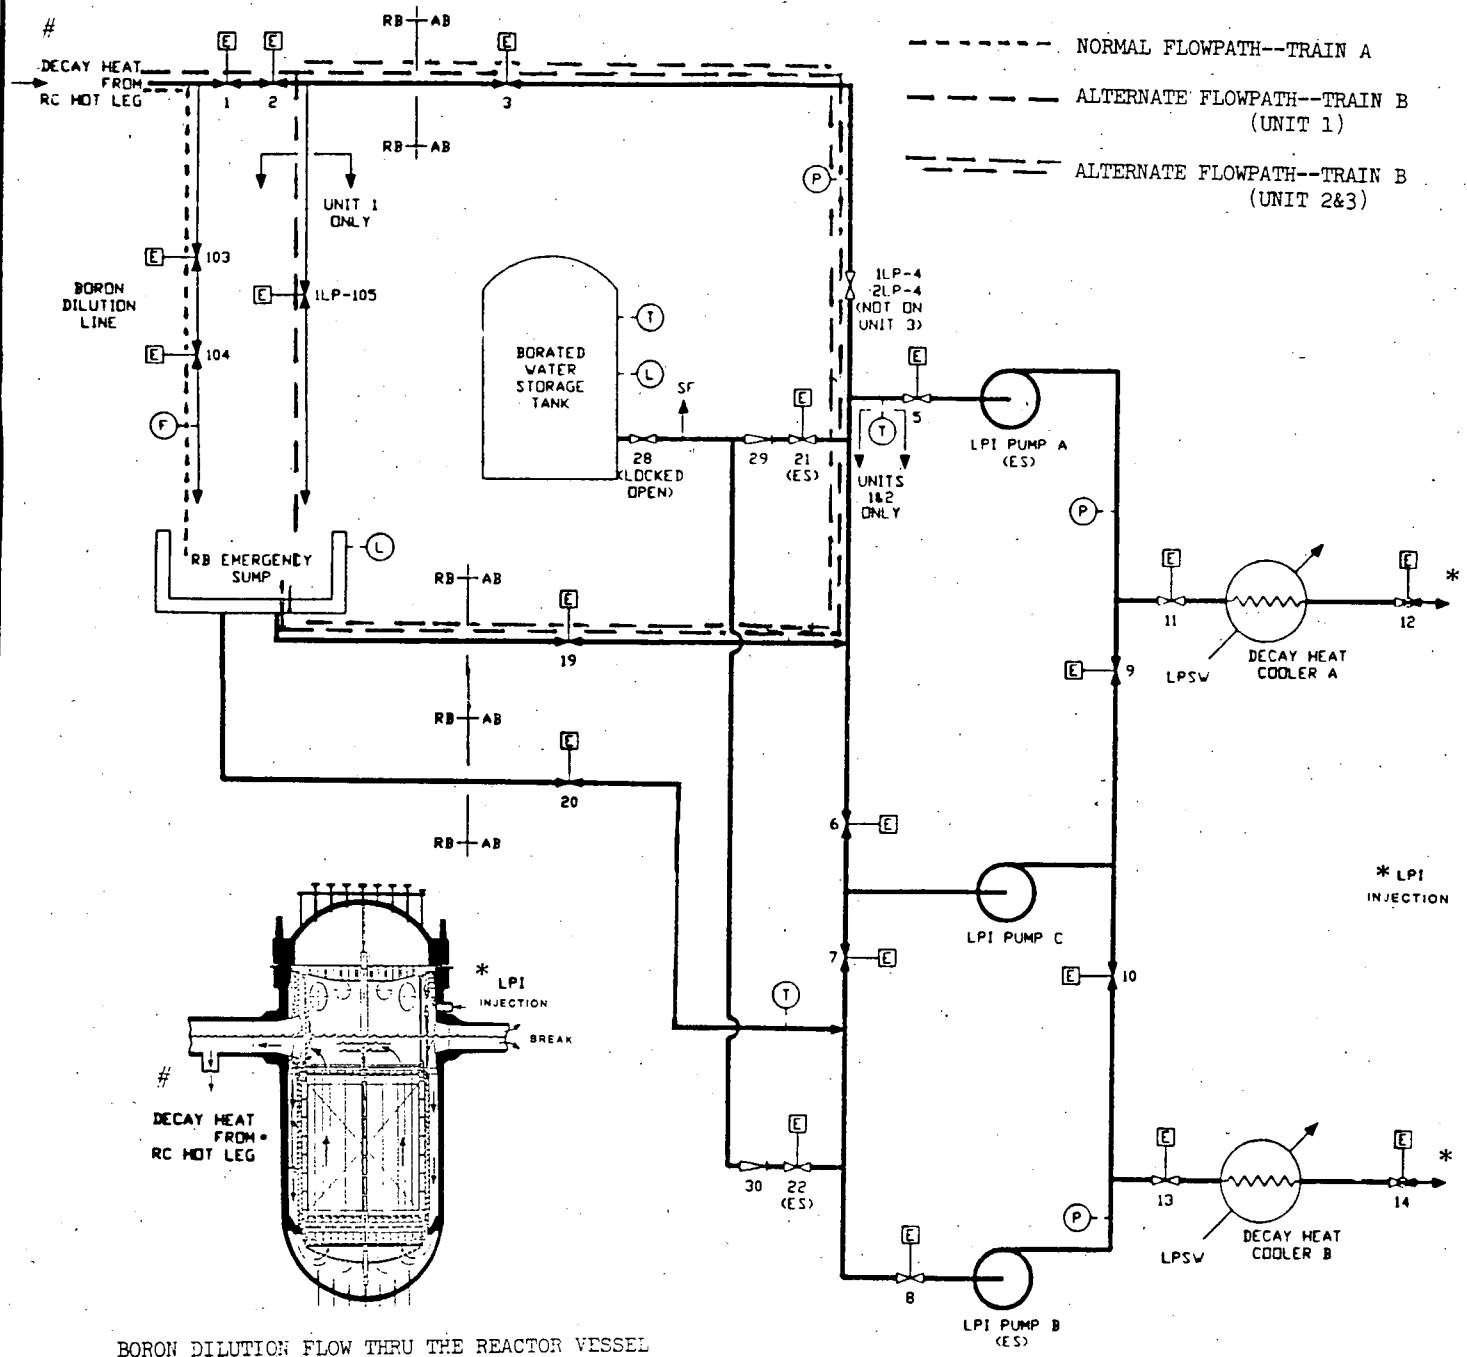
ATTACHMENT 1

The system operates by providing a gravity flow path from the decay heat drop line (off the bottom of the hot leg) to the Reactor Building [EIIIS:NH] emergency (RBE) sump. Two redundant flow paths, or trains, are available. Train A, normal dilution flow path, goes through LP-103 and LP-104 (Post LOCA Boron Dilution valves) directly to the RBE sump. Train B, the alternate boron dilution flow path, runs through LP-1 (LPI Return Block from the Reactor Coolant System), LP-2 (LPI Return Block), and other valves to the RBE sump. (See attachment 1)

BORON DILUTION FLOWPATHS VIA THE LOW PRESSURE INJECTION SYSTEM
