SUBJECT: PRELIMINARY ACCIDENT SEQUENCE PRECURSOR (ASP) ANALYSIS OF  
THE OCONEE LOSS OF POWER EVENT

## ACCIDENT SEQUENCE PRECURSOR PROGRAM EVENT ANALYSIS

LER No.: 270/92-004  
 Event Description: Loss of offsite power with failed emergency power  
 Date: October 19, 1992  
 Plant: Oconee 2

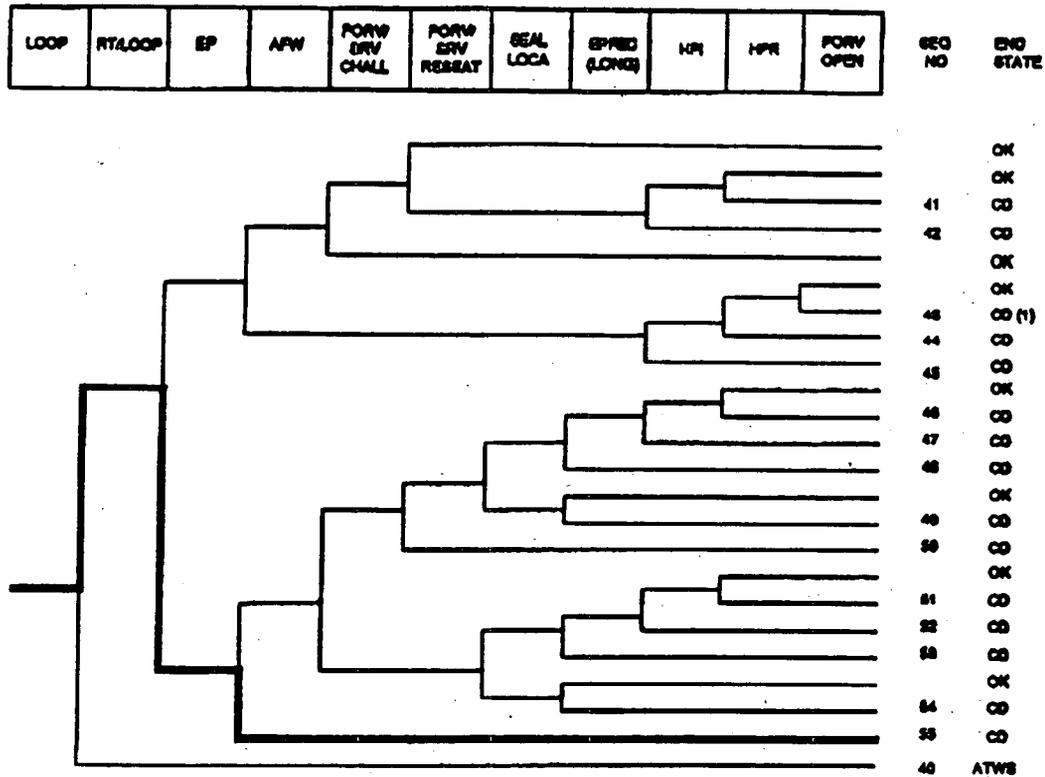
Dominant Core Damage Sequence for LER 270/92-004

The conditional core damage probability estimated for the event is  $3.0 \times 10^{-3}$  [ $0.9 \times 2.8 \times 10^{-3}$  (case 1) +  $0.1 \times 3.2 \times 10^{-3}$  (case 2, Oconee 2) +  $0.1 \times 2.0 \times 10^{-3}$  (case 2, Oconee 1)]. The dominant core damage sequence, highlighted on the following event tree, involves a LOOP on Oconee 2 only with failure to recover emergency power and failure of the degraded turbine-driven EFW pump.

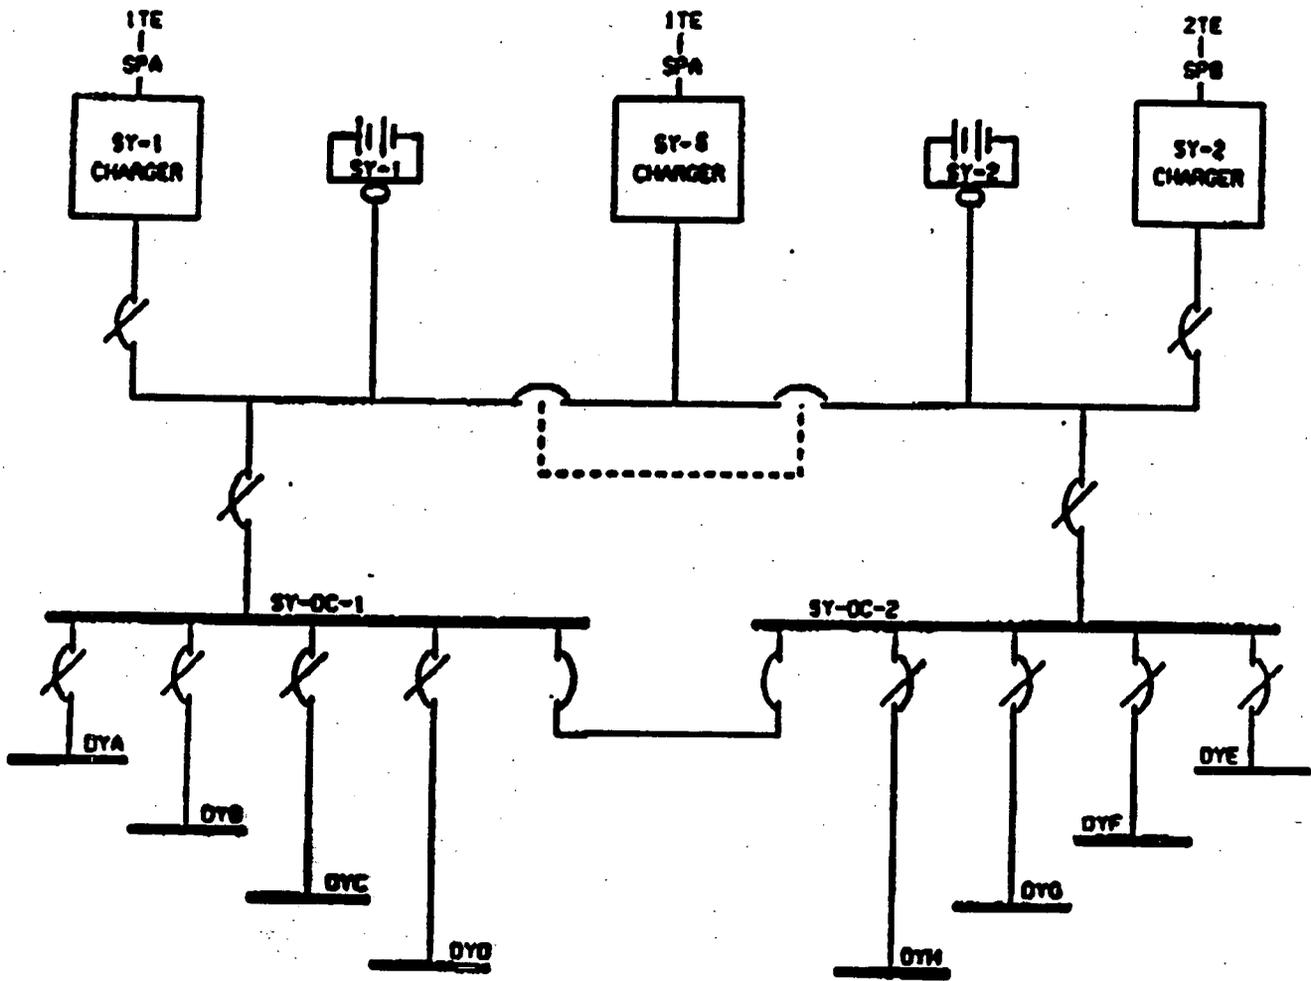
Fig. 2.

On October 19, 1992, Oconee 2 was operating at 100% power. Keowee Hydro Unit 1 (Keowee 1), one of the emergency power sources for the three Oconee units, was supplying power to the grid via the overhead power path (see Fig. 1). Keowee 2 was shutdown and was aligned to provide emergency power via the underground path. Replacement of the 230-kV switchyard batteries was in progress — battery SY-2 and charger SY-2 were disconnected, switchyard DC buses SY-DC-1 and SY-DC-2 were cross-tied, and charger SY-1 and battery SY-1 were powering both buses (see Fig. 2).

A point had been reached during the battery replacement when charger SY-2 was to be reconnected to its bus and the two buses separated. This alignment was allowed by the battery replacement procedure. Once this was done, bus SY-DC-2 would be powered only by its charger. Battery SY-2, which was normally connected to the bus, would remain unconnected. This highly unusual alignment (which can subject a bus to large voltage fluctuations because of battery charger instability) had been used between October 6-12, 1992, when battery SY-1 was replaced, without any complications. The Oconee 1 Unit Supervisor went to the switchyard relay house with several technicians to perform the procedure steps to reconnect the charger and separate the DC buses. He connected the charger to the bus and then, at 2121 hours, opened the tie breaker to separate the two switchyard DC buses. Within the next several seconds a switchyard lockout, Oconee 2 trip, Keowee 1 normal trip, and emergency start of both Keowee units occurred. The Unit Supervisor suspected that his actions had initiated the event, and "backed out" of the procedure by reclosing the switchyard DC bus tie breakers and opening the breaker from the SY-2 charger.

The 230-kV switchyard lockout was a result of a voltage transient on switchyard DC bus SY-DC-2 caused by charger SY-2. Bus SY-DC-2 powered the breaker failure circuits for all of the 230-kV switchyard breakers. Breaker failure circuitry is designed to actuate an AR relay and trip adjacent breakers after a time delay if a faulted breaker fails to trip. The breaker failure circuitry employed a zener diode as a surge protector in a design which caused current to flow through the breaker AR relay coil when the zener diode conducted (performed its protective function). The relays had been identified as susceptible to spurious operation due to excessive voltages in 1980, but were never modified. The AR relay for power circuit breaker (PCB)-24 was the first to actuate on the Yellow 230-kV Bus. This relay tripped PCB-23 and initiated a Yellow Bus lockout, which tripped PCBs-9, 12, 15, 18, 21, 24, 27, and 30. A lockout also occurred on the Red Bus, and tripped PCBs-4, 7, 10, 13, 16, 19, 22, 26, and 28. PCBs-31 and 33 were tagged open to support maintenance and did not trip. All of the PCBs are shown in Fig. 1.

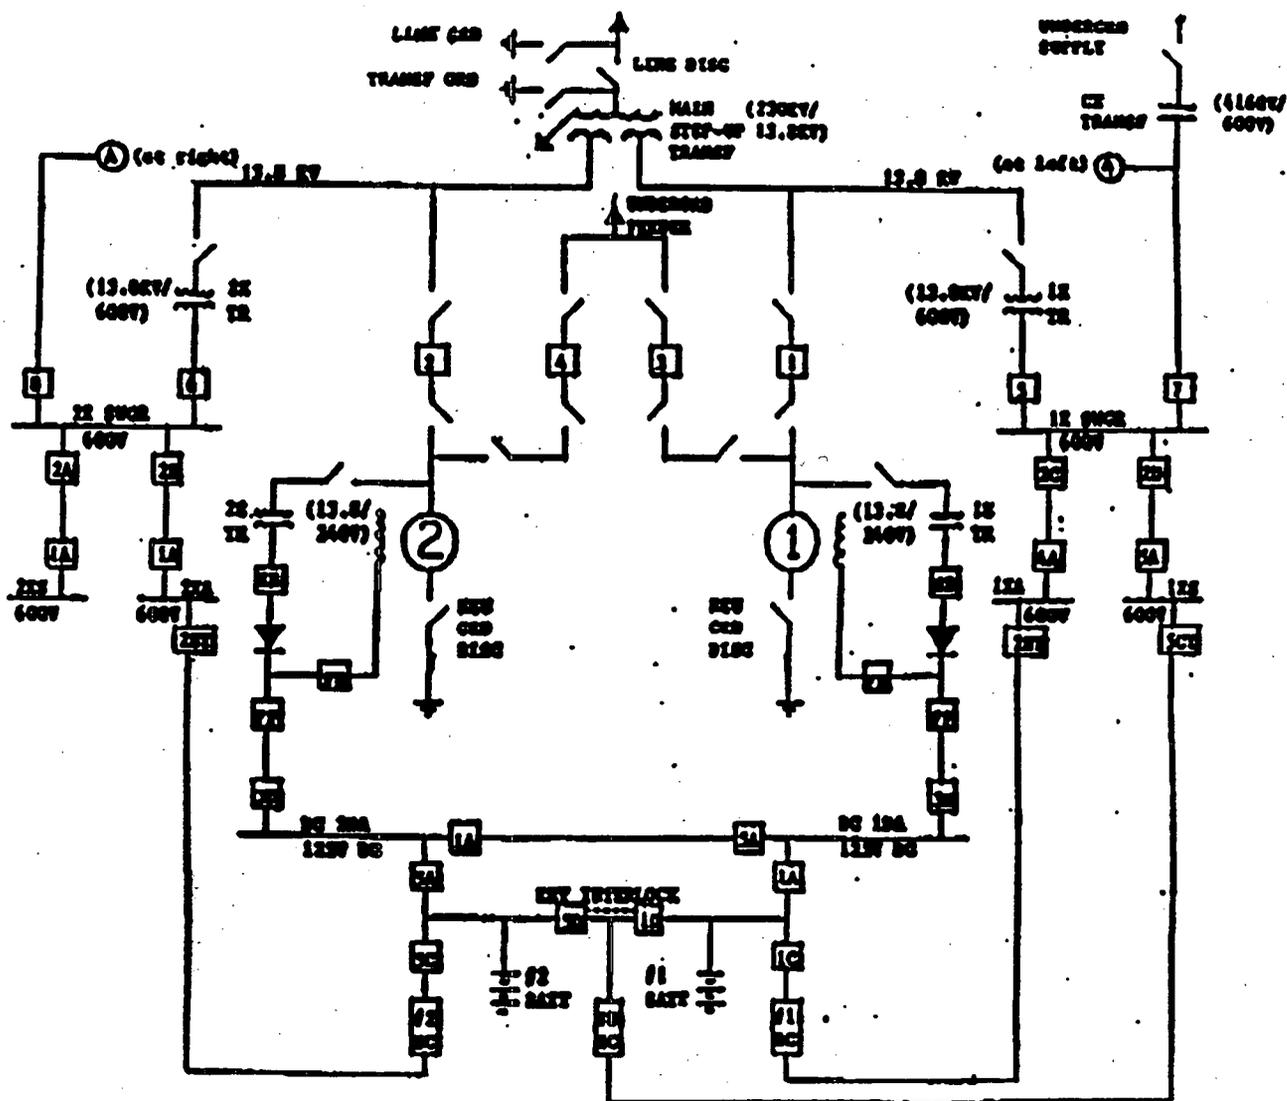
Fig. 3.

The Keowee operator was in the turbine room when the event began. When he returned to the Keowee control room he observed multiple alarms but failed to observe an alarm indicating that an emergency start signal existed. He noted that Keowee 1 was operating with no load, concluded that the hydro unit might be in danger of failing, and manually tripped output breaker ACB-1 (see Fig. 3). With ACB-1 tripped, the Keowee auxiliary buses 1X and 2X attempted to transfer to their alternate power source, transformer CX (which is powered from Oconee 1 switchgear ITC-4). A bus lockout was received on auxiliary bus 1X (apparently caused by rapid and repeated breaker operations during the event as a result of dirty and misaligned time-delay relay contacts), which prevented ACB-7 from closing. Bus 1X remained deenergized. ACB-8 failed to close (because of a high resistance on a close permissive contact) and auxiliary bus 2X remained deenergized as well. Loss of these two buses resulted in loss of all auxiliary power to the Keowee units. The Keowee control room lights went off, the annunciator panels went dark, and the telephone connection to Oconee and the alarm typer were lost (the computer remained operable). A Keowee main transformer lockout also occurred, which prevented reclosure of ACB-1. At this point, the Keowee operator realized Keowee 2 was starting and that an emergency start had occurred. The Keowee units continued to operate with their control functions supplied by batteries.

Unavailability of Keowee auxiliary power prevented makeup to the hydraulic oil accumulator tanks. These accumulators provide the oil to operate the governor and wicket gates to control turbine speed and generator output. Keowee can operate up to about one hour, depending upon load changes, without auxiliary power before governor and wicket gate control becomes unavailable.

Keowee auxiliary power (buses 1X and 2X) is required for the AC hydraulic oil pumps, along with other loads. These pumps are used to pressurize the air pre-loaded accumulators that provide hydraulic oil pressure to the governor which controls the position (depending on load) of the wicket gates on the Keowee water turbine. The length of time that the Keowee units can run without AC auxiliaries is limited by the changing load for which the governor must respond. The utility has indicated in several LERs that one hour is the expected maximum time period of Keowee operation without AC auxiliaries.

The normal Keowee configuration at the time of the event had either Keowee 1 or 2 available for generation to the grid using the overhead path (via ACB-1 for Keowee 1 or ACB-2 for Keowee 2). One unit was also aligned to supply the underground path with emergency power (either ACB-3 or ACB-4 closed). The design of the Keowee control circuitry was to provide emergency power to the underground power path from one unit for all emergency start situations while providing power to the overhead path from the other unit only if offsite power was lost.

The Keowee auxiliary buses normally were powered from the overhead path through their respective 1X and 2X transformers, the Keowee main step-up transformer, and the 230 kV switchyard. Normal power was supplied to the 1X bus through ACB-5 and to the 2X bus through ACB-6. These two load centers also had an alternate power source from the CX transformer that receives power from Oconee 1 load center 1TC. Alternate power from the CX transformer for the 1X bus was provided via ACB-7 and alternate power for the 2X bus was provided via ACB-8. An automatic transfer scheme would quickly switch these buses to their alternate power supply on loss of normal power. The transfer scheme was designed to be normal

A dedicated phone was installed between the Keowee and Oconee control rooms. Previously, a commercial phone line had been used. Protective logic was revised so that the Keowee units would no longer trip due to undervoltage on the main step-up transformer. A special test was performed to confirm (1) the proper response of Keowee hydro to a simulated switchyard isolation signal when aligned to the grid and (2) the implementation of an Oconee "live" bus transfer procedure to repower loads from the switchyard. Generally, the Keowee units performed as expected during the test. The Oconee operators had difficulty controlling Keowee 1 while initially tying it to the grid and while paralleling the overhead path to the grid during system restoration after the test, which resulted in Keowee 1 and 2 tripping. In addition, the Keowee operator was unfamiliar with the response required to several annunciators which alarmed during the test.

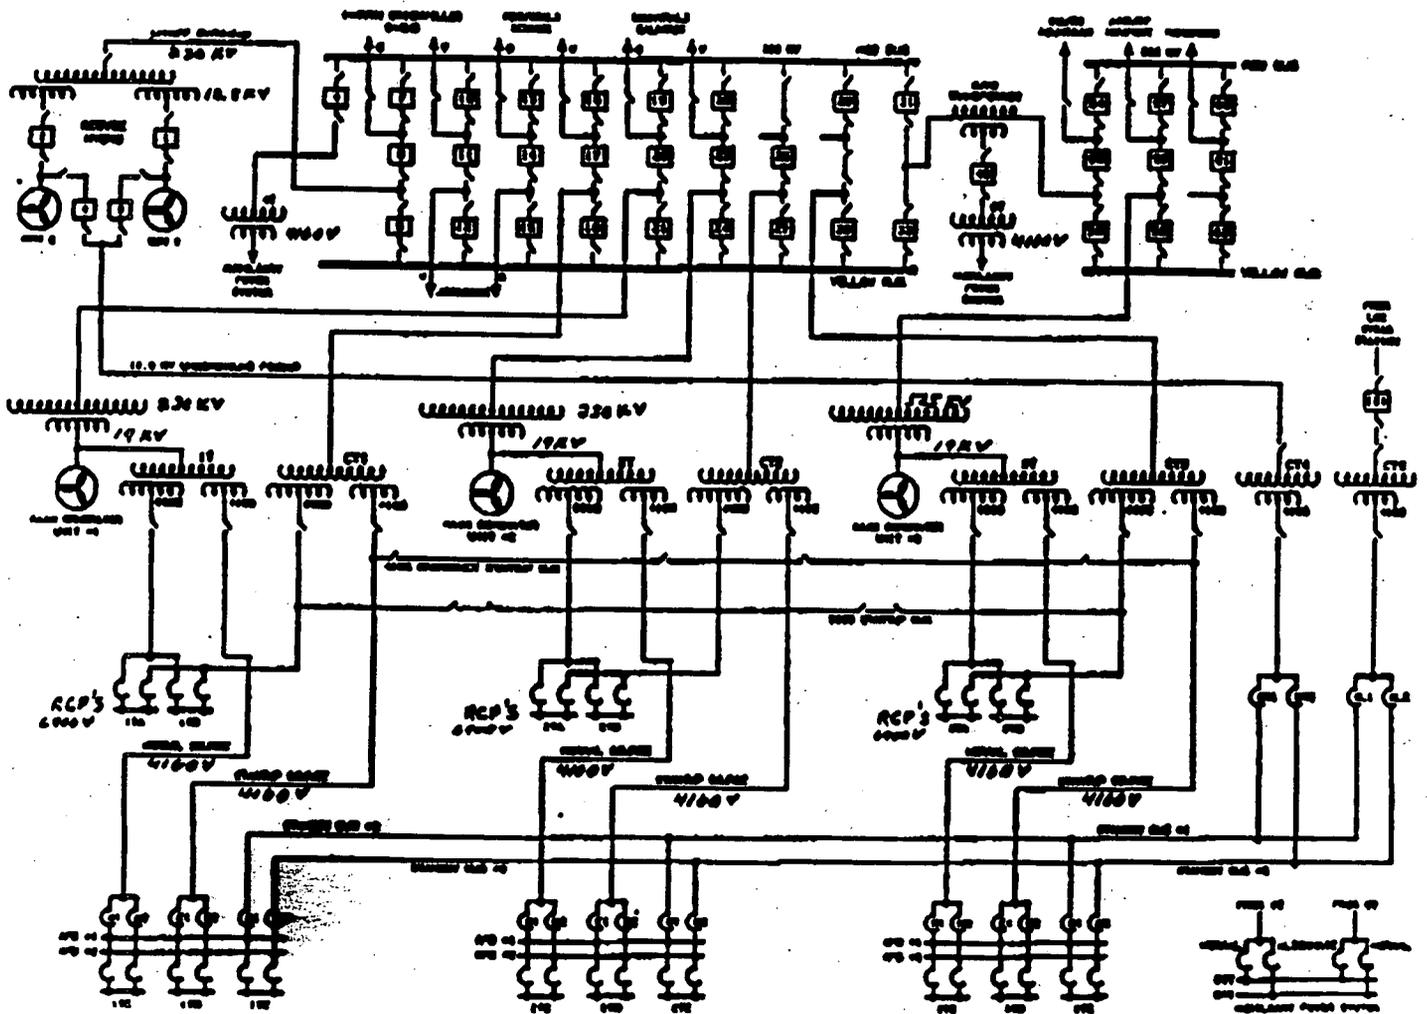
Fig. 1.

Actuation of the AR relay in PCB-24 also caused an Oconee 2 generator transformer lockout, which resulted in a turbine and reactor trip. With PCBs-26 and 27 open and the reactor tripped, Oconee 2 had no source of offsite power available. The External Grid Protective System sensed the loss of voltage and frequency on the Yellow and Red Buses [which indicated a LOOP] and generated a Switchyard Isolation signal. This signal tripped PCBs-8, 9 and 17, loadshed Keowee 1, and gave an emergency start signal to both Keowee units. Oconee 1 and 3 continued to operate.

All three Oconee units have the same generating capacity (850-MWE net) and similar AC power systems (See Fig. 1). Output from the Oconee 1 and 2 generators feed power to the 230-kV switchyard via step-up transformers T1 and T2. The output of Oconee 3 generator feeds the 525-kV switchyard via step-up transformer T3.

The 230-kV and the 525-kV switchyards are divided into two buses designated as the Red Bus and the Yellow Bus. The switchyards are normally operated with both buses energized through a breaker-and-one-half scheme to the grid. The Yellow Bus in the 230-kV switchyard is identified as safety-related. The Keowee hydro station supplies power to the switchyard via an above ground (overhead) path. The overhead path is used to supply power to the Yellow Bus if the grid is lost.

Upon loss of power from an Oconee generating unit and 230-kV switchyard, power is supplied from both Keowee units through two separate and independent paths. One path is a 4000 ft underground 13.8-kV cable feeder to transformer CT-4 which supplies power to the 4160 V standby buses through breakers SK1 and SK2. The underground power path is connected at all times to one hydro unit on a predetermined basis by having either ACB-3 or ACB-4 locked closed. The underground power path and associated transformer are sized to carry full engineered safeguards auxiliaries of one Oconee unit plus auxiliaries for safe shutdown of the other two units. If a Keowee unit is to provide power to an Oconee unit through the underground power path, due to the limited capacity of CT-4, loadshed of non-essential loads from the Oconee units MFBs occurs. The second path from Keowee is a 230-kV transmission line through ACB-1 or ACB-2, via the Yellow Bus, to each Oconee unit's startup transformer.
