UNITED STATES
NUCLEAR REGULATORY COMMISSION
REGION II
101 MARIETTA STREET, N.W.
ATLANTA, GEORGIA 30323

Report Nos.: 50-269/90-16, 50-270/90-16 AND 50-287/90-16

Facility Name: Oconee Units 1, 2 and 3

Inspection Conducted: May 17 - 22, 1990

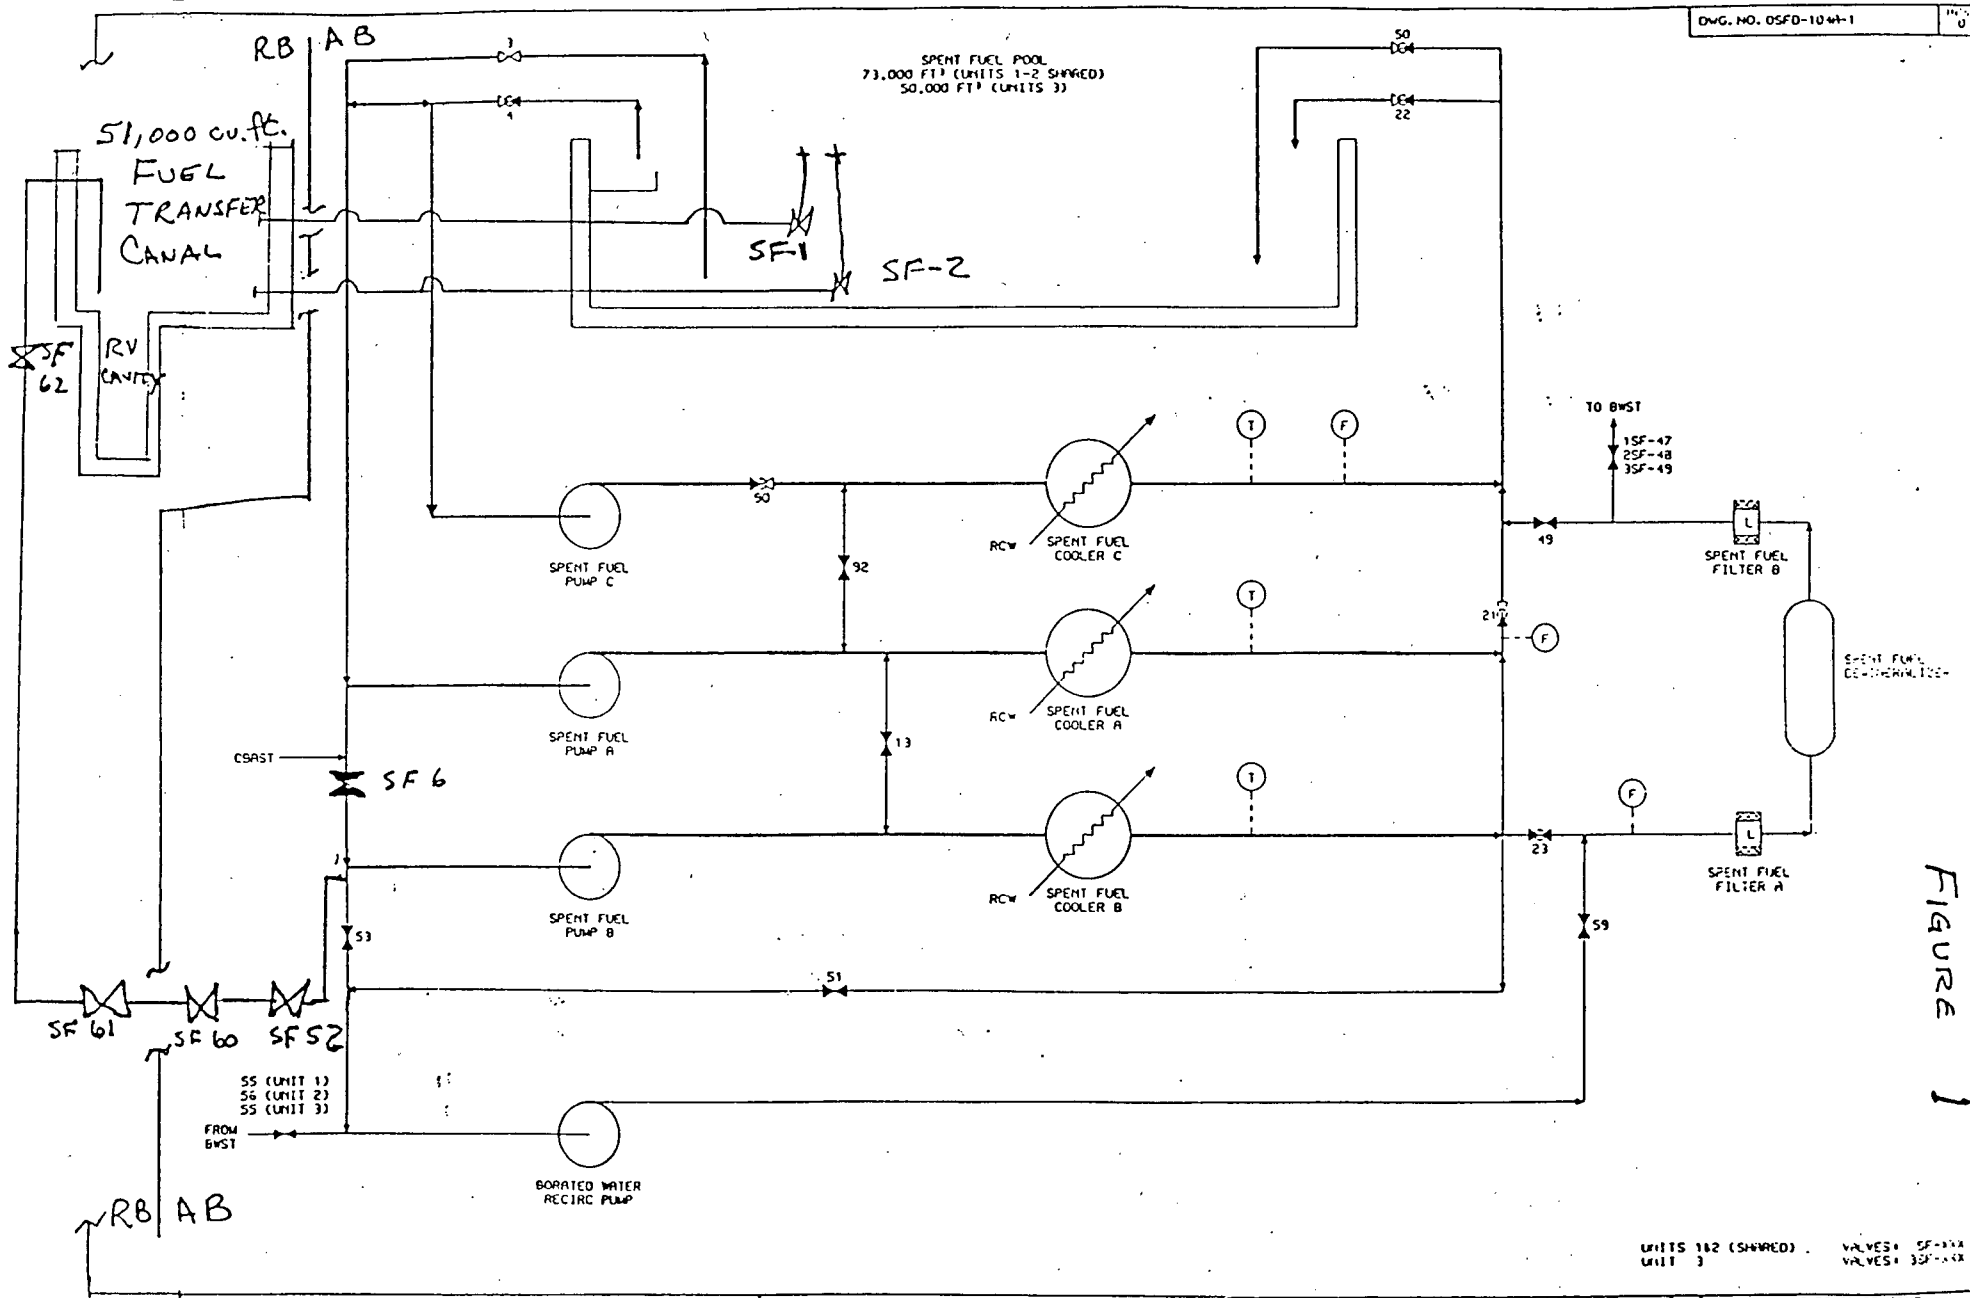
Figure 1

1. General Description Of Spent Fuel Cooling System (See Figure 1)

The SF consist of a common storage pool and three cooling trains (pumps and heat exchanger) which serve both Units 1 and 2. These trains are connected in parallel loops. The number of loops in use depends upon the heat load in the SFP. The SF system also contains two filters and a demineralizer. The system under normal operation takes suction from a high point in the pool and discharges to both a high point and a low point in the pool to keep solids in suspension. The system is designed to limit pool temperature to 205 degrees F or less assuming loss of one train under maximum heat load in the pool. The pool is designed to handle 1312 spent fuel assemblies. During fueling/defueling operations, the SF system pump 'B' is normally aligned to take a suction on the fuel transfer canal and discharge to the spent fuel pool. The suction of pump B is isolated from the suction of pumps A and C at that time.

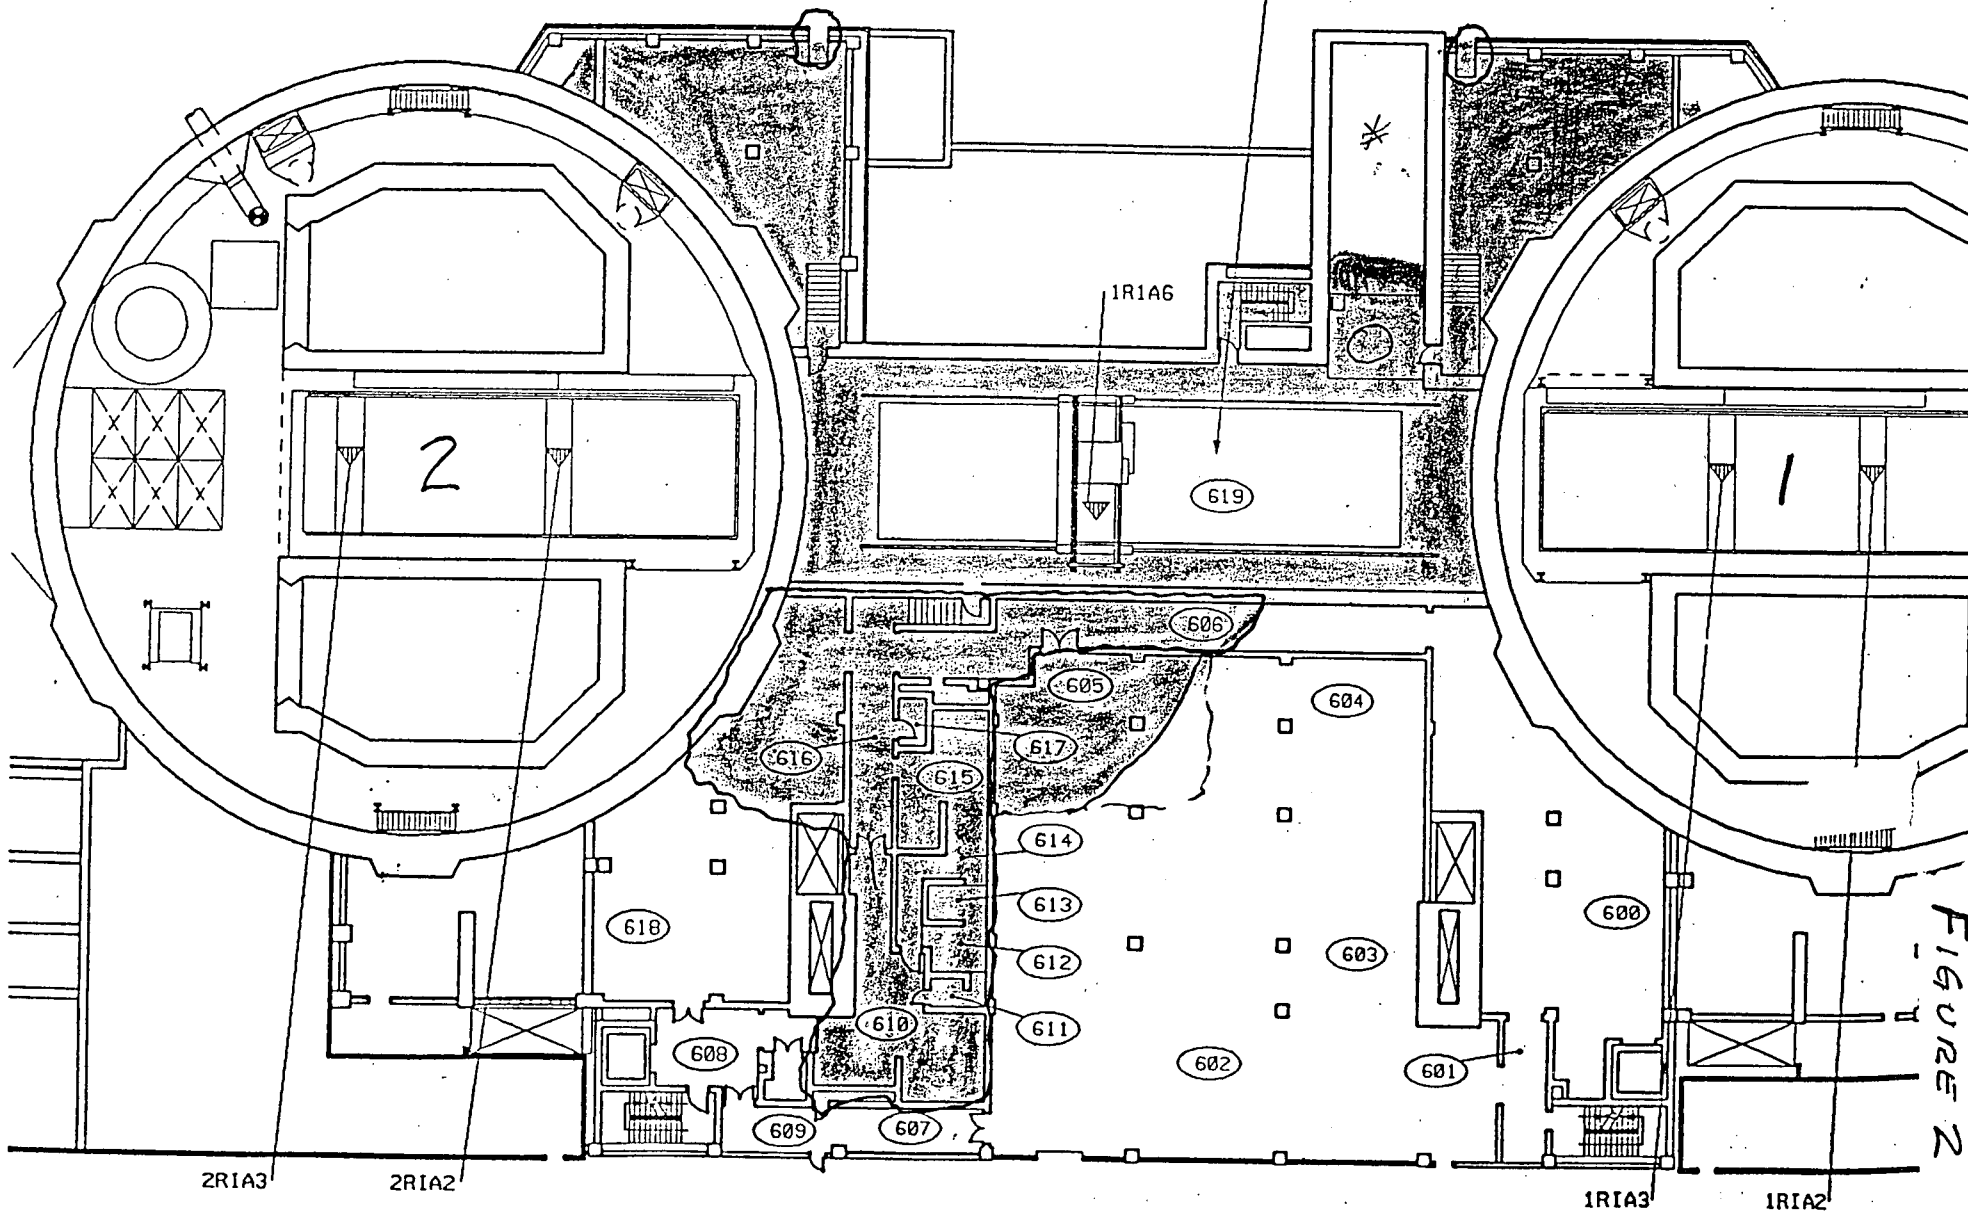
FIGURE 2

- Auxiliary Building - sixth floor (Figure 2) - Spent Fuel Pool, Spent Fuel Pool Change Room, Unit 1 and 2 Purge Rooms, stairs to the Hot Machine Shop, a portion of the Unit 2 Ventilation Equipment Room.

SHADED PORTION SHOWS EXTENT
OF CONTAMINATION

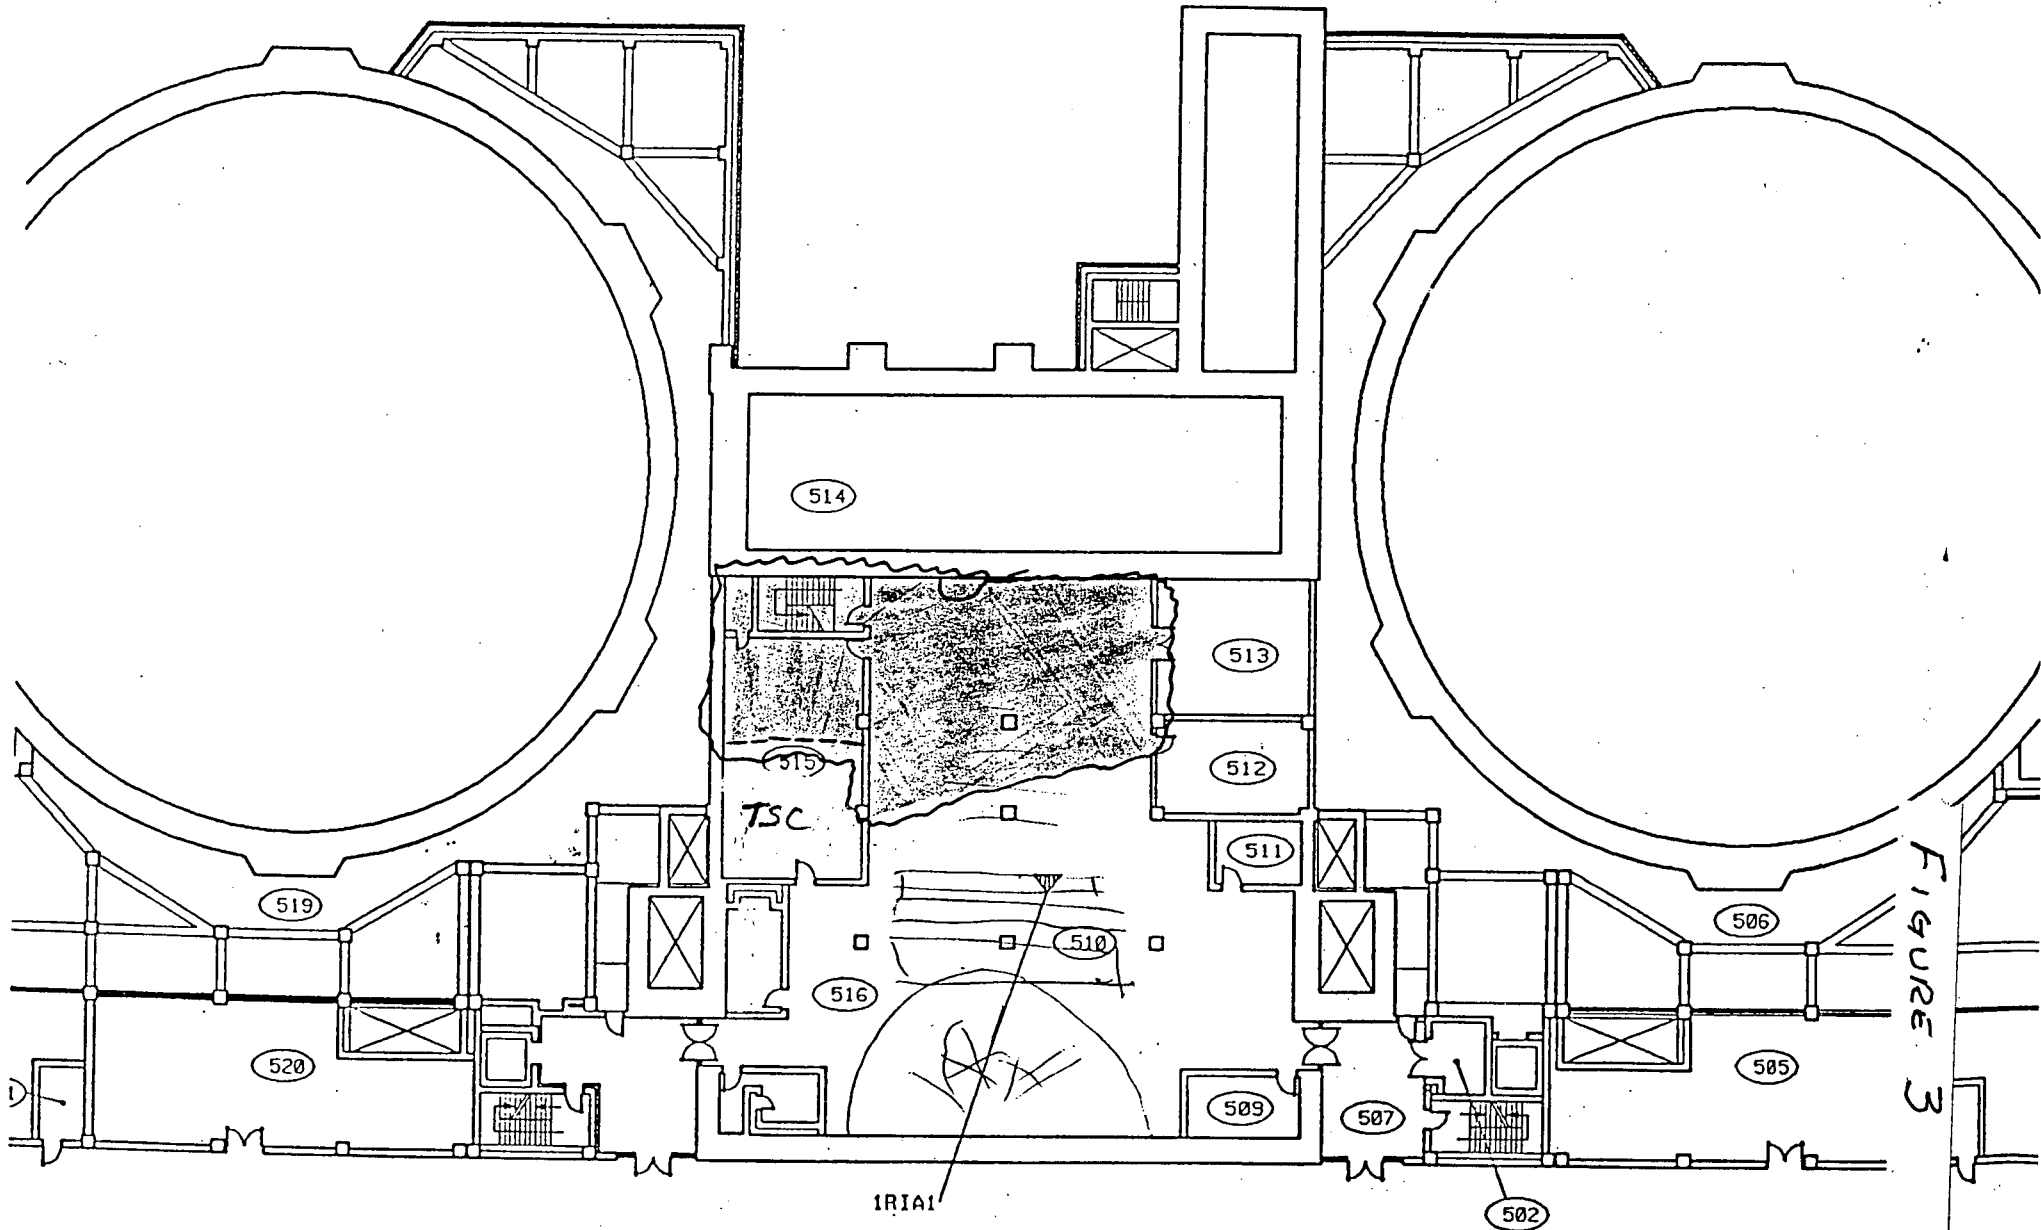
FIGURE 3

- Auxiliary Building - fifth floor (Figure 3) - the portion of the TSC and the Control Room from about 20 feet east of the west wall to the west wall. This did not interfere with normal operation of Unit 2 or Unit 1.

SHADED PORTION SHOWS EXTENT
OF CONTAMINATION

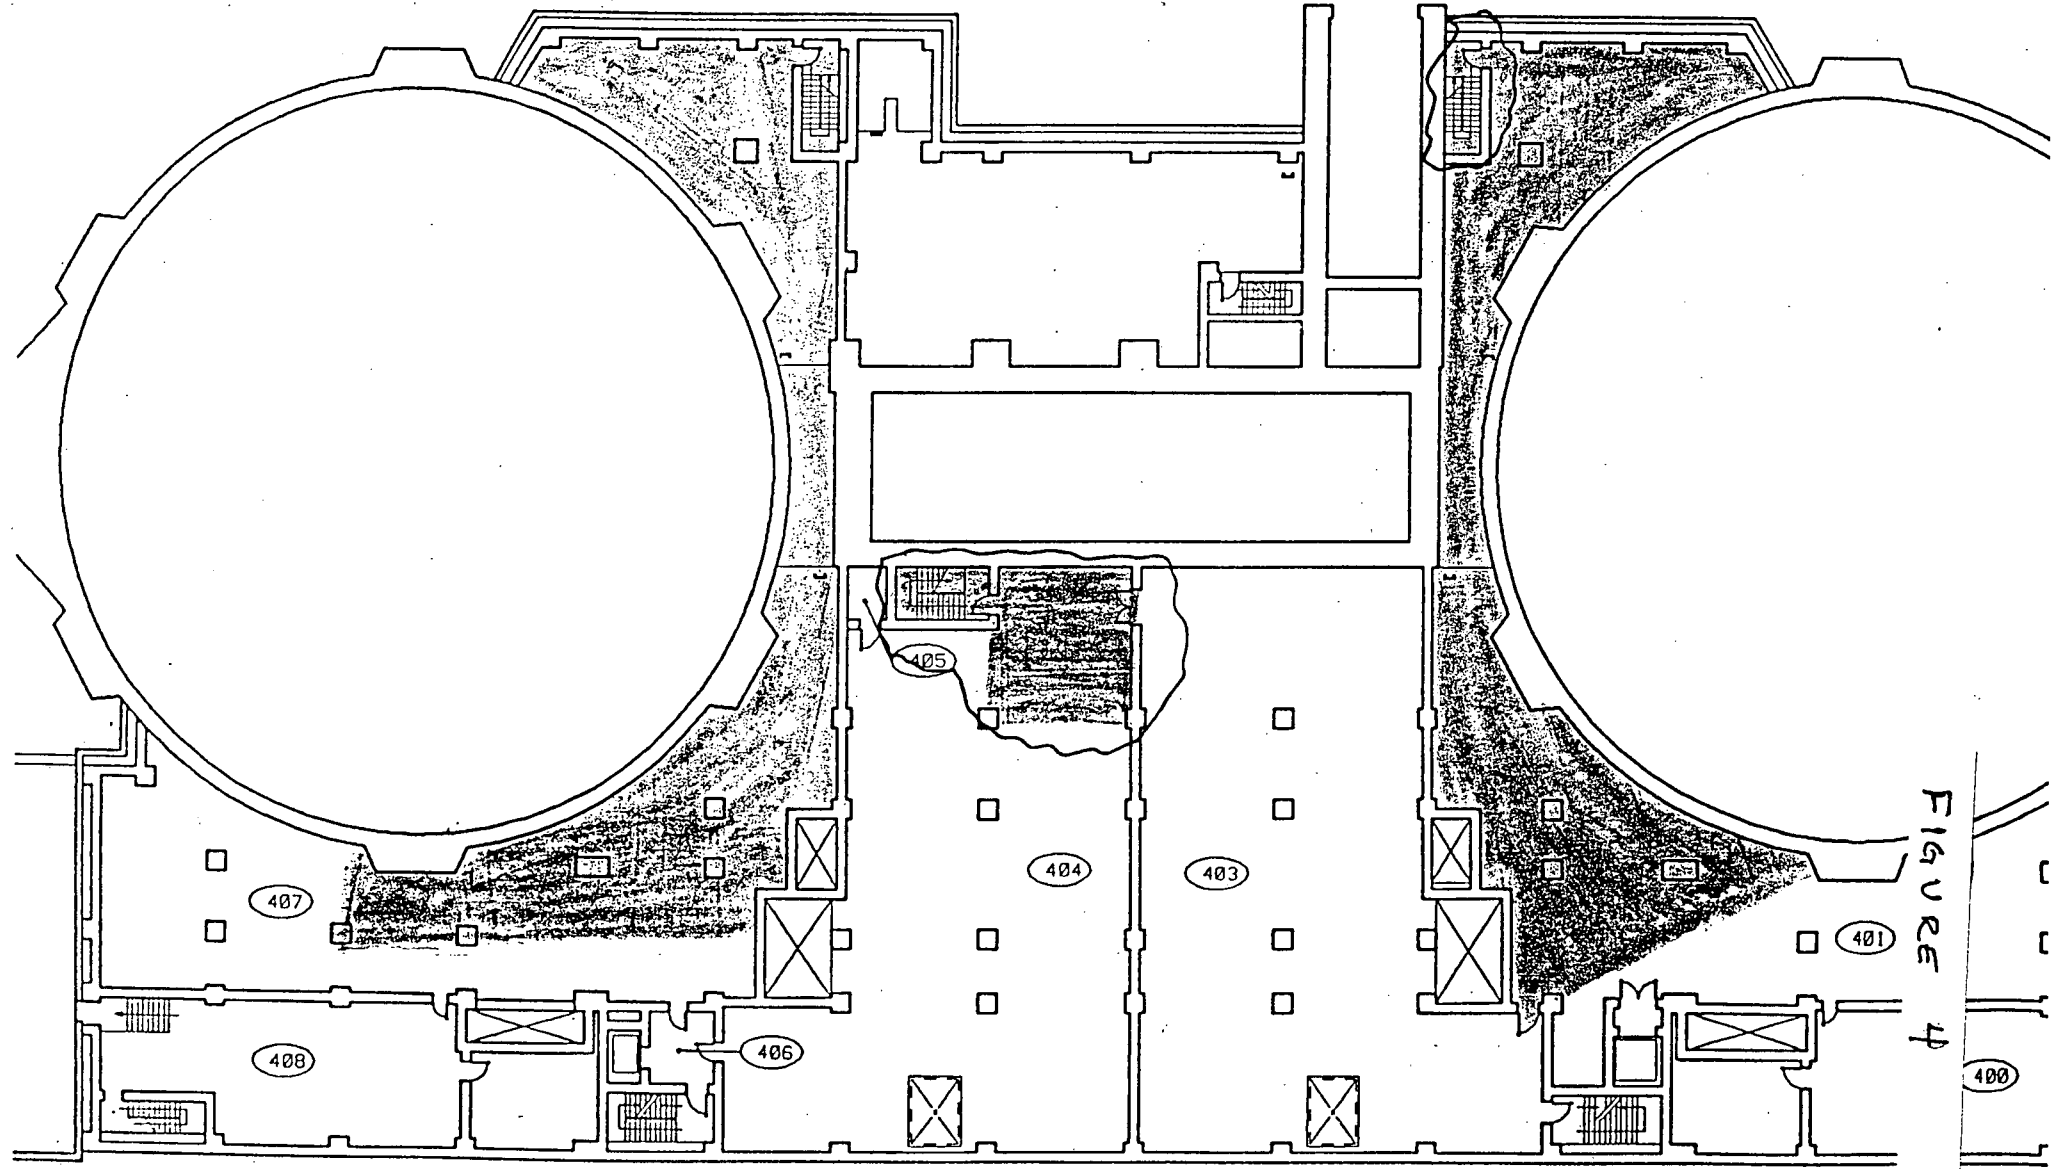
FIGURE 4

- Auxiliary Building - fourth floor - (Figure 4) Unit 1 and 2 West Penetration Rooms and about one half of the East Penetration Rooms.
- Auxiliary Building - third floor (Ground Level -Figure 5) - the area below the East Penetration Room on Units 1 and 2 and the hallway in Unit 1.

SHADED PORTION SHOWS EXTENT
OF CONTAMINATION

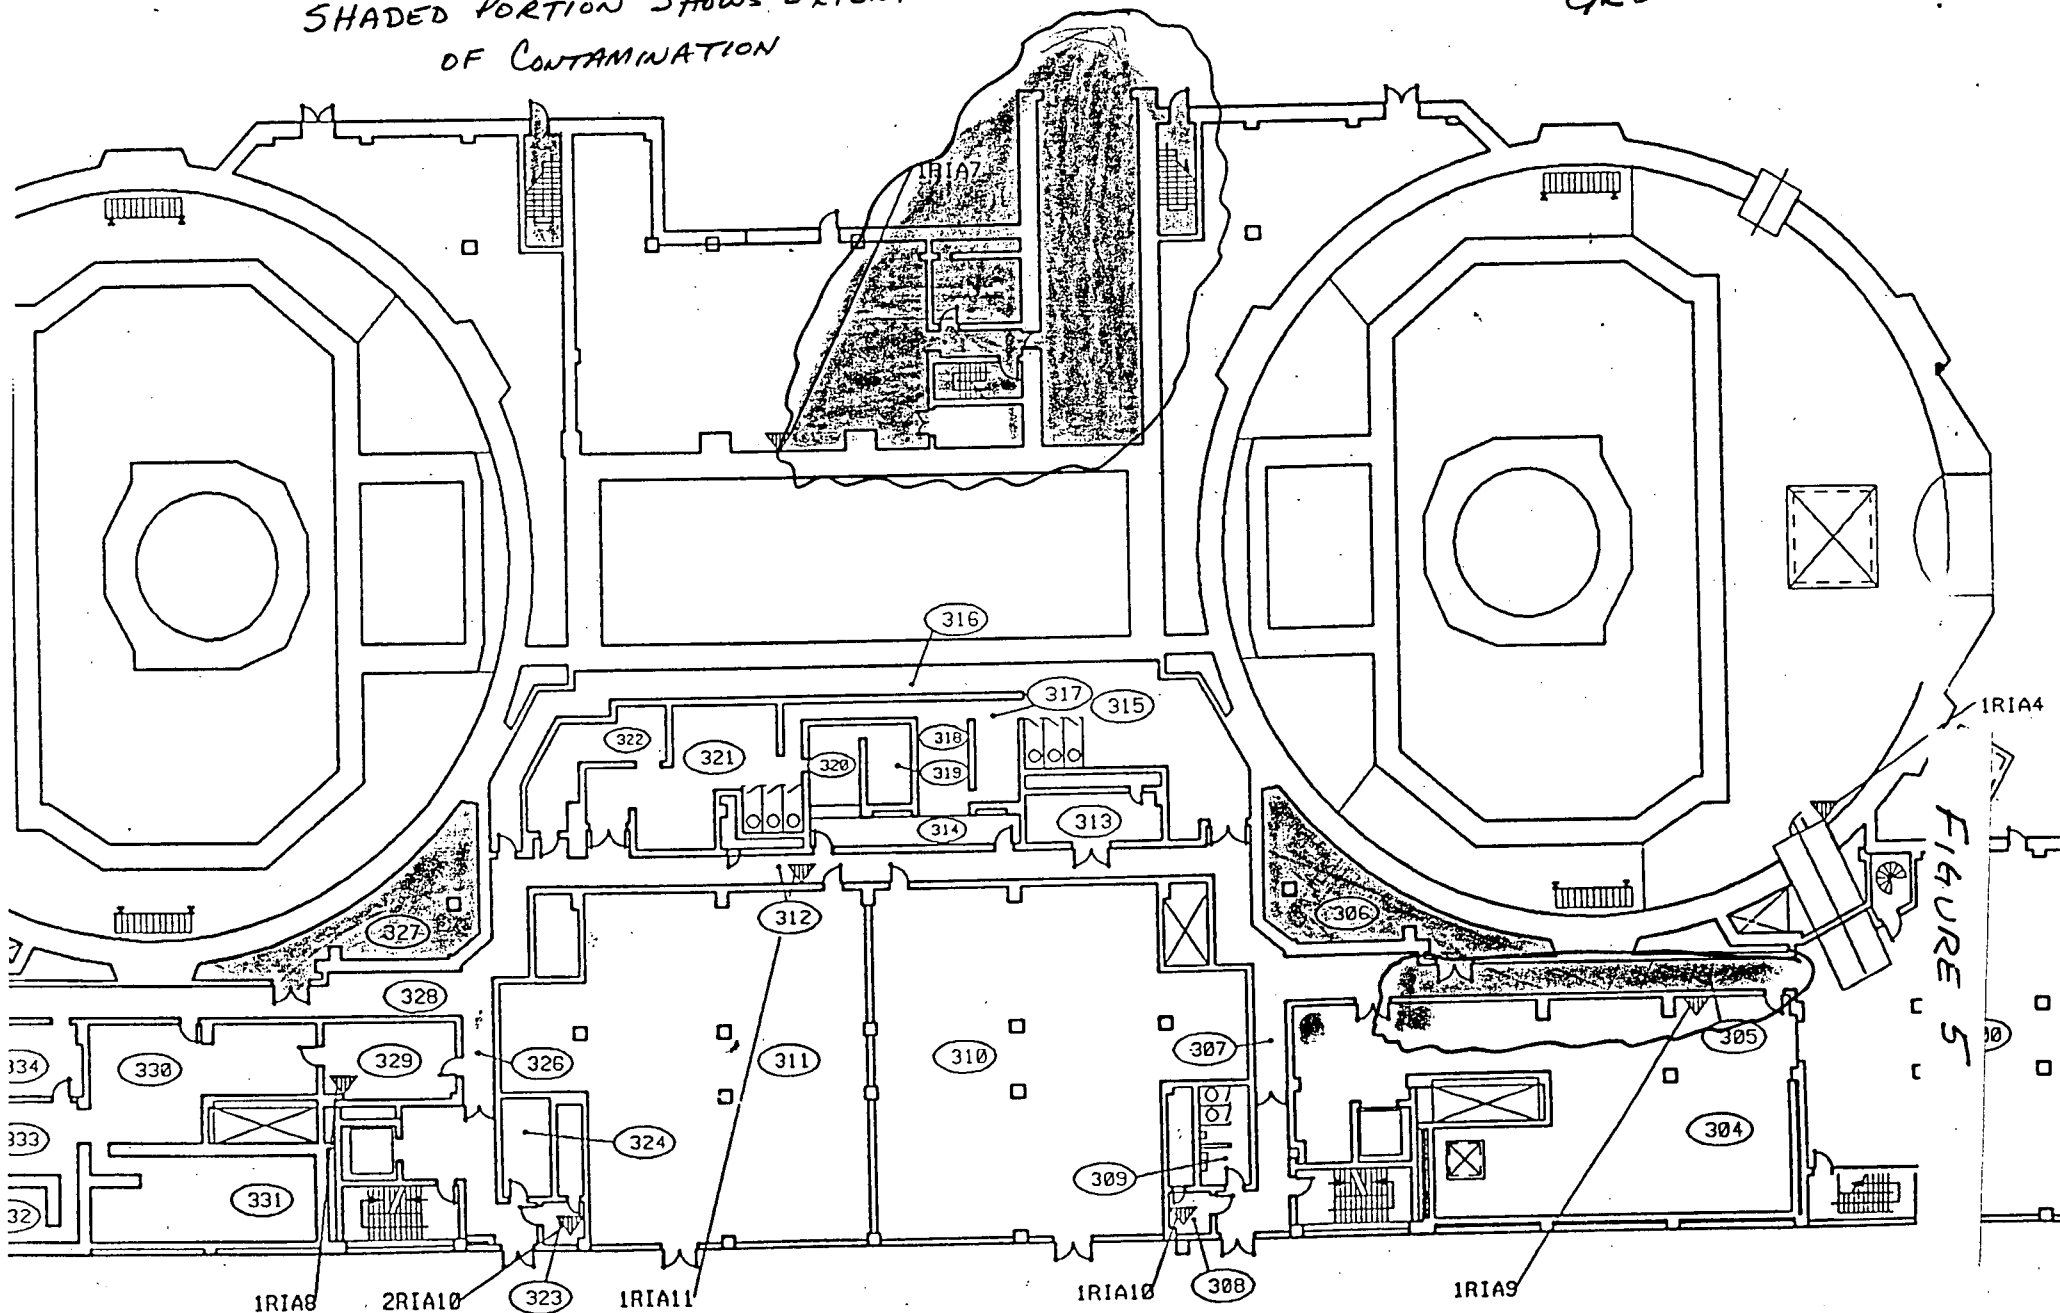
FIGURE 5

- Outside Auxiliary Building (Fuel Receiving Bay)(Figure 5) - ground level between Unit 1 and 2 BWST about 870 square feet was contaminated.

— DECONNED AREAS AS
OF 5/19/90 ≈ 5 P.M.
SHADED PORTION SHOWS EXTENT
OF CONTAMINATION

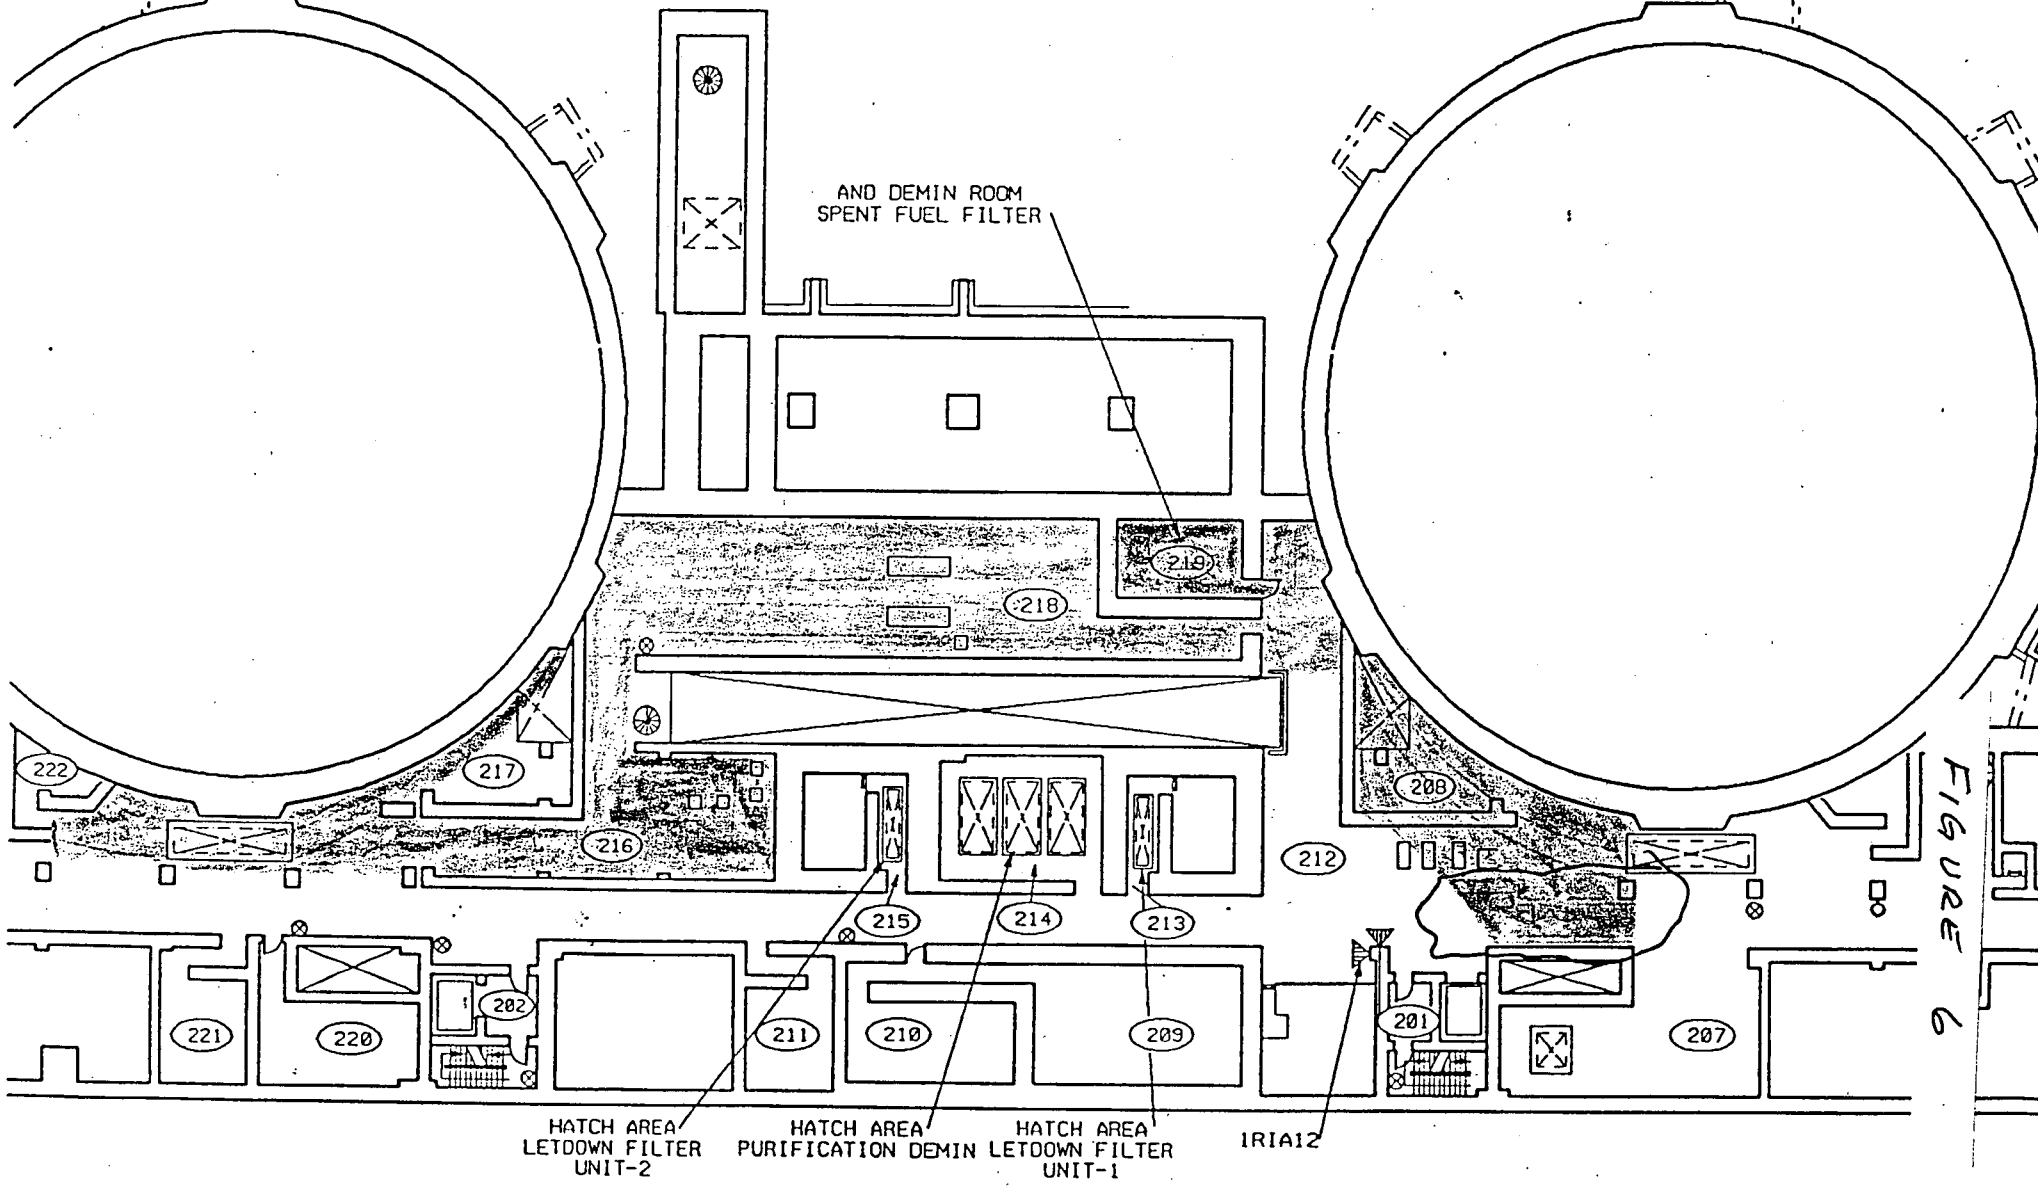
FIGURE 6

- Auxiliary Building - second floor (Figure 6) - Spent Fuel Pool Heat Exchanger and Cooler areas and hallways adjacent to areas directly beneath the East Penetration Rooms.

— DECONNED AREA AS
OF 5/19/90 ≈ 5 P.M.
SHADED PORTION SHOWS EXTENT
OF CONTAMINATION

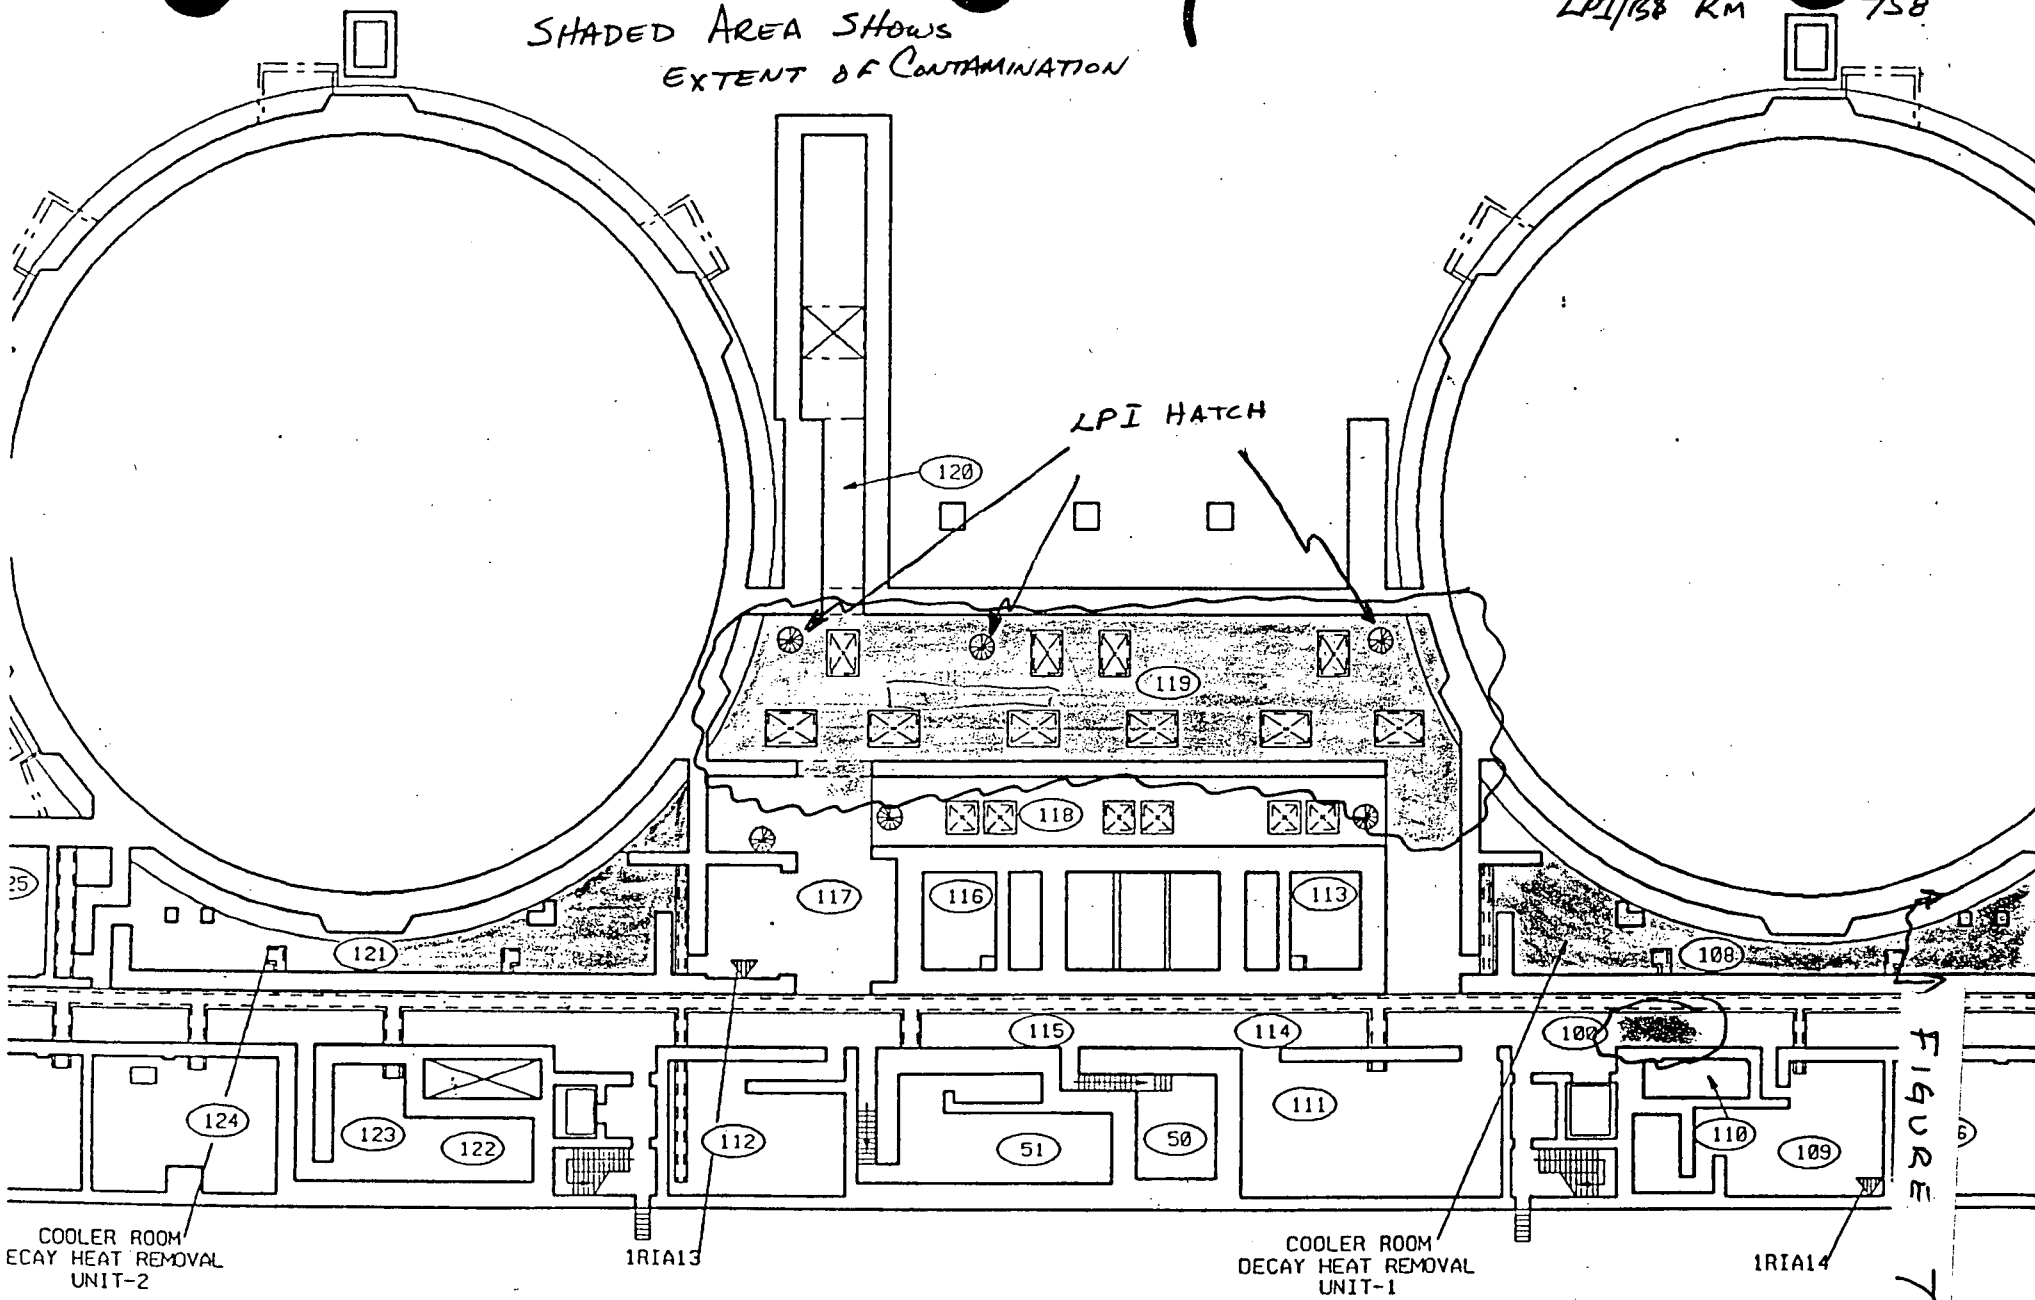
FIGURE 7

- Auxiliary Building - first floor (Figure 7) - Low Pressure and Building Spray Pump rooms Units 1 and 2 and Decay Heat Removal Cooler rooms on Units 1 and 2.

— DECONNED AREA AS
OF 5/19/90 \approx M.
SHADED AREA SHOWS
EXTENT OF CONTAMINATION
