Peach Bottom Atomic Power Station, Units 2 and 3
Renewed Facility Operating License Nos. DPR-44 and DPR-56
NRC Docket Nos. 50-277 and 50-278

Subject: Response to Request for Additional Information Regarding Proposed Relief Request associated with the Common Emergency Service Water (ESW) System Piping for Peach Bottom Atomic Power Station, Units 2 and 3

**Response to Request for Additional Information Regarding
Proposed Relief Request Concerning I4R-56**

Enclosure 1 – ESW Leak NDE UT Results, Response to Question 3

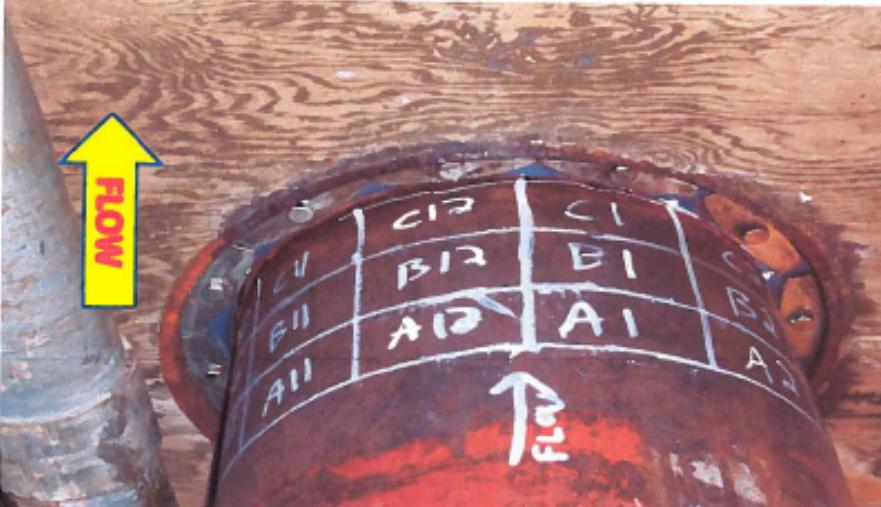
THERMOMETER:	0002834215 Due 6/5/15 CAL TEMP 80° COMP TEMP 70°				9	0.303 "	0.266 "	0.124 "	
DRAWING (If Applicable)	<u>ISO-2-33-17 Leak Upstream of MO-2972</u>

<small>"A thru wall leak was identified on ISO-2-33-17 upstream of MO-2972. Mapping was performed as per ASME Code Case N-513-3. Although the low in C5 is a thru wall leak, the lowest recordable reading of the leak was found to be .034" for continuous monitoring purposes.</small>									
<small>See Attached Page For ISO Bar.</small>									
COMMENTS:									
Grid location C5 was identified as below Engineering Min. Wall criteria. See attached Iso bar.									
Material: A-106 GR. B Carbon Steel.									
Examination Performed in Accordance with ER-AA-335-004 REV. 7									
Reference Min Wall Acceptance Criteria per A1998930-E01									
Surface Condition = Prepped, Paint Removed.									
James Martin / III / 5/4/15 n/a / n/a

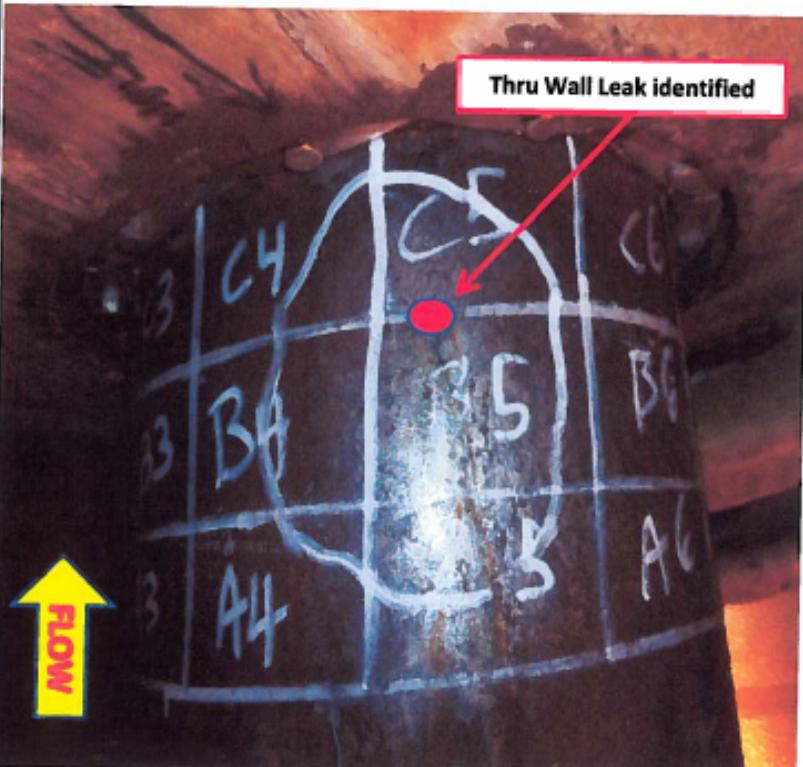
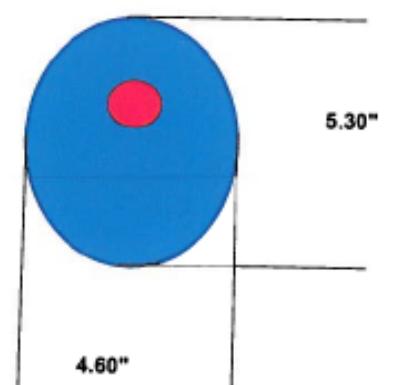
ULTRASONIC EXAMINATION PHOTO SHEET	NDE SUPPORT GROUP
IS0-2-33-17 Leak Upstream of MO-2972

<div style="border: 1px solid black; padding: 2px; display: inline-block; position: absolute; top: 190px; left: 400px; width: fit-content; background-color: white;"> Thru Wall Leak identified </div>		<div style="border: 1px solid black; padding: 5px; margin-bottom: 10px;"> Engineering Minimum Wall Thickness = .063" </div> <div style="display: flex; align-items: center;">

COMMENTS: Area below Engineering Minimum Wall Thickness is .750" rounded, with the area below .328" approximately 4.6" x 5.30".

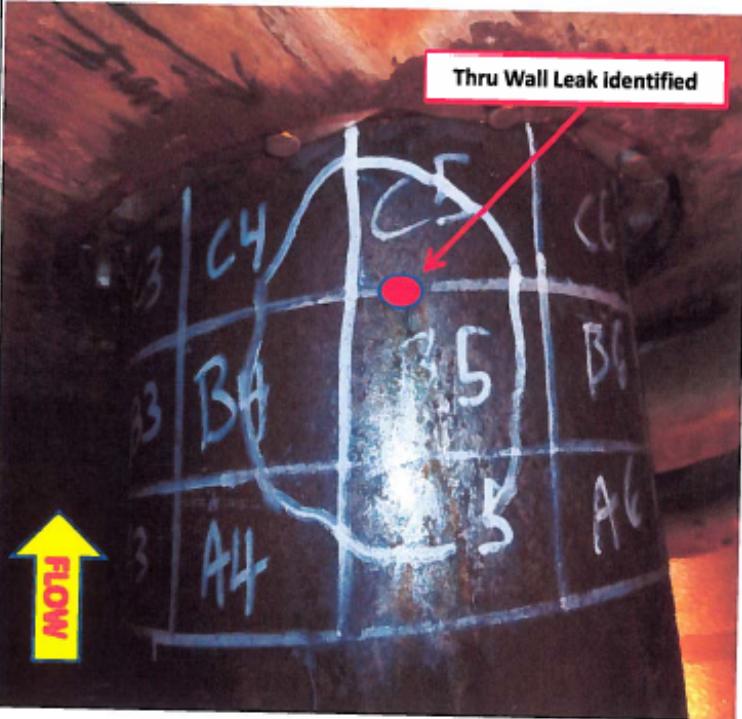
ExelonGeneration,	ULTRASONIC EXAMINATION PHOTO SHEET	NDE SUPPORT GROUP
IS0-2-33-17 Leak Upstream of MO-2972

<p>Thru Wall Leak identified</p> <p>Engineering Minimum Wall Thickness = .063"</p> <p>.750"</p> <p>AXIAL</p> <p>Lm(a) = .750" Lm(c) = .750"</p> <p>Iscbar out .328"</p> <p>5.30"</p> <p>4.60"</p>
<p>COMMENTS: Area below Engineering Minimum Wall Thickness is .750" rounded, with the area below .328" approximately 4.6" x 5.30".</p>		
James Marlin / III NAME / LEVEL	/ 6/15 DATE	n/a NAME / LEVEL / n/a DATE

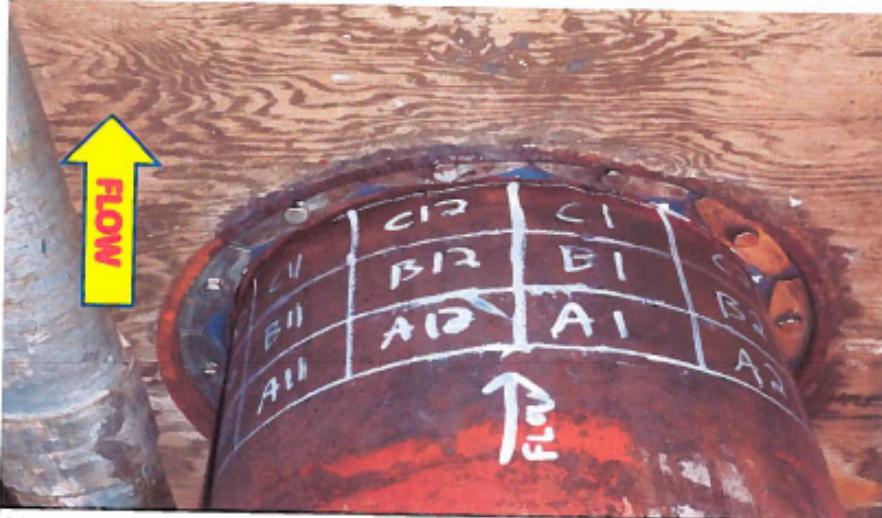
DRAWING (If Applicable)	<u>ISO-2-33-17 Leak Upstream of MO-2972</u>

<small>*A thru wall leak was identified on ISO-2-33-17 upstream of MO-2972. Mapping was performed as per ASME Code Case N-513-3. Although the low in C5 is a thru wall leak, the lowest recordable reading of the leak was found to be .034" for continuous monitoring purposes.</small>			
COMMENTS:	<small>Grid location C5 was identified as below Engineering Min. Wall criteria. See attached Iso bar. Material: A-106 GR. B Carbon Steel. Examination Performed in Accordance with ER-AA-335-004 REV. 7 Reference: Min Wall Acceptance Criteria per A1998930-E01 Surface Condition = Prepped, Paint Removed.</small>								
<small>Calibration</small>						Actual	Meas.		
William Carrasquillo Jr / II	/	6/29/15	n/a	/	n/a	.500"	.500"		
NAME / LEVEL	DATE		NAME / LEVEL	DATE		.300"	.300"		
						.200"	.200"		
						.100"	.100"

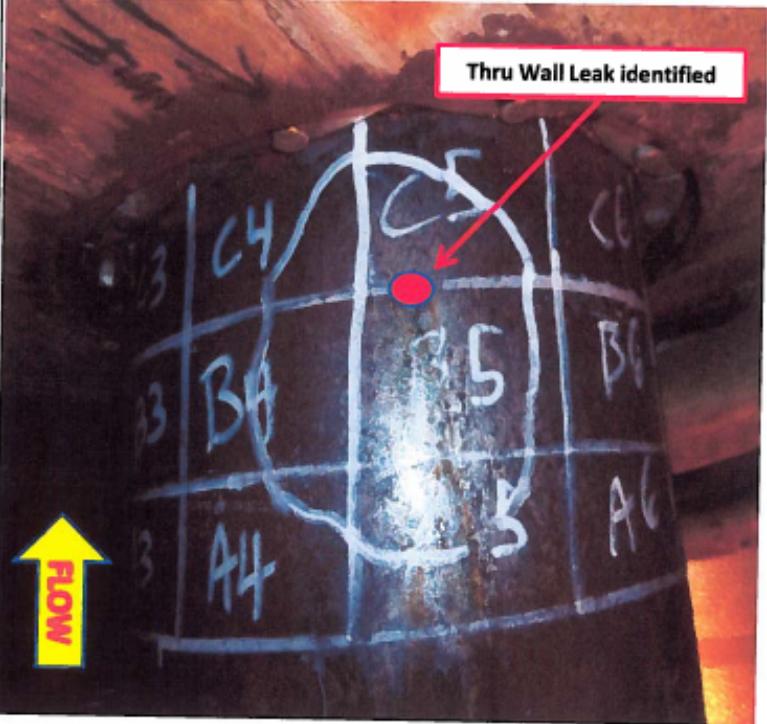
ExelonGeneration.	ULTRASONIC EXAMINATION PHOTO SHEET	NDE SUPPORT GROUP	
ISO-2-33-17 Leak Upstream of MO-2972

<p>Thru Wall Leak identified</p> <p>Engineering Minimum Wall Thickness = .063"</p> <p>.750"</p> <p>.750"</p> <p>AXIAL</p> <p>Lm(a)= .750" Lm(c)= .750"</p> <p>Isober out .328"</p> <p>5.30"</p> <p>4.60"</p>	
<p>COMMENTS: Area below Engineering Minimum Wall Thickness is .750" rounded, with the area below .328" approximately 4.6" x 5.30".</p>			
William Carrasquillo Jr / II NAME / LEVEL	6/29/15 DATE	n/a NAME / LEVEL	n/a DATE

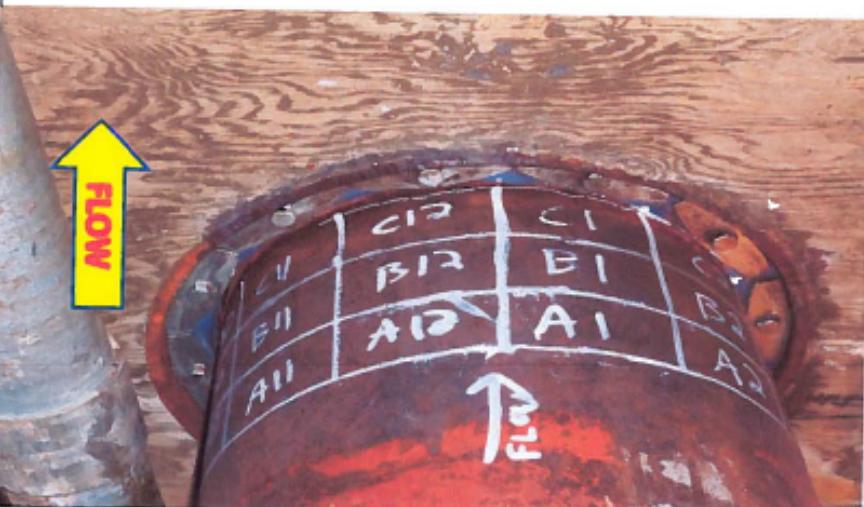
DRAWING (If Applicable)	<u>ISO-2-33-17 Leak Upstream of MO-2972</u>

<small>*A thru wall leak was identified on ISO-2-33-17 upstream of MO-2972. Mapping was performed as per ASME Code Case N-513-3. Although the low in C5 is a thru wall leak, the lowest recordable reading of the leak was found to be .034" for continuous monitoring purposes.</small>										
<small>30 Day inspection was performed on Grid Location C5. No change in the flaw dimension was observed.</small>										
COMMENTS:										
<small>Grid location C5 was identified as below Engineering Min. Wall criteria. See attached Iso bar. Material: A-106 GR. B Carbon Steel.</small>										
<small>Examination Performed in Accordance with ER-AA-335-004 REV. 7 Reference: Min Wall Acceptance Criteria per A1998930-E01 Surface Condition = Prepped, Paint Removed.</small>										
<small>Calibration</small>										
<small>Actual Meas.</small>

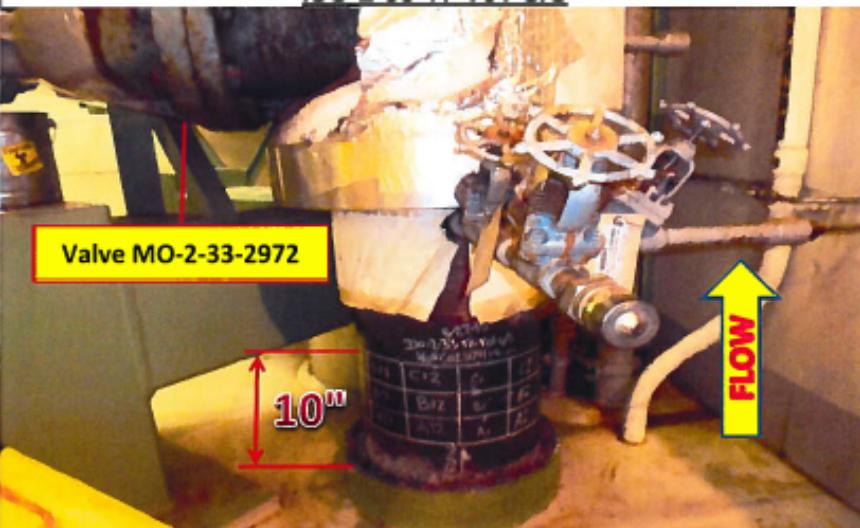
DRAWING (If Applicable)	ISO-2-33-17 V01 U/S

No Readings found below Min Wall.	
											Grid Band ends 10" D/S of Top of Pipe Collar.	
COMMENTS:												
Lowest reading found was .0181" in Grid Box C8.											Calibration	
Grid Boxes were dynamically scanned with the lowest reading recorded at each location.											Actual	Meas.
No readings were identified as below Engineering Min. Wall criteria.											.500"	.500"
Reference Procedures ER-AA-335-004 REV. 7 / Reference Drawing ISO-2-33-17 V01 U/S											.400"	.400"
Reference Acceptance Criteria per A1999B98-E01											.300"	.300"
Surface Condition = Prepped, Paint Removed. Material: Carbon Steel.											.200"	.200"
William Carrasquillo Jr / LII		5/27/15	James Martin / LII		5/27/2015	NAME / LEVEL	DATE	NAME / LEVEL	DATE	.100"	.100"
