LOST CREEK ISR, LLC

MEMO

Subject: Incident Investigation for Release of Yellowcake through Dryer 1 Packing

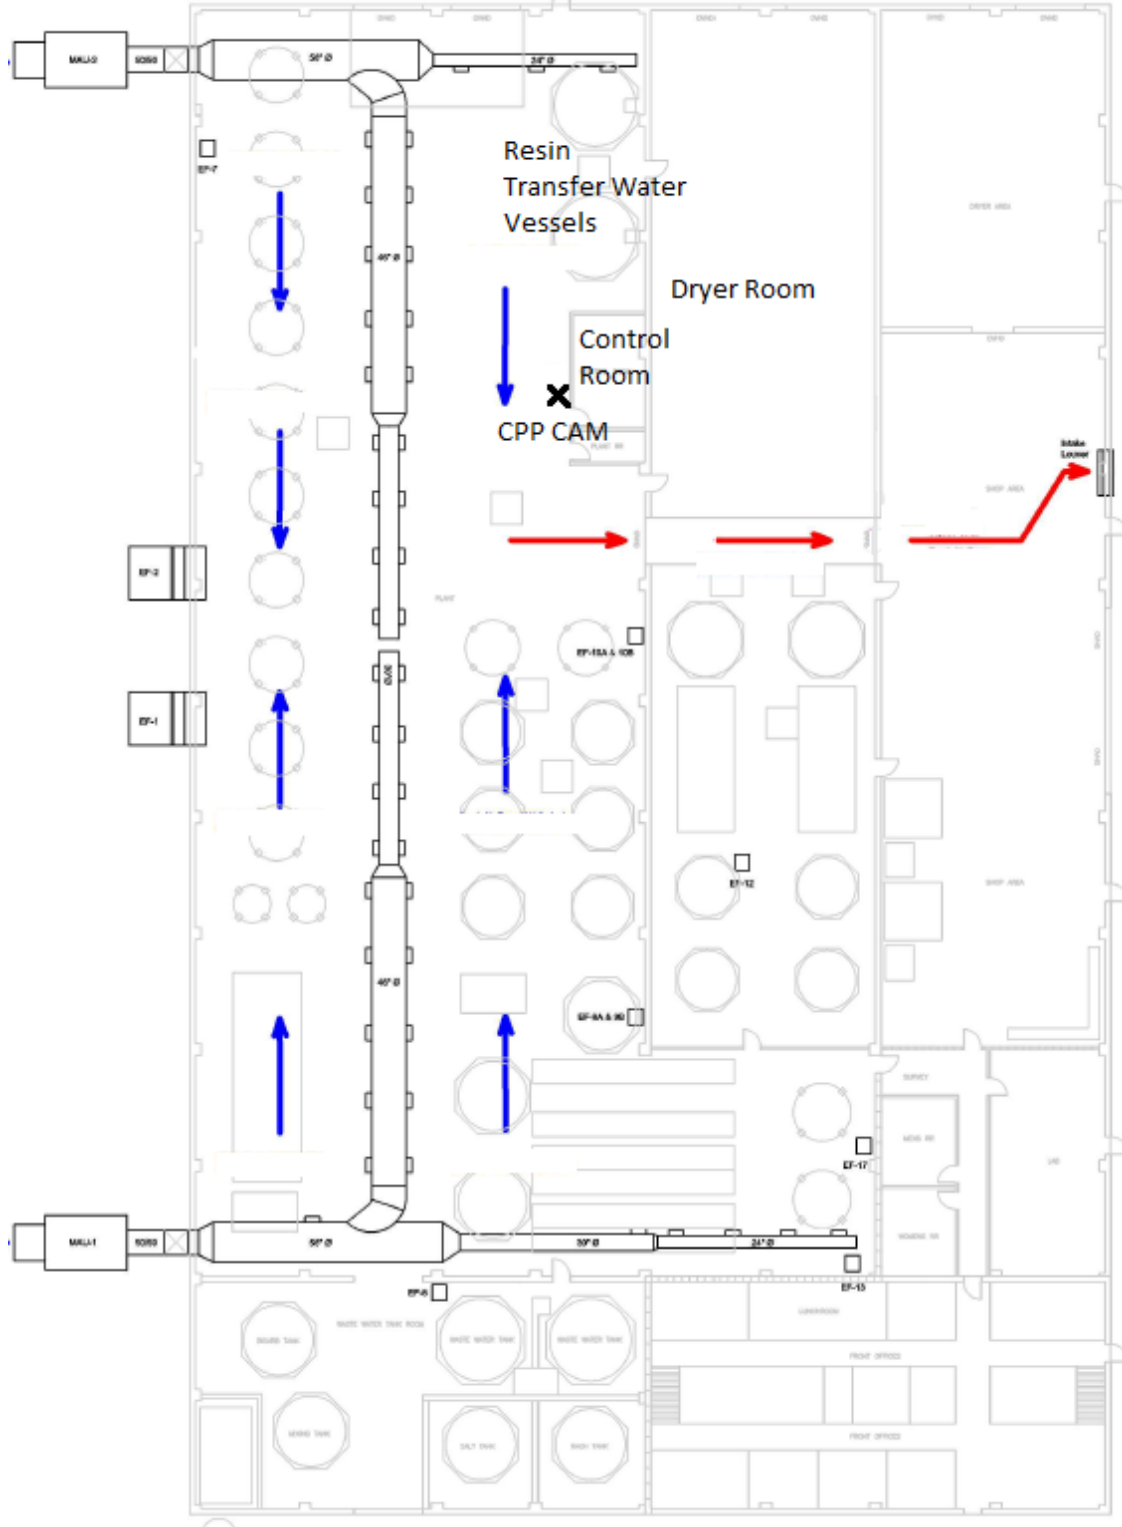
Figure 2: Plant Ventilation Air Flow

In order for uranium to be collected on the CPP CAM filter the airborne uranium would have to leave the dryer room. Based on the airflow of the plant ventilation (see Figure 2) the most likely place for a release from the dryer room detected on the CPP CAM would have to come from the wall shared by the control room/resin water transfer area and the dryer room.

A plant maintenance worker and the RSO inspected the wall above the control room and behind the Resin Transfer Water Vessels. There were two potential holes noted where the insulation meets the I-beam on the ceiling. The holes appear to have some yellow residue settled on the insulation within a few inches of the hole. Due to obstructions and safety considerations the residue was not sampled.
