HOLTEC INFORMATION BULLETIN (HIB)*

Title of the Bulletin: VCT Restraint Strap Weld Failure

CoC Holder:	Holtec International	HIB No. (sequential):	67	Revision Log:		
				Name	Date	
System Name:	Lift System VCT	Ref. Nuclear Plant:	Diablo Canyon Power Plant	Author (Rev. 0):	Arthur Barrett	7/28/15
				Reviewer (Rev 0):	Robert Tindal	7/28/15
Holtec Program No.:	1027	Period of Occurrence (m/y):	05/2015	Author (Rev. 1):		
				Reviewer (Rev 1):		
Affected Component(s):	Diablo VCT	Affected equipment or part	Diablo Lift Systems VCT	Author (Rev. 2):		
				Reviewer (Rev 2):

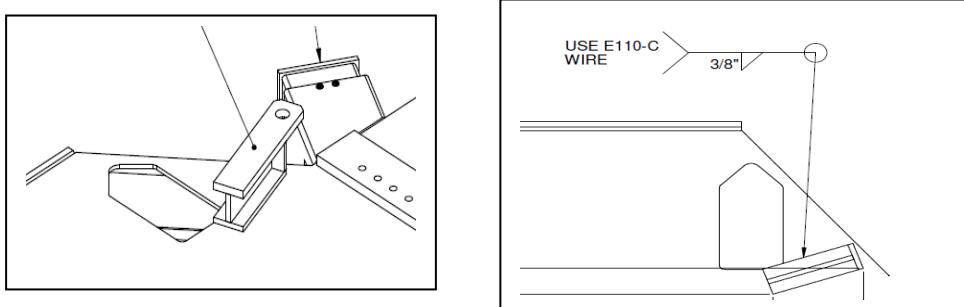
Diablo Canyon has a Lift Systems VCT, which was the first generation of transporters supplied by Holtec to its clients. Upon review, Diablo's Lift System design is unique as it pertains to the strap cylinder mount and the weld at the base. The RH Chassis Assembly part number is identified as 103862. See below for the design and weld detail for the strap cylinder mount.

The Diablo VCT was designed to withstand a high seismic event as well be able to climb steep inclines. Therefore the belly band and cylinder are much larger than those provided with the standard VCT used at every other site. The failure of the weld occurred while tightening the belly band as required by procedure.

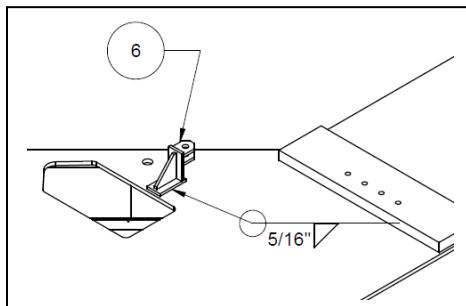
Thirteen (13) other Lift System VCT's were fabricated and delivered to clients. These thirteen other systems were reviewed and all had a different RH Chassis Assembly part number than Diablo's design. All but one had a 100393A part number. See below for the strap fitting mount for the other VCT's.

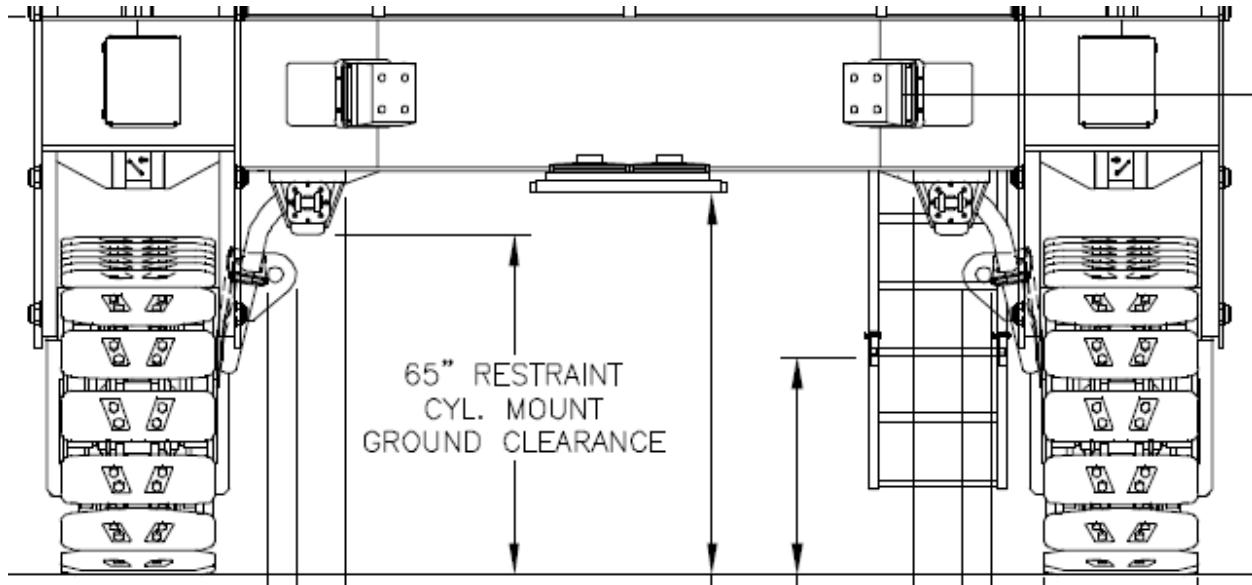
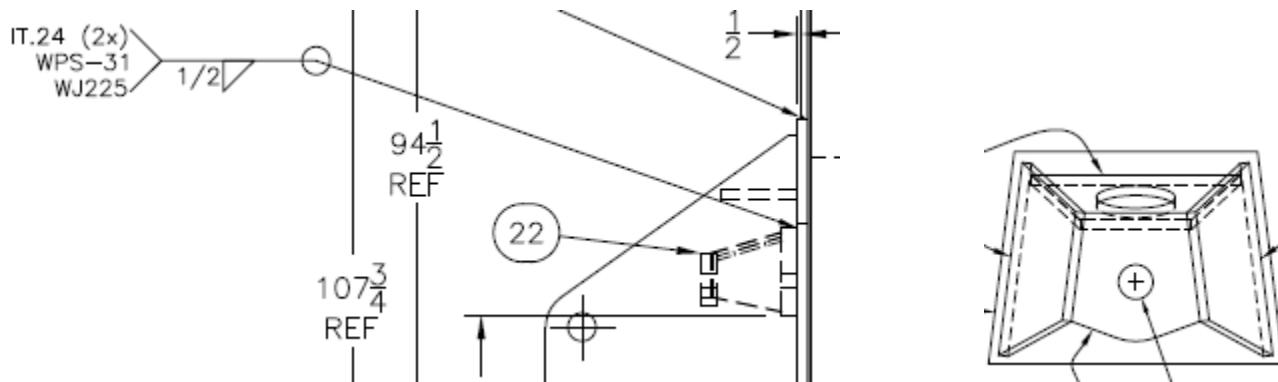
J&R Engineering

for each mounting system design. Both designs are shown below. J&R has the mounting welded to the underside of the VCT with a $\frac{1}{2}$ " all around fillet weld. MMH/KoneCranes design consisted of a pin connection with a welded subassembly to the VCT top deck. Both designs differ from the Lift Systems design and there is no reason to think that these designs are inadequate for their intended use.

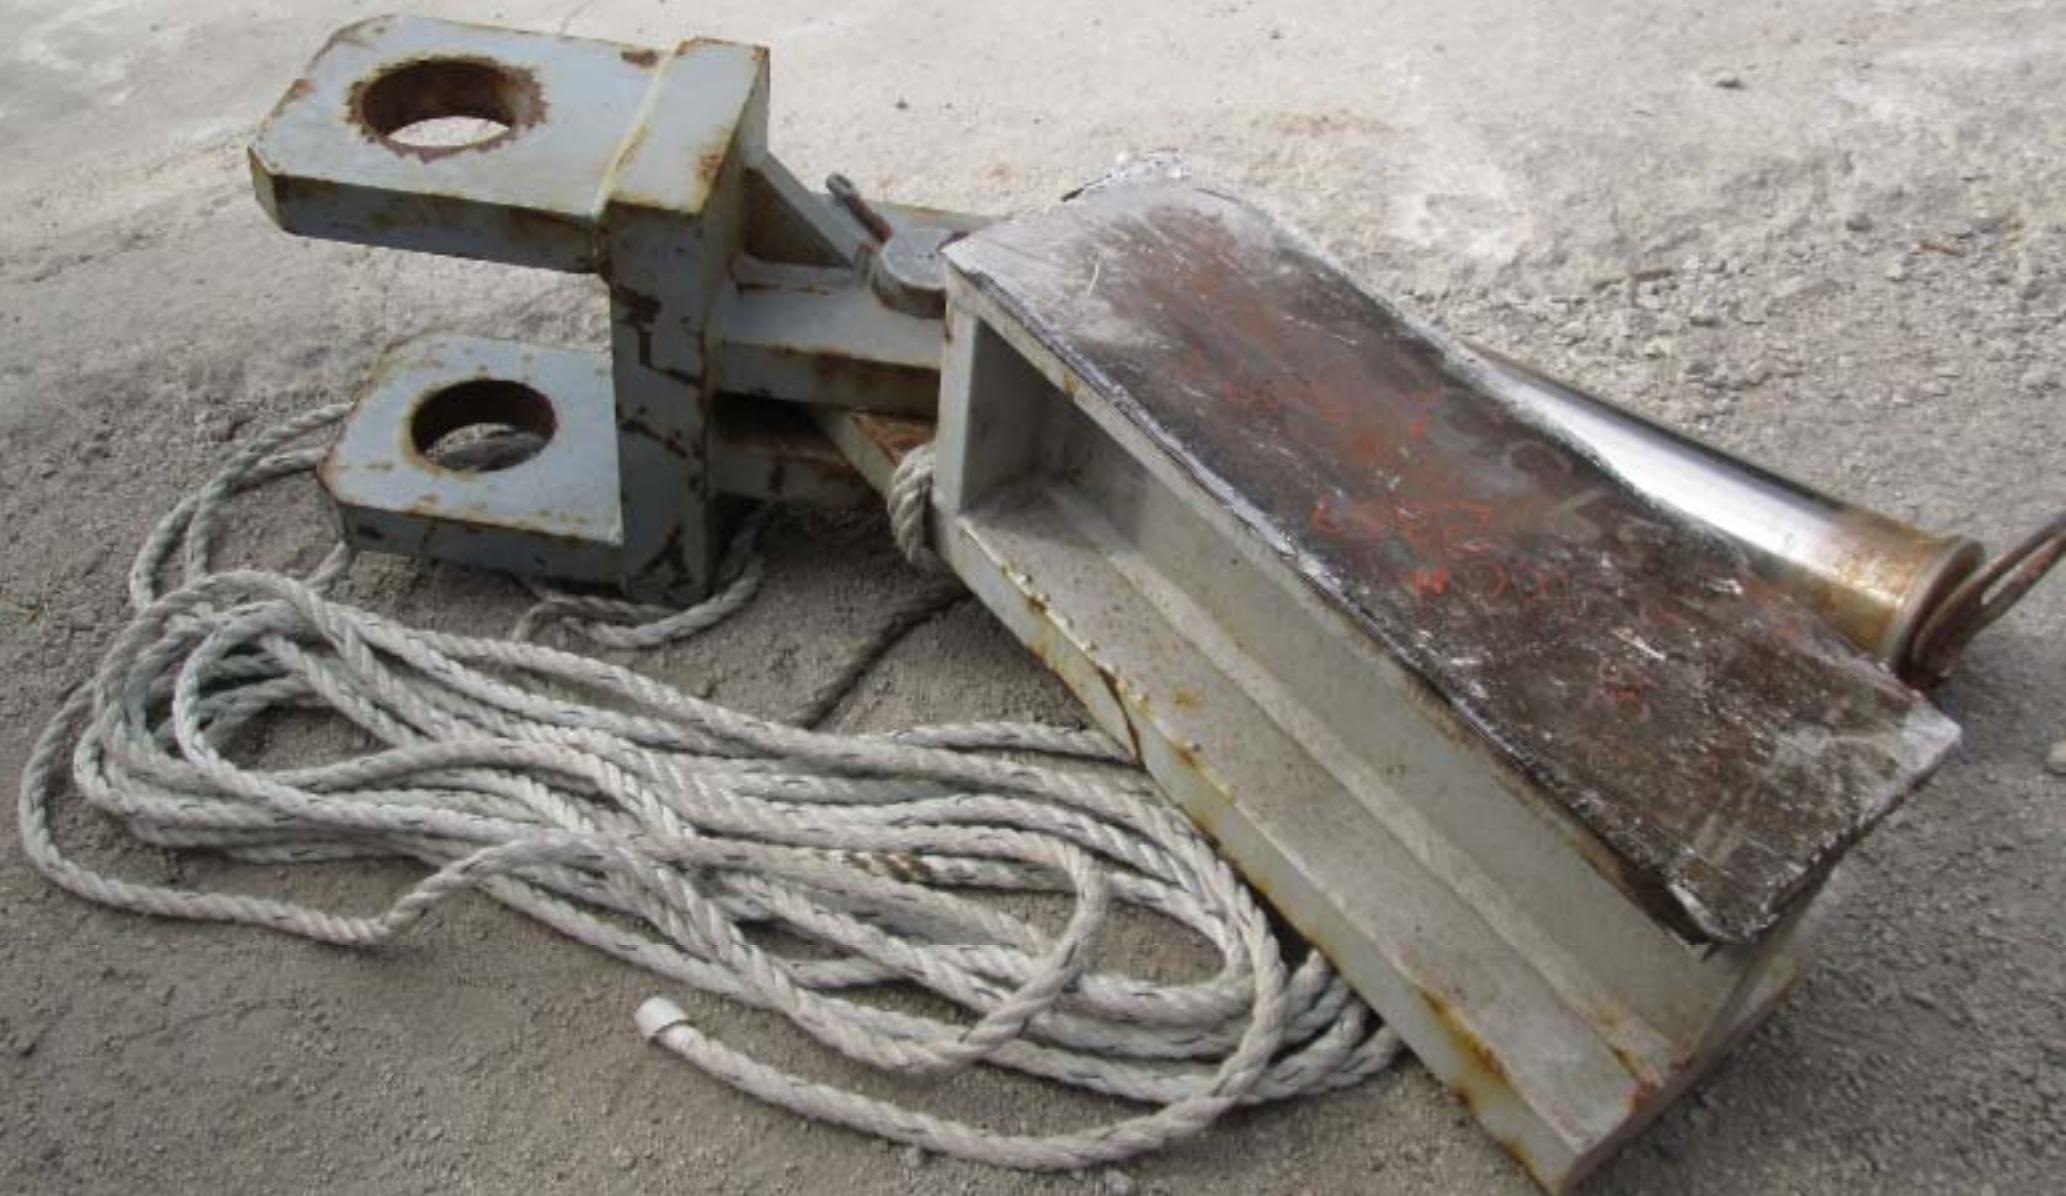
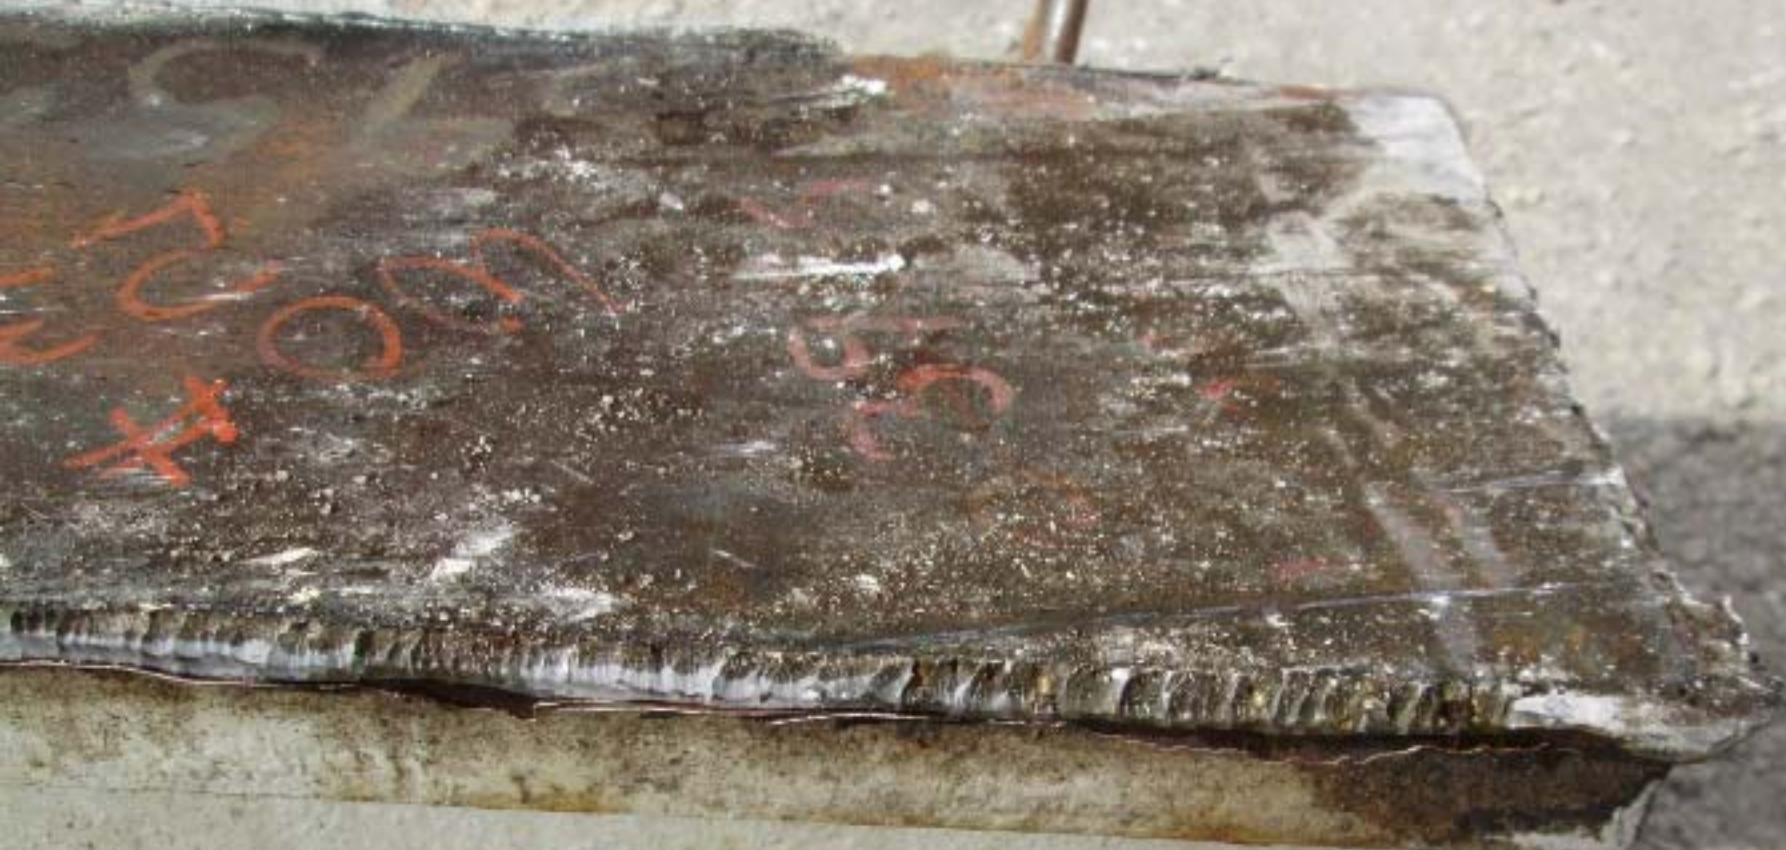
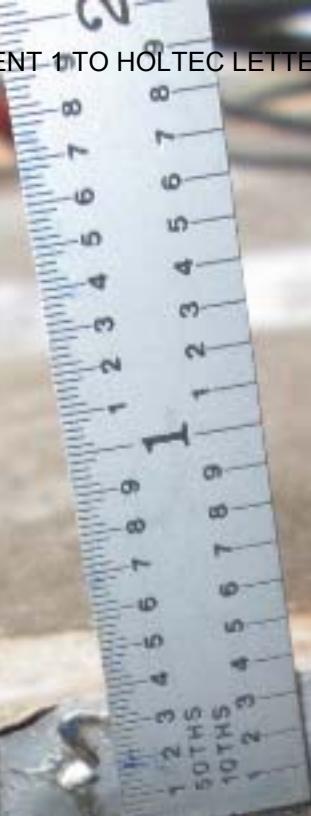
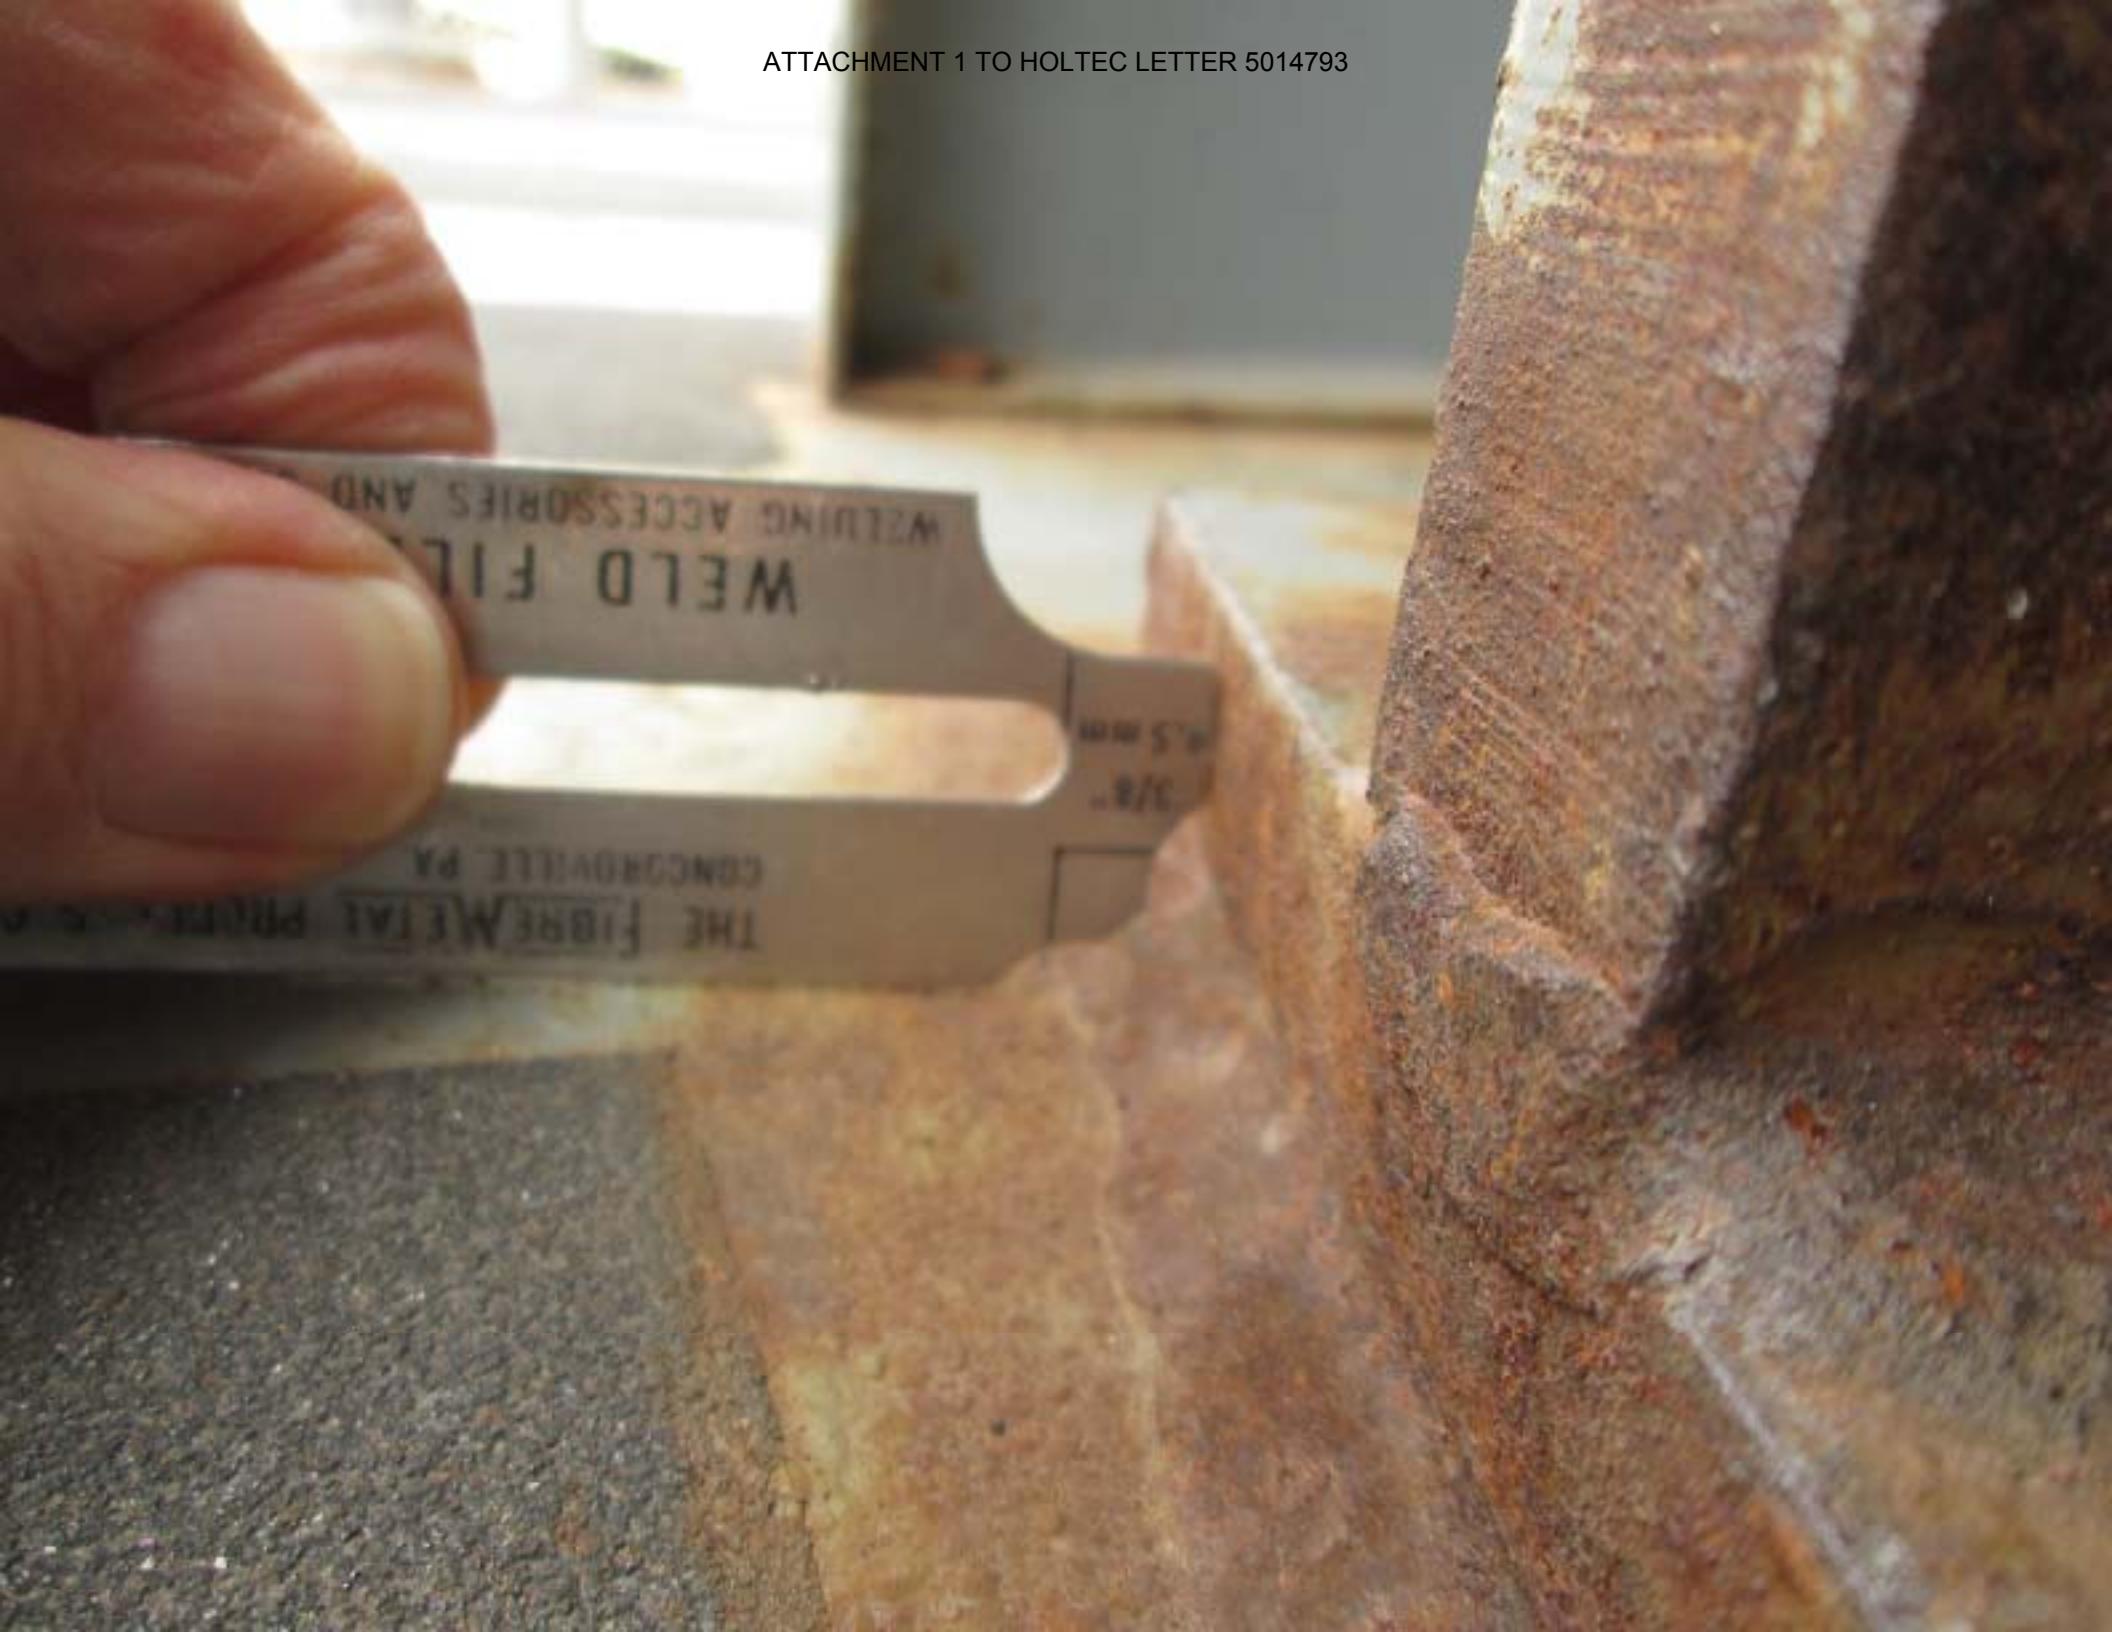
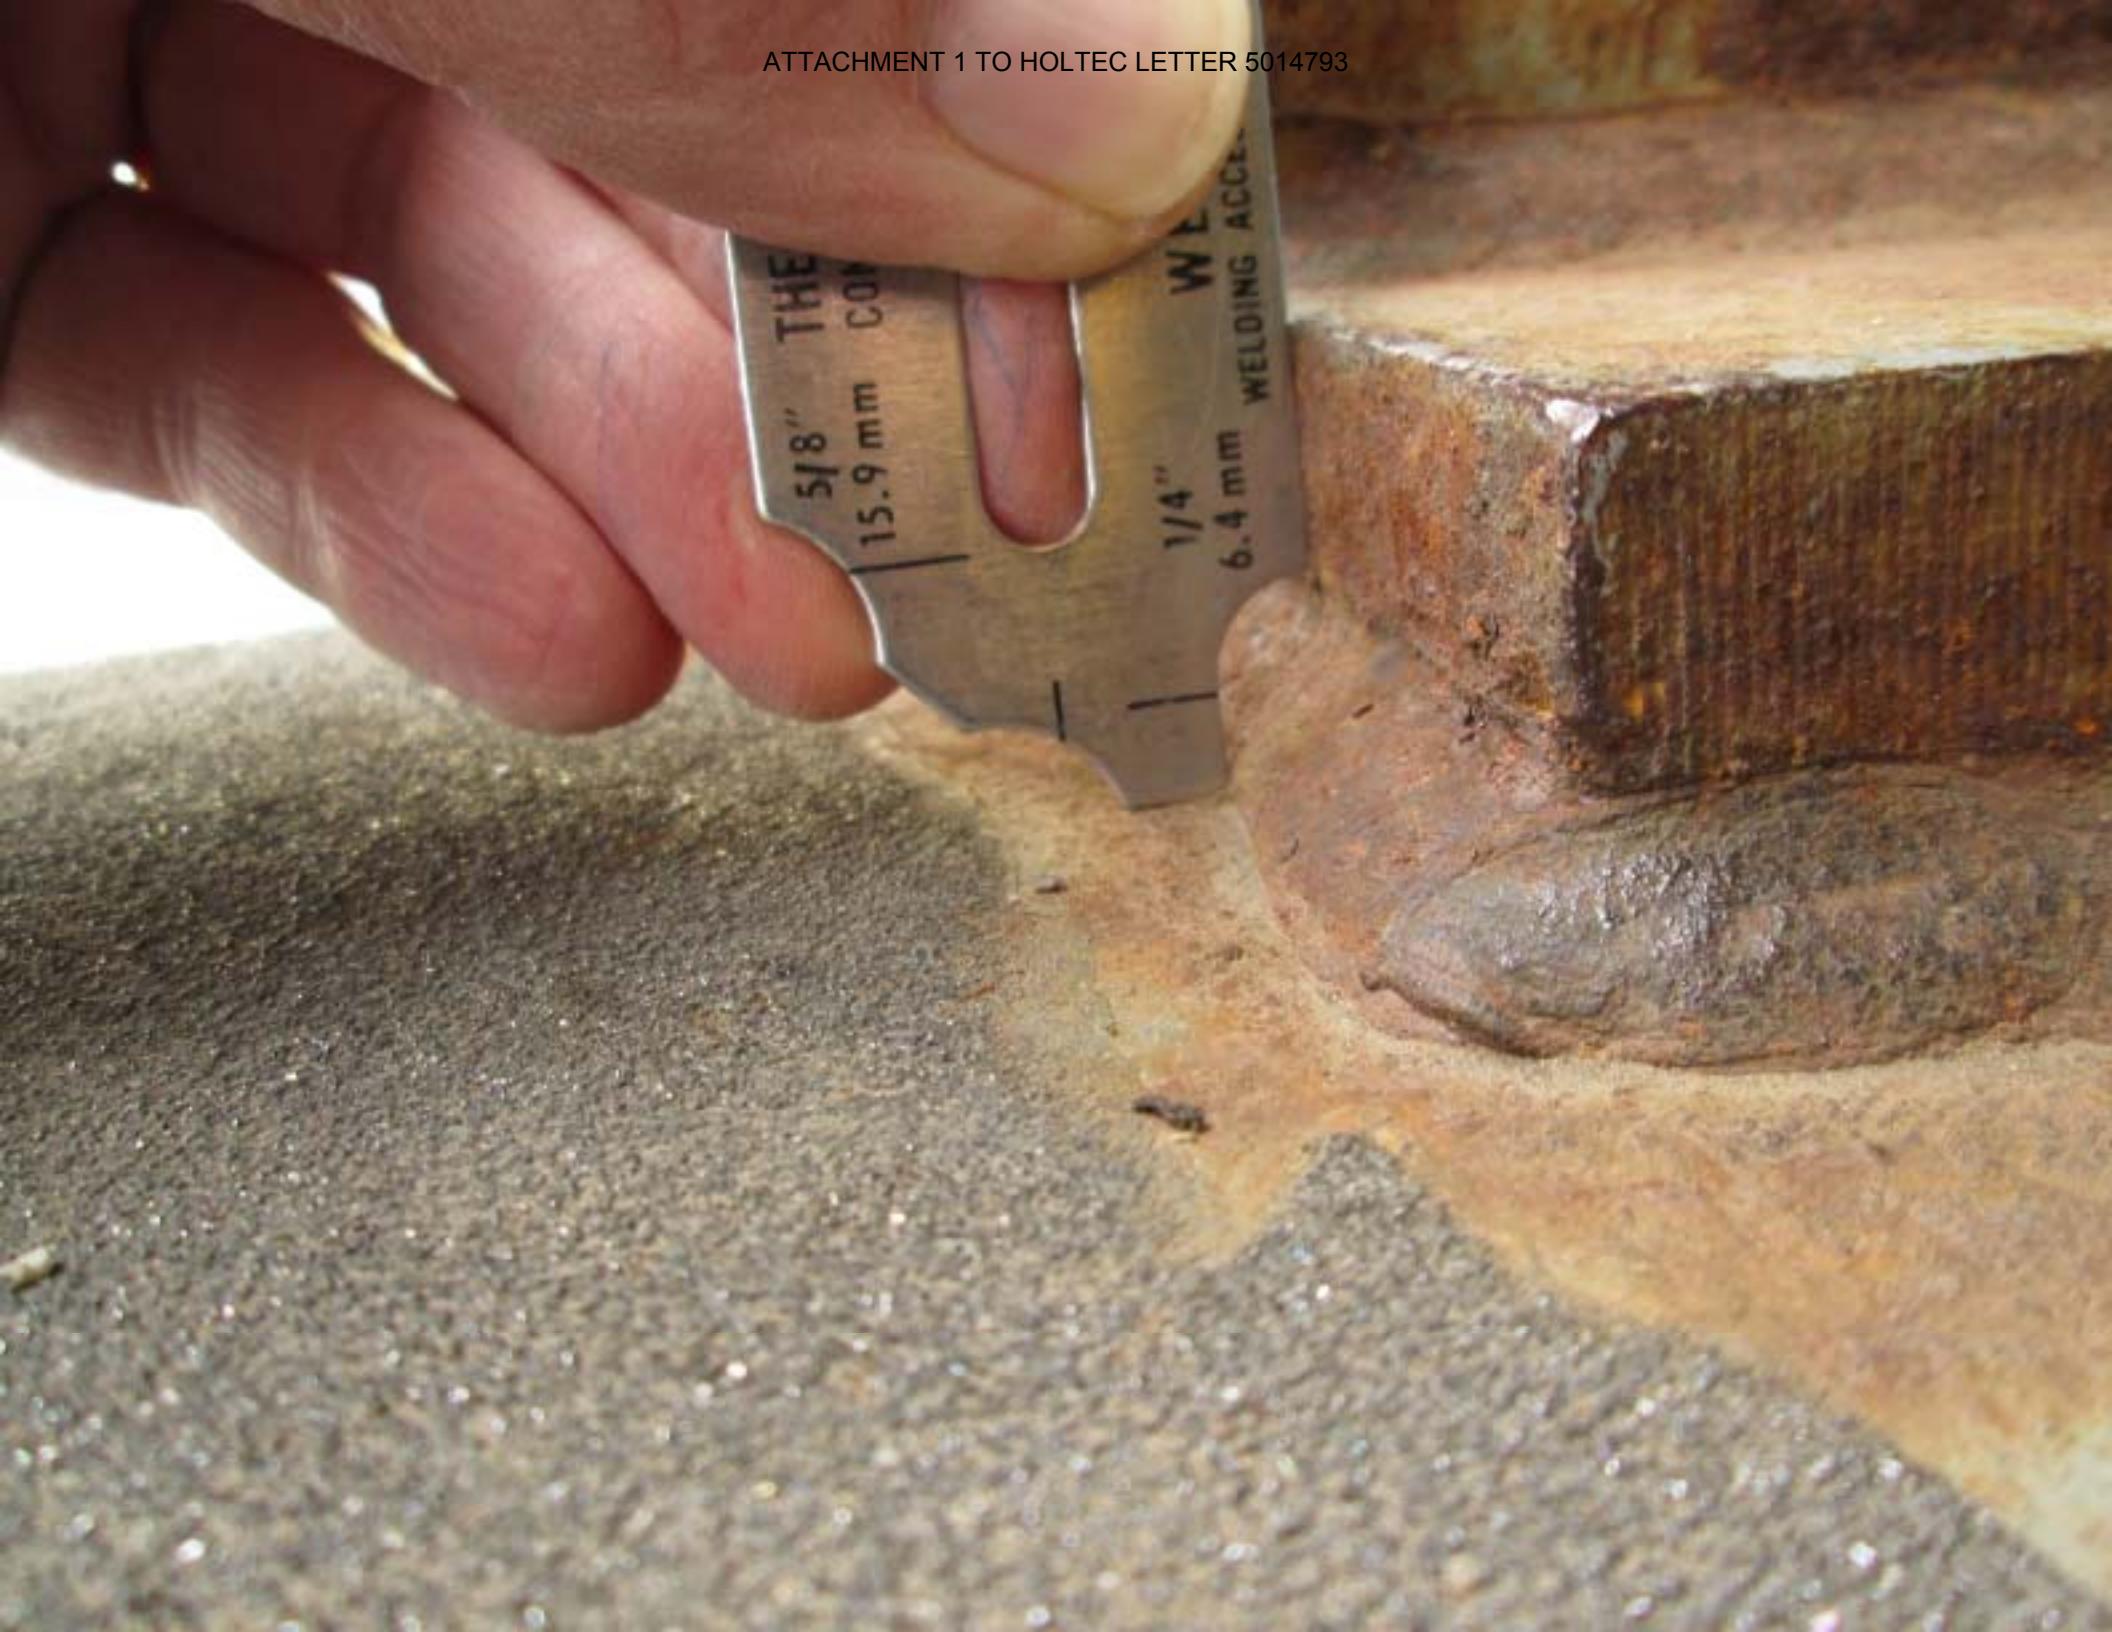
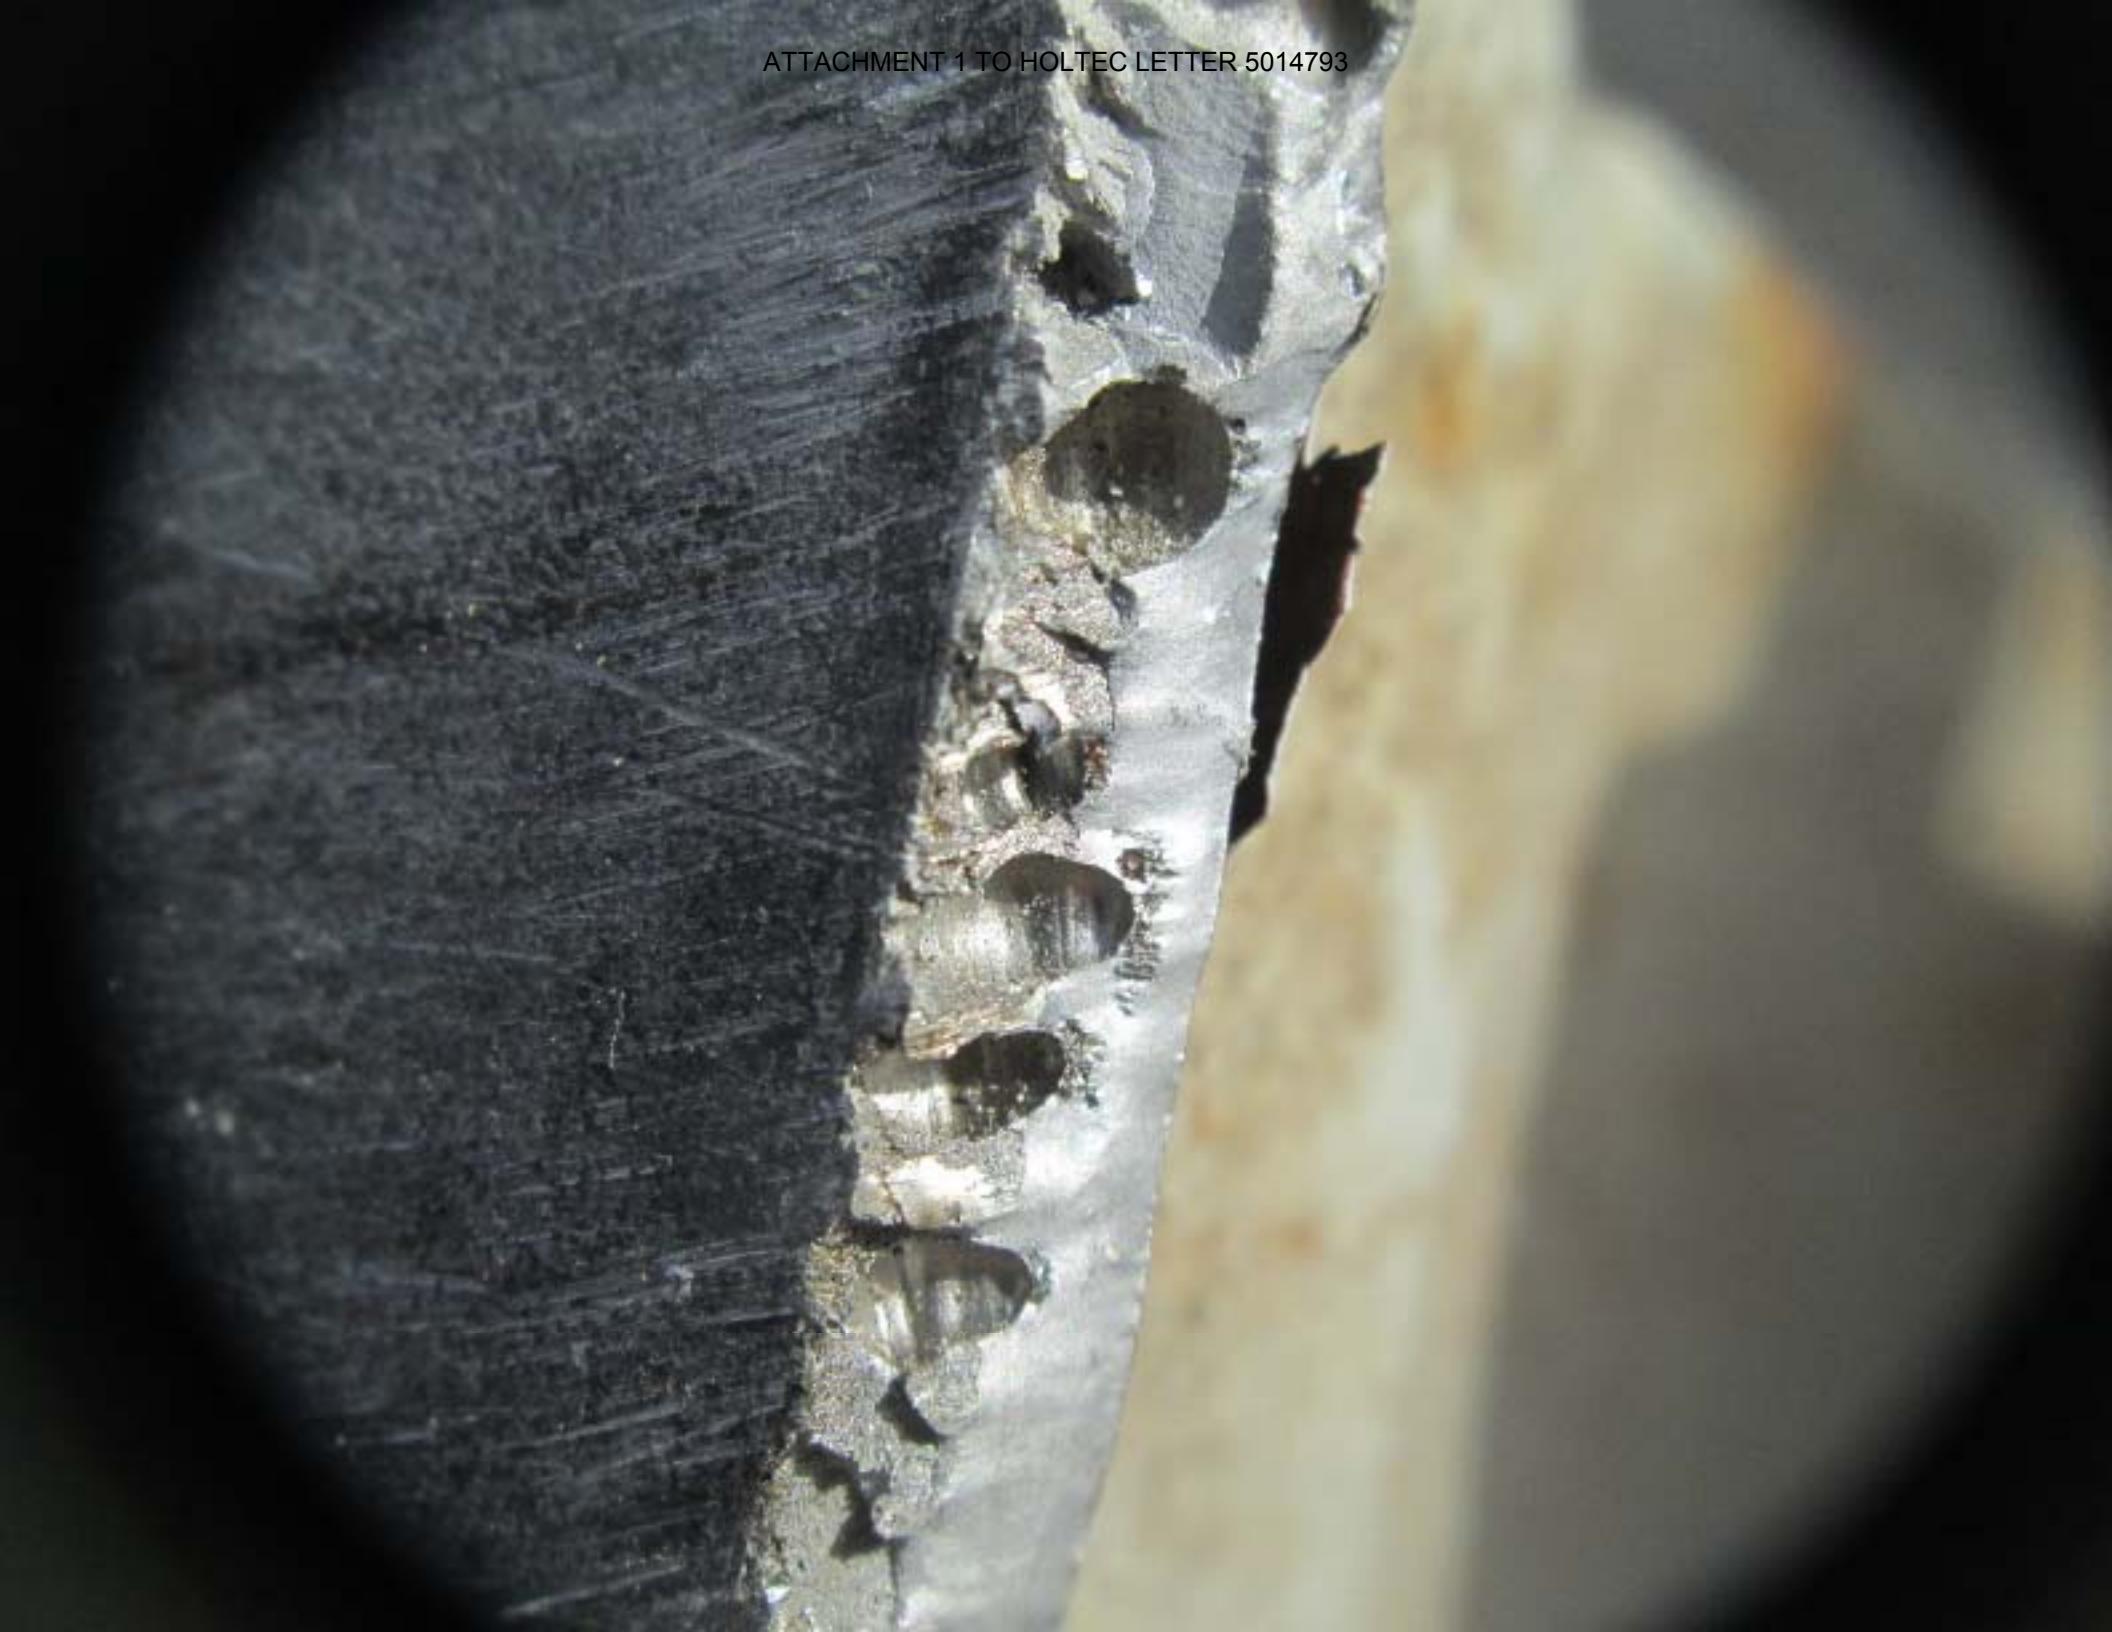
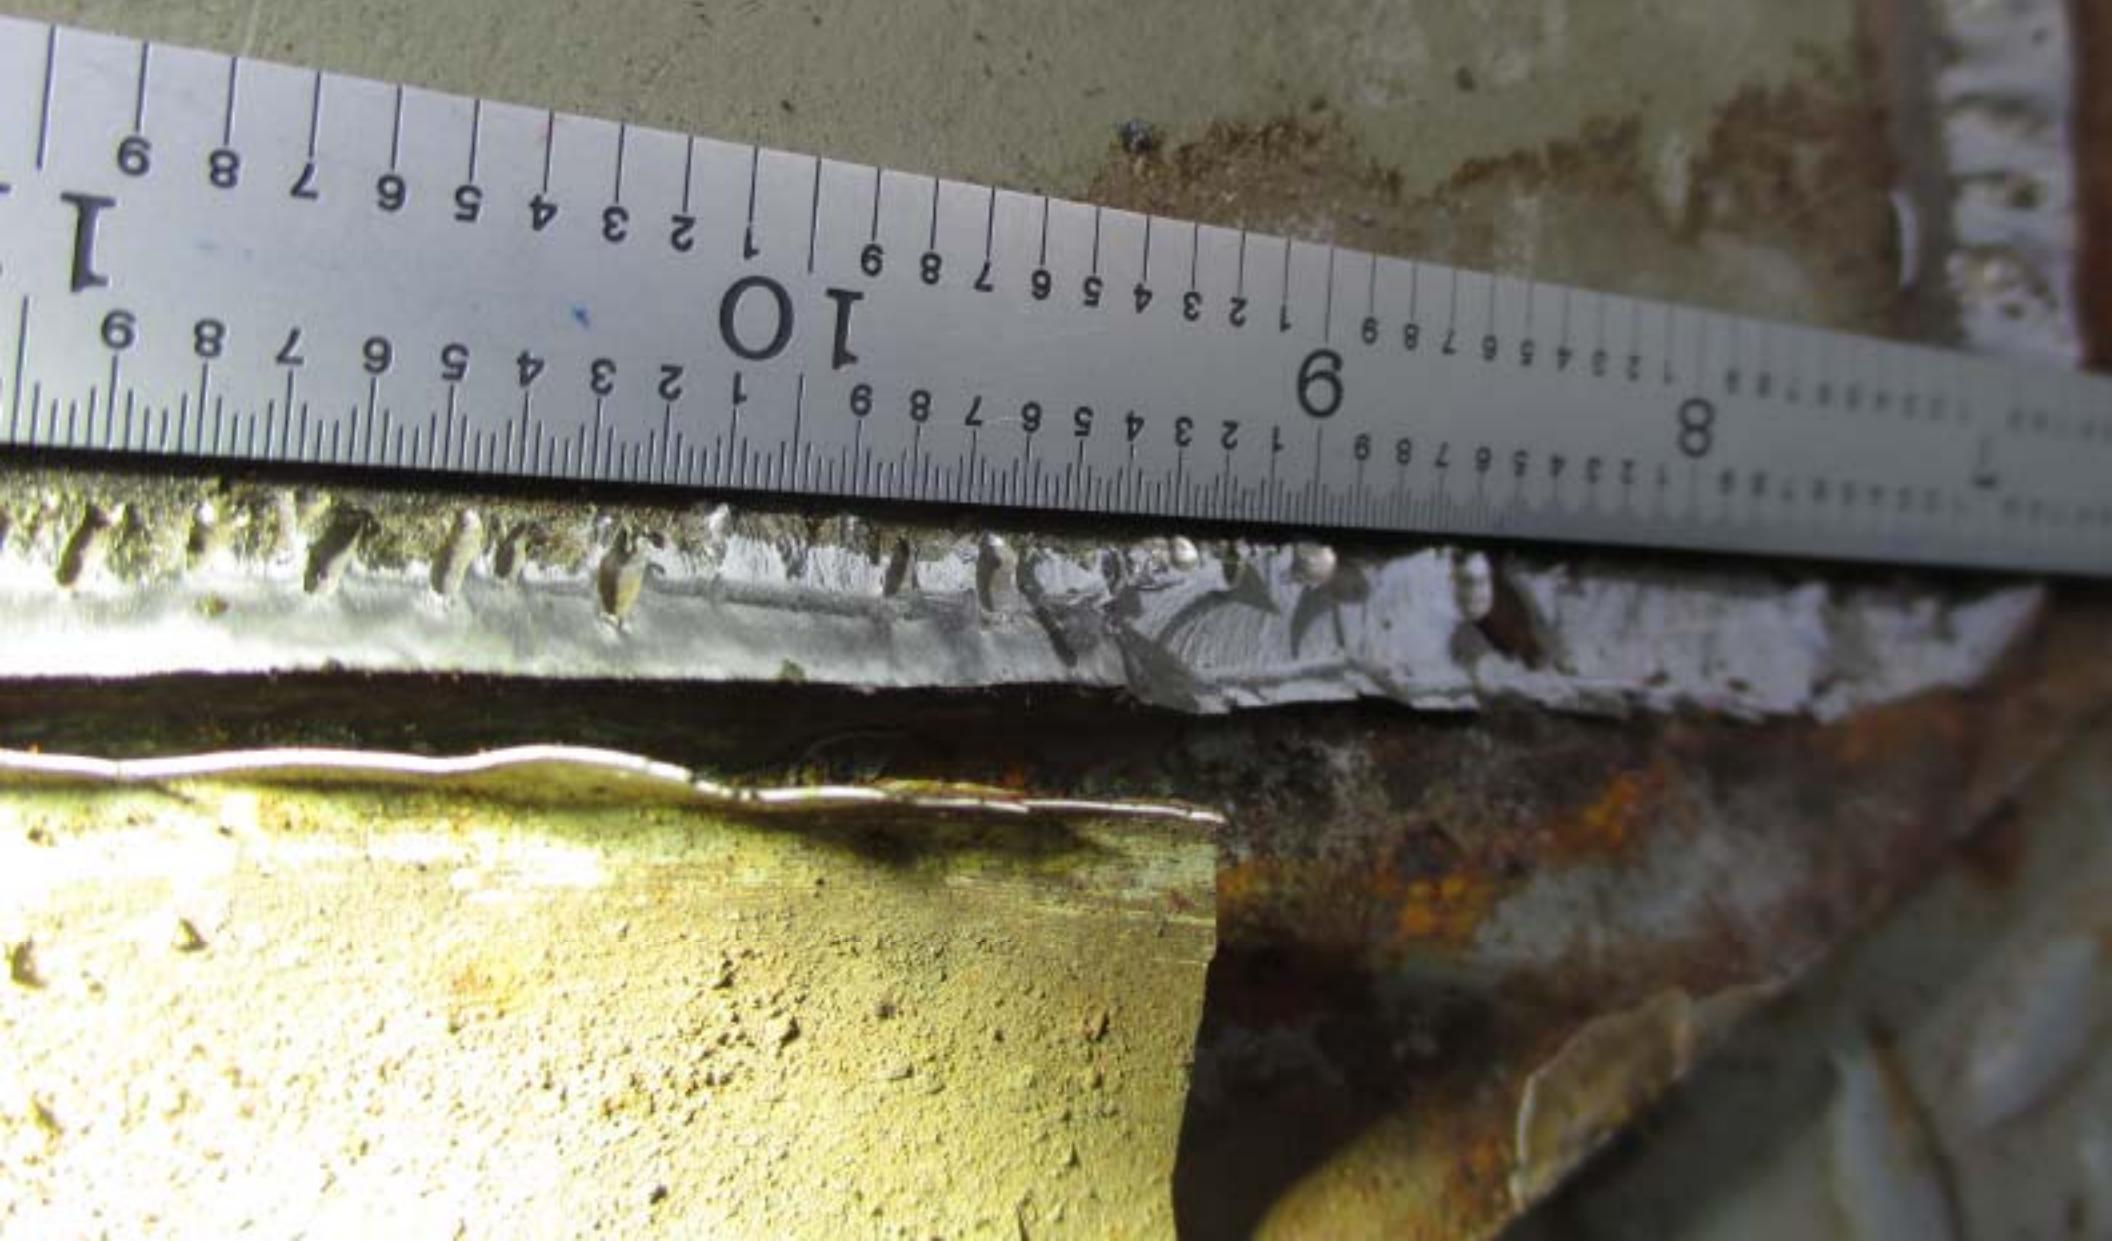
ATTACHMENTS (List all attachments, if any): Photos (provided by courtesy of Diablo Canyon)

- The weld performed on the VCT restraint strap mounts did not meet the minimum weld size of a 3/8" fillet weld specified by the drawing (pictures attached).

- The drawing calls for an all-around weld which was not possible as the mount partially extended over a cutout in the VCT deck for routing of hydraulic hoses. The weld ended adjacent to the cutout and did not wrap down and along the bottom of the mount to weld the transporter plate at the hole. If this had been done then the weld would have met the intentions of an "all around" fillet weld.

- Paint was present at the base metal where the mount was welded. Standard practices were not followed which led to the weld being deposited over a painted surface.

- Large porosity pores were noted in some portions of the failed weld, likely a result from welding on the painted surface.
- Lack of fusion at the weld root was noted in some instances.

- Rusting on the underside of the weld suggests this weld had failed over an extended period of time.

As a corrective action, a weld repair of the failed belly band mount was performed by Diablo Canyon. In addition, the driver's side mount, which did not fail, was also proactively repaired as there were sections of weld not meeting the minimum weld size called out on fabrication drawing (see attached pictures). Once both sides were successfully repaired, the transporter was used to finish out Diablo's 2015 loading campaign with no further VCT weld issues reported.

- Holtec recommends that all users owning a Lift Systems manufactured VCT add a visual inspection of the clevis to deck assembly weld into their VCT maintenance programs and perform this inspection prior to their next campaign. If there are visible cracks or stress induced defects to the weld, the weld should be repaired accordingly.
- Owners of J&R and MMH/KoneCrane manufactured VCTs may add the equivalent systems weld to their VCT maintenance programs as a defense in depth approach, however this matter is believed to be isolated to a single vendor at this time.
- Sites shall continue to stress the importance of situational awareness practices and instruct workers to stay clear of anchorage points in pre-job briefings.
