NL-15-087

SUBJECT: Licensee Event Report # 2015-005-00, "Automatic Reactor Trip Due to a Turbine-Generator Trip Caused by the Trip of 345kV Main Generator Output Breaker 3 due to a Failure of South Ring Bus 345kV Breaker 5"
Indian Point Unit No. 3
Docket No. 50-286
DPR-64

LICENSEE EVENT REPORT (LER)

4. TITLE: Automatic Reactor Trip Due to a Turbine-Generator Trip Caused by the Trip of 345kV Main Generator Output Breaker 3 due to a Failure of South Ring Bus 345kV Breaker 5

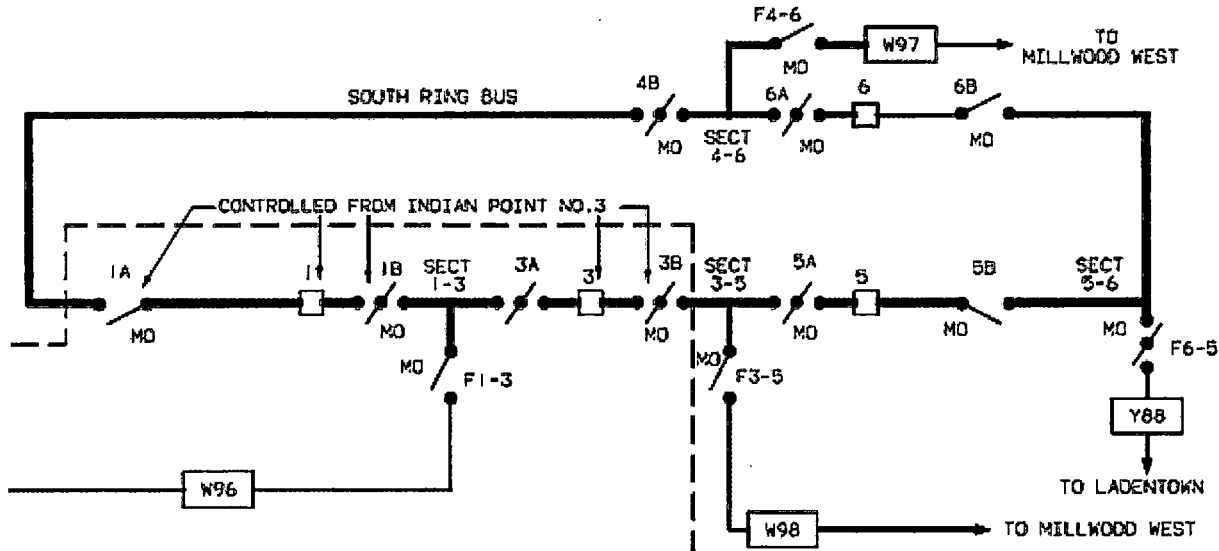
Figure of South Ring Bus at Buchanan 345kV Substation

The Unit 3 High Voltage Electrical Distribution System consists of the following subsystems: 1) 22kV system, 2) 345kV system, and 3) 138kV and 13.8kV system. The Unit 3 Main Generator supplies electrical power at 22kV through isolated phase bus to the two Main Transformers (MT). The MTs increase the voltage of the generator output to 345kV which is transmitted to the Buchanan Substation South Ring Bus via feeder W96. The Buchanan Substation contains two 345kV Ring Buses (North and South) and a 138kV bus. The South Ring Bus is normally supplied by Unit 3 and the North Ring Bus by Unit 2. The South Ring Bus is connected to the Millwood West Substation via two feeders, W97 and W98 and to the Ladentown Substation via feeder Y88. The South Ring Bus consists of four 345kV breakers, numbered 1, 3, 5 and 6. The 345kV breaker #5 was a Power Circuit Breaker, Type 345GA 25-30, SN 41-39006-2044, manufactured by ITE Imperial Corporation {I004} in 1971 and installed in 1973. This breaker is owned by Con Edison.

The apparent cause has not been determined. Con Edison who owns breaker 5 will perform a detailed failure analysis with assistance from the breaker manufacturer and determine the root cause and provide a report to Entergy. The direct cause of the RT was an internal fault to ground of the 345 kV Breaker 5 Phase C. An initial internal inspection of breaker 5 revealed extensive damage to Phase C. The trip of breaker 5 activated protective relays that opened breaker 3 which caused a direct generator trip resulting in a turbine trip and RT.

- A detailed inspection and failure analysis of 345kV breaker 5 is being performed by Con Edison to identify the specific failure mechanism and root cause. The Con Edison report will be provided to Entergy and the Entergy Apparent Cause Evaluation will be updated.
- 345kV Breaker 5 will be replaced by Con Edison.
- This LER will be revised as necessary based on the results of the Con Edison report after breaker inspection and evaluation.
