NL-15-087

SUBJECT: Licensee Event Report # 2015-005-00, "Automatic Reactor Trip Due to a Turbine-Generator Trip Caused by the Trip of 345kV Main Generator Output Breaker 3 due to a Failure of South Ring Bus 345kV Breaker 5"
Indian Point Unit No. 3
Docket No. 50-286
DPR-64

1. FACILITY NAME: INDIAN POINT 3

4. TITLE: Automatic Reactor Trip Due to a Turbine-Generator Trip Caused by the Trip of 345kV Main Generator Output Breaker 3 due to a Failure of South Ring Bus 345kV Breaker 5

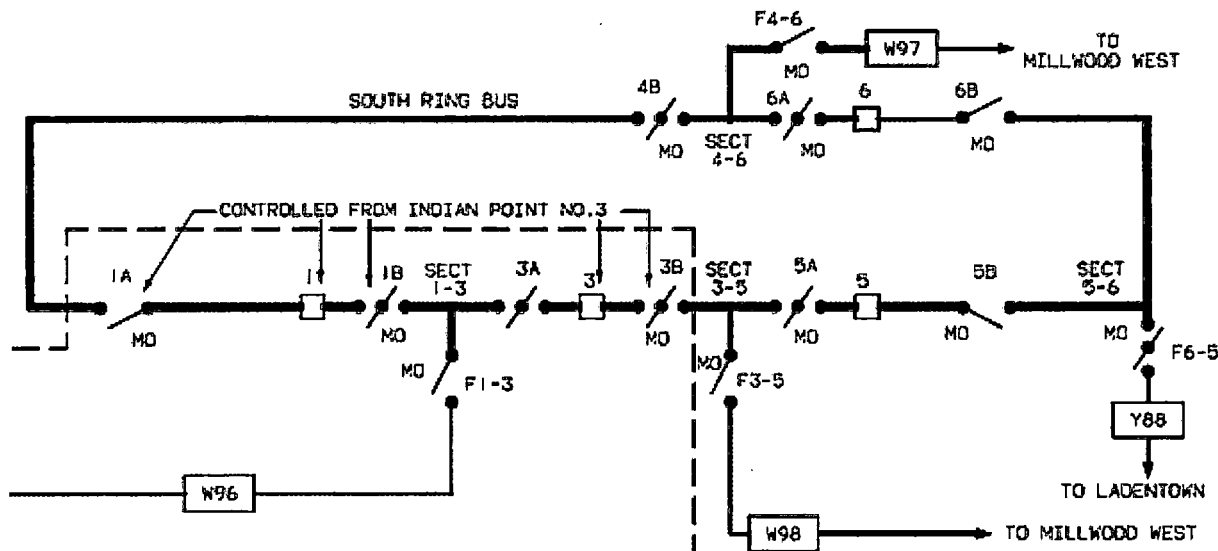
Figure of South Ring Bus at Buchanan 345kV Substation

As a result of two successive in-service failures of breaker 3, both breaker 1 and 3 were replaced with HVB Model SF6 circuit breakers. Con Edison has also replaced breaker 6 leaving no other same style 345kV breakers in the Buchanan switchyard. 138kV breakers are considered similar in that they are high power circuit breakers. 138kV breaker BT5-6 is manufactured by ITE. Based on the results of Preventive Maintenance (PM)s performed on BT5-6, it was determined the probability of an in-service failure was medium. 138kV breaker BT5-6 is scheduled for replacement in the 2019 refueling outage. The PMs performed and their periodicities are consistent with ENN-EP-G-004 (Switchyard and Large Power Transformer Preventive Maintenance Guidelines). A review of the PM results did not show any negative or degrading trend.

The apparent cause has not been determined. Con Edison who owns breaker 5 will perform a detailed failure analysis with assistance from the breaker manufacturer and determine the root cause and provide a report to Entergy. The direct cause of the RT was an internal fault to ground of the 345 kV Breaker 5 Phase C. An initial internal inspection of breaker 5 revealed extensive damage to Phase C. The trip of breaker 5 activated protective relays that opened breaker 3 which caused a direct generator trip resulting in a turbine trip and RT.

- A detailed inspection and failure analysis of 345kV breaker 5 is being performed by Con Edison to identify the specific failure mechanism and root cause. The Con Edison report will be provided to Entergy and the Entergy Apparent Cause Evaluation will be updated.
- 345kV Breaker 5 will be replaced by Con Edison.
- This LER will be revised as necessary based on the results of the Con Edison report after breaker inspection and evaluation.
