Edwin I. Hatch Nuclear Plant  
10 CFR 71.95 Report on Potential Issues Involving Radwaste Cask 8-120B

**Subject: 10 CFR 71.95 Report on the 8-120B Cask**

**Failure to Observe Certificate of Compliance Conditions  
for the 8-120B Vent Port Pre-Shipment Leak Test**

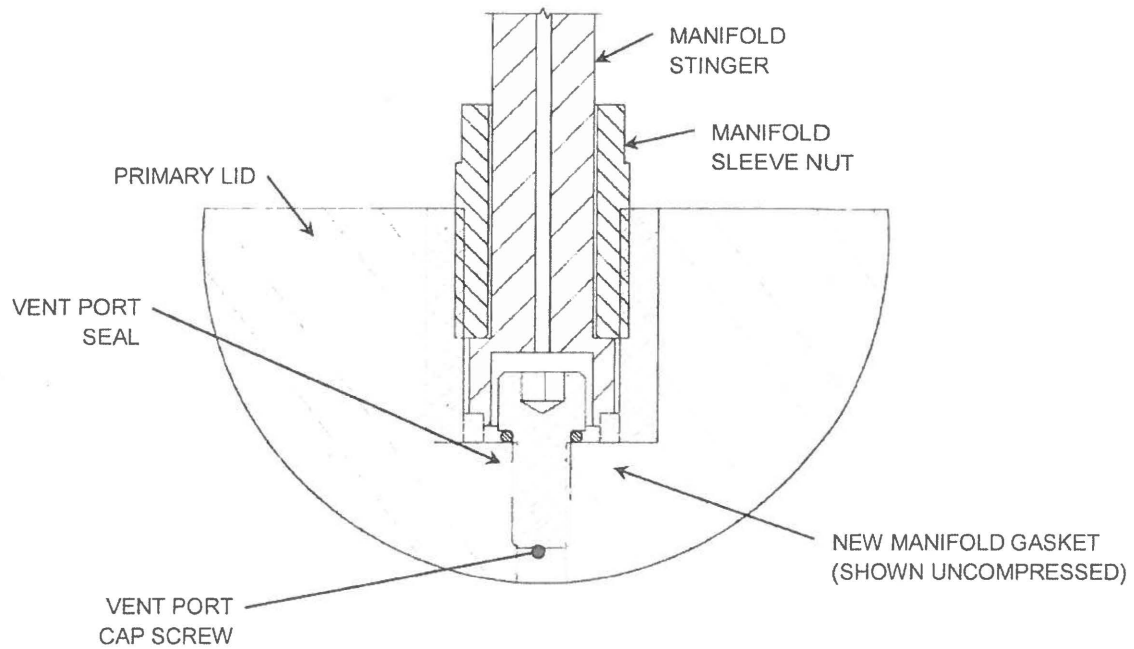
Corrective Action – Modified Test Seal

The neoprene gasket can constrict on the head of the vent port plug cap screw when it is compressed by the bottom end of the test manifold stinger, which could reduce the sensitivity of the pre-shipment leak test. Consequently, the vent port pre-shipment leak tests performed using the neoprene gasket may not have provided the required test sensitivity of  $1 \times 10^{-3}$  ref-cm<sup>3</sup>/sec.

The new manifold gasket design, shown below, replaces the manifold O-ring seal and neoprene gasket previously used with a neoprene gasket that fits within the notch at the base of the manifold stinger.

- EnergySolutions notified all 8-120B cask users with upcoming shipments to require use of a new procedure, in conjunction with the new manifold gasket design, for pre-shipment leak testing of the vent port seal on all future shipments.
- EnergySolutions designed and tested new manifold gasket design that does not constrict onto the head of the vent port plus screw when compressed, and therefore it does not reduce the test sensitivity. The new gaskets have been distributed to all upcoming shipment users. The new manifold gasket design is shown in Attachment 1.

The EnergySolutions drawing for the 8-120B air drop manifold have been revised to include the new gasket seal, and the air pressure drop test procedure TR-TP-002 has been revised to incorporate the new pre-shipment leak test procedure for the vent port. Use of the new procedure and the new manifold gasket will assure that the pre-shipment leak test satisfies the required test sensitivity and that the manifold gasket is removed from the test port after completing the pre-shipment leak test.
