ZS-2015-0131

Subject: 10 CFR 71.95 Report on the 8-120B Cask

Failure to Observe Certificate of Compliance Conditions for the 8-120B Vent Port Pre-Shipment Leak Test

Details of the 8-120B Vent Port Leak Rate Test Setup

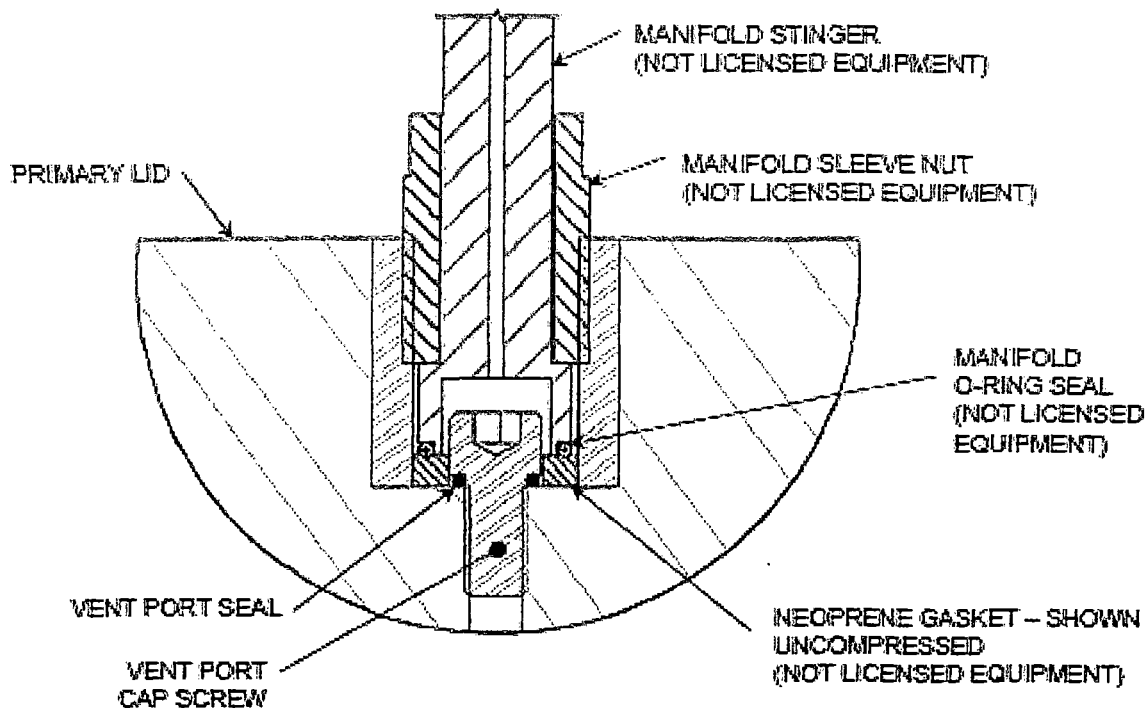
The neoprene gasket can constrict on the head of the vent port plug cap screw when it is compressed by the bottom end of the test manifold stinger, which could reduce the sensitivity of the pre-shipment leak test. Consequently, the vent port pre-shipment leak tests performed using the neoprene gasket may not have provided the required test sensitivity of 1×10^{-3} ref-cm³/sec.

On Monday June 1, 2015, an 8-120B cask user identified a concern that the neoprene gasket could potentially affect the integrity of the vent port seal pre-shipment leak test. Later that week EnergySolutions performed a bench test that confirmed that the neoprene gasket can constrict on the head of the vent port plug cap screw when it is compressed by the manifold, resulting in a reduction of the test sensitivity.

The pre-shipment leak test of the vent port is a pressure drop test performed using a dedicated test manifold. The test manifold is not a part of the licensed package. It includes a stinger (shown below), an O-ring seal that contacts the stinger and the bottom of the vent port hole, and a sleeve nut to compress the O-ring seal. The test manifold was designed so that it surrounds the vent port cap screw, leaving a small gap between itself and the vent port cap screw. The 8-120B cask fleet began to ship with a new lid design in September 2013, and operations staff noted more frequent difficulty getting the manifold to seal. It became desirable to find a better way to seal the bottom of the manifold in order to minimize operator exposure. They found that adding a neoprene gasket (also not part of the licensed package) under the base of the stinger as shown below helped reduce testing time and exposure.
