SUBJECT: 10 CFR 71.95 Report Involving 8-120B Cask
Vermont Yankee Nuclear Power Station
Docket No. 50-271
License No. DPR-28

Energy Solutions 10CFR 71.95 Report on the 8-120B Cask

**Failure to Observe Certificate of Compliance Conditions
for the 8-120B Vent Port Pre-Shipment Leak Test**

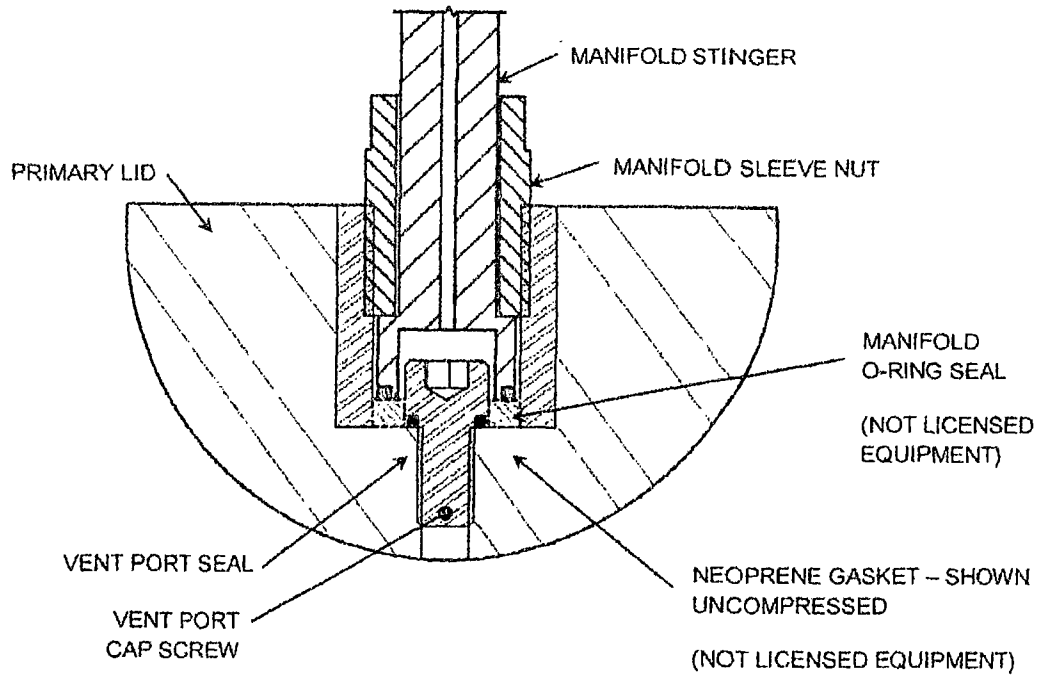
The neoprene gasket can constrict on the head of the vent port plug cap screw when it is compressed by the bottom end of the test manifold stinger, which could reduce the sensitivity of the pre-shipment leak test. Consequently, the vent port pre-shipment leak tests performed using the neoprene gasket may not have provided the required test sensitivity of 1×10^{-3} ref-cm³/sec.

On Monday June 1, 2015, an 8-120B cask user identified a concern that the neoprene gasket could potentially affect the integrity of the vent port seal pre-shipment leak test. Later that week *EnergySolutions* performed a bench test that confirmed that the neoprene gasket can constrict on the head of the vent port plug cap screw when it is compressed by the manifold, resulting in a reduction of the test sensitivity.

The pre-shipment leak test of the vent port is a pressure drop test performed using a dedicated test manifold. The test manifold is not a part of the licensed package. It includes a stinger (shown below), an O-ring seal that contacts the stinger and the bottom of the vent port hole, and a sleeve nut to compress the O-ring seal. The test manifold was designed so that it surrounds the vent port cap screw, leaving a small gap between itself and the vent port cap screw. The 8-120B cask fleet began to ship with a new lid design in September 2013, and operations staff noted more frequent difficulty getting the manifold to seal. It became desirable to find a better way to seal the bottom of the manifold in order to minimize operator exposure. They found that adding a neoprene gasket (also not part of the licensed package) under the base of the stinger as shown below helped reduce testing time and exposure.
