Subject: Oconee Nuclear Station Units 1, 2, & 3
Docket Nos. 50-269, 270, 287
Response to Request for Additional Information Concerning Generic Letter
95-03

OCONEE NUCLEAR STATION
RESPONSE TO RAI FOR GL 95-03

Response to Request for Additional Information Regarding Circumferential Cracking of Steam Generator Tubes - Oconee, Unit 1, 2, and 3

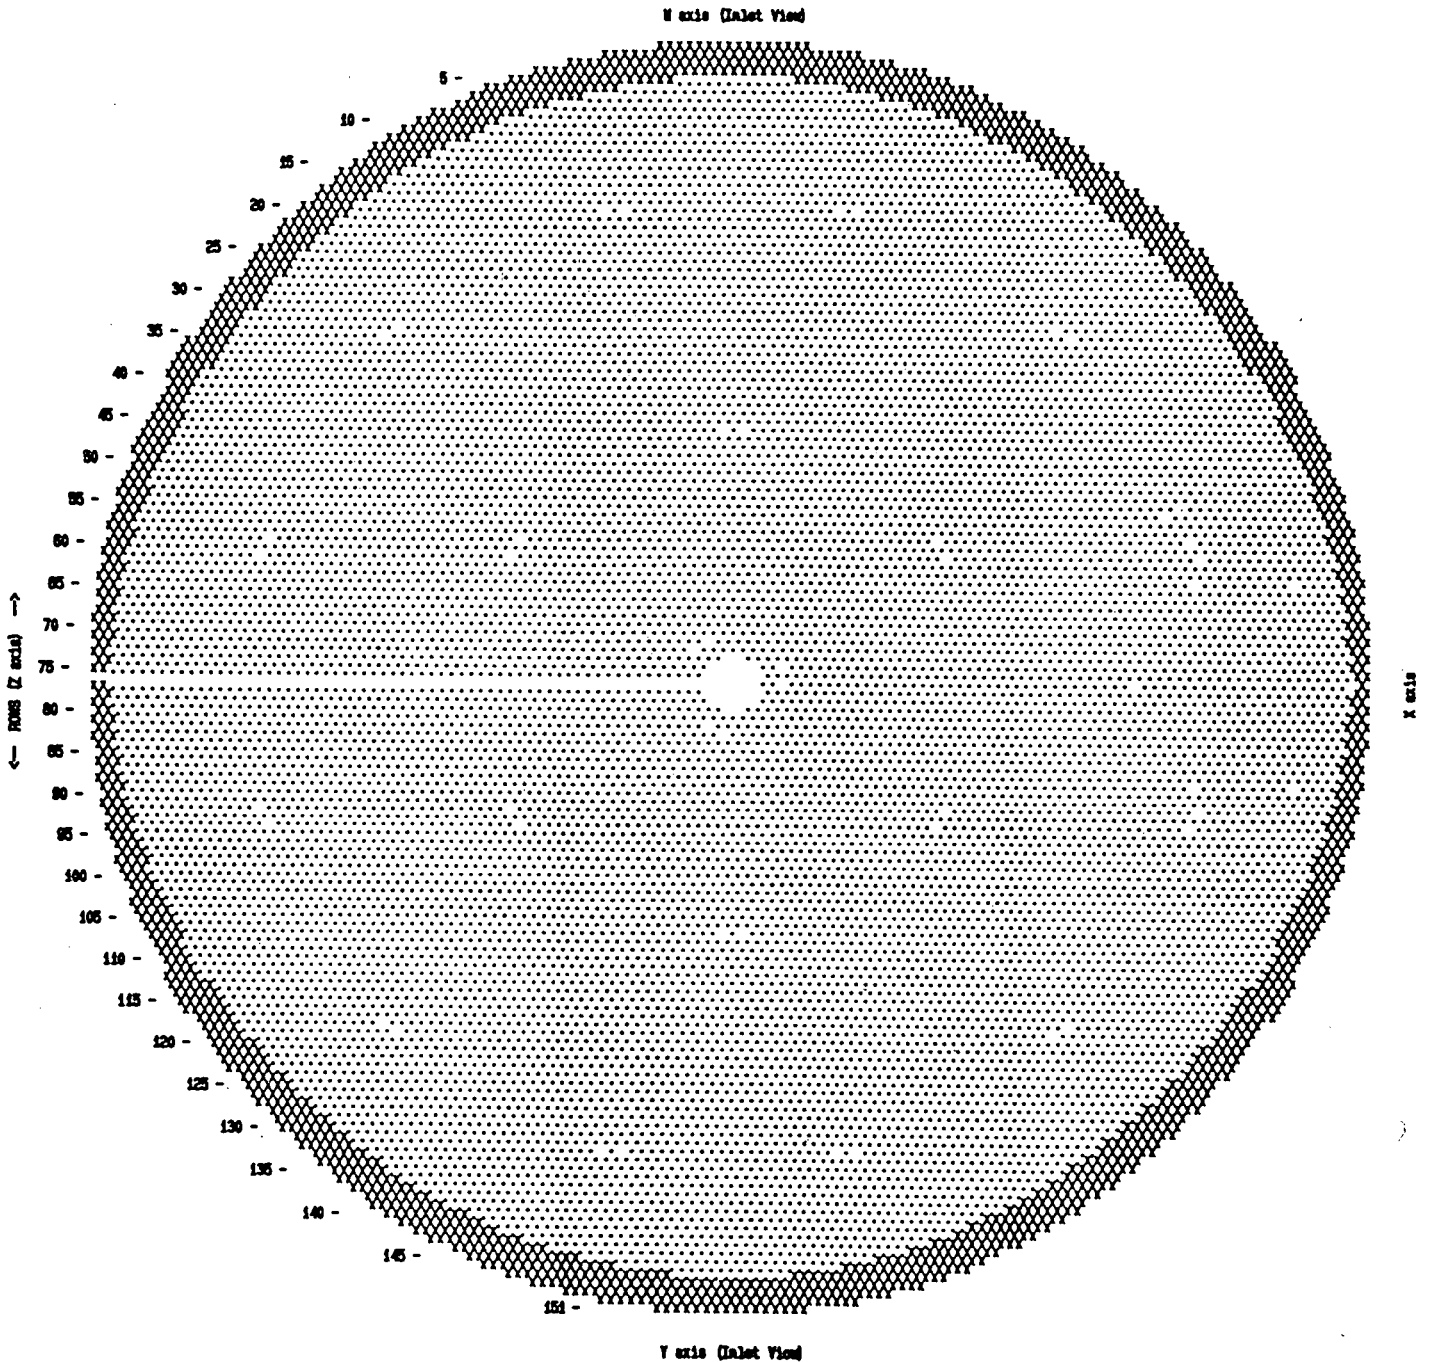
FIGURE 1

1. The B&W generic response indicated that all of the TSP's had broached holes. This information is correct except that there are drilled holes around the periphery of the 15th TSP as shown in figure 1.

As indicated in the question 1 response, the drilled holes are located at the 15th TSP. The denting at TSP's has been limited to broached hole locations.

DRILLED ONLY 15th TSP TUBE HOLES

x = 15th TSP DRILLED ONLY (1621)
