SUBJECT: Forwards response to 820308 request for justification for continued operation in light of problems w/HPI nozzle thermal sleeve area. Safe operation justified through completion of respective fuel cycles for Units 2 & 3.

Re: Oconee Nuclear Station
Docket Nos. 50-269, -270, -287

OCONEE NUCLEAR STATION
STATUS OF HPI NOZZLES

ATTACHMENT 3

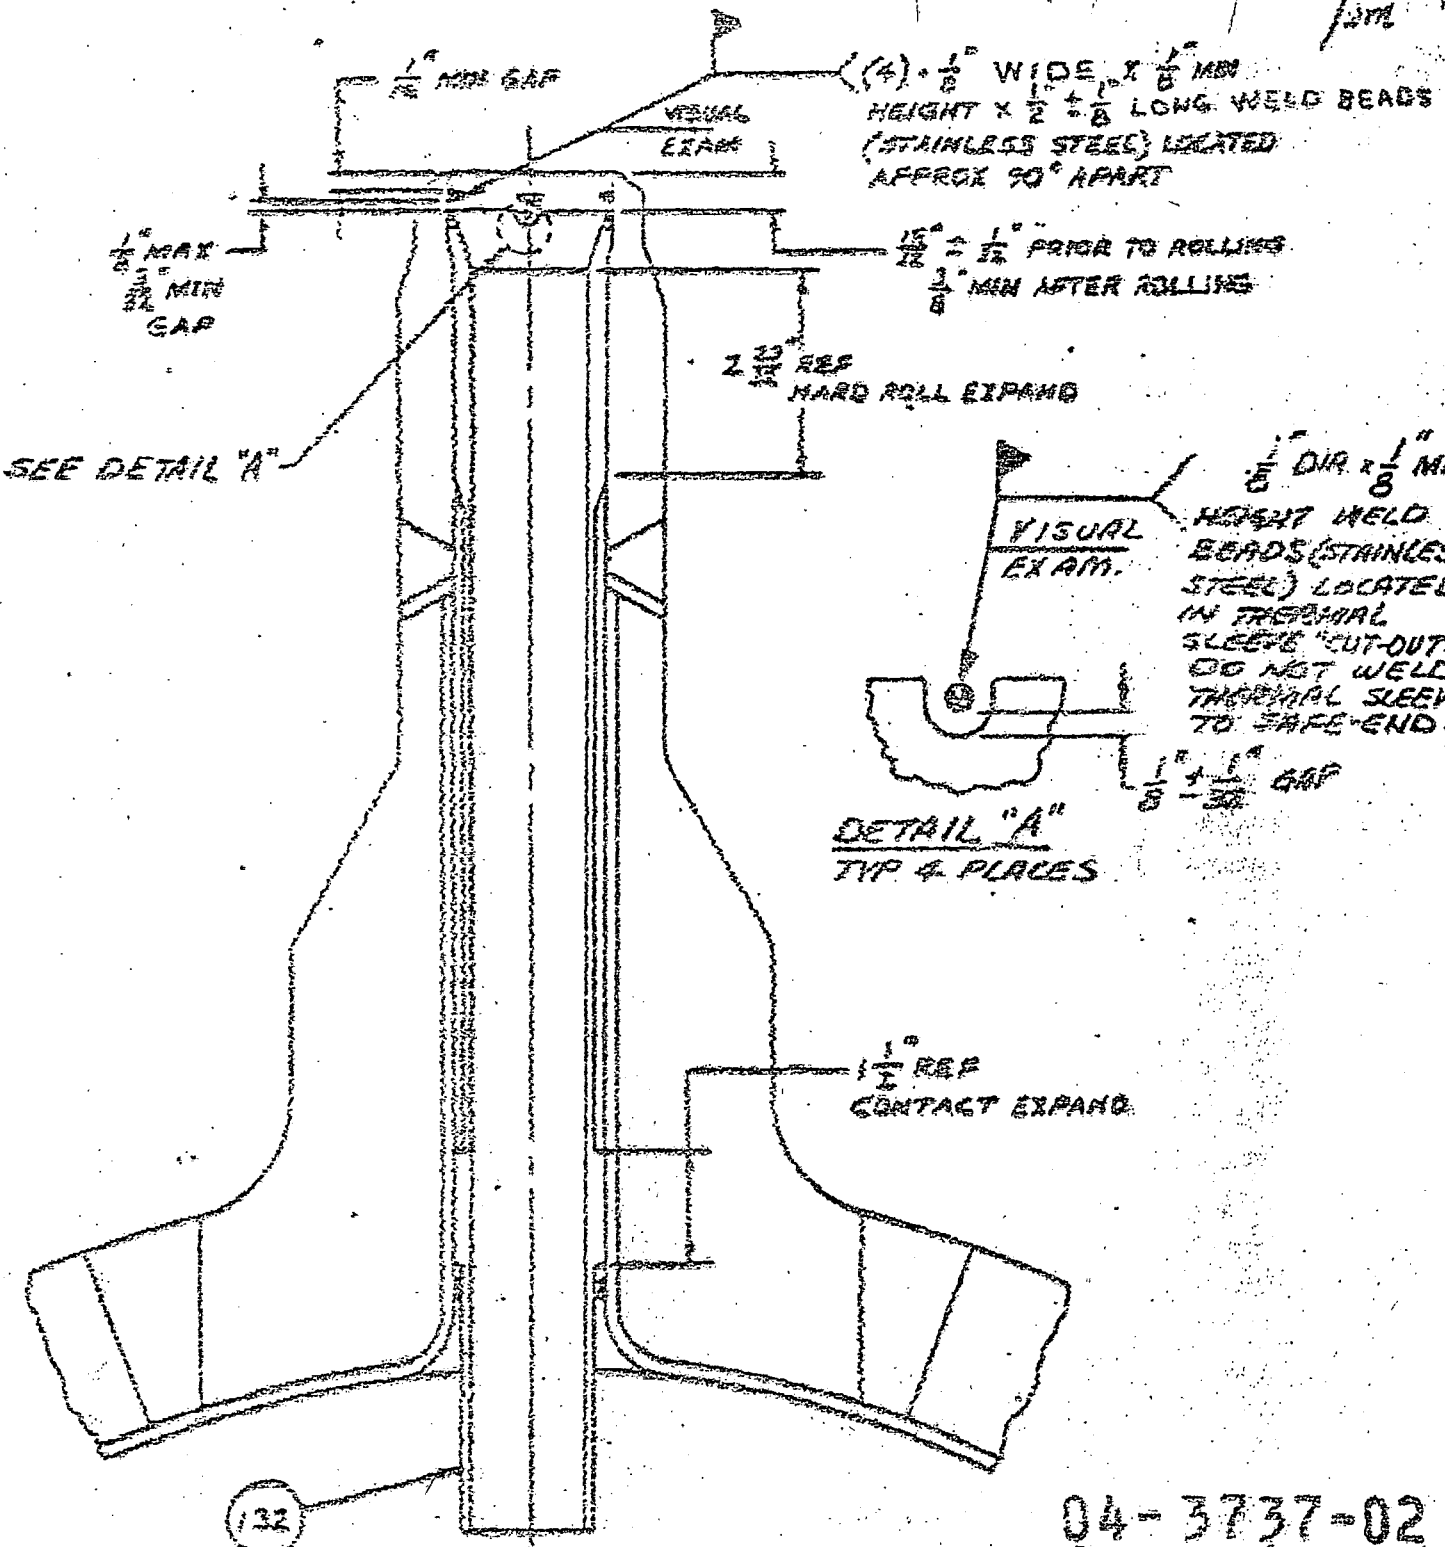
Repairs have been initiated to correct anomalies found on Oconee 2 and 3 nozzle areas. Attachment 3 shows the newly designed thermal sleeve modification being used to repair the 3A2 nozzle area. This design incorporates a safe end modification to facilitate thermal sleeve installation from the extension of the RC Piping. The outboard portion of the thermal sleeve/safe end interface area will be hard roll expanded and the inboard thermal sleeve/nozzle interface area will be contact roll expanded. The outboard end of the thermal sleeve also incorporates a flange which will prevent the sleeve from entering the reactor coolant system in the unlikely event that the roll expansion is lost. The radiograph of 3B1 nozzle area indicated the thermal sleeve is loose. To repair this thermal sleeve, the piping connection to the safe end will be cut, inspections of the accessible ID surface will be performed and the thermal sleeve will be hard roll expanded. This repair will return the nozzle area to its intended condition and has been conservatively analyzed to be acceptable for at least the remaining number of design HPI flow initiation cycles. This assumes that no indications are found on the internal surface inspections.

The repair effort on Oconee 2 has not been fully planned but is expected to be similar to the repairs on Oconee 3. The 2A2 safe end and thermal sleeve will be replaced with the new design safe end and thermal sleeve. The 2B1 and 2B2 thermal sleeves will be replaced with the new design thermal sleeve.
